**Jecks Place  
Housing Complex  
PRO 0702**

**Detailed Engineering Evaluation  
Quantitative Assessment Report**

# **Jecks Place Housing Complex**

## **Quantitative Assessment Report**

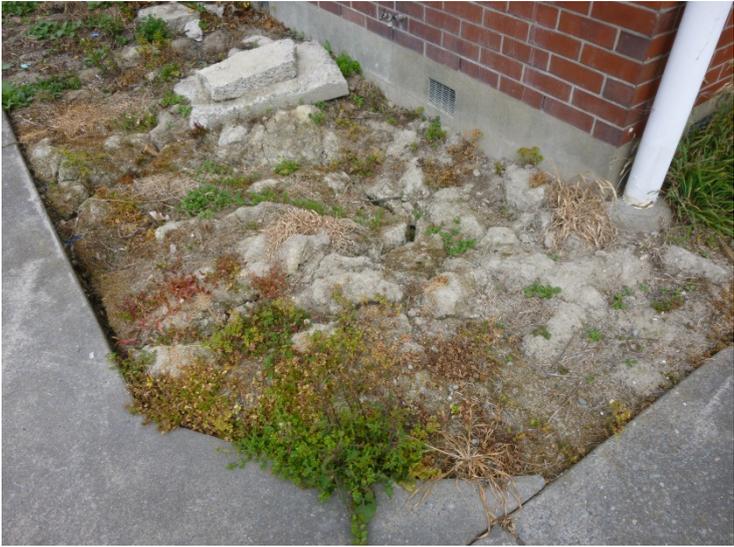
Minor land movement was observed in many of the units and the Residents Lounge. It was noted that there was evidence of land damage in garden plots and on the driveways (photos 17 and 18). As can be seen from the results of the level survey Blocks K and J were most affected by this residual displacement.

Damage		
17.	Land damage in garden plots

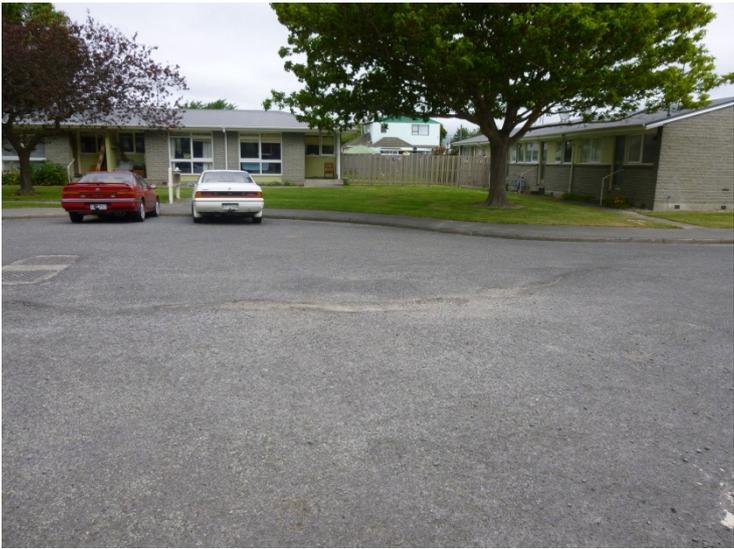
18.	Land damage creating swelling and large crack in road

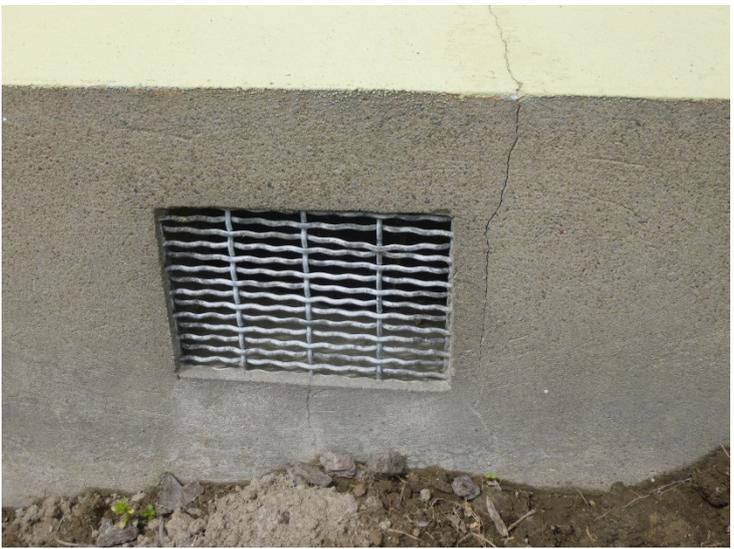
Cracking of the strip footing was observed. This ranged from hairline cracks in the render on the perimeter walls to significant cracks approximately 7mm wide extending through the concrete (photos 19-23). Cracking was typically observed around grates and pipes. In some cases this connected to stepped cracking in the veneer (see section 5.5). The piles themselves could not be checked for damage as there was no subfloor access.

19.	Typical hairline cracking of strip footing

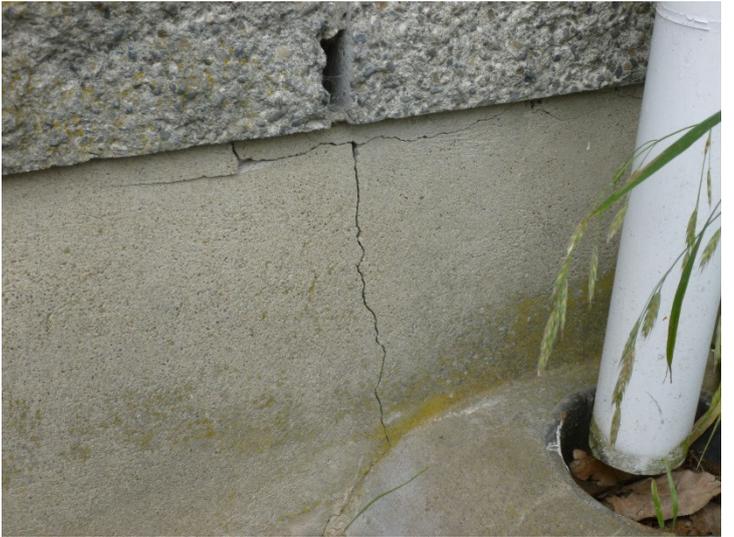
20.	Lateral cracking in strip footing

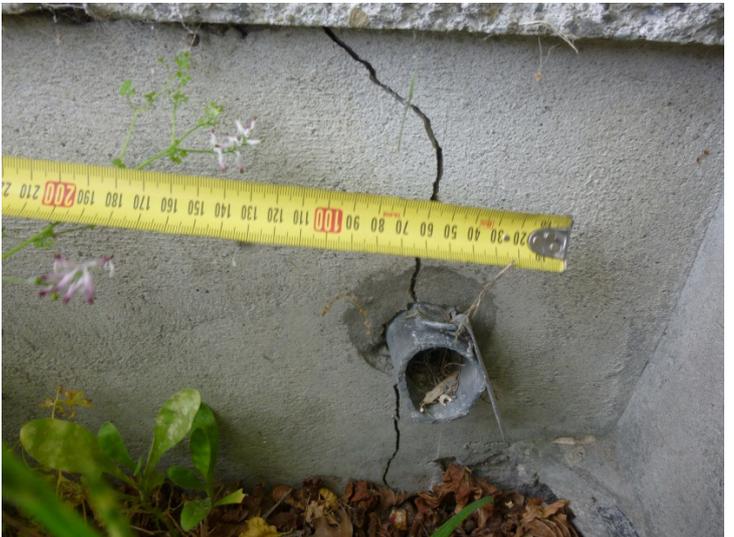
21.	Typical medium cracking of strip footing

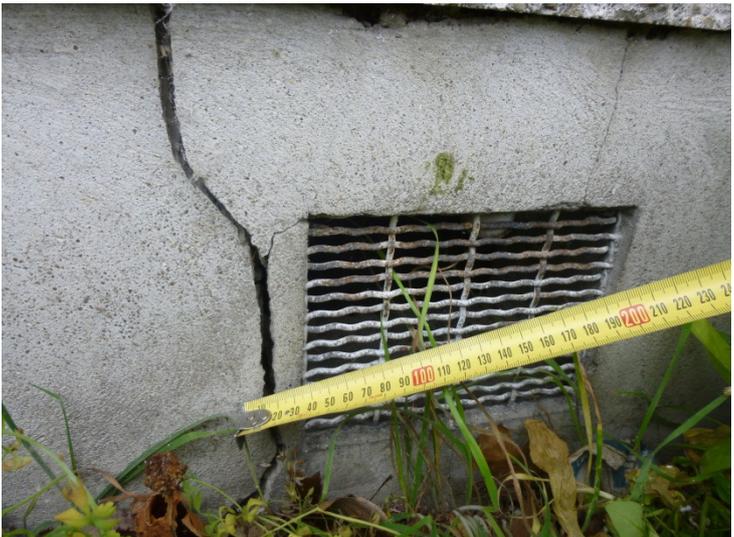
22.	Typical significant cracking of strip footing

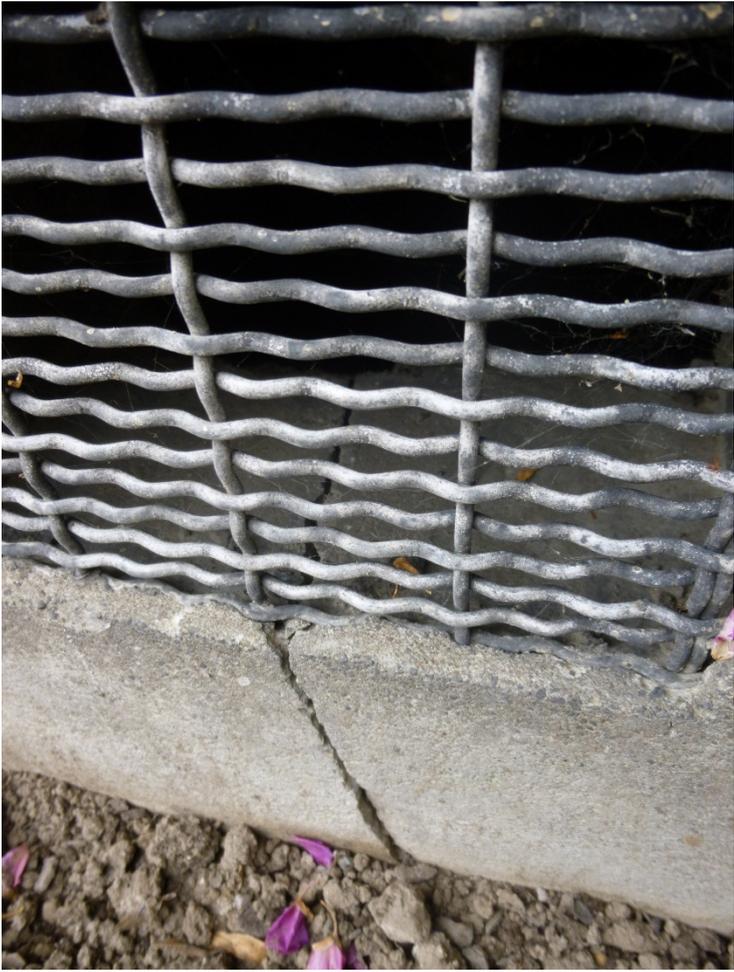
<p>23.</p>	<p>Cracking of strip footing through grate – shows cracking right through footing</p>

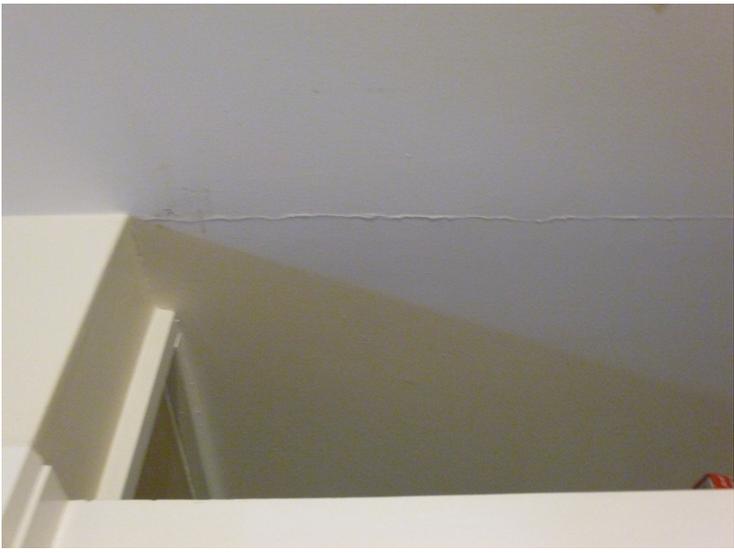
Cracking to the plasterboard ceiling diaphragm was observed in almost all units. This was characteristically a lateral crack running over the division between the living and bedroom areas (photo 24). Another typical crack was a lateral crack running through the living room from the corner of the chimney (photo 25). In some cases these lateral ceiling cracks have been plastered over (photo 26), although this damage was still noticeable.

<p>24.</p>	<p>Typical cracking in ceiling above division between living and sleeping spaces</p>

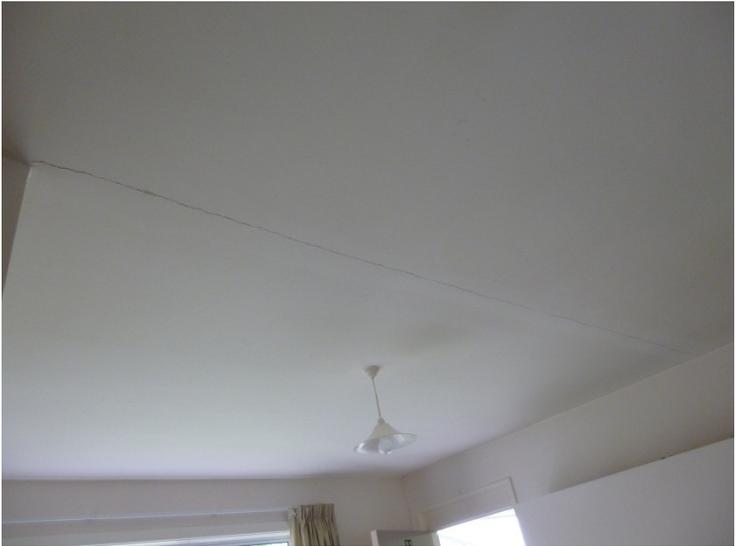
<p>25.</p>	<p>Typical cracking in ceiling above living room, running from corner of chimney</p>

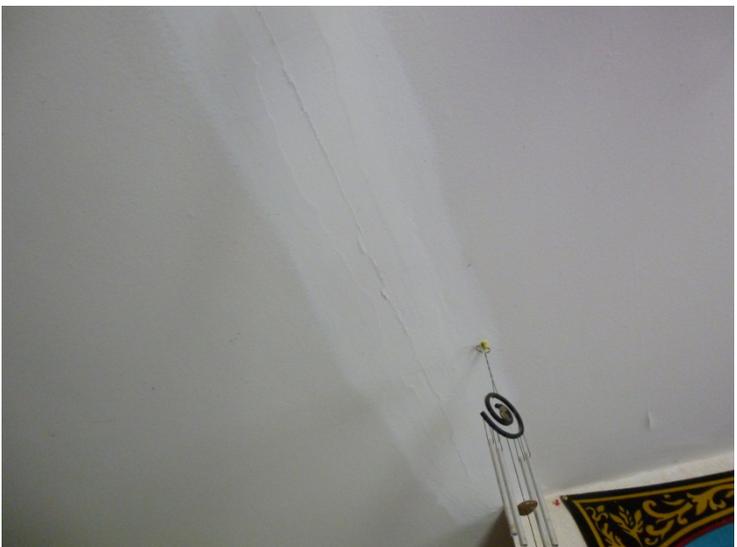
<p>26.</p>	<p>Attempted repair to ceiling crack</p>

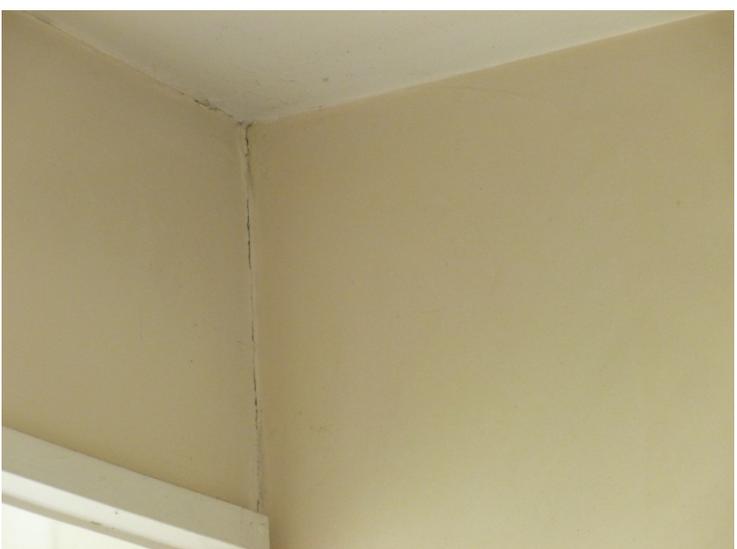
In addition to characteristic cracking described in section 5.4, a variety of other cracks were observed. This was predominately separation cracking around walls, ceilings and joinery (photos 27-29) and some walls. There was also short lateral and vertical cracking from the corners of doorways and windows in a number of units (photos 30-31).

<p>27.</p>	<p>Typical separation cracking in corners</p>

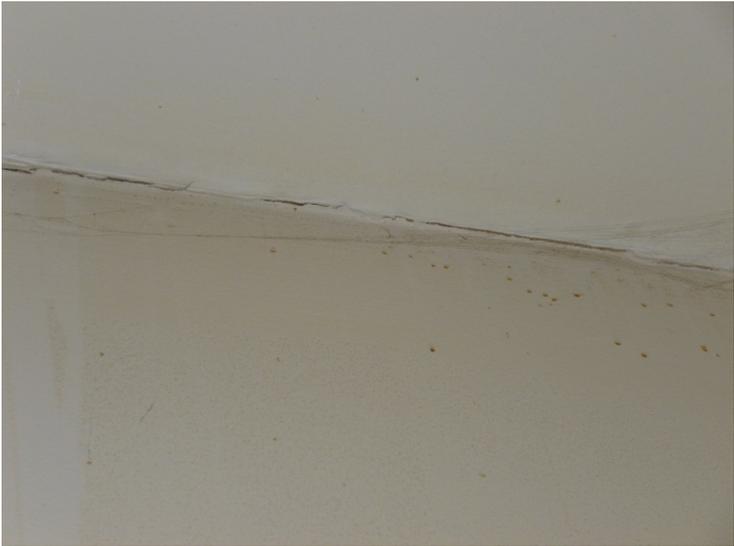
28.	Typical separation cracking between ceiling and walls

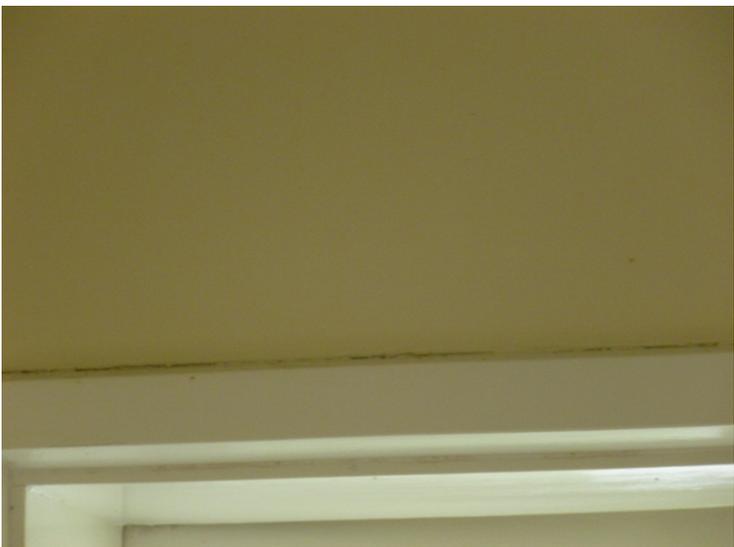
29.	Typical cracking above doorways and windows

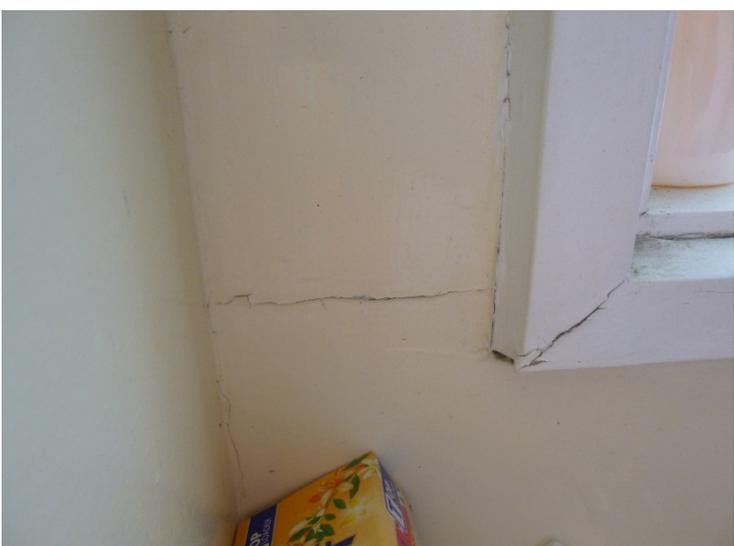
30.	Typical lateral cracking from doorways and windows

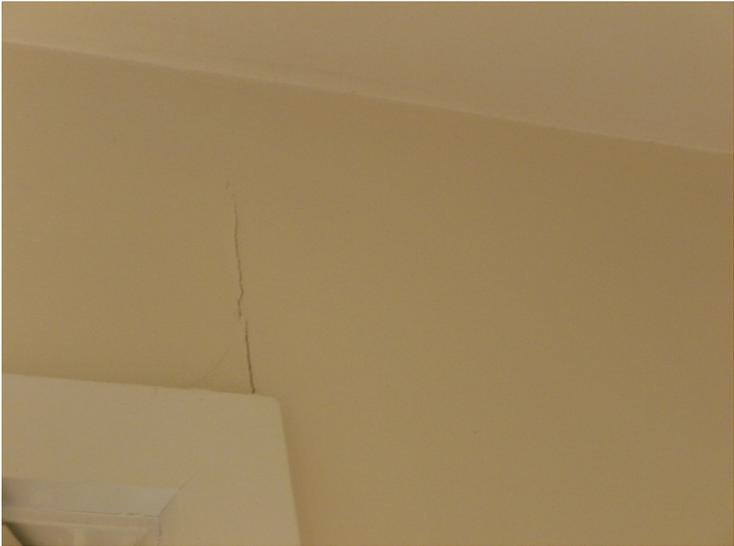
<p>31.</p>	<p>Typical vertical cracking above doorways and windows</p>

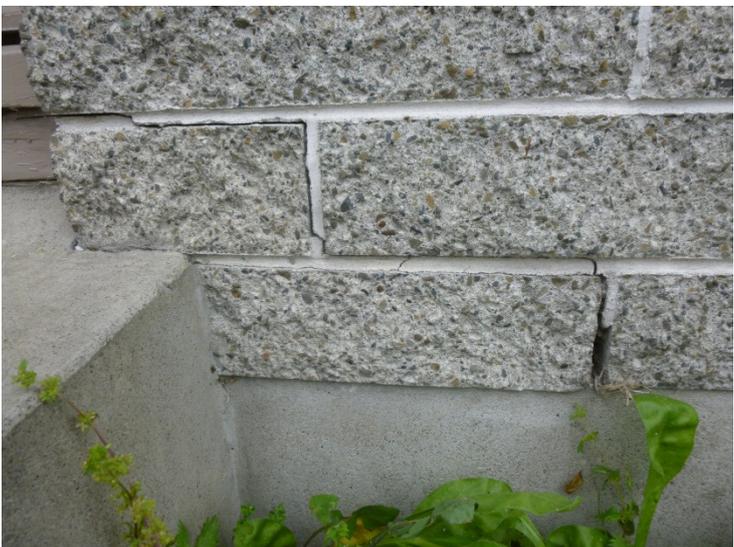
Damage to external cladding was also observed on many units. A number of units showed stepped cracking in the veneer (photo 32). Loose bricks were observed in the gable ends of most units (photo 33). It was noted that the veneer on the north gable end of Block I has been temporarily braced (photo 34).

<p>32.</p>	<p>Typical step cracking in veneer</p>

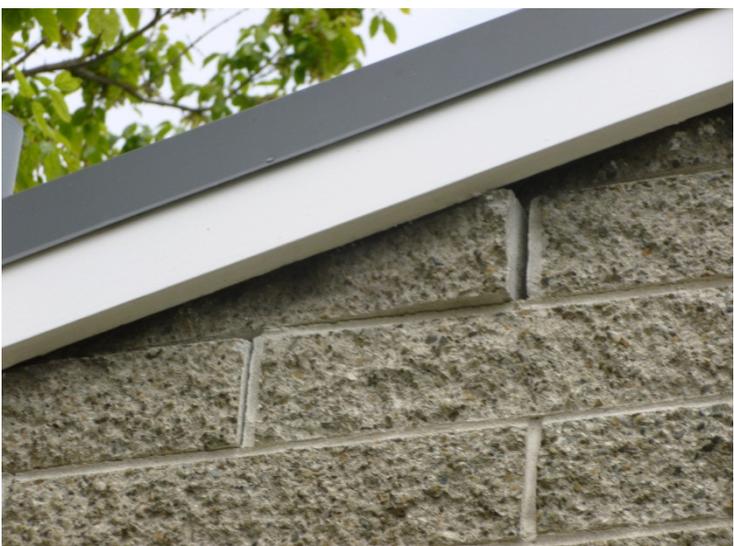
<p>33.</p>	<p>Typical loose brick in gable end</p>

- Strengthening schemes be developed to increase seismic capacity of Blocks A - K to 67%NBS.
- Veneer at height (gable ends) have the veneer ties checked.
- Work to permanently stabilize the gable end veneer of Block I be undertaken.
- The concrete perimeter footings be repaired on blocks where cracking occurs.
- The porch at Unit 44 be repaired to cover exposed reinforcing.
- Cosmetic repairs be undertaken as required.

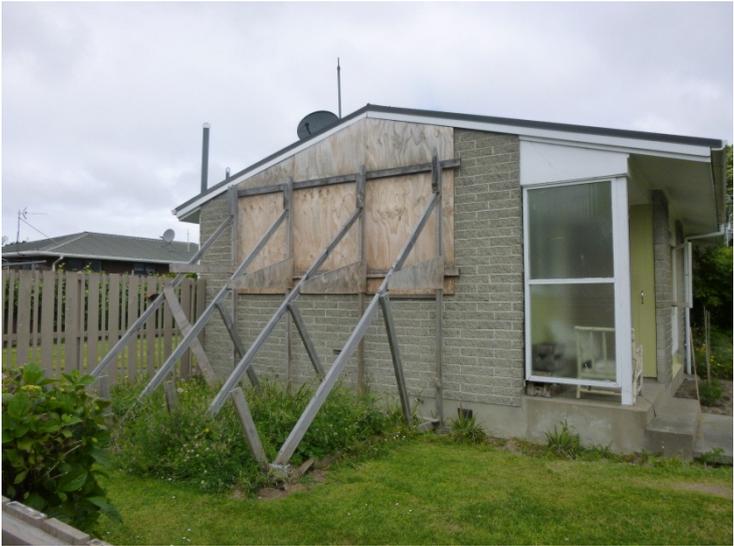
<p>34.</p>	<p>Veneer bracing at end of Block I</p>

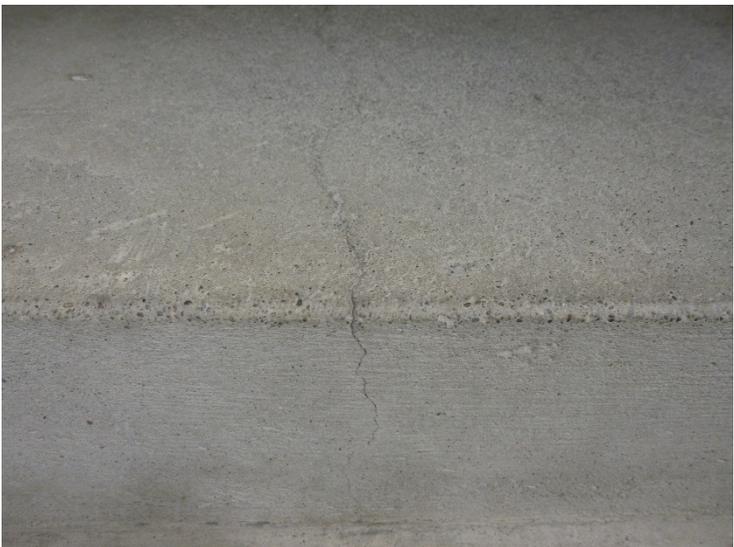
In the same manner as cracking of the foundations, cracking of the front porches was observed. This was predominately hairline cracking but was extensive in places (photos 35-36). Significant damage was observed on the front porch of Unit 44 (photo 37), to the extent

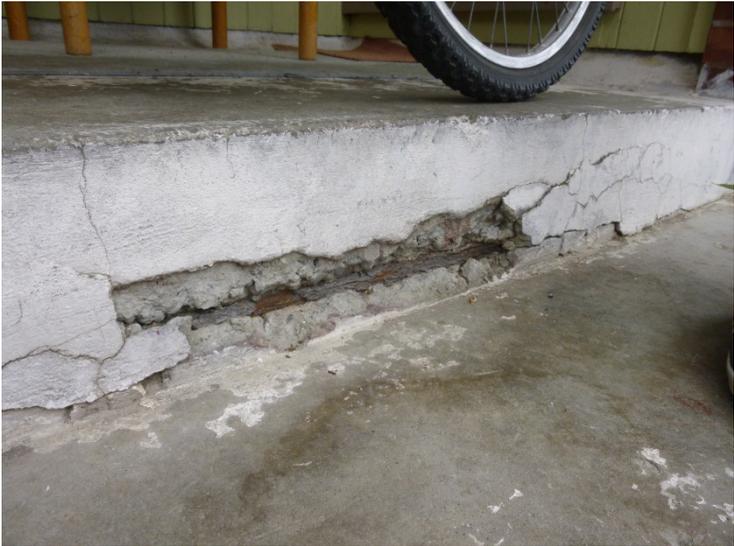
that metal reinforcing was exposed. Some cracking to the back steps was also noted. It should be noted that it is believed the back steps were poured at the same time as the foundations as there is no cold joint.

37.	Extensive cracking in porch (Unit 44)

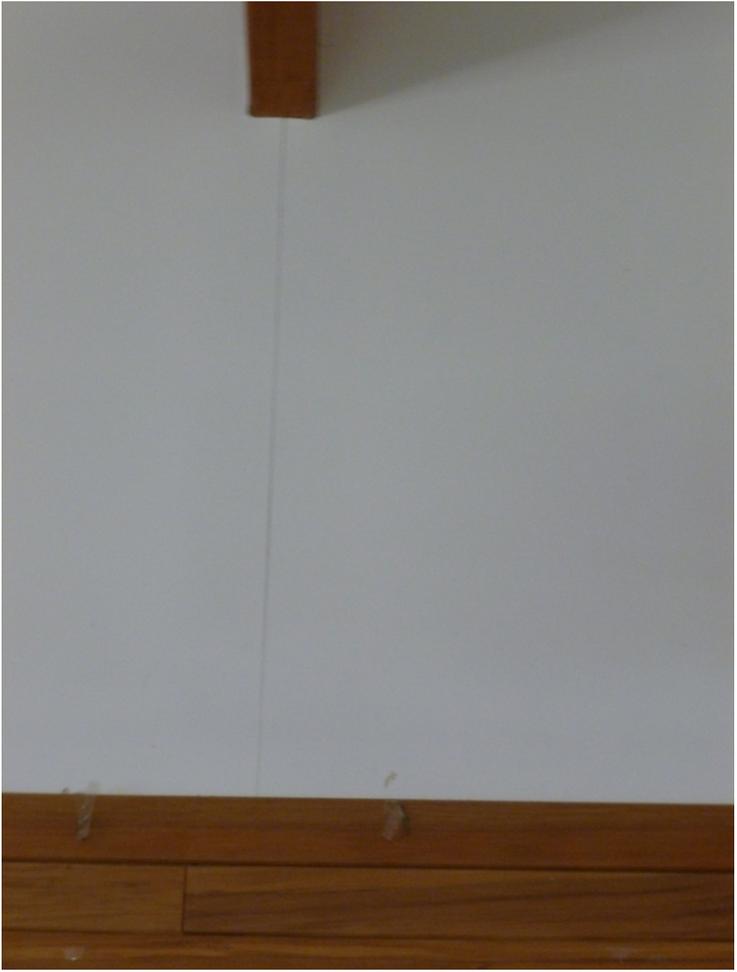
The only observable damage in the Residents Lounge was a vertical crack in the plasterboard lining extending from the centre beam in the main room (photo 39) and a loose brick in the veneer in the North West corner (photo 40).

39.	Internal cracking in Residents Lounge

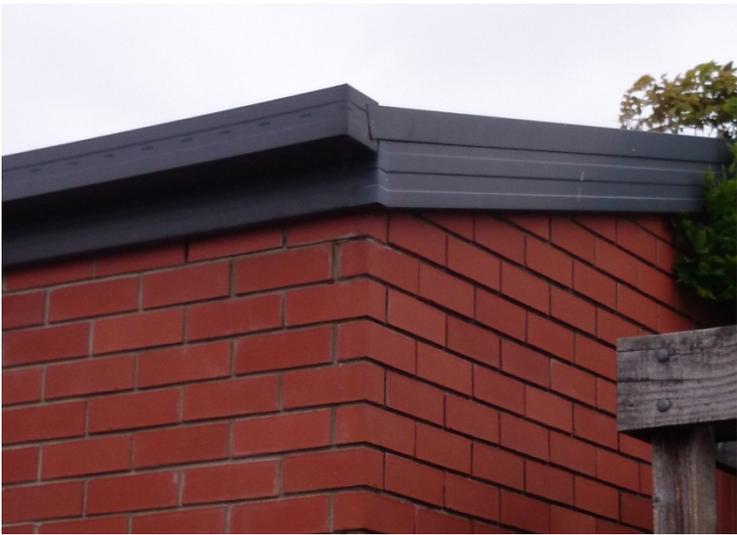
40.	Loose brick in veneer of Residents Lounge (north-west corner)
