Detailed Engineering Evaluation Quantitative Report

Kapuatohe Schoolhouse Residence
665 Main North Road, Christchurch

Prepared For:
Christchurch City Council

Ref: 1599-099
20 February 2013

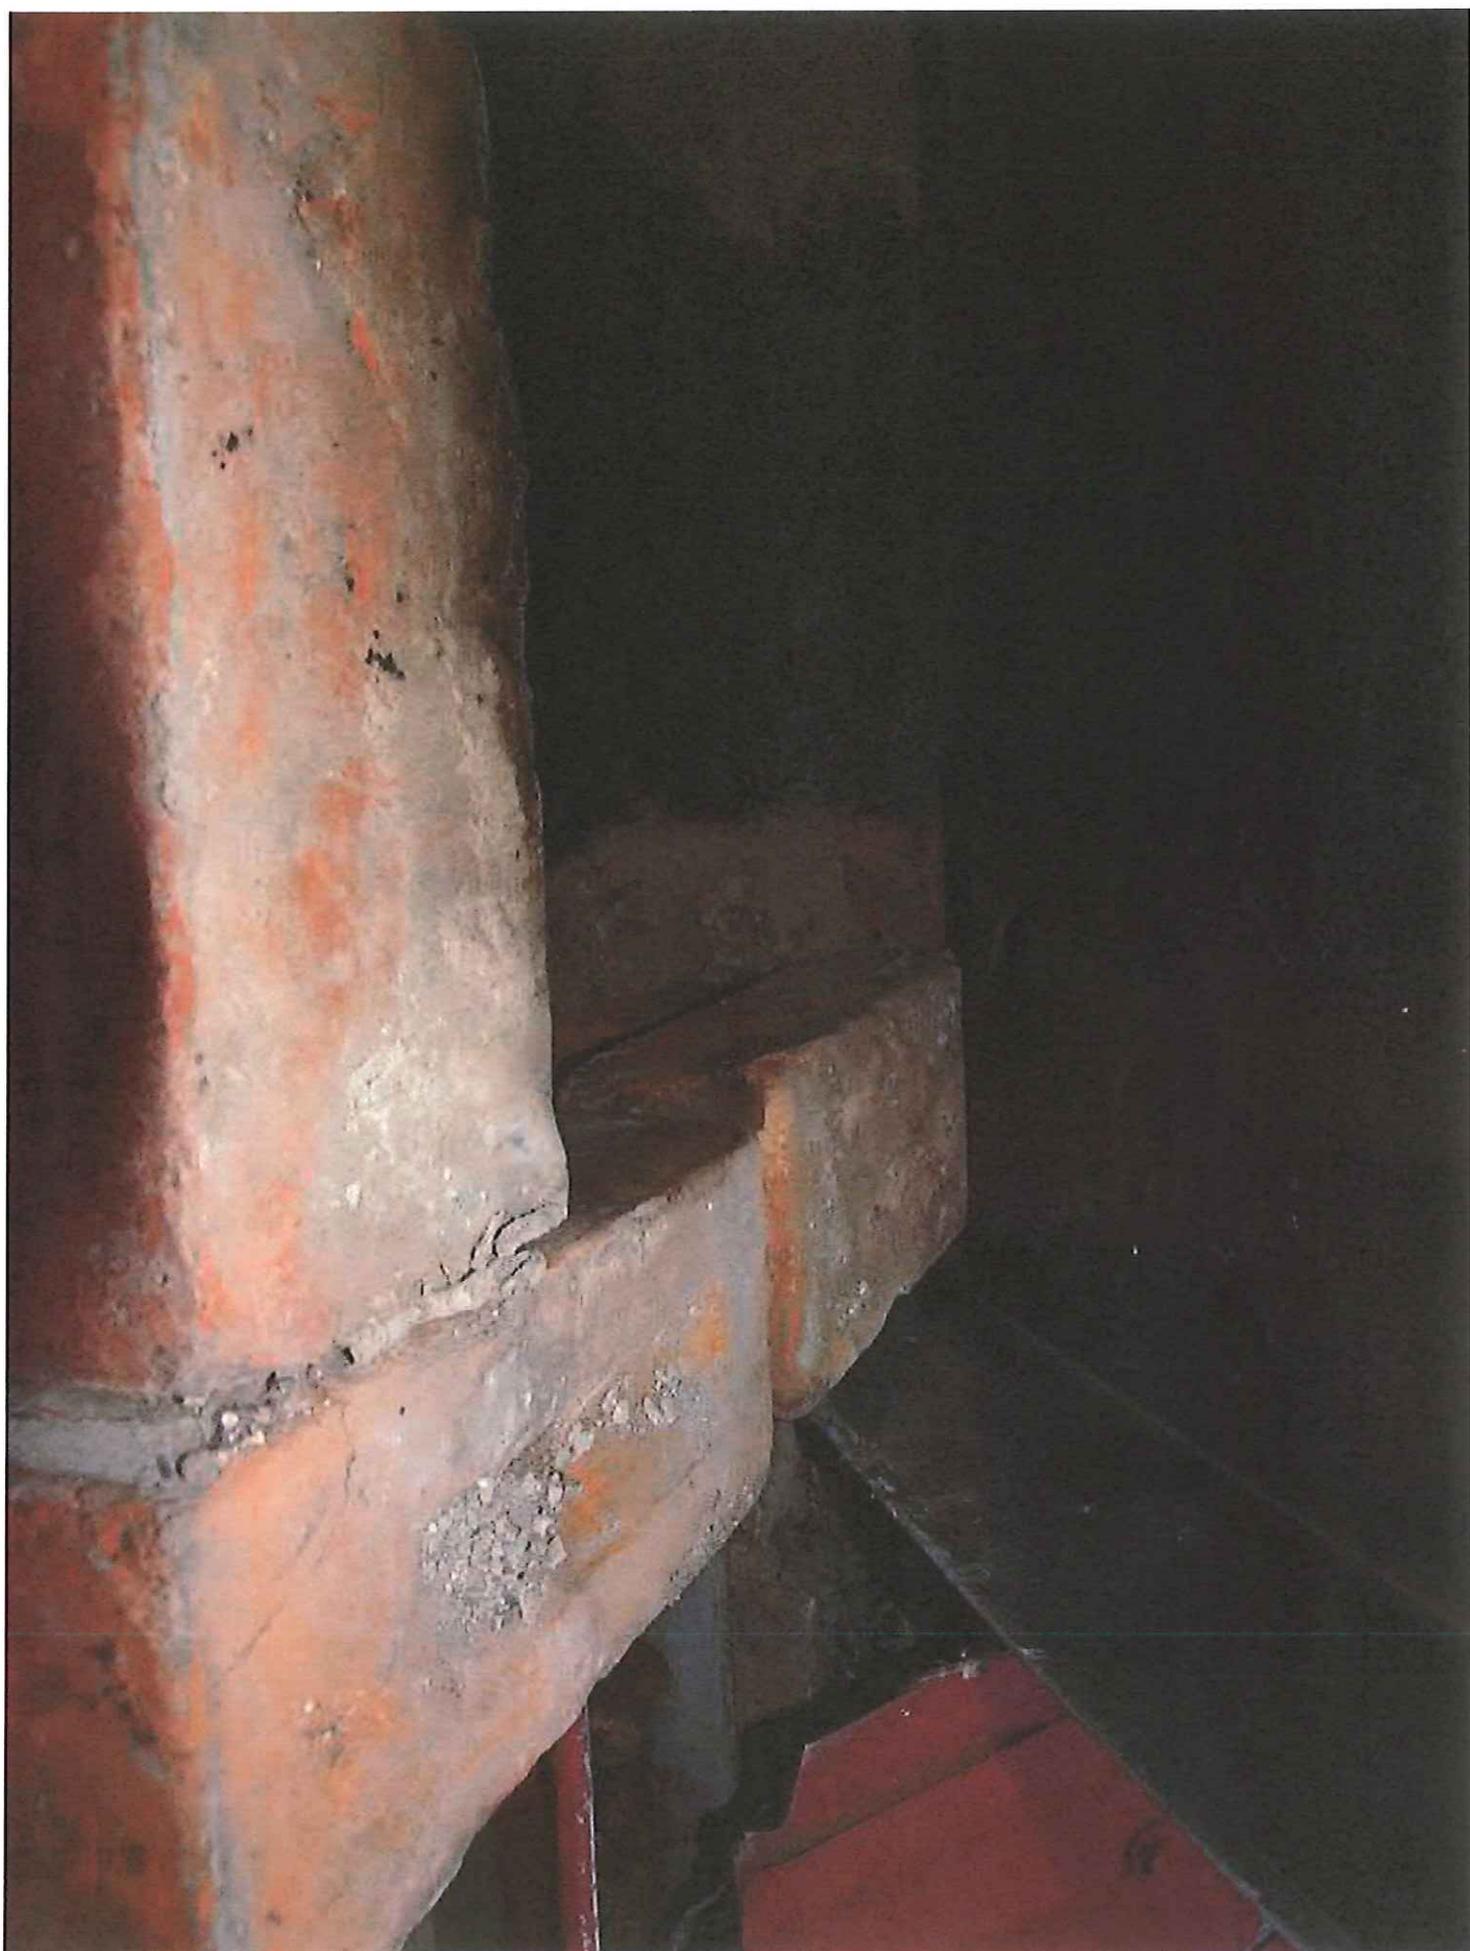
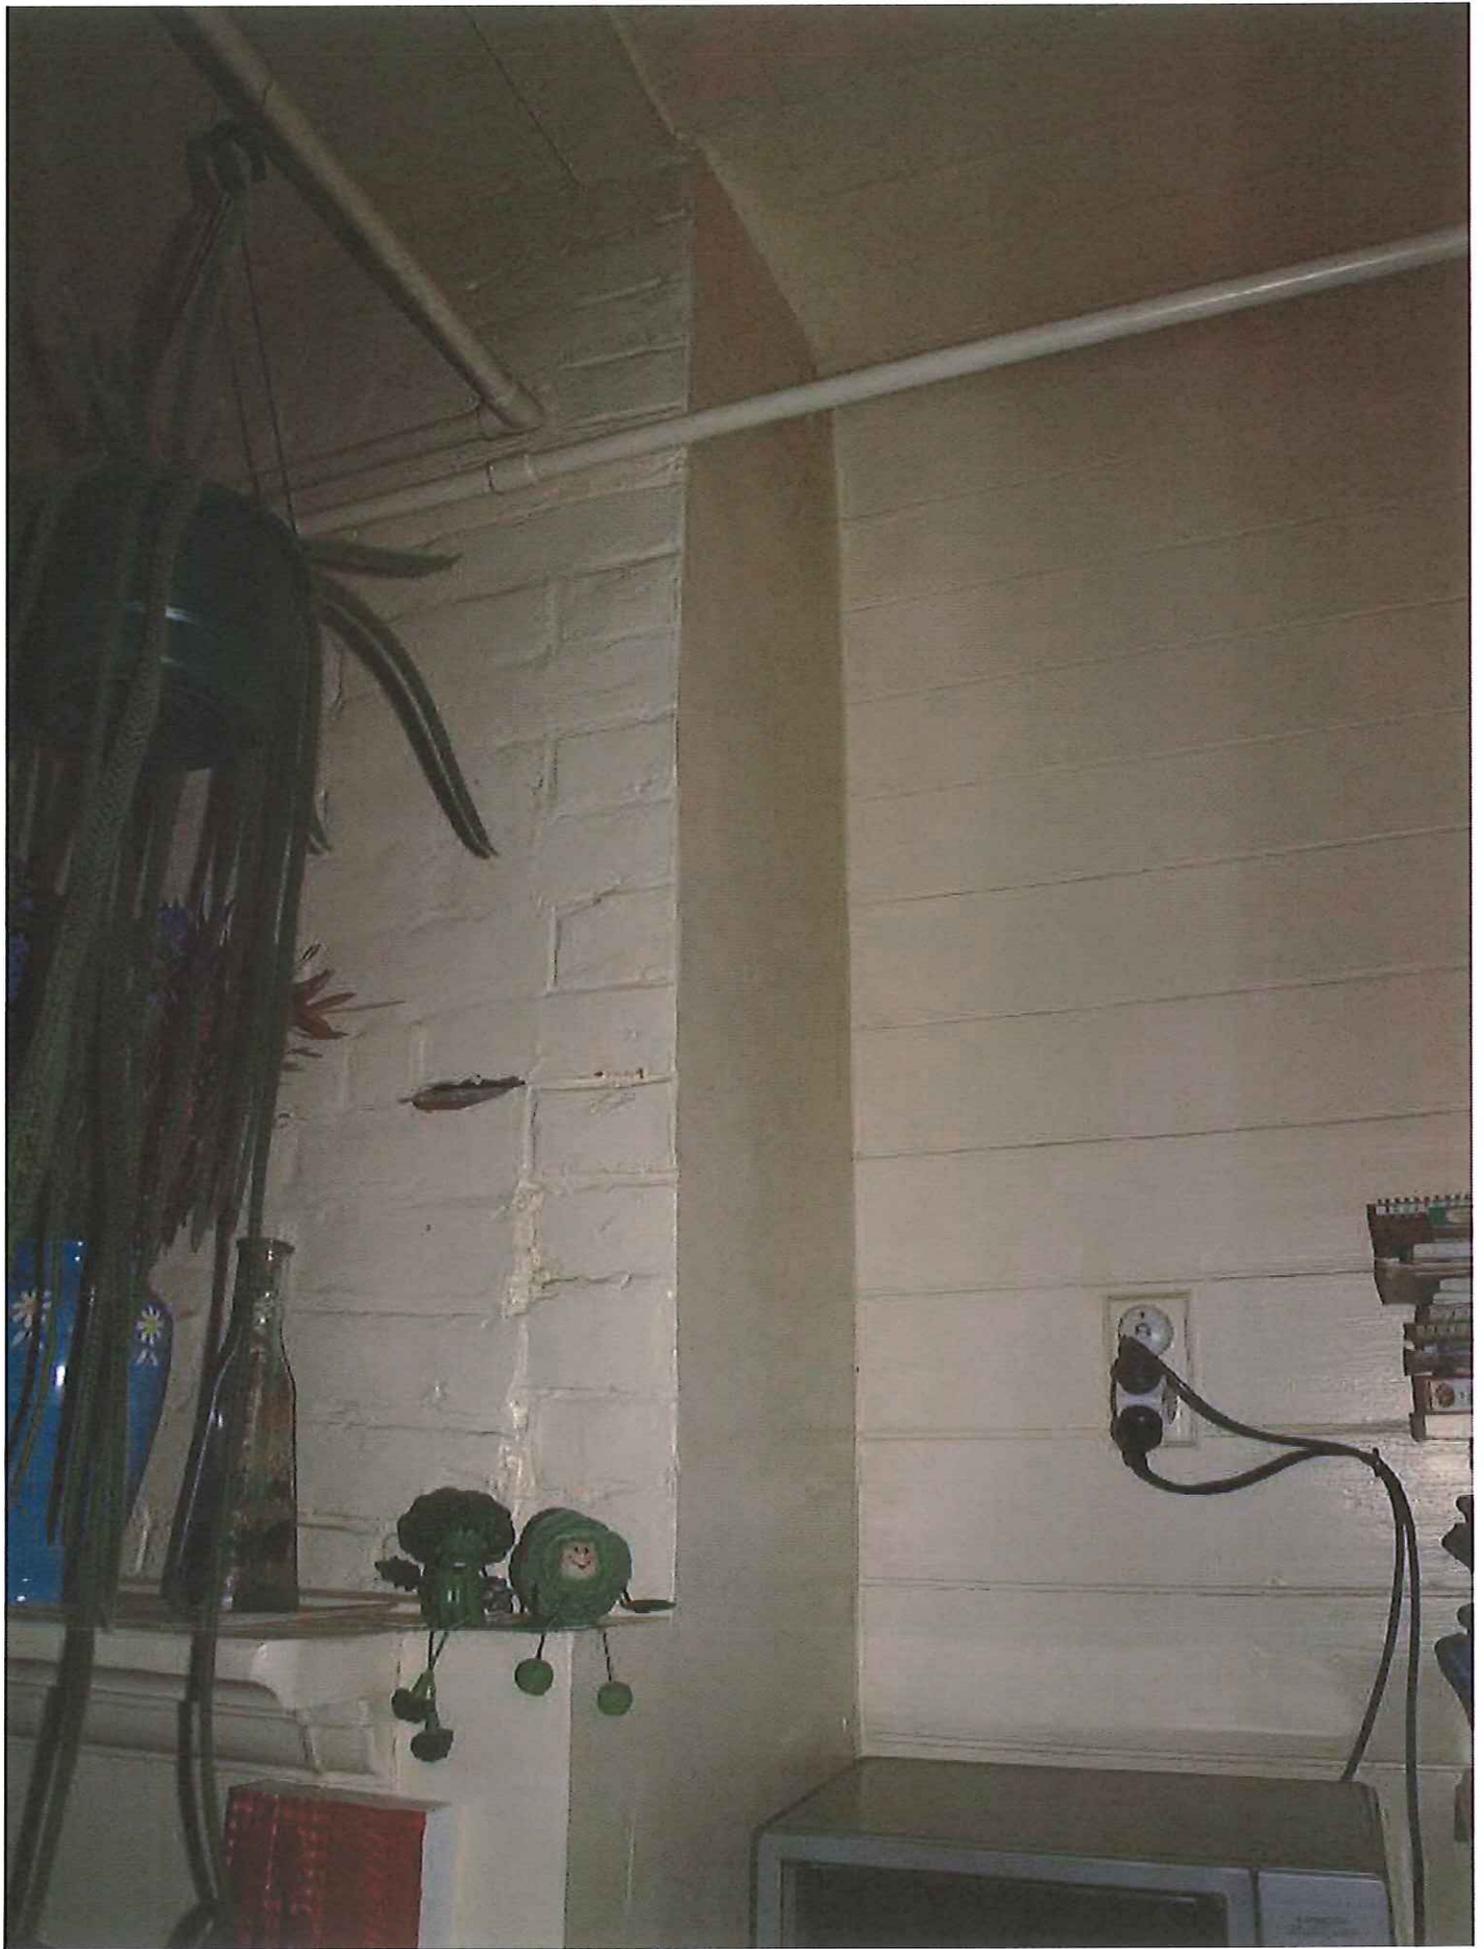
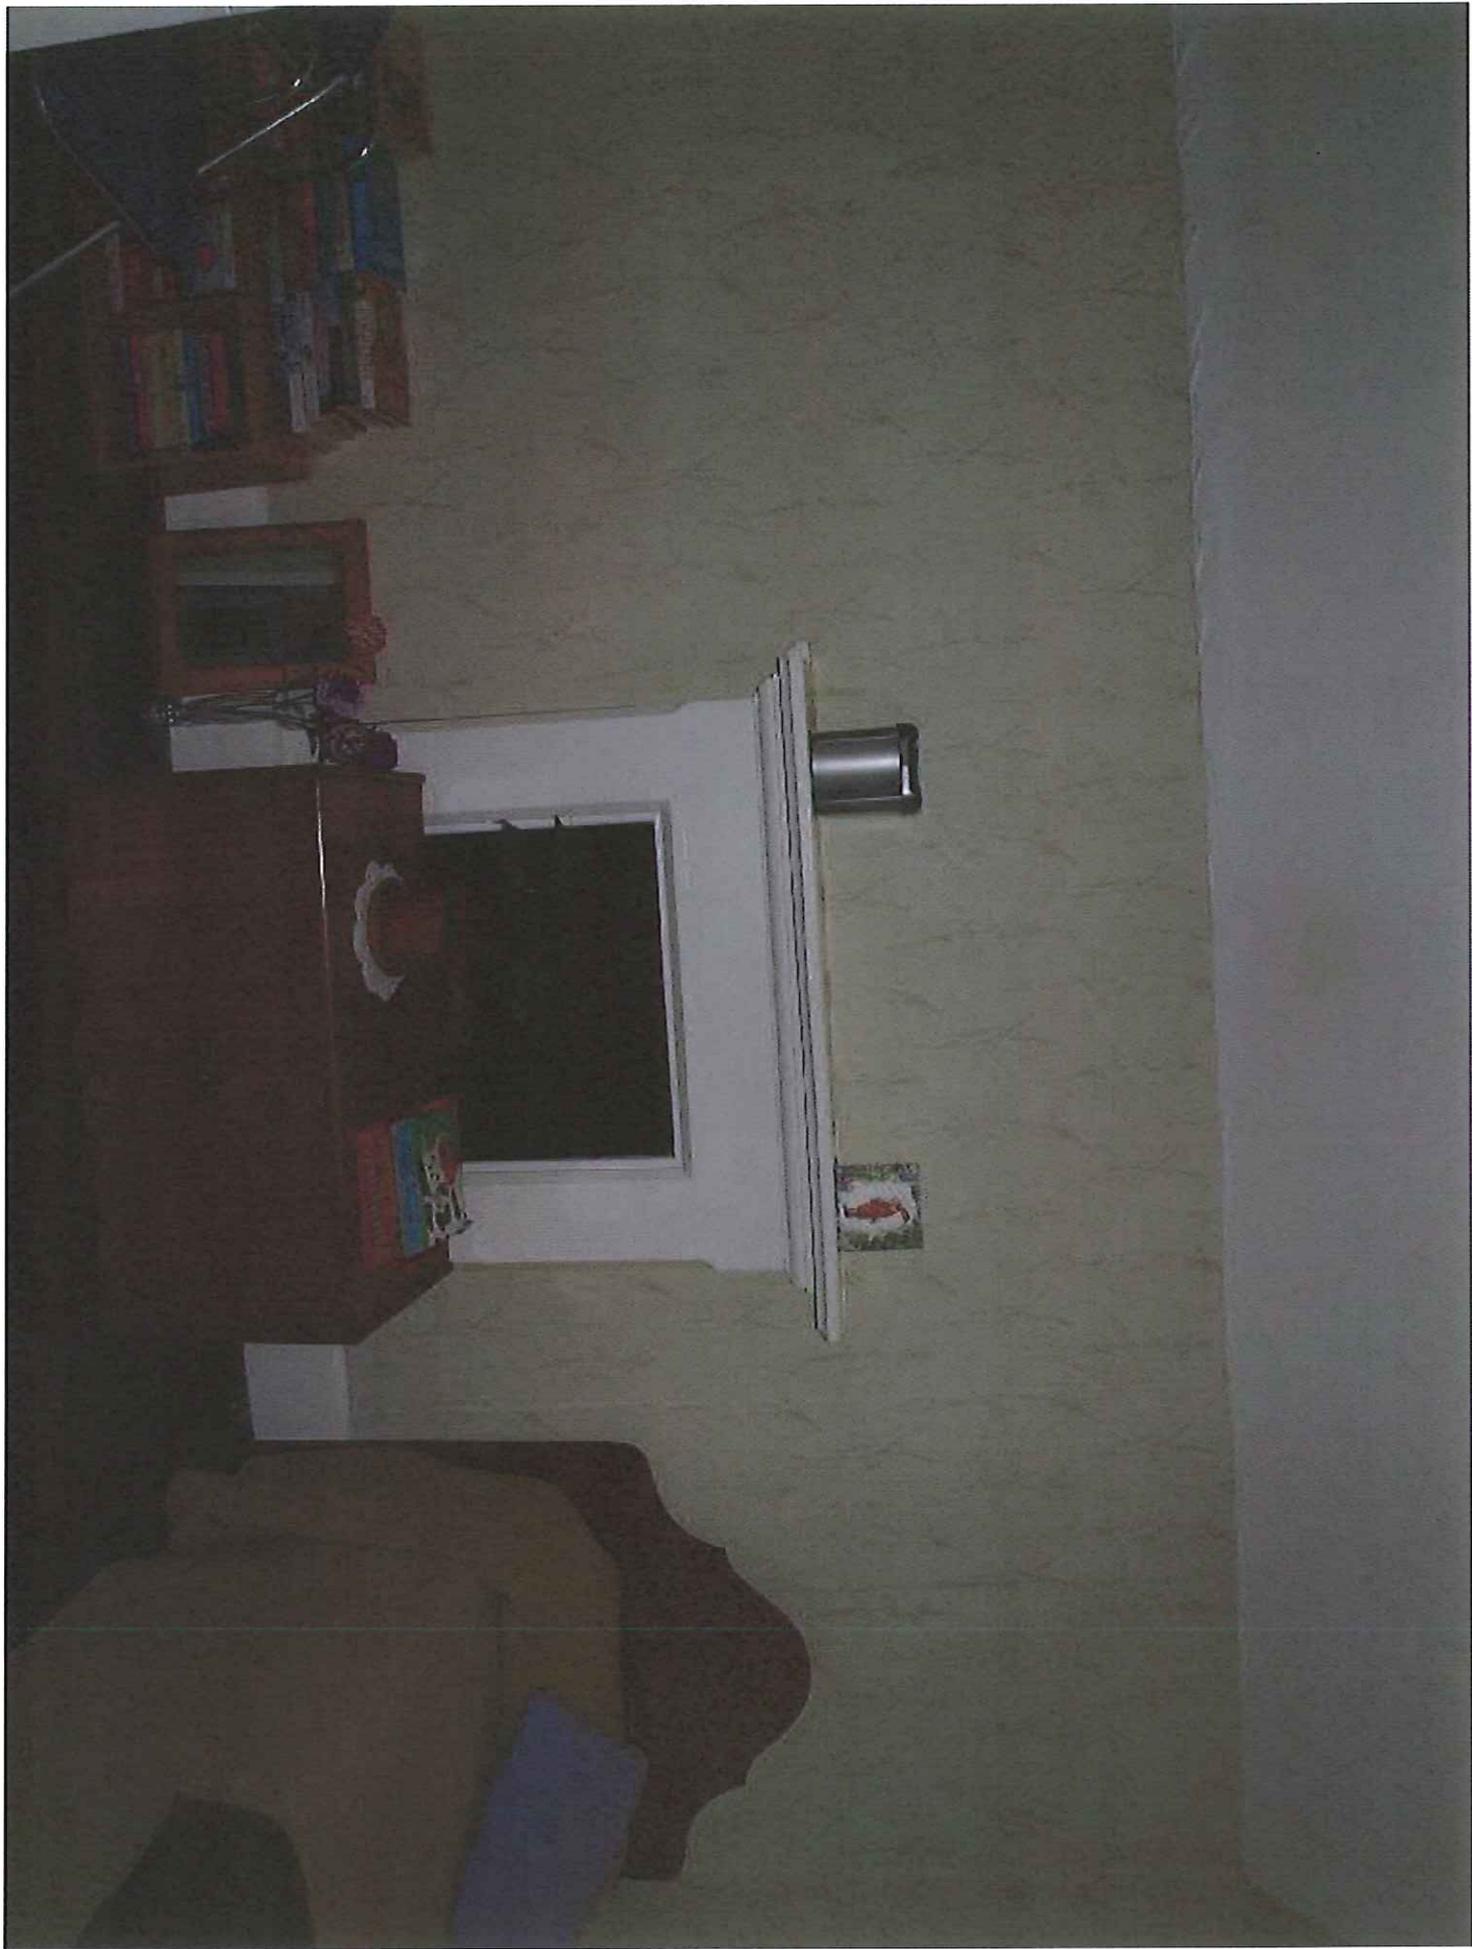
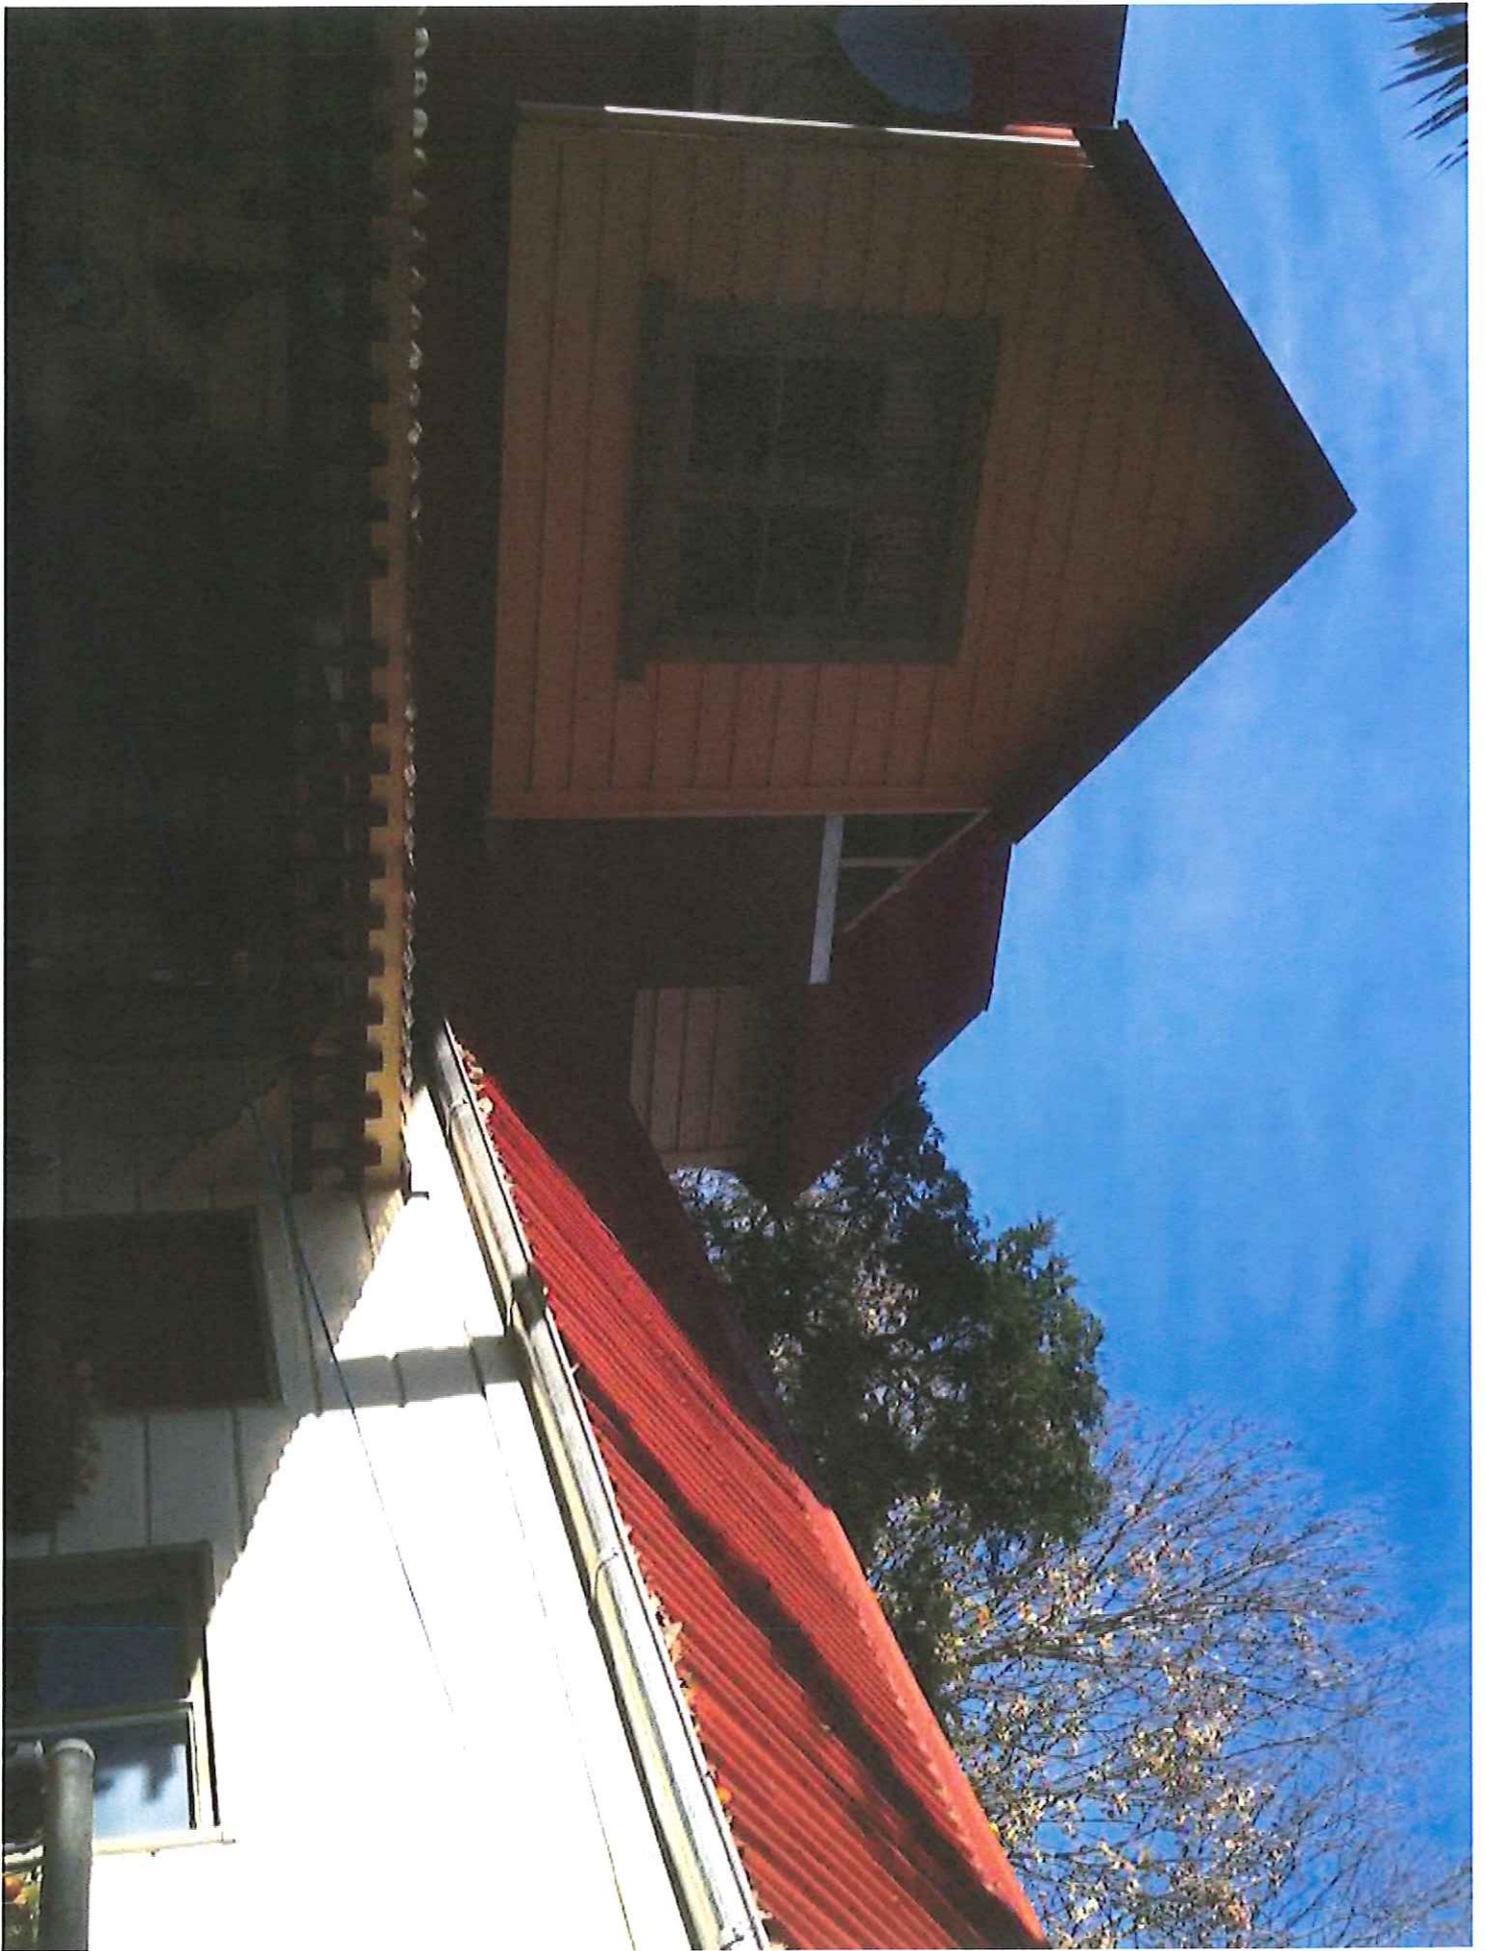
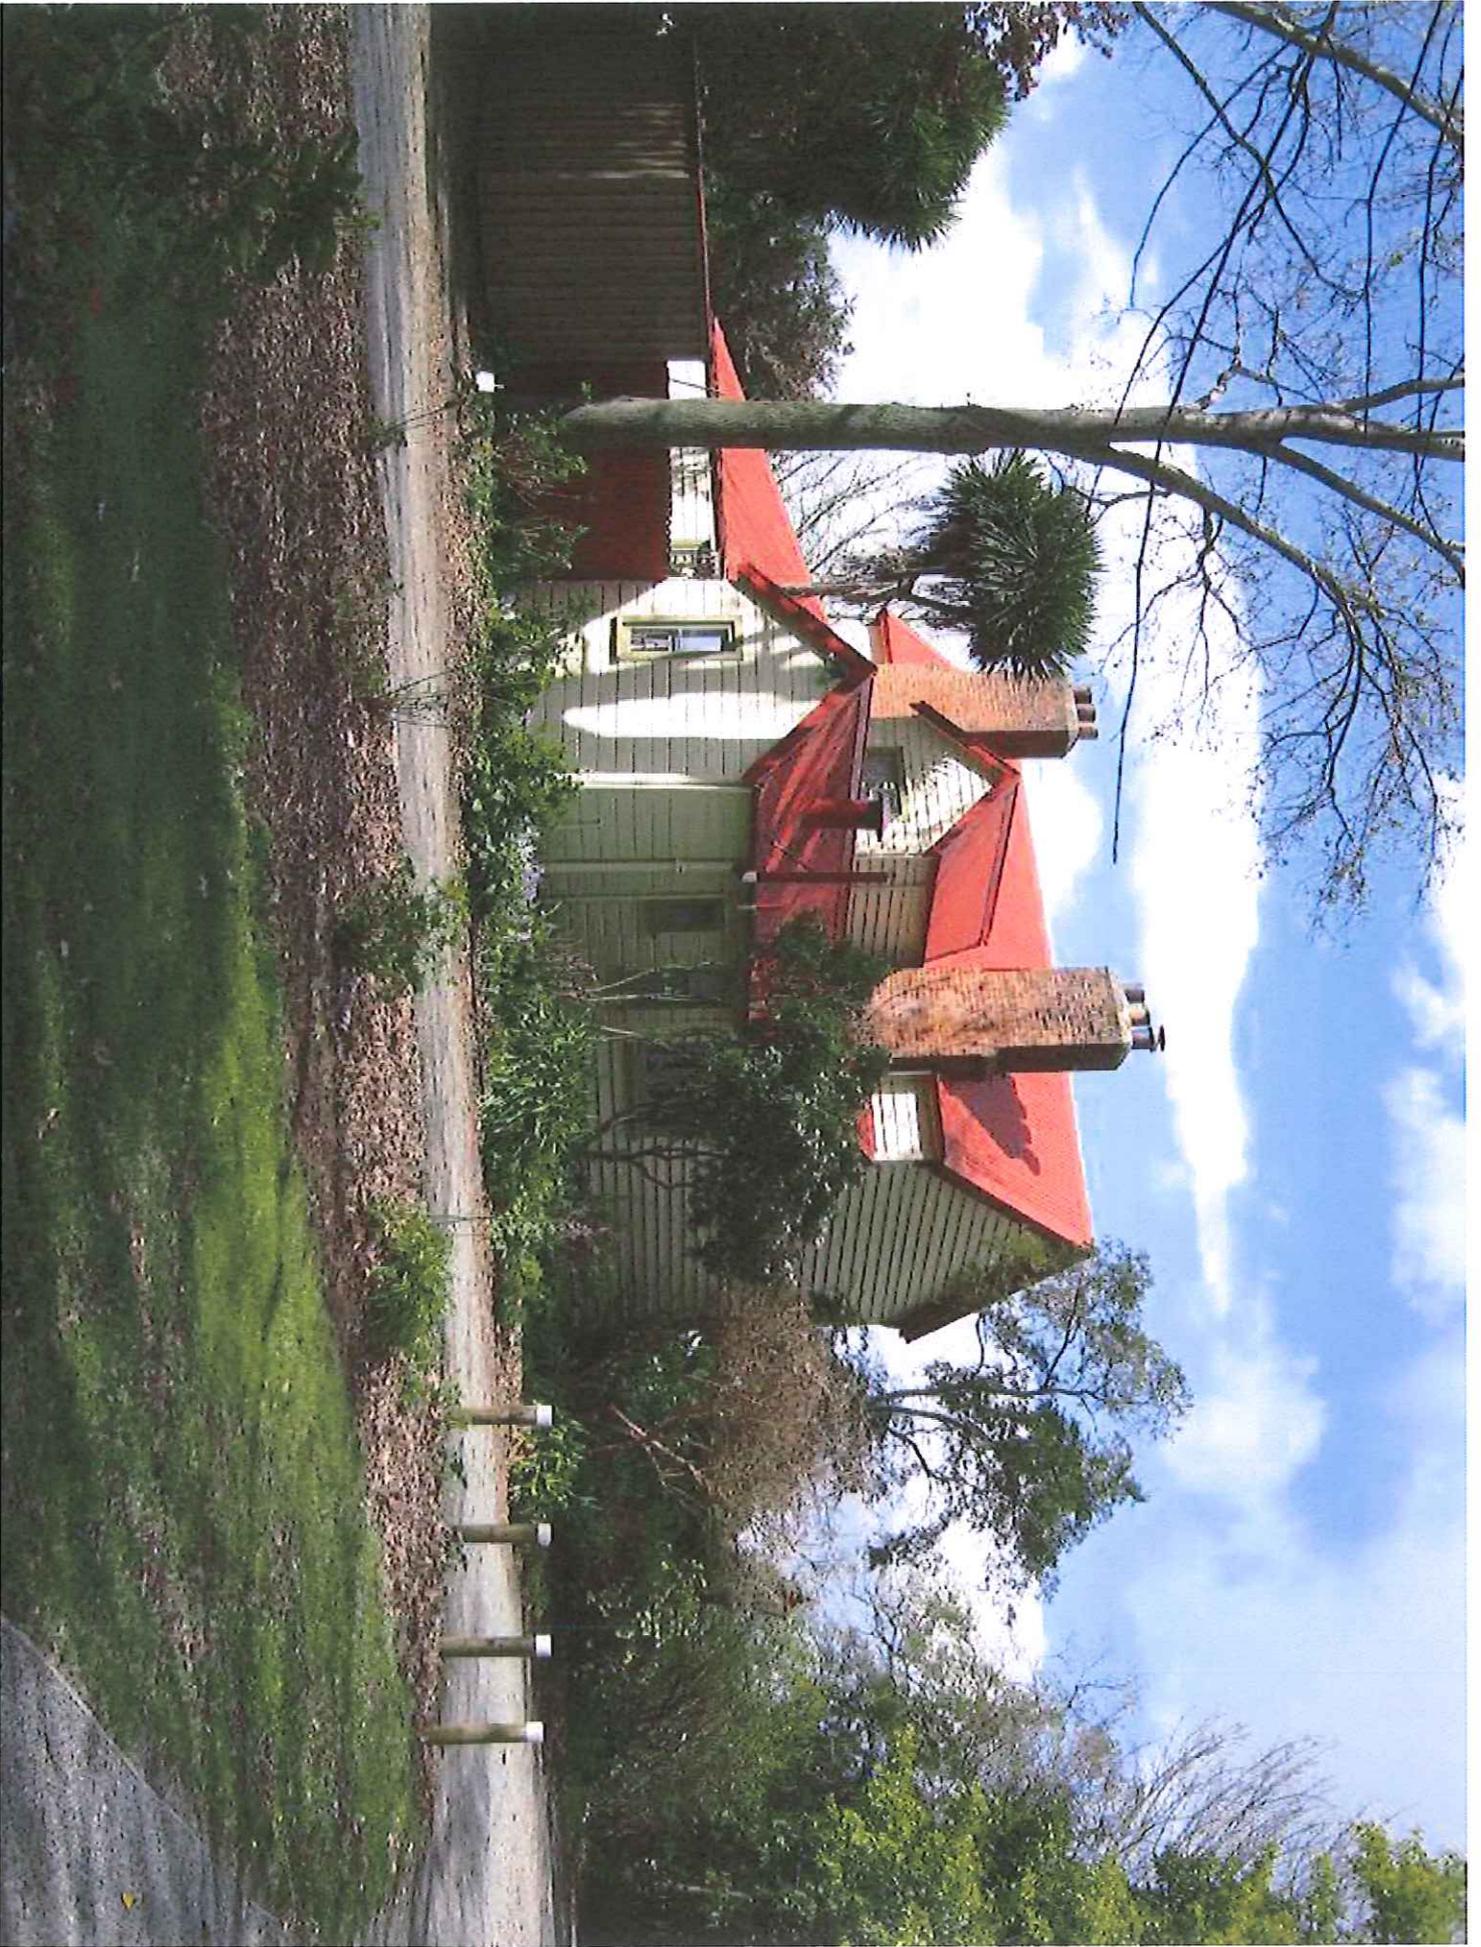
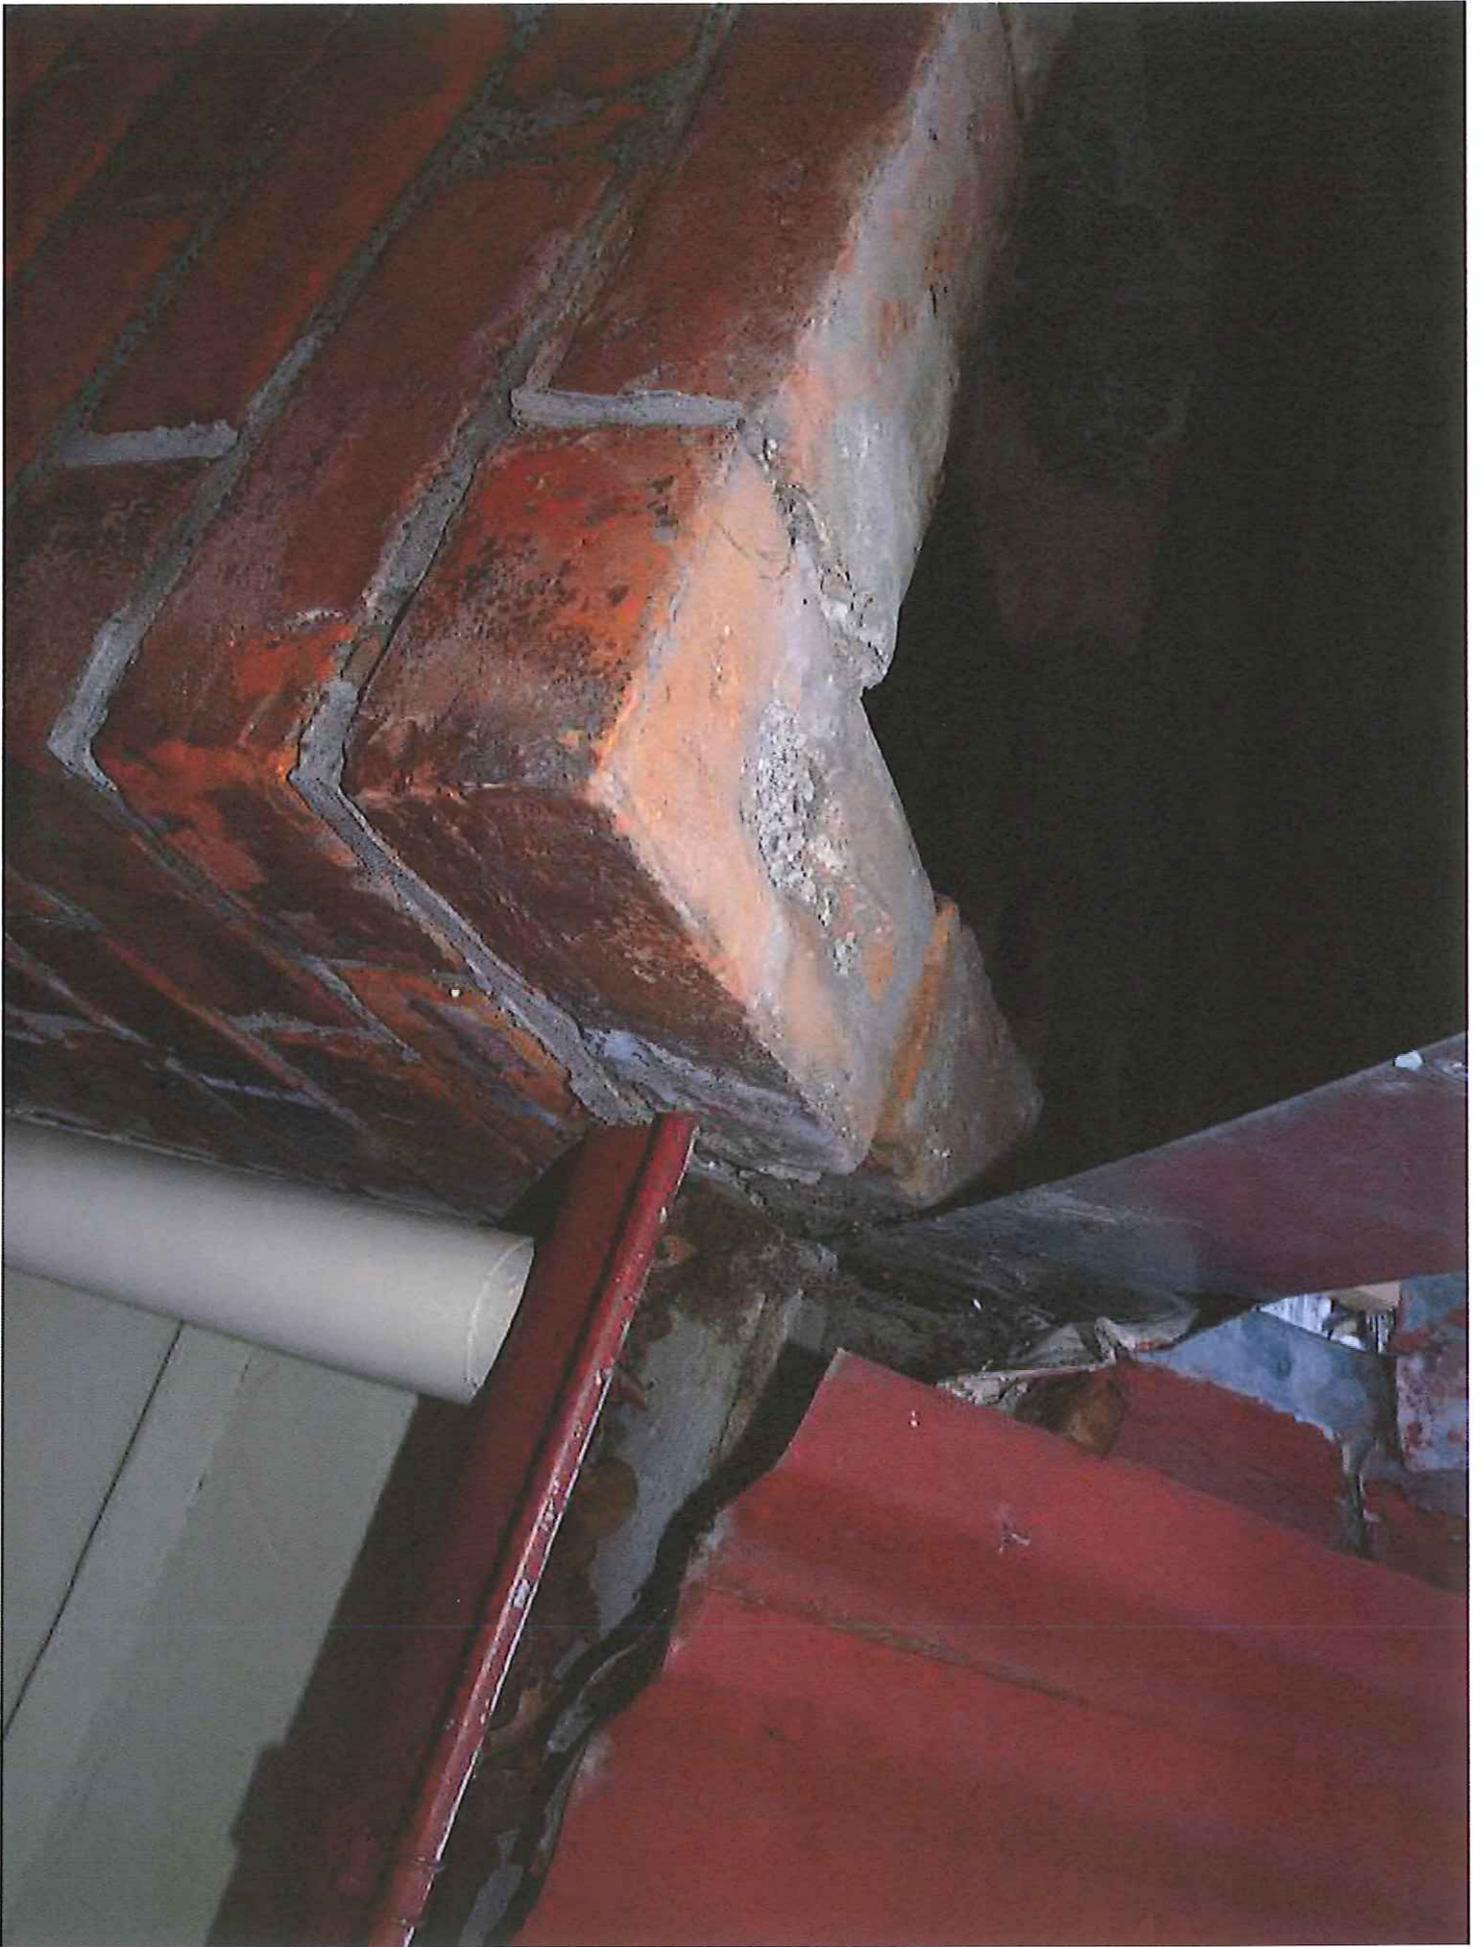
- i. General damage includes minor cracking of plaster to walls and ceilings.
- ii. Two brick chimneys have been damaged and have been dismantled to roof level. The chimneys have caused significant damage to the ceilings immediately adjacent where they pass through same. There is some cracking to the internal chimney fireplace in the kitchen. The first floor bedroom chimney has dislodged bricks in the arch.

- Reconstruct chimneys using light weight replicas in the form of brick veneer over plywood on timber framing with steel structures are recommended.
- Deconstruct existing chimneys to ceiling level.
- See attached details in Appendix C.
