# Landsdowne Community Centre Detailed Engineering Evaluation BU 1771-001 EQ2 Quantitative Report

## Landsdowne Community Centre BU1771-001 EQ2

### Detailed Engineering Evaluation Quantitative Report – SUMMARY

8 Landsdowne Terrace  
Cashmere  
Christchurch

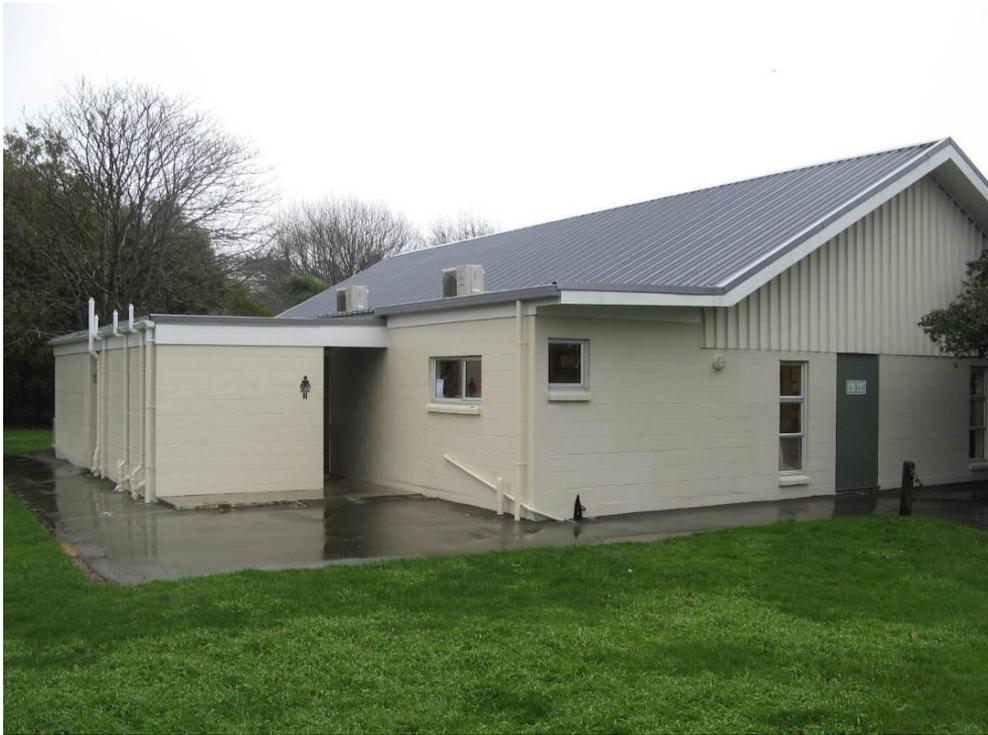
**Photo 1:** External view from the east.

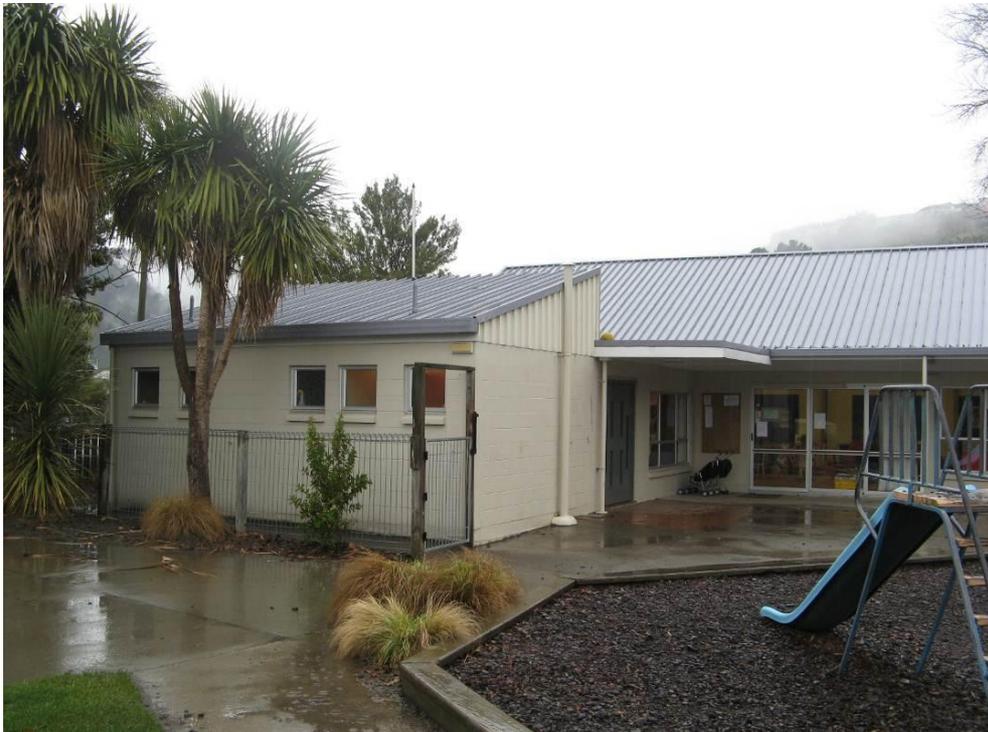
**Photo 2:** External view from the north

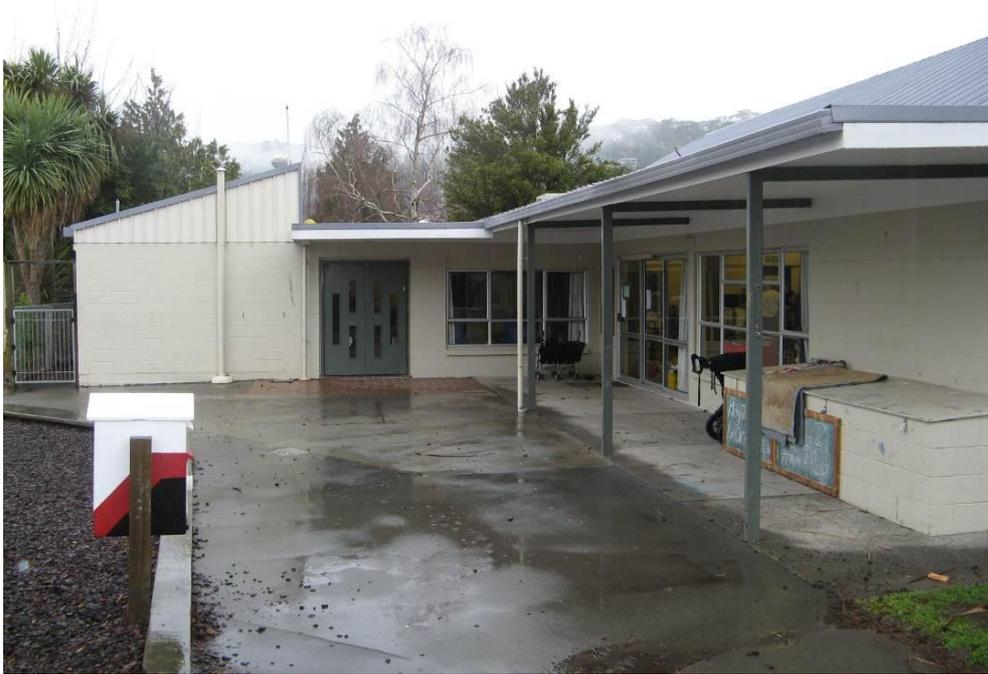
**Photo 3:** External view from the north

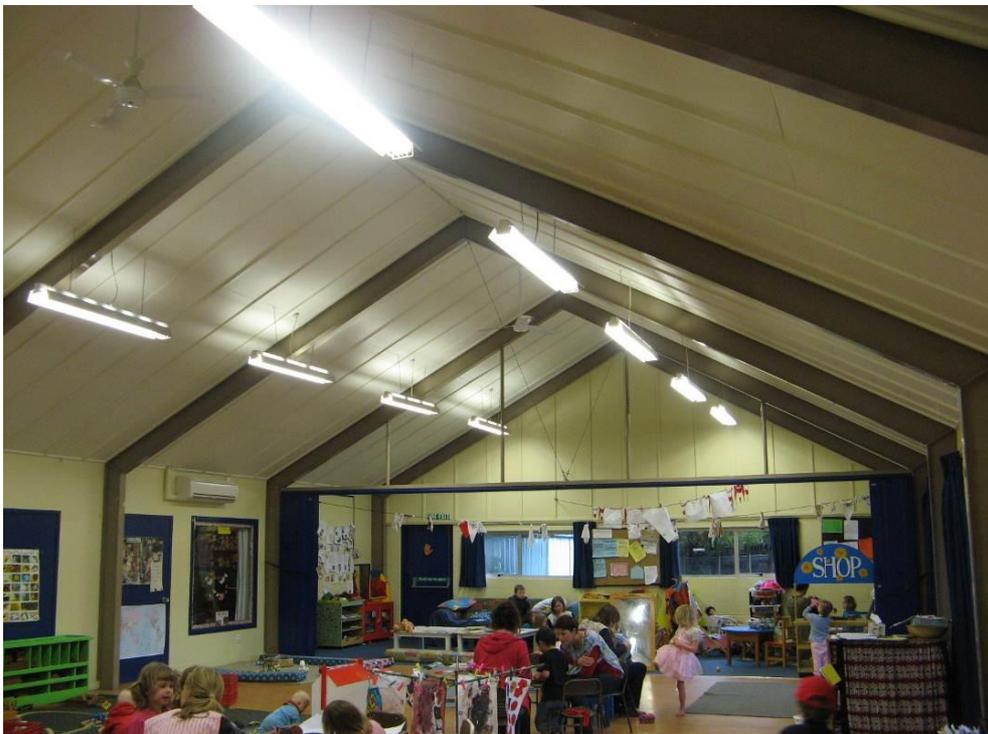
**Photo 4:** Internal view of building showing structural system

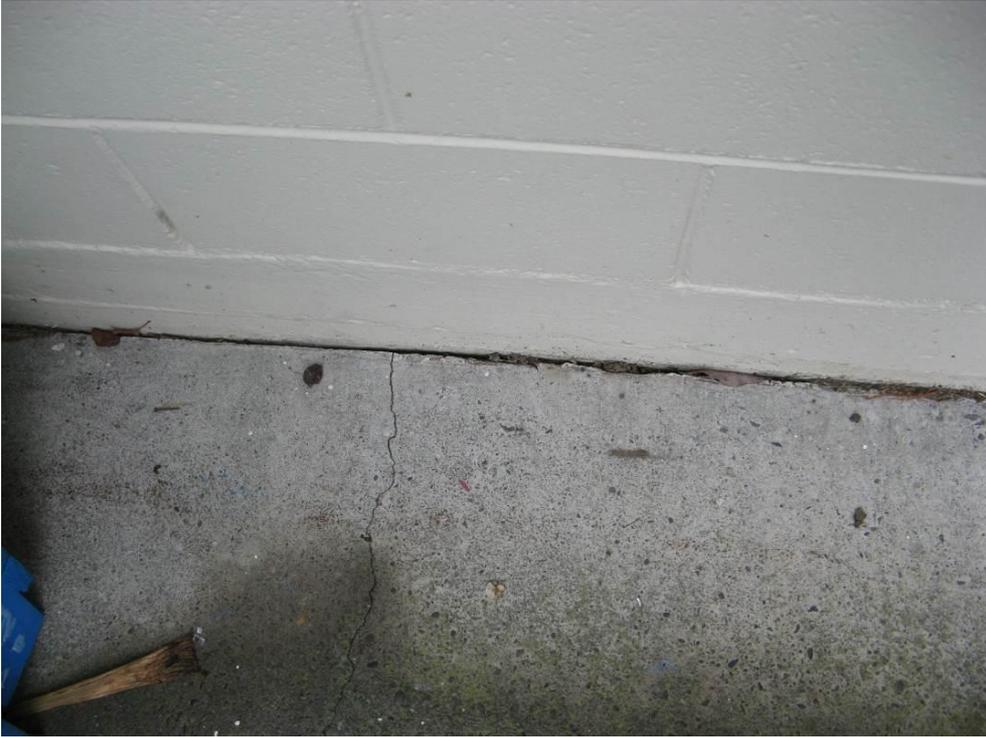
**Photo 5:** Cracking to concrete ground slab (west of building).

**Damage:** Cracking to external concrete slab

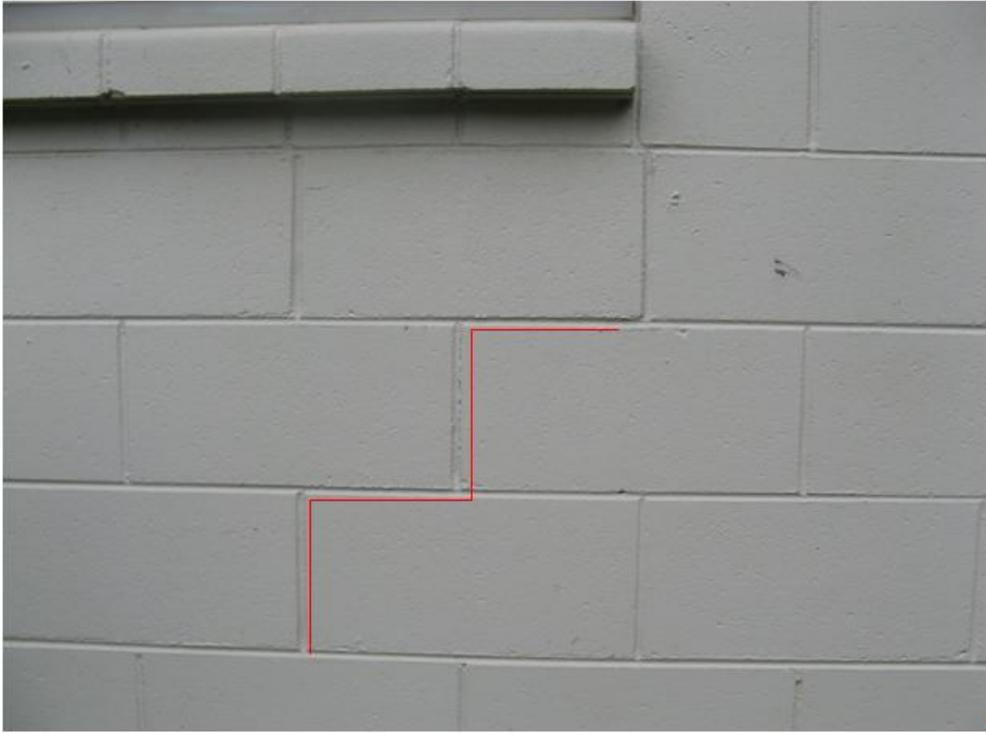
**Photo 6:** Cracking to masonry wall

**Damage:** Stepped cracking to masonry wall

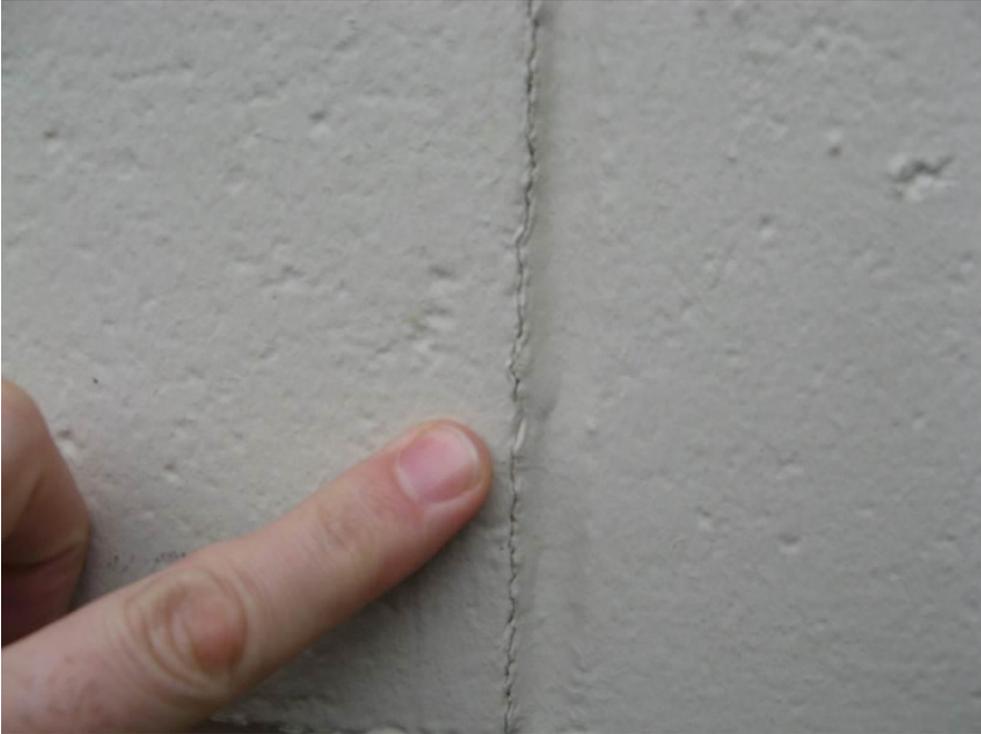
**Photo 7:** Cracking to concrete masonry wall (close up)

**Damage:** Cracking to concrete masonry mortar

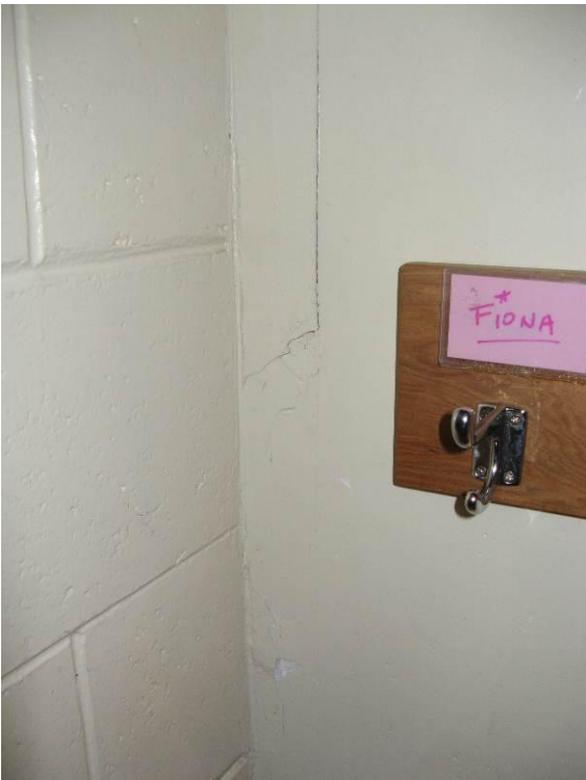
**Photo 8:** Joint between walls

**Damage:** Minor non-structural cracking to wall at joint

General Comment \_\_\_\_\_  
 \_\_\_\_\_ *no damage observed* \_\_\_\_\_  
 \_\_\_\_\_ *Minor crack at joint between toilet* \_\_\_\_\_  
 \_\_\_\_\_ *block + main building* \_\_\_\_\_

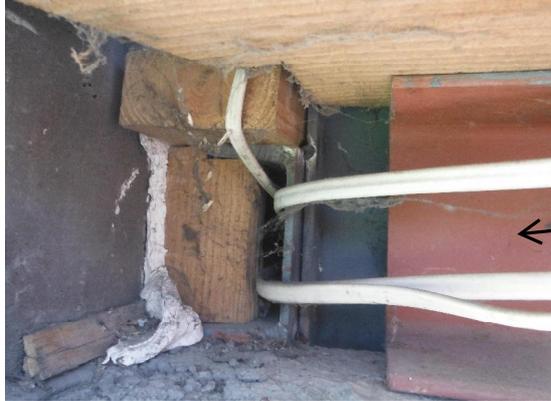
152 x 76 PFC Beam  
along end wall grids

Photo 1: View from outside onto end wall

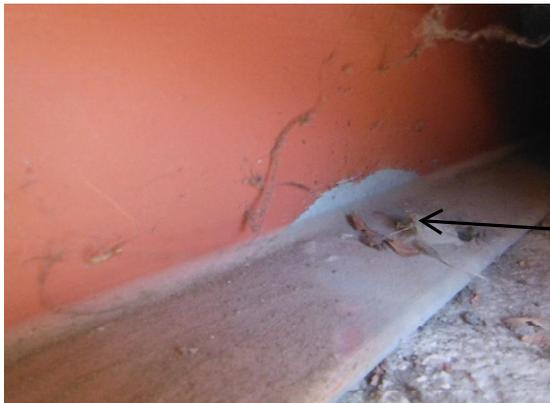
Reinforcing bar bent over bottom  
flange of PFC to connect PFC and  
wall. Connections at 1200 centres.

Photo 2: View along end wall

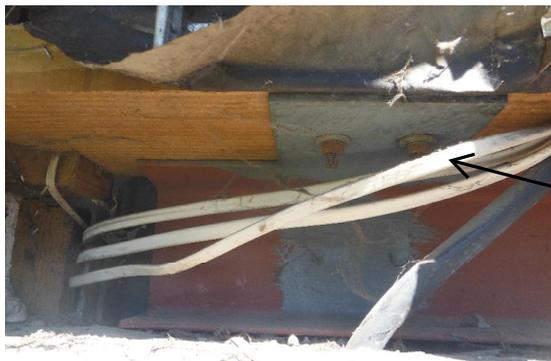
2 M10 bolts into 5mm plate welded  
to top flange of PFC to connect to  
200 x 50 timber beam above.  
Connections at 1200 centres.

Photo 3: View of top plate connection

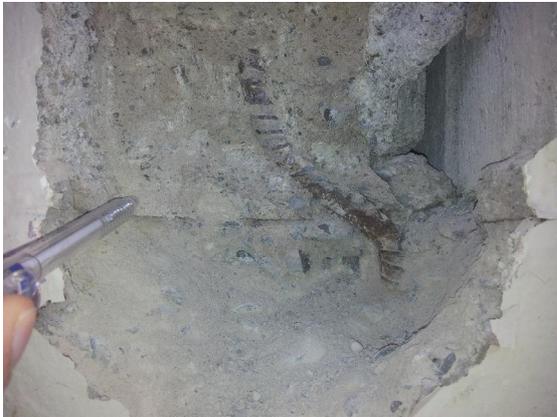
Photo 1: West wall hole 1

It was found that the vertical wall reinforcement continued into the foundation beams. The wall is reinforced vertically with 12.5mm bars at 600mm centres. The reinforced cores were typically filled at the location of reinforcing.

Note: At hole location 1 on the west wall the wall reinforcement was bent to avoid contacting the joint in the masonry. At hole location 2 on the wall wall the masonry core was not filled due to the location of electrical socket.

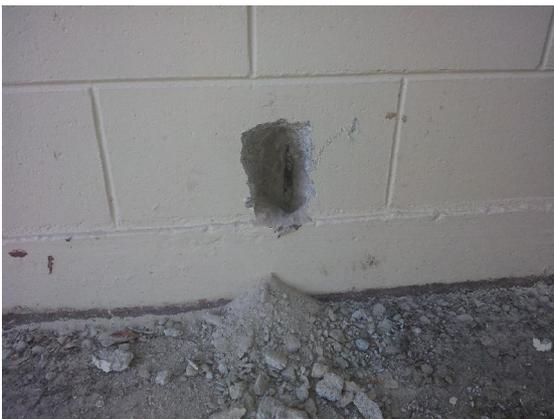
Photo 3: East wall hole 1

Photos 3 and 4 are representative of typical situation expected.
