**Le Bons Bay Community Hall**  
BU 3597-001 EQ2  
**Detailed Engineering Evaluation**  
**Quantitative Report**

# **Le Bons Bay Community Hall**

## **Detailed Engineering Evaluation Quantitative Report**

Date: October 2012  
Reference: 6-QUCCC.73  
Status: Final

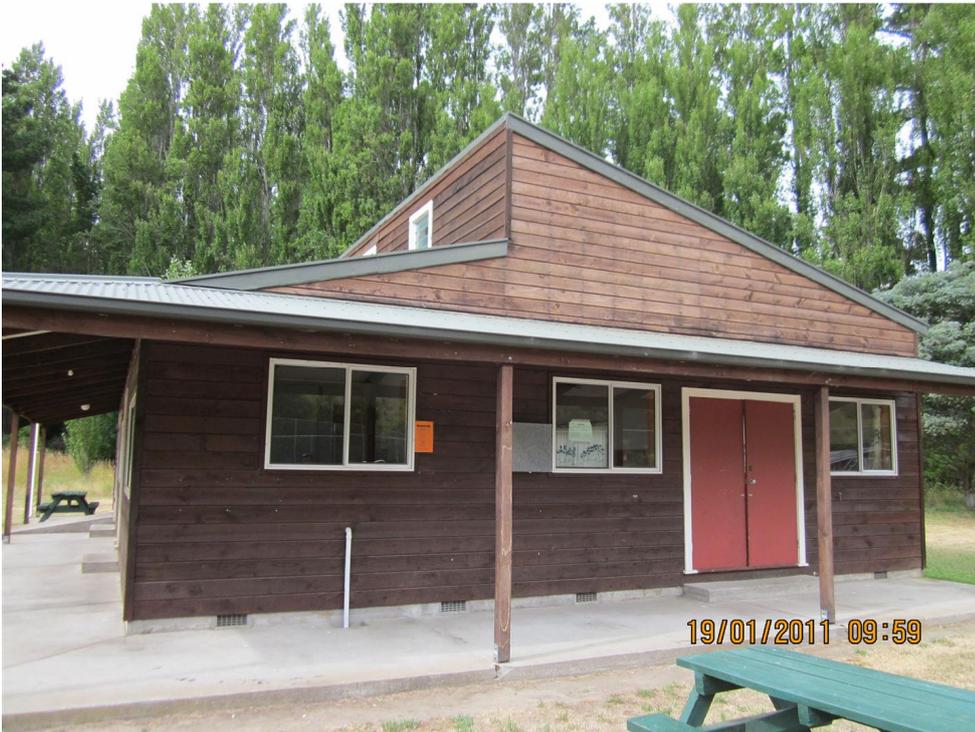
**Photo 1 – The north perimeter wall**

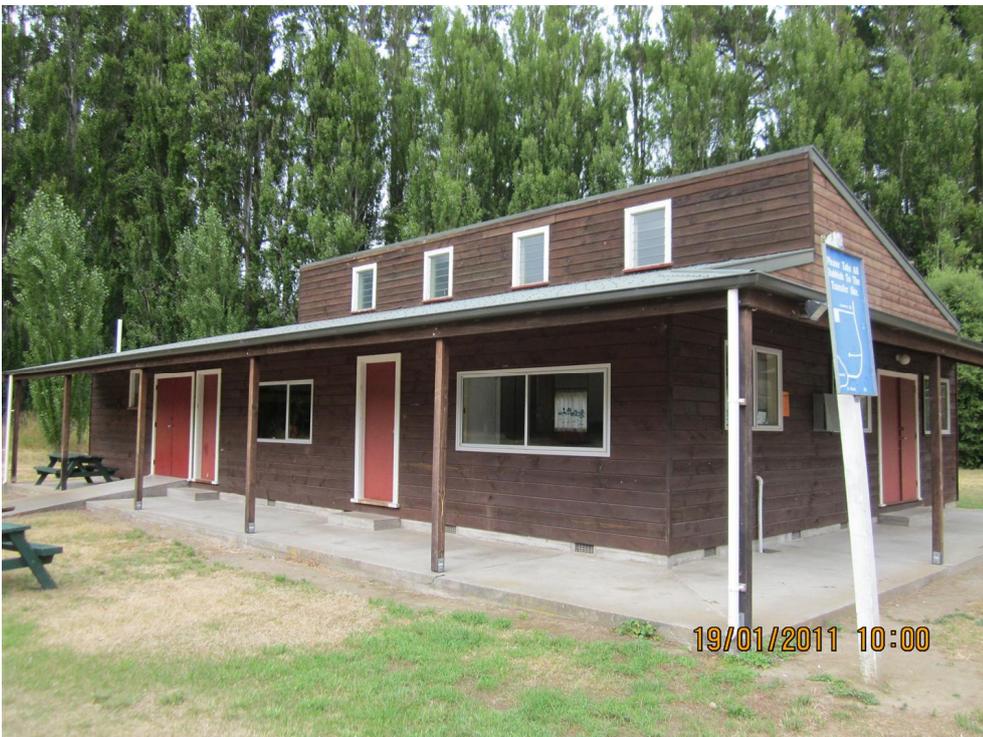
**Photo 2 – The east perimeter wall**

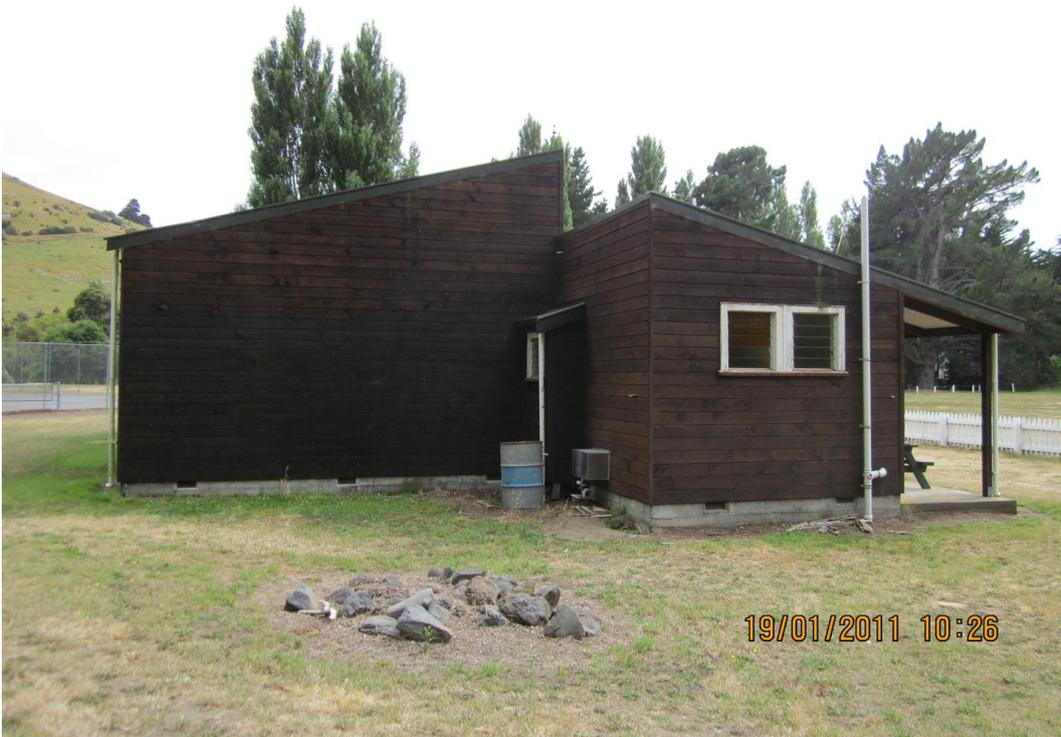
**Photo 3 – The south perimeter wall**

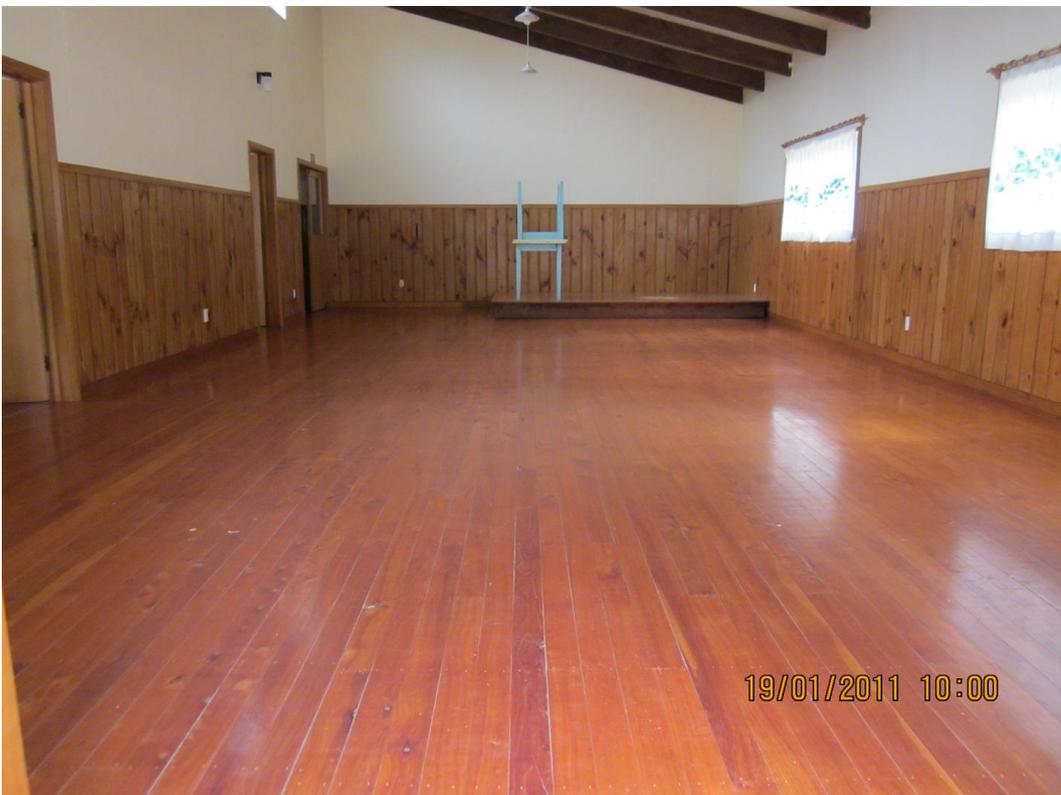
**Photo 4 – View of the main hall room**

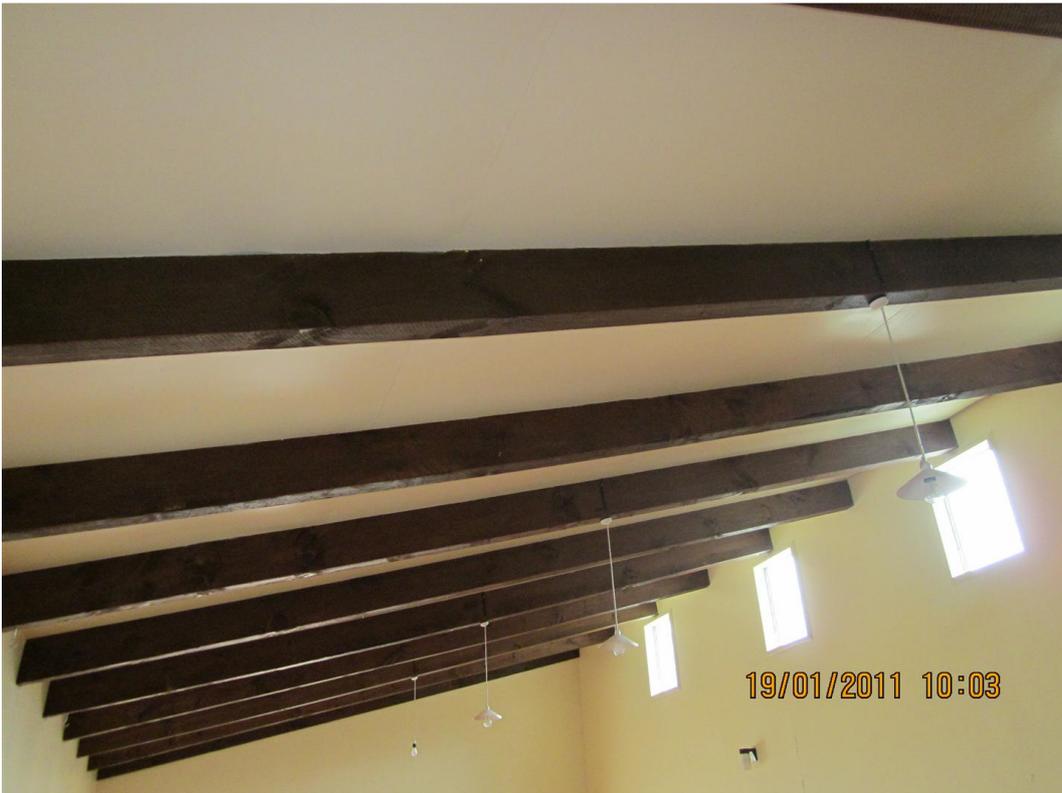
**Photo 5 – View of the exposed rafters in the main hall room**

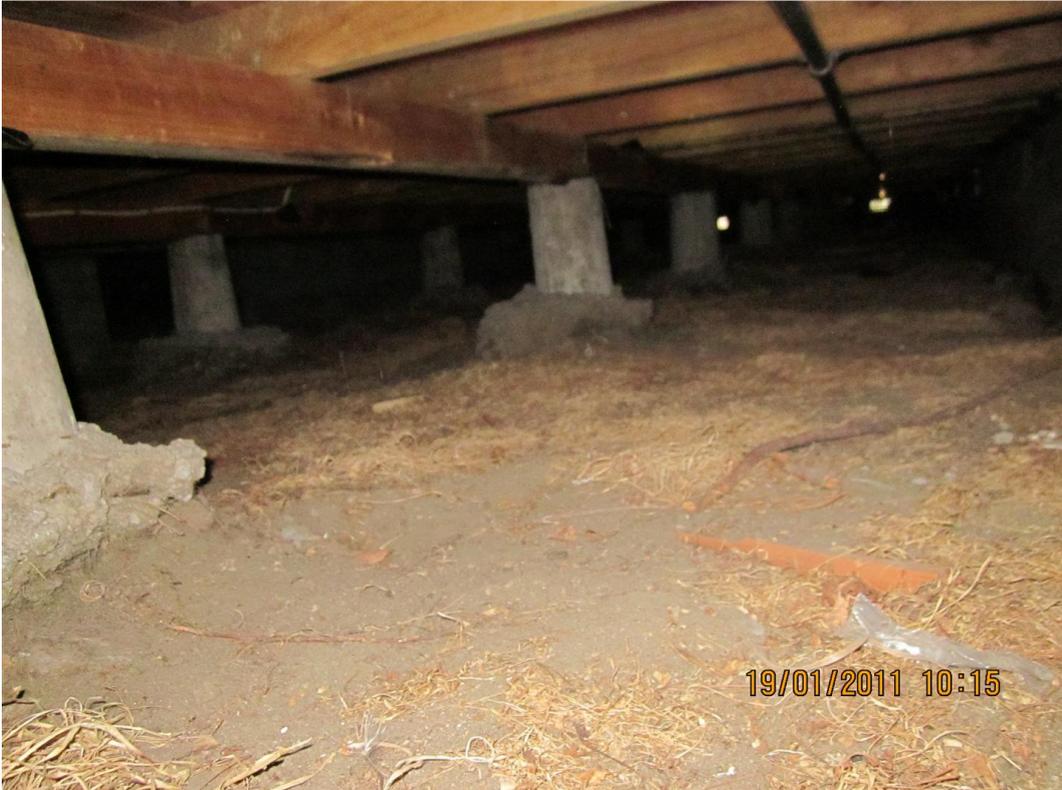
**Photo 6 – View of the pile foundations and subfloor framing**

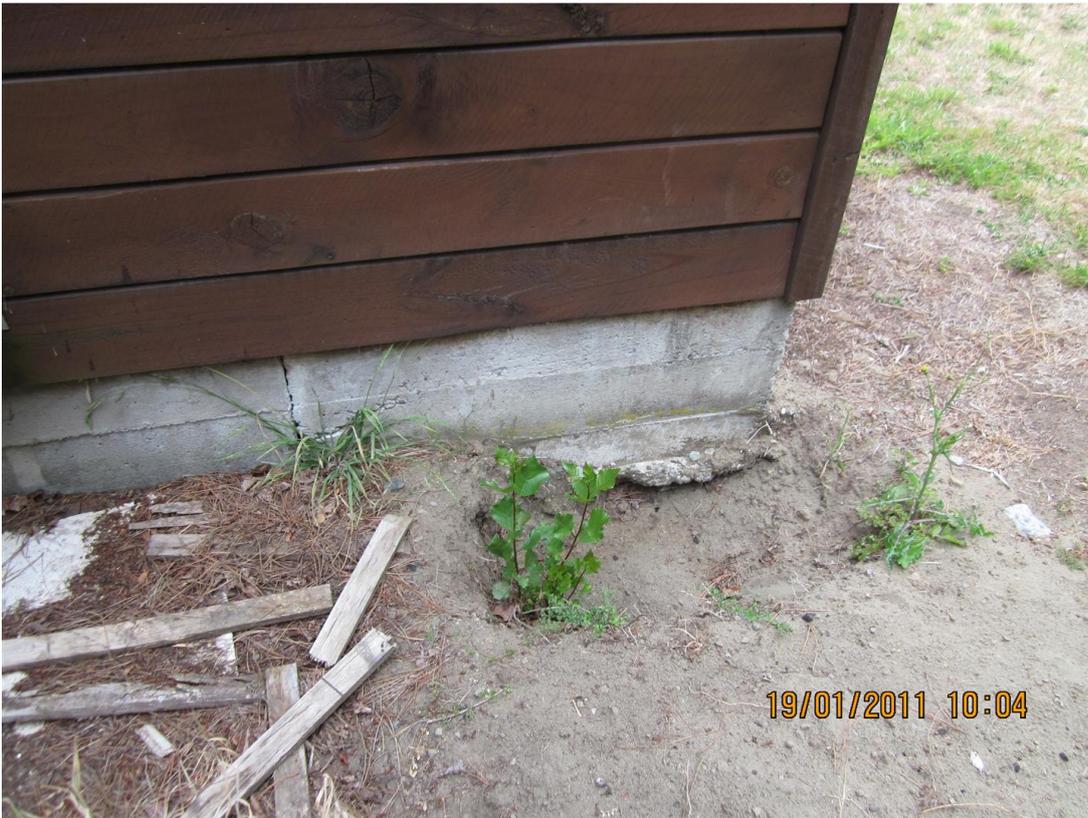
The existing foundations appear to have performed satisfactorily in the recent seismic events. No ground deformation or liquefaction has been observed at the site. The undermining of the foundations on the south west corner of the building is unlikely to have been caused by the recent seismic events. The 5mm crack that is also evident in this area is due to the extension of the building and not the recent seismic events. Due to the

**Photo 7: Undermined footing and cracks**

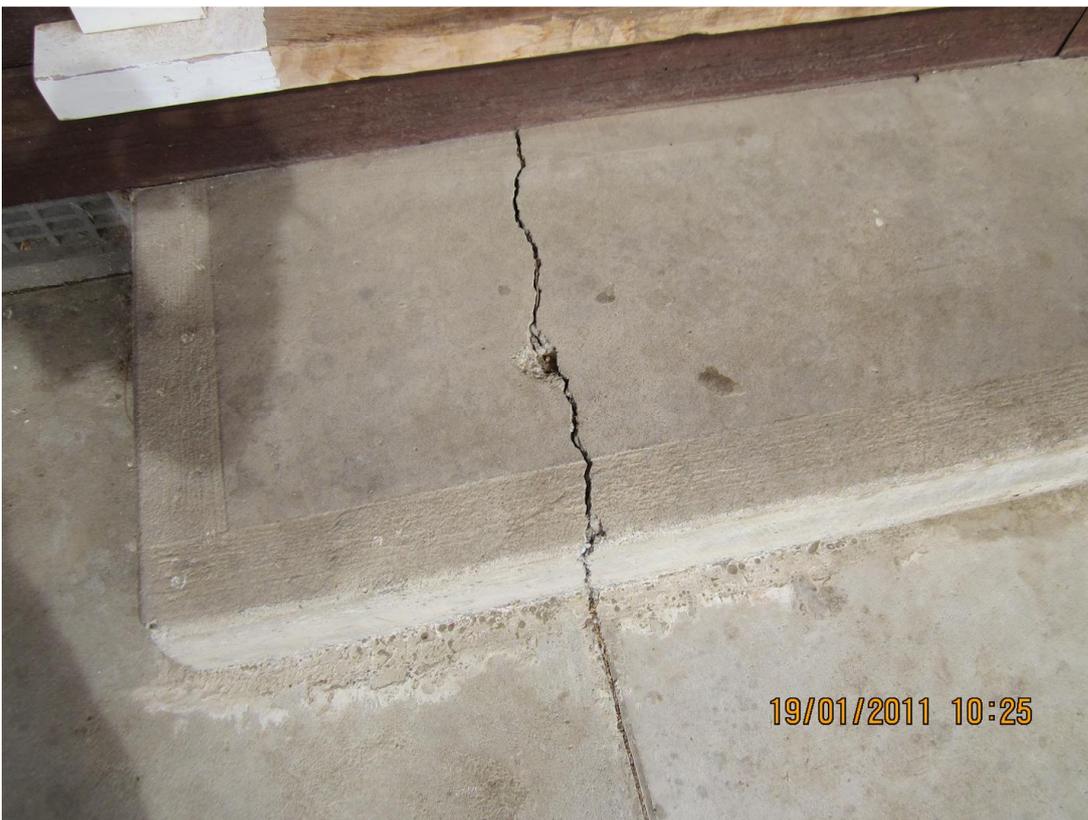
The building does not appear to have suffered any damage as a result of the recent earthquake events. A crack was observed in the concrete step on the veranda, however this appears to be historic damage.

- The building is located on a flat site, 220m west of the beach and 250m north of the river.
- The building is founded on a perimeter strip footing of unknown dimensions and interior concrete cone piles. All concrete piles appear to be tied to the timber bearers.
- There does not appear to have been any ground movement in the vicinity of the building.
- The foundations appear to have been undermined at the south west corner of the building. A 5mm crack is present in this location. Settlement is not attributed to the recent seismic events. Refer to Photo 7.
- The building does not appear to have differentially settled.
- A 5mm crack has continued up a step on the east side, which connects to a concrete shrinkage cut line. Refer to Photo 8.

**Photo 8: 5mm crack on step**
