**Le Bons Bay Domain Toilets
PRK-3596-BLDG-001**
Detailed Engineering Evaluation
Quantitative Report
Version FINAL

Christchurch City Council

Date
6 June 2013

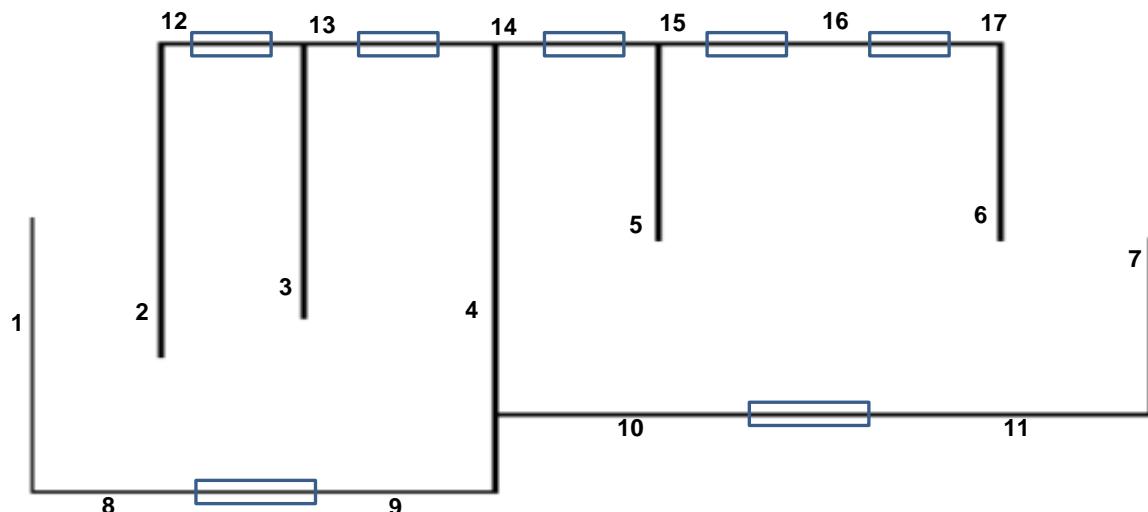
Figure 3 Wall Numbering

The in-plane capacities of the structure's walls were checked against lateral seismic loading. It was found that the shear capacities of the walls were the controlling in-plane values. The in-plane shear capacities of the walls are shown in Table 4 below. Walls are identified in Fig 3 below. The critical in-plane shear capacity was found to be 13.8% for Wall 7.

Wall 3 and Wall 5 as identified in figure 3 are partial height walls. The out of plane capacities of full and partial height walls are shown in Table 5 below. The critical out-of-plane capacity was found to be 12% NBS for partial height walls.

The building has been assessed as an Earthquake Prone building. Although NZSEE guidelines recommend strengthening to 67% NBS, due to the extent of the works required to achieve this, it may be prudent to demolish the existing structure and rebuild.

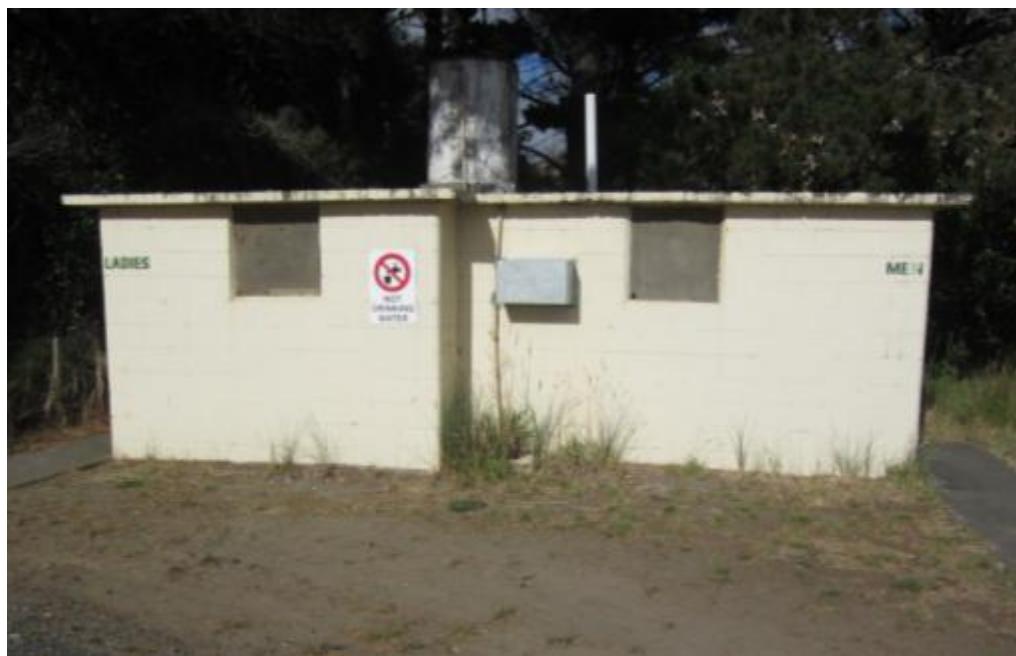
Photograph 1 Eastern elevation of structure

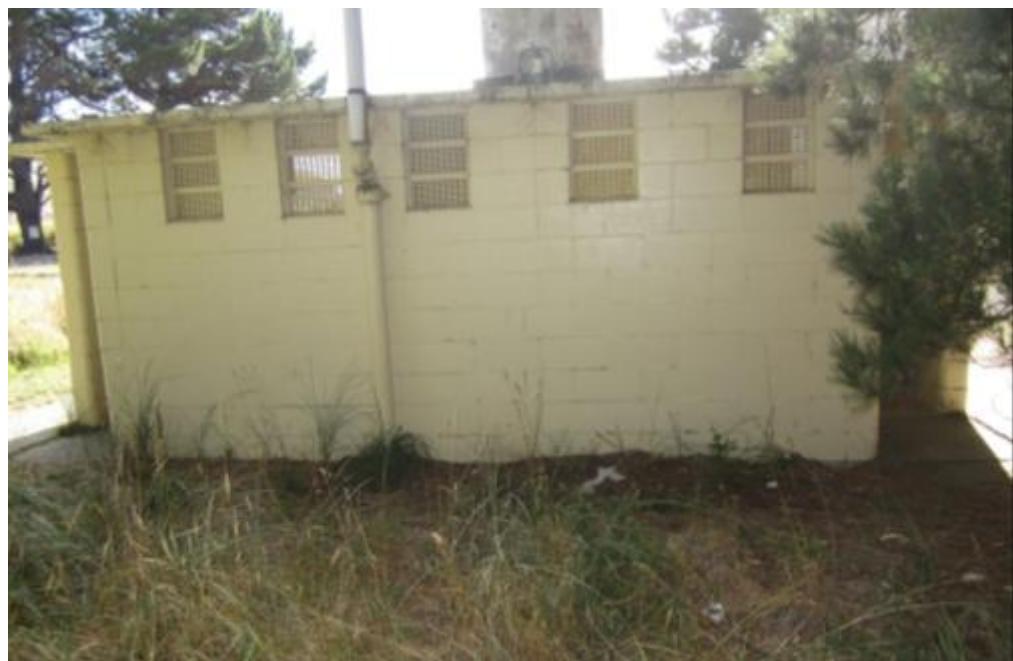
Photograph 2 Western elevation of structure

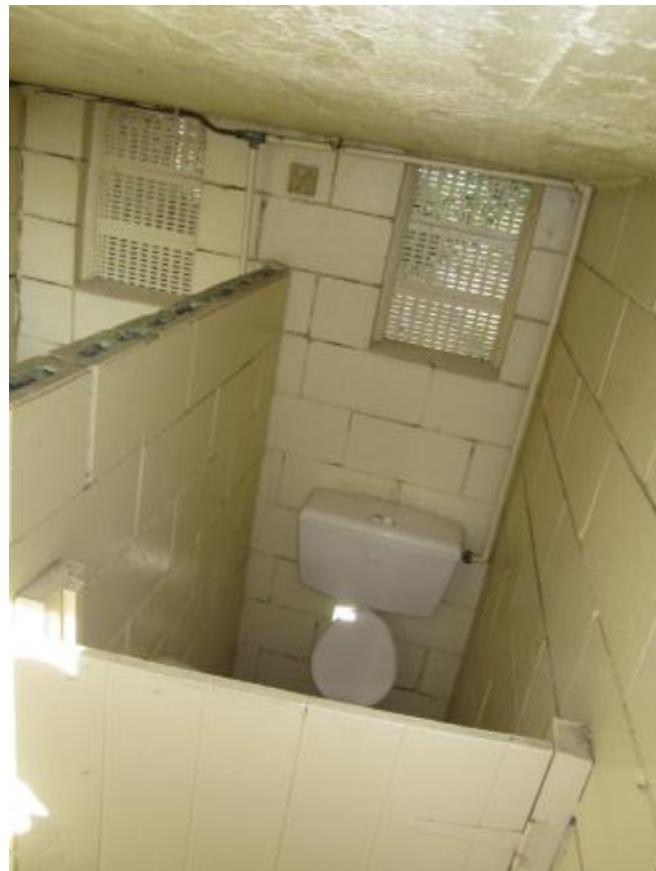
Photograph 3 Partial height wall on left and full height wall on right

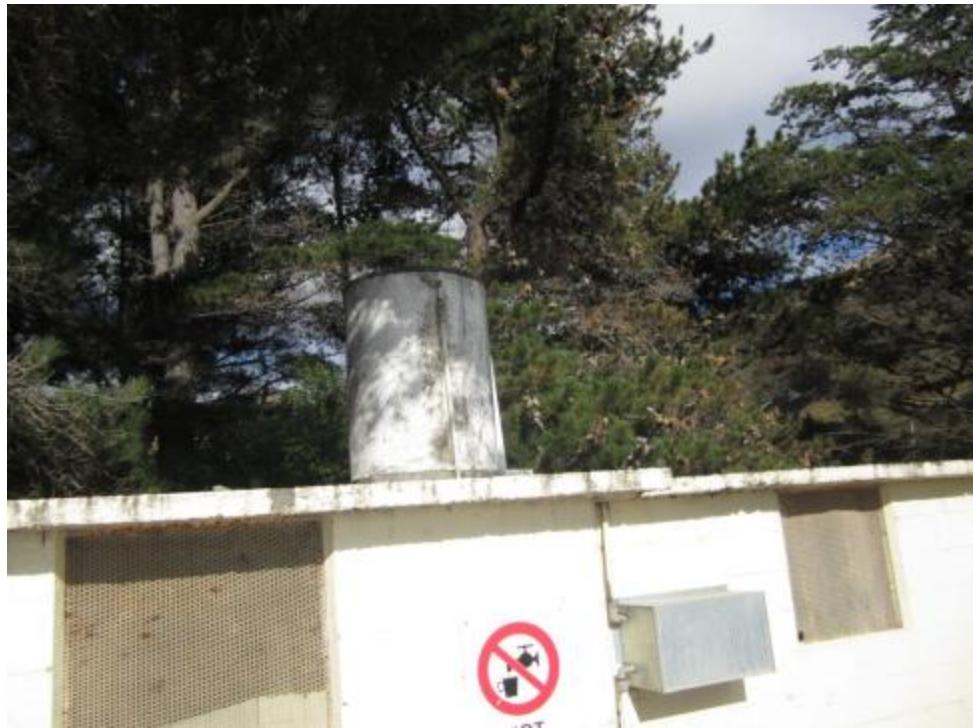
Photograph 4 Water storage tank on roof of structure

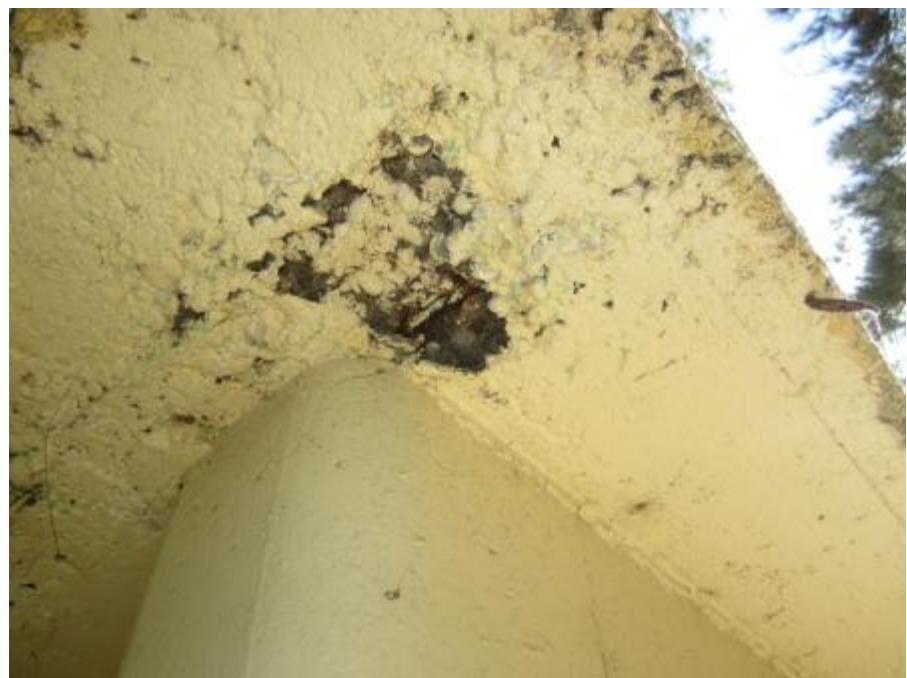
Non seismic damage in the form of minor concrete spalling was observed in some areas of the concrete roof slab.

Concrete honeycombing of the roof slab during construction resulted in reduced cover to reinforcement and has allowed corrosion to occur in the reinforcing mesh. The corrosion has led to minor spalling in some areas of the roof. The spalling will not affect the lateral load capacity of the roof diaphragm.

Photograph 5 Example of minor spalling in concrete roof slab
