Linwood Community Crèche

BU 0836 002 EQ2

**Detailed Engineering Evaluation
Quantitative Report**

Date: September 2012
Reference: 6-QUCCC.60
Status: Final

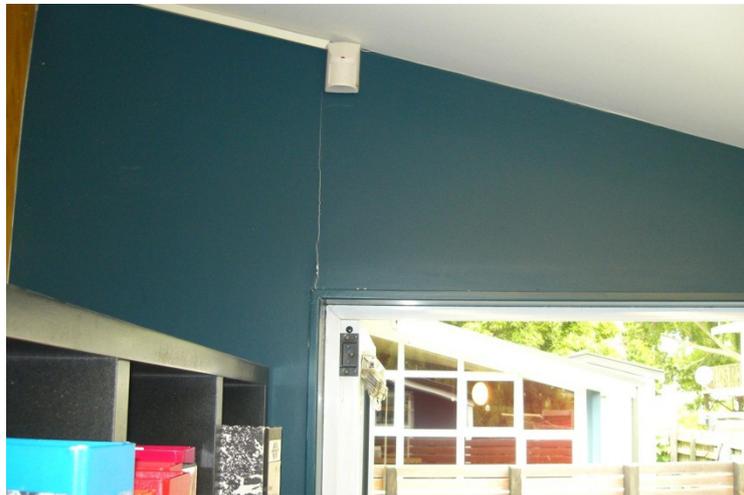
There is some cracking to the slab at the interface between the new staff room extension and the original building. The door from the staff room outside jammed following the February earthquake event and has since been repaired. The movement of the slab foundation is limited and appears to be within acceptable limits.

Photo 4 - Cracking to GIB lining in the staff room where the slab extension has moved

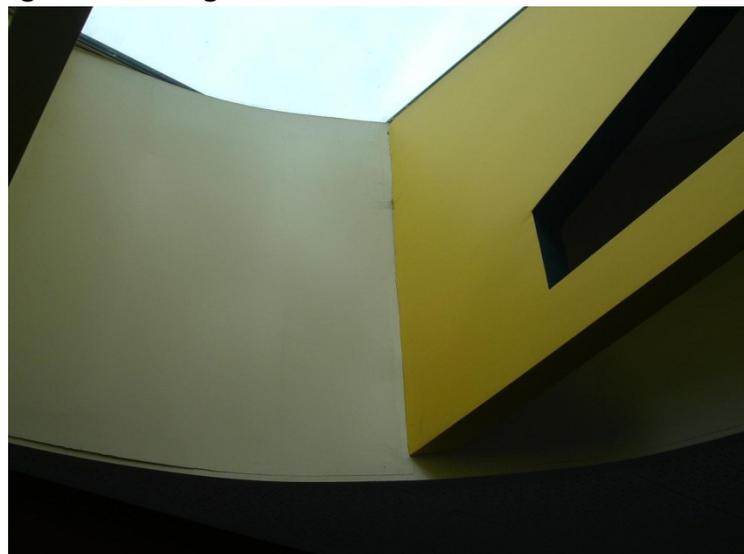
There was some minor cracking to the paint/linings at the corners where the roof trusses pass through the circular skylight.

Photo 5 – Paint cracking in the circular skylight
