**Linwood Community
Crèche Storage Shed
BU 0836-003 EQ2**

**Detailed Engineering Evaluation
Quantitative Assessment Report**

136 Aldwins Ave, Christchurch

Date: February 2013

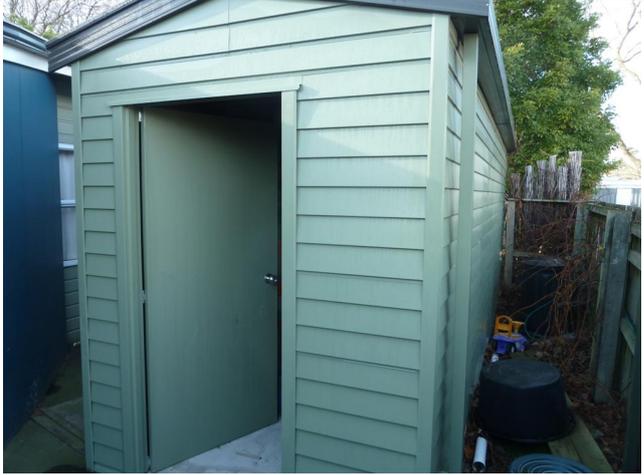
Site Name		
No.	Item description	Photo
General		
1.	View of the south west corner of the shed and door to the smaller filing room.

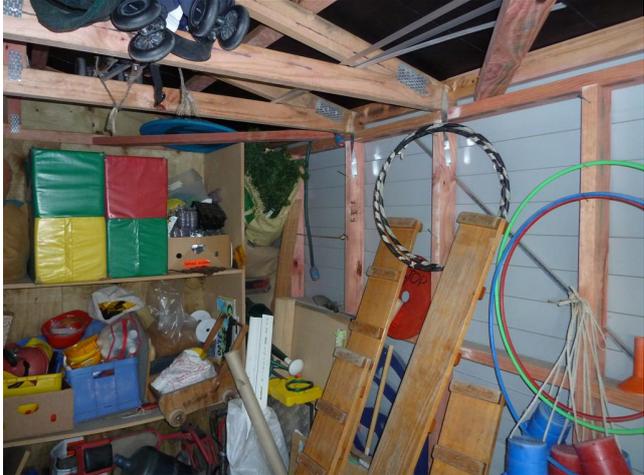
2.	View of the interior northern wall in the main storage room. Plywood lining can be seen at the western end and a steel angle brace can be seen on the north wall

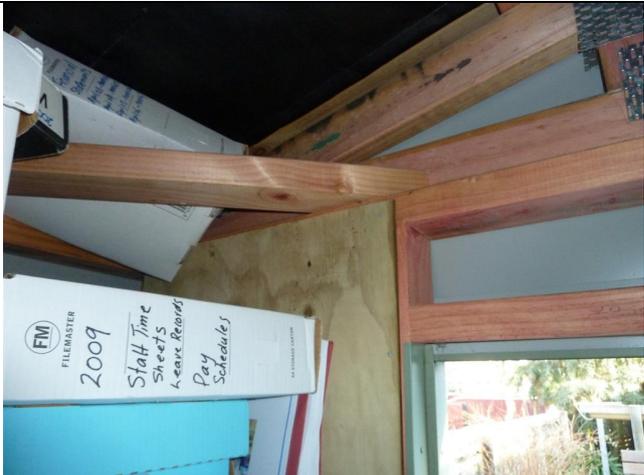
3.	View of the ply lining adjacent to the entrance in the interior south west corner of the small filing room.

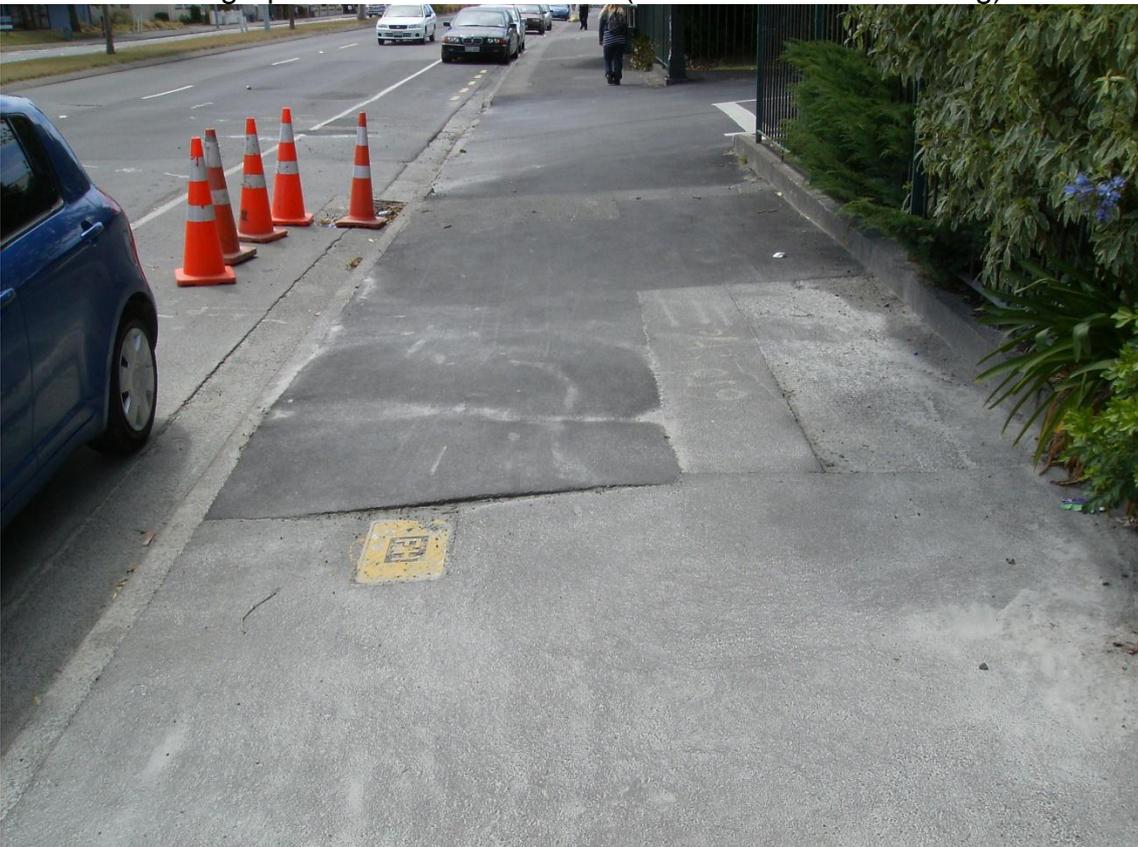
- 50mm undulations in the asphalt footpath due to liquefaction, observed 20m northeast of property on Aldwins Road near fire hydrant (refer Photograph 2);
- Evidence of ejected sand material due to liquefaction at the kerb on Aldwins Road;
- 10mm depression in asphalt carpark surface;
- hairline cracks in concrete encasement to slotted drain around the perimeter of the building. Possibly due to seismic shaking (Refer Photograph 3);
- settlement of concrete tile/paver in rear of section by up to 20mm;
- 3mm crack in concrete path;
- numerous cracks in gib and gib linings in interior of the dwelling, predominantly confined to the northern part of the building;
- a number of windows and doors had been realigned to open and close properly. Largely confined to the northern part of the building;

Photograph 2. 50mm undulations in asphalt footpath adjacent site on Aldwins Road

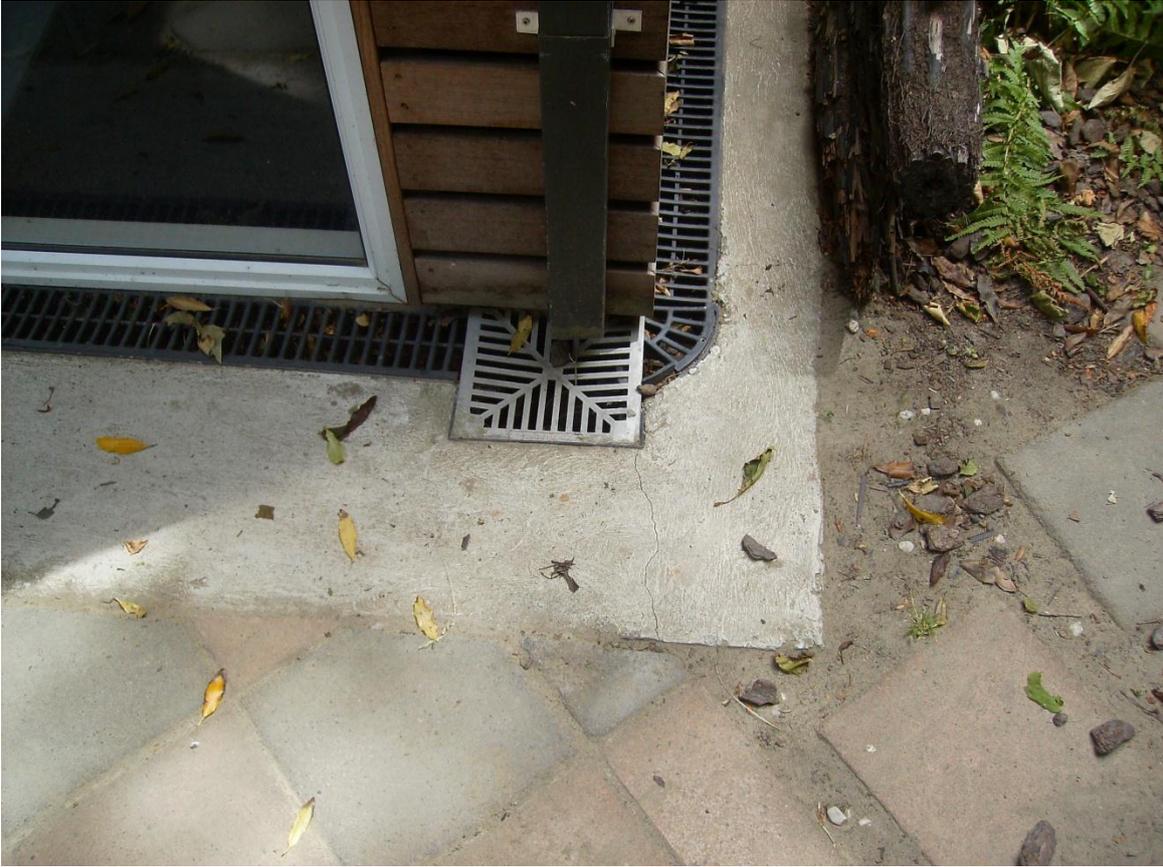
Photograph 3. Hairline crack in concrete encasement to slotted perimeter drain

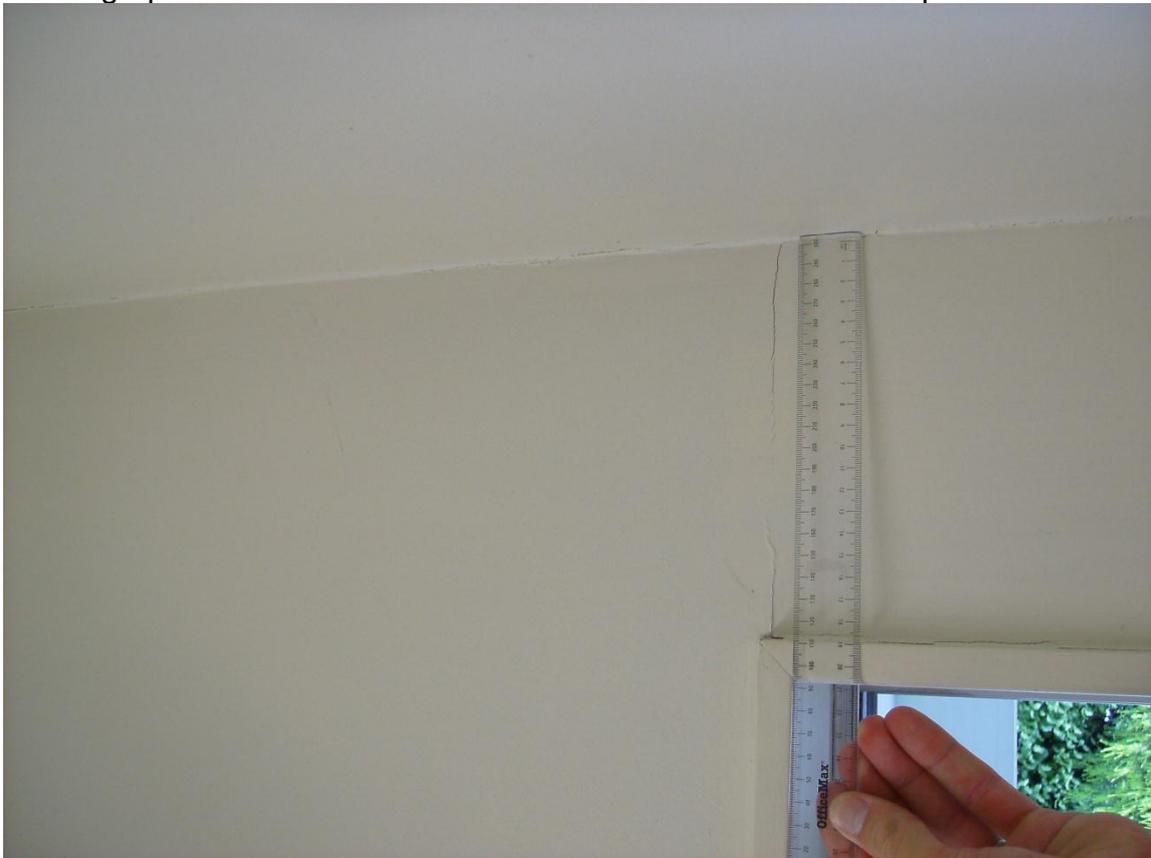
Photograph 4. Typical cracking in Gib above door frame in northern part of building
