CHRISTCHURCH CITY COUNCIL

Linwood Resource Centre – Toy Library
322 Linwood Avenue, Linwood
BU 0822-016

QUALITATIVE ASSESSMENT REPORT

- Rev 0
- 01 June 2012

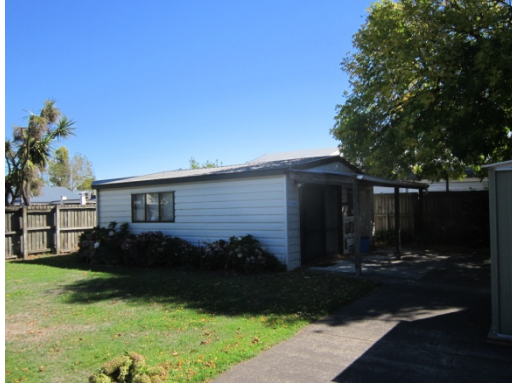
PHOTO 1: Eastern Elevation

No external damage was noted

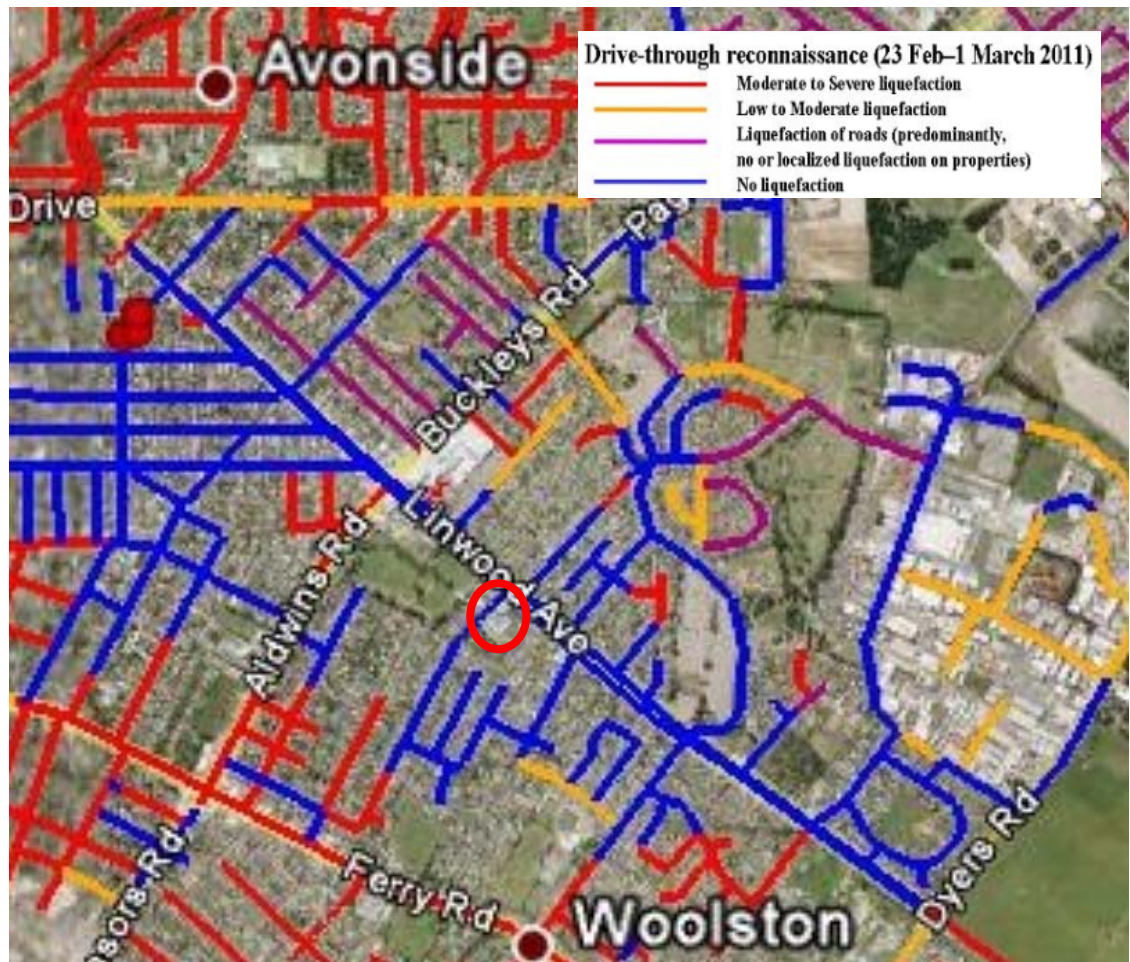
■ Figure 4 – Liquefaction map (Cubrinovski & Taylor, 2011). Site marked in red.

Following the 22 February 2011 event drive through reconnaissance was undertaken from 23 Feb until 1 Mar by M Cubrinovski and M Taylor of Canterbury University. Their findings show no liquefaction at this site.

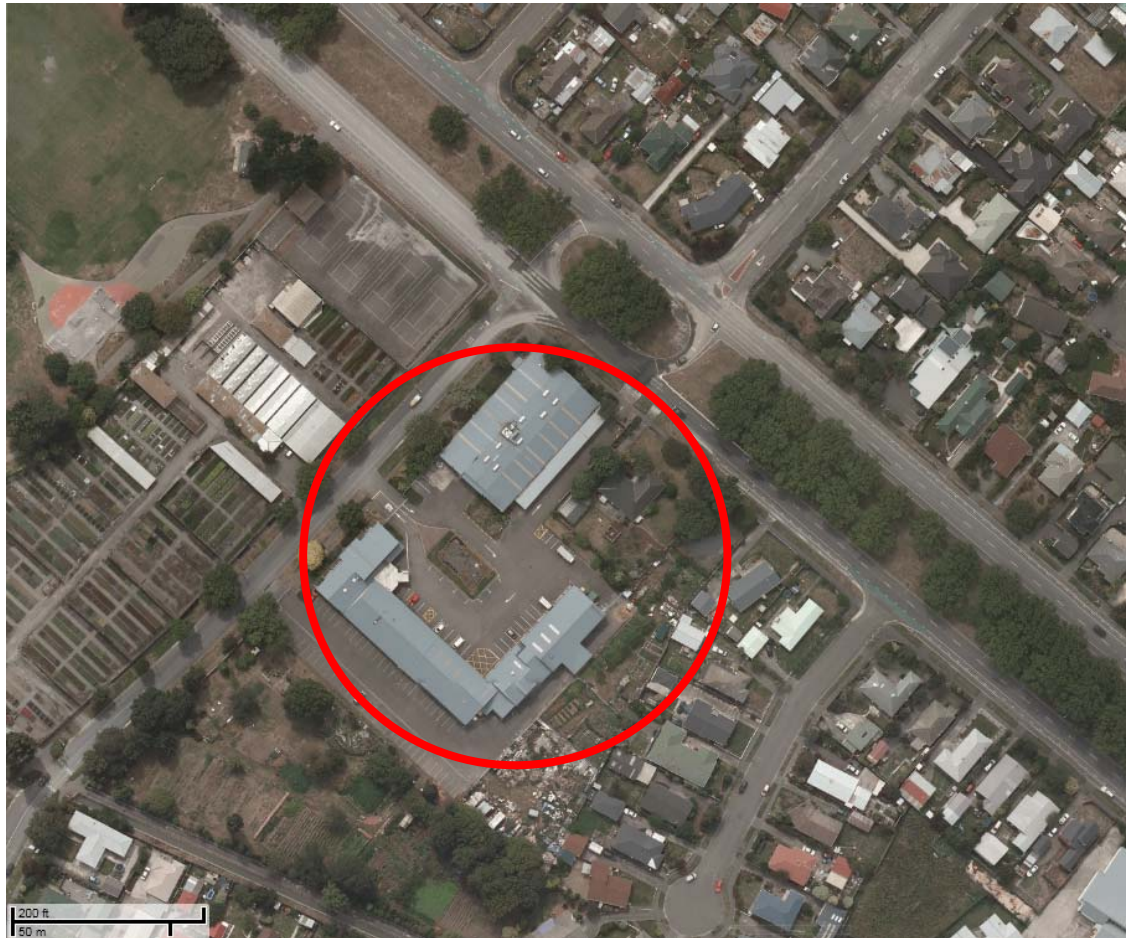
■ **Figure 5 – Aerial photography from 24 Feb 2011 (<http://viewers.geospatial.govt.nz/>)**

Aerial photography shows relatively little damage after the 22 Feb 2011 event. There appears to be a burst water main on Linwood Avenue, and what may be a single source of liquefied material in the tennis courts to the north west of the property. This coincides with a change of geology as identified on the geological maps.

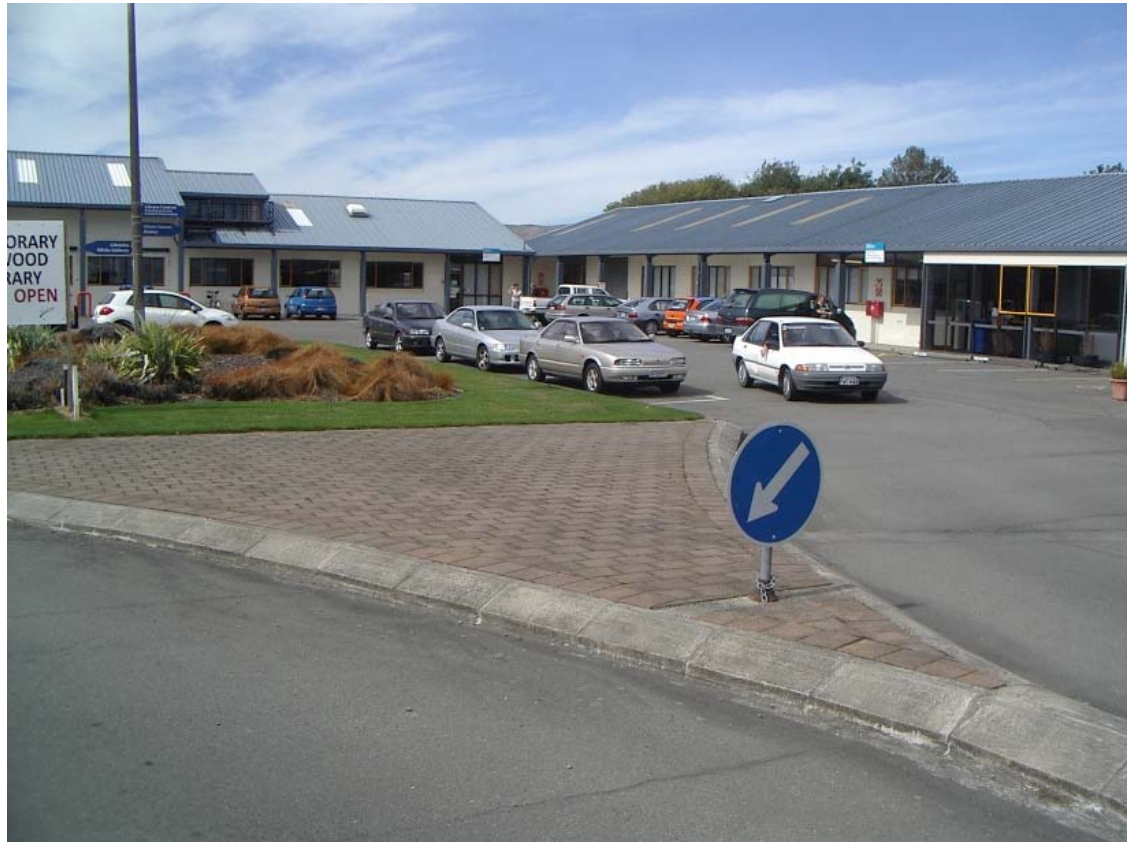
■ **Figure 7 Overview of Linwood Services Centre and Library**

The Linwood Resource Centre and Library were mostly constructed using masonry block with an iron roof, Figure 7 shows the overview of the site. The buildings were both in good condition, with no external evidence of structural damage. The majority of the land on the site was asphalt, which showed no signs of land damage. There was no evidence that liquefaction occurred on the site.

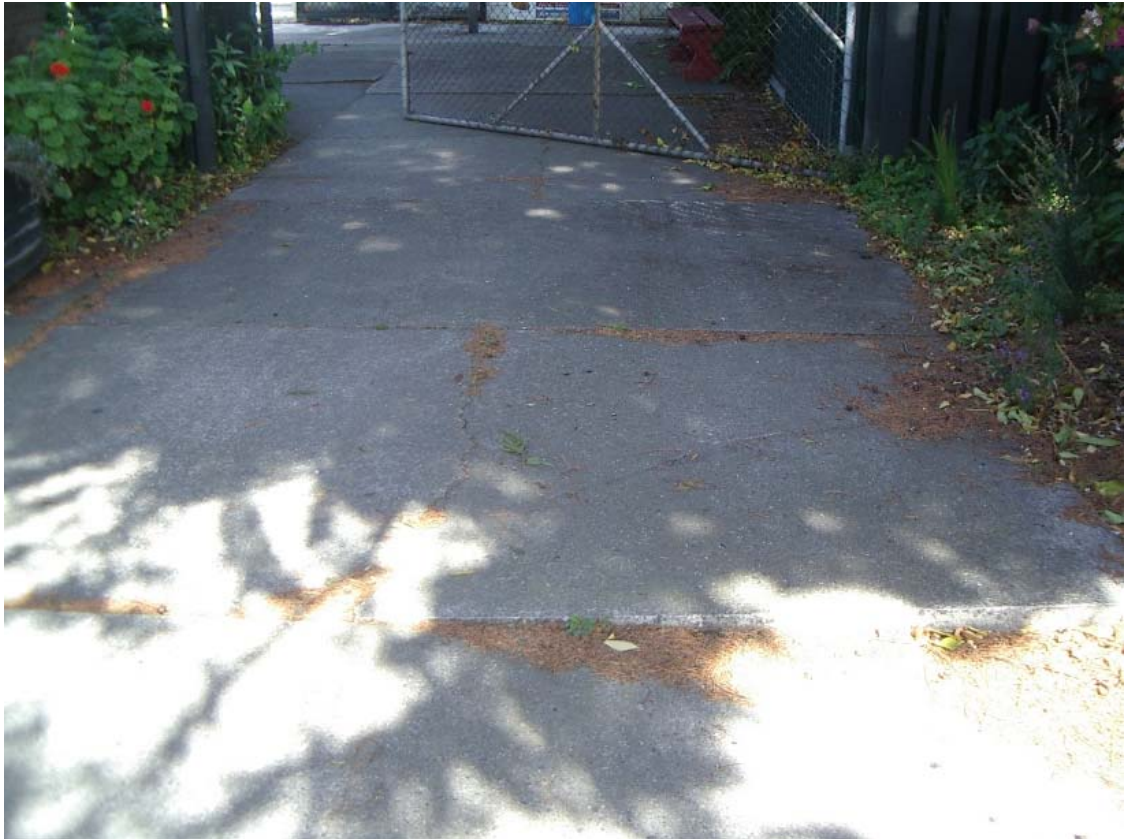
■ **Figure 8 Damaged paving slabs at Linwood Resource Centre**

Residents report that the only damage occurred to the footpaths, with paving slabs being displaced, (Figure 8) and that no liquefaction occurred on the site.
