Little River Community Facilities  
Qualitative Engineering Evaluation

**Reference:** 228600  
**Prepared for:**  
Christchurch City Council

Functional Location ID: PRO 3659 003

Address: 40 Western Valley Road

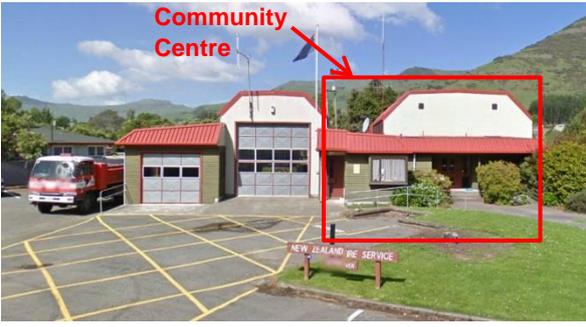
Building north-eastern elevation.

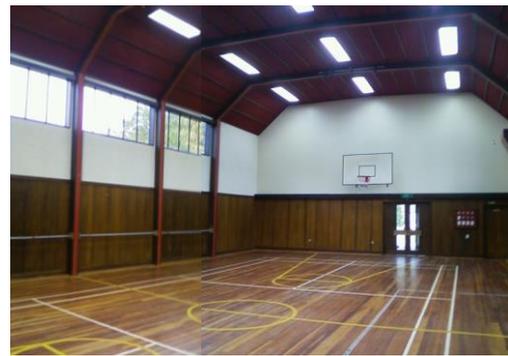
Building internal view.

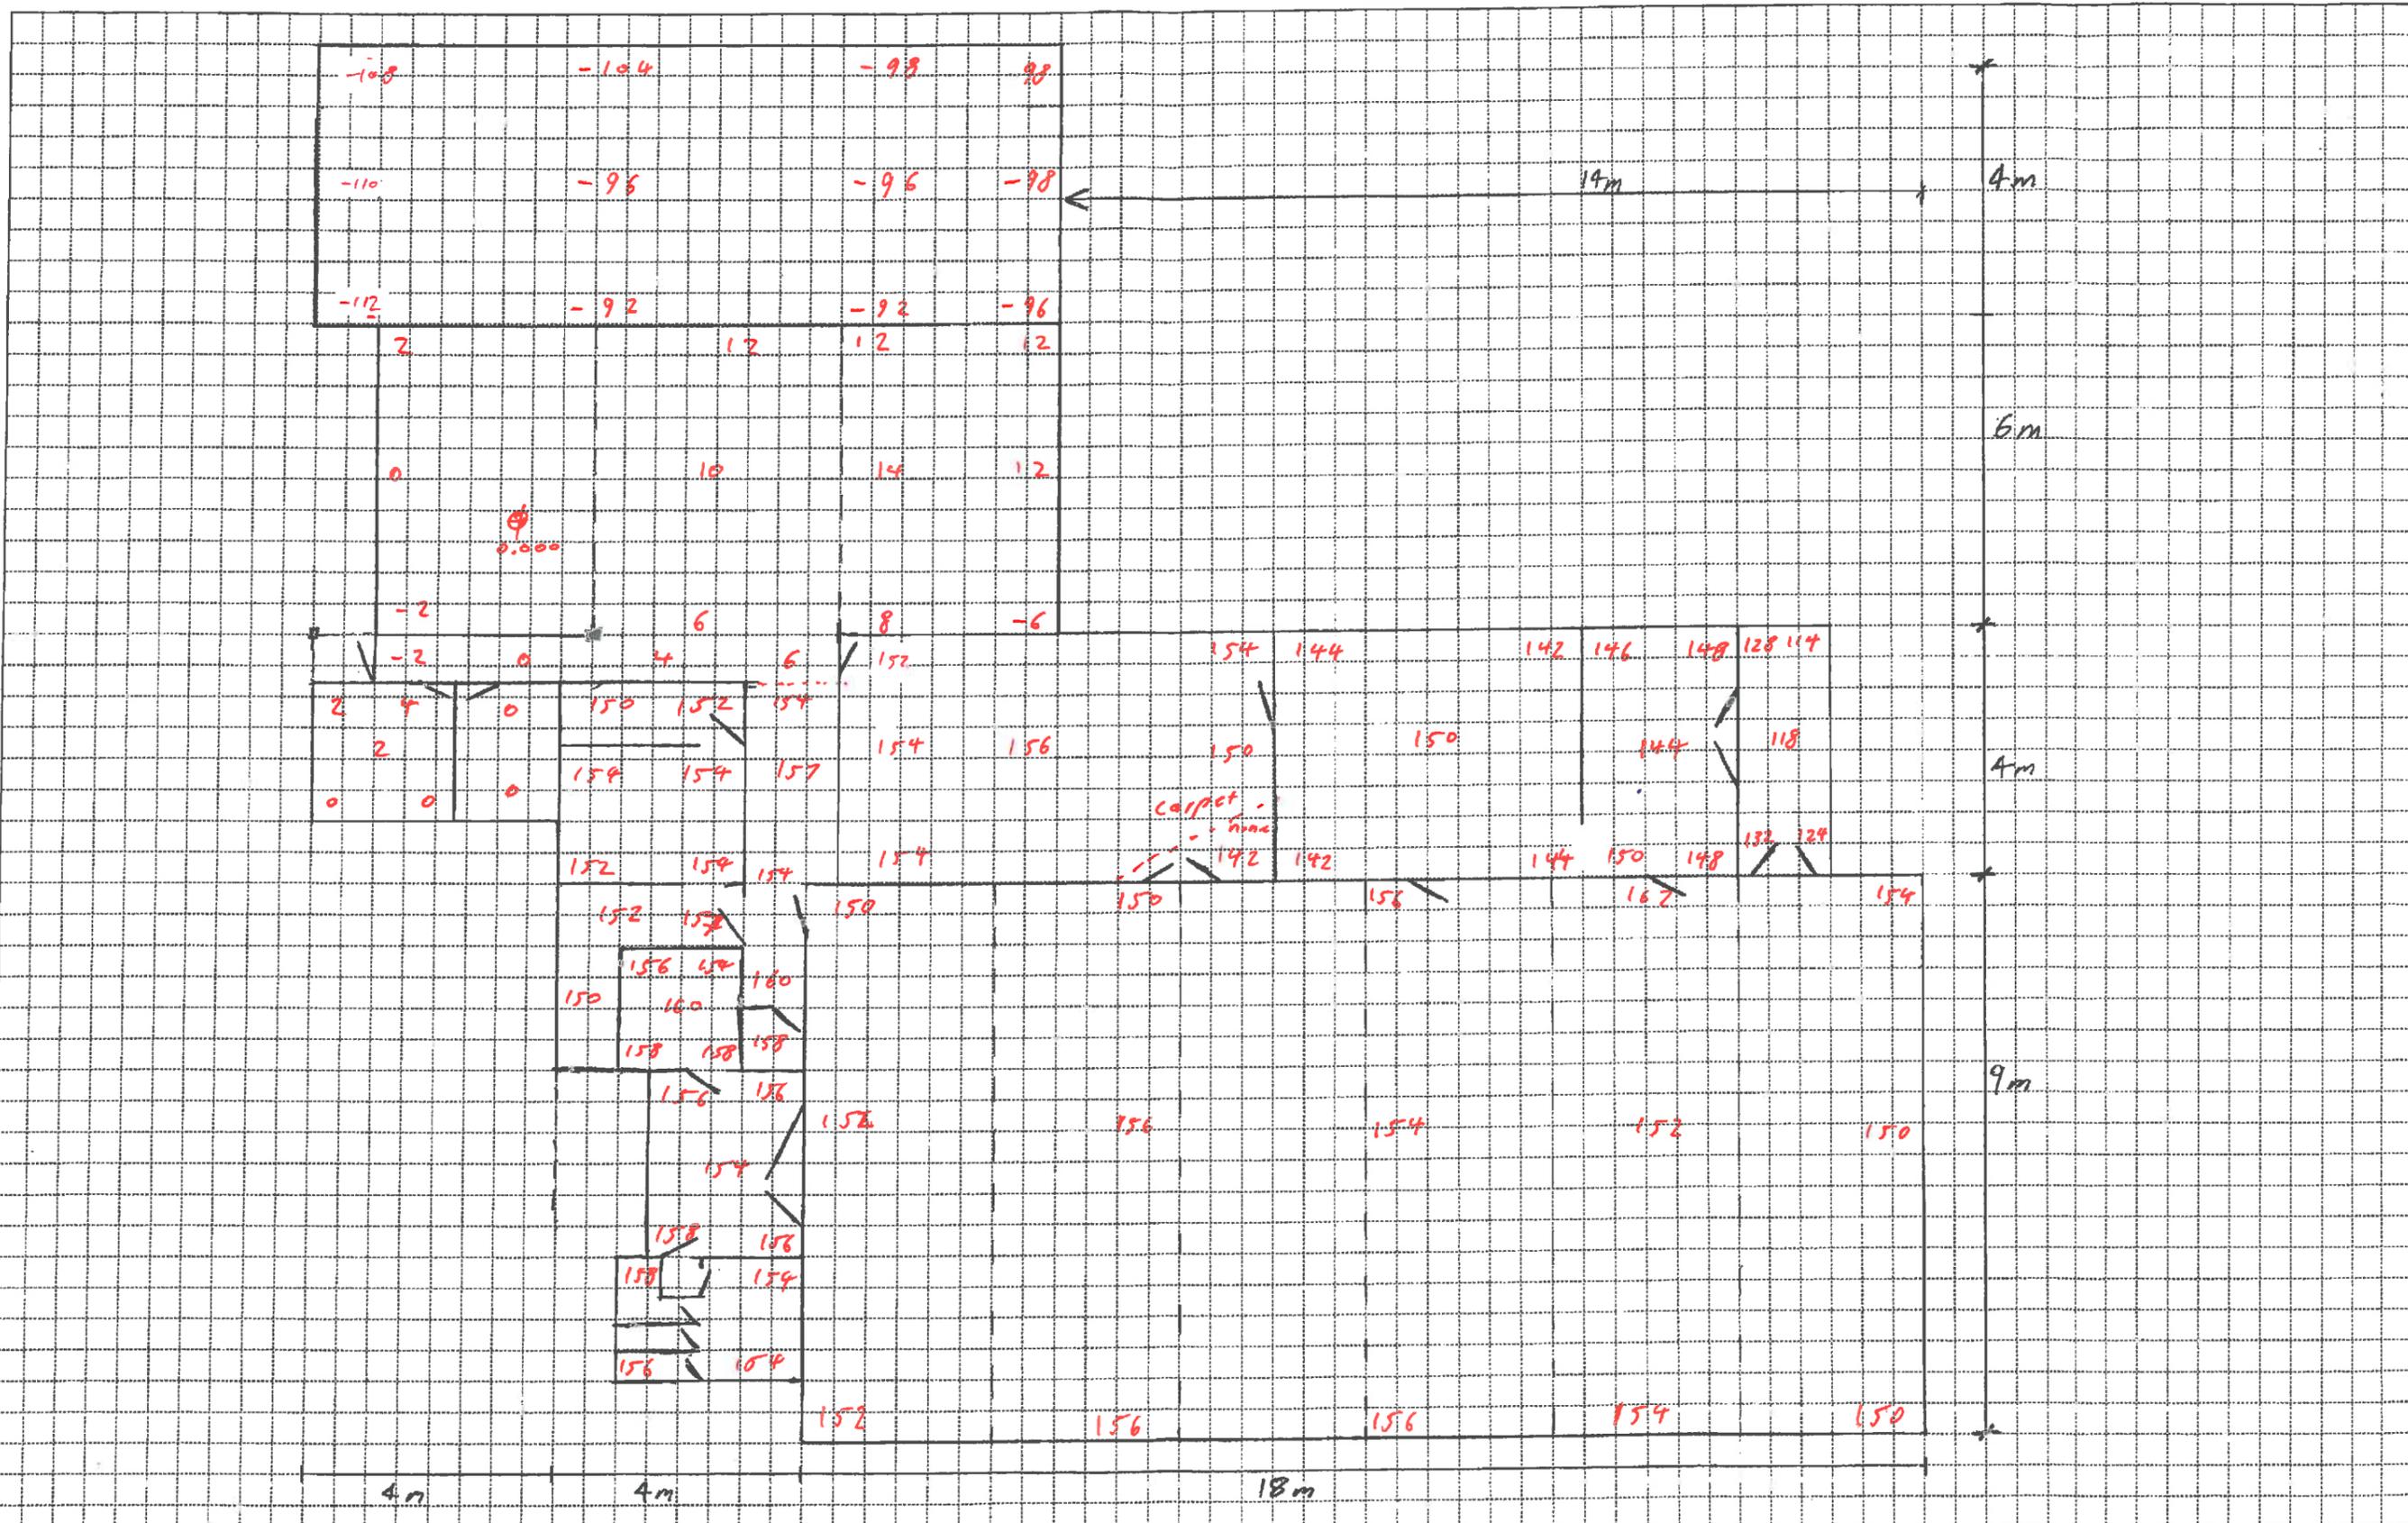
Drawing Title: **Plan**

A floor level survey was undertaken to establish the level of unevenness across the floors. The results of the survey are presented on the attached sketch in Appendix A. All of the levels were taken on top of the existing floor coverings which may have introduced some margin of error.

The floor levels for the Little River Community Facilities were found to be within the recommended tolerances once the various floor coverings are taken into account.
