**Dairy Unit**  
**PRK 2561 BLDG 004 EQ2**  
Detailed Engineering Evaluation  
Qualitative Report  
Version FINAL

75 Lower Styx Road, Bottle Lake

Christchurch City Council

**Date**  
18<sup>th</sup> December 2013

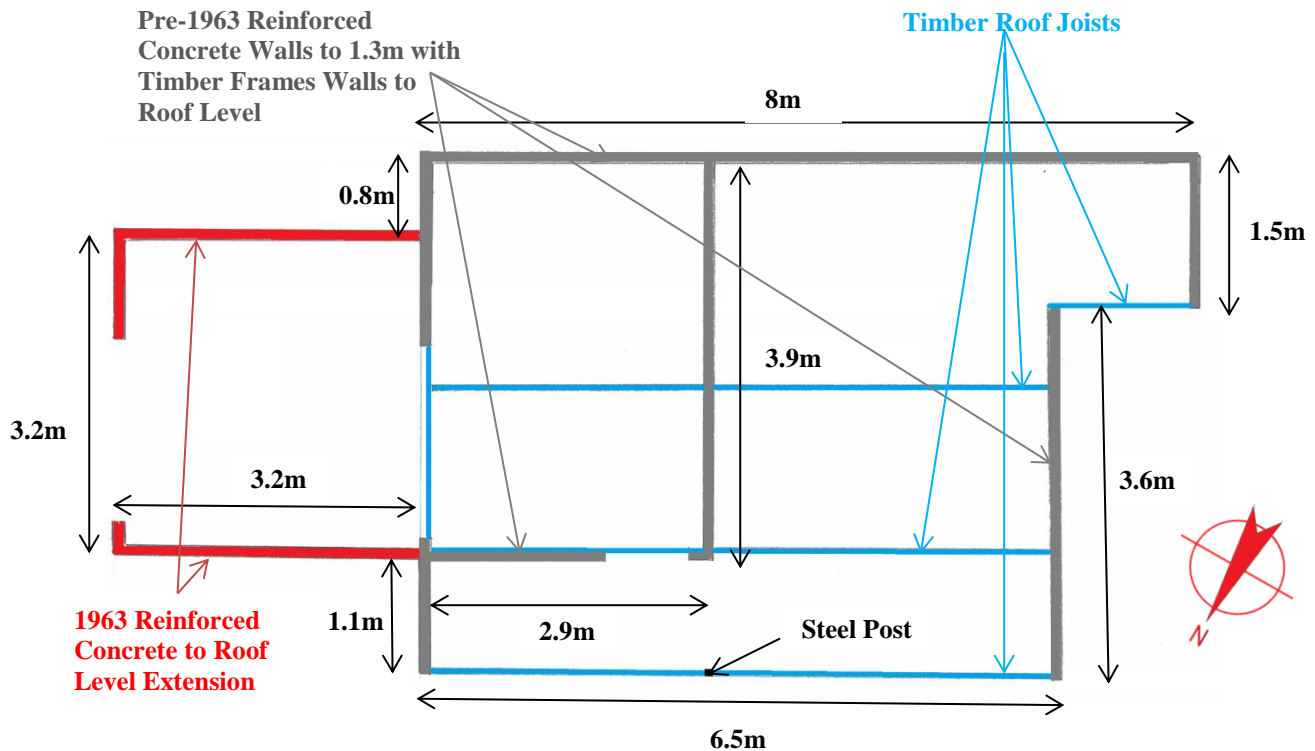
Figure 2 Plan Sketch Showing Key Structural Elements

The dimensions of the building are approximately 11.2m in length, 5.1m in width and 3.6m and 2.3m in height for the 1963 extension and the older portion of the building respectively. The plan area of the building is approximately 46m<sup>2</sup>.

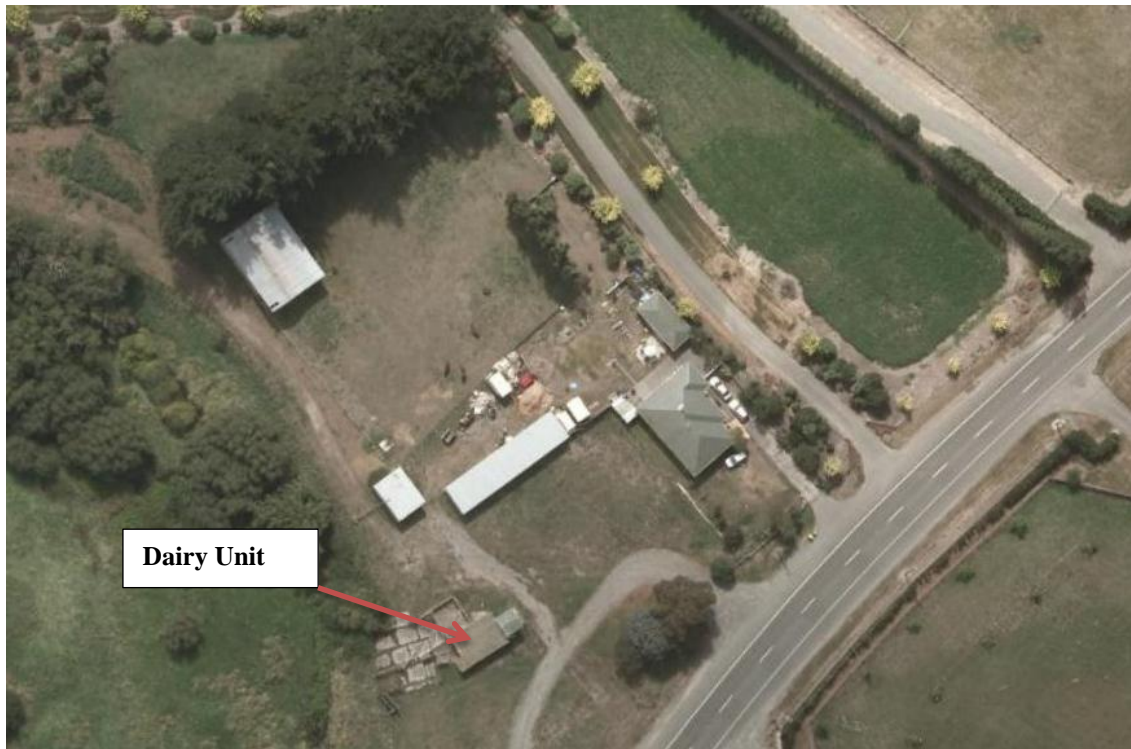
**Figure 3 Post February 2011 Earthquake Aerial Photography <sup>2</sup>**

Aerial photography taken following the 22 February 2011 earthquake doesn't show clear signs of liquefaction (see Figure 3), however, liquefaction was observed close to the property.

Due to the anticipated presence of sand at the shallow depth, and the sites proximity to a local water course, it is considered possible that liquefaction will occur at the site. It is not clear from the post-earthquake aerial photography (Figure 3) whether liquefaction has occurred at the site, however, it was observed close to the property. The site is considered to have a moderate-high liquefaction potential at this stage of investigation.

It is recommended that three piezocone CPTs be conducted to target depths of 20m. This will allow a liquefaction assessment to be carried out.

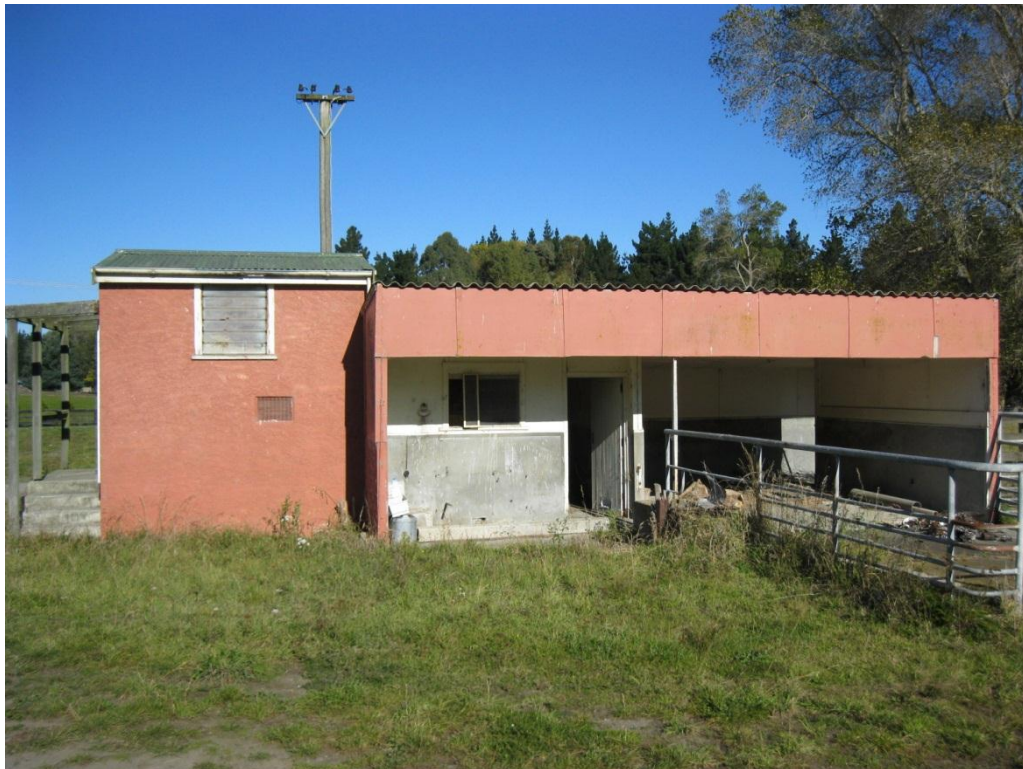
**Photograph 2 View of the dairy unit from the north-west. The 1963 extension is to the left and original portion is to the right in this photo. A large opening is clearly visible.**

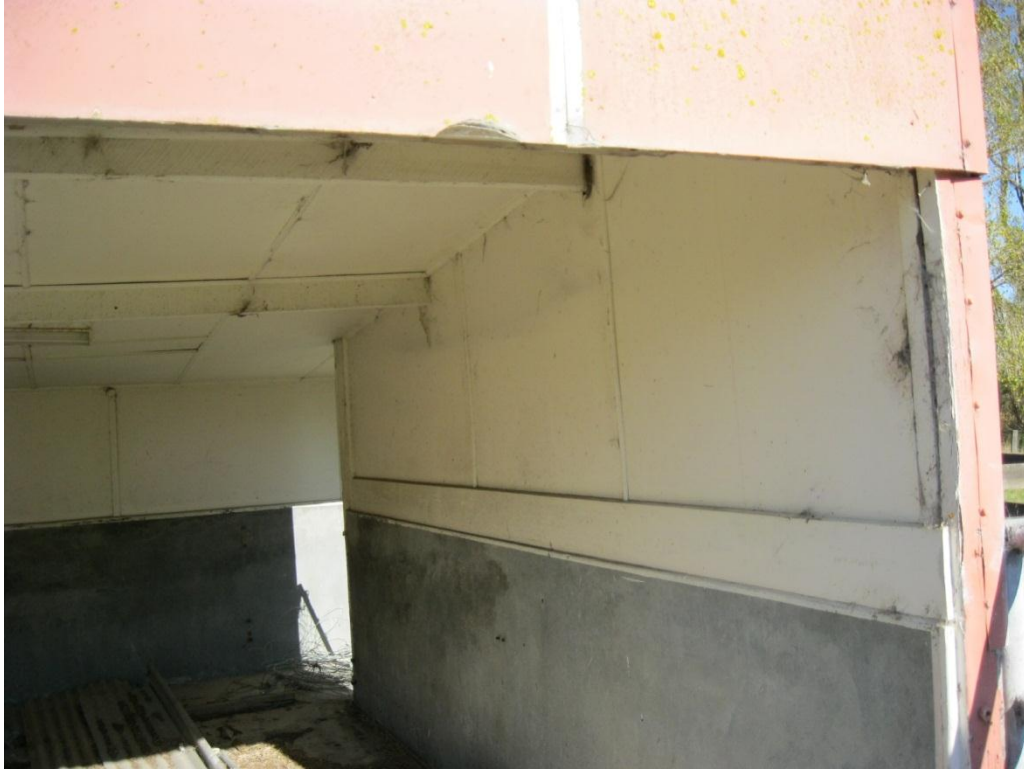
**Photograph 5 View of the interior at the south-eastern wall of the building. Wall and roof linings and roof joists are clearly visible.**

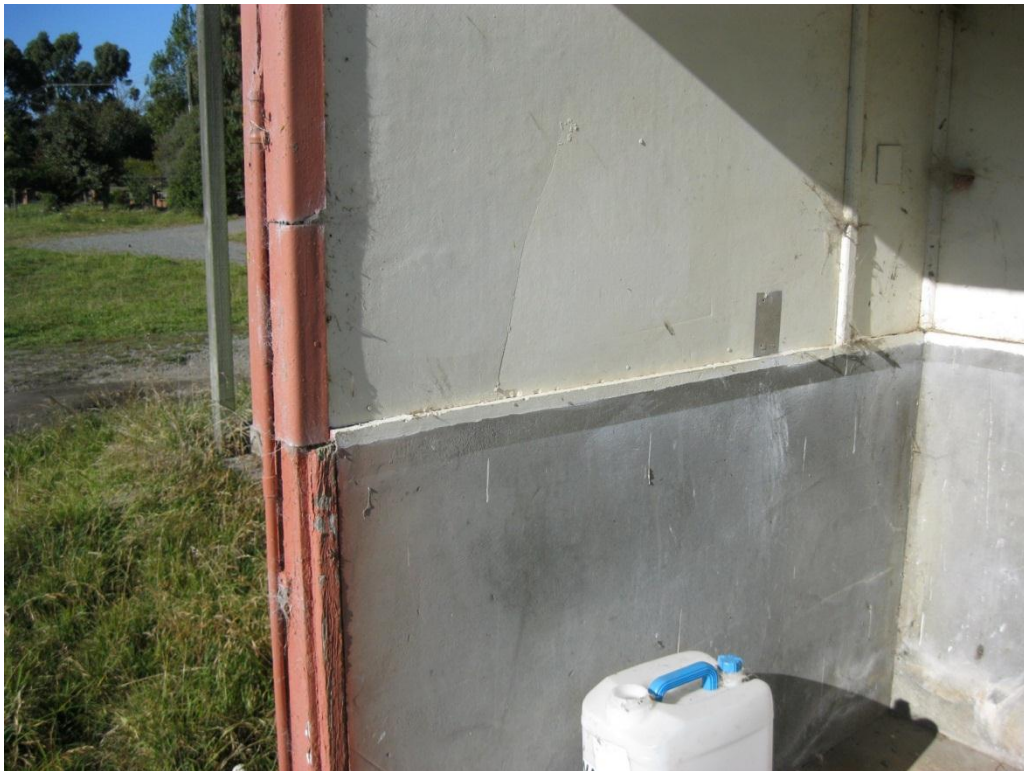
The only damage noted to the building was cracking to the suspected asbestos wall linings but this is not believed to be as a result of the earthquakes. It is not expected that the damage to the linings will have a negative effect on the structural capacity of the building. The % NBS of the building has not been reduced as a result of this damage.

**Photograph 6 Cracking to the timber frame lining that is not believed to be earthquake related.**

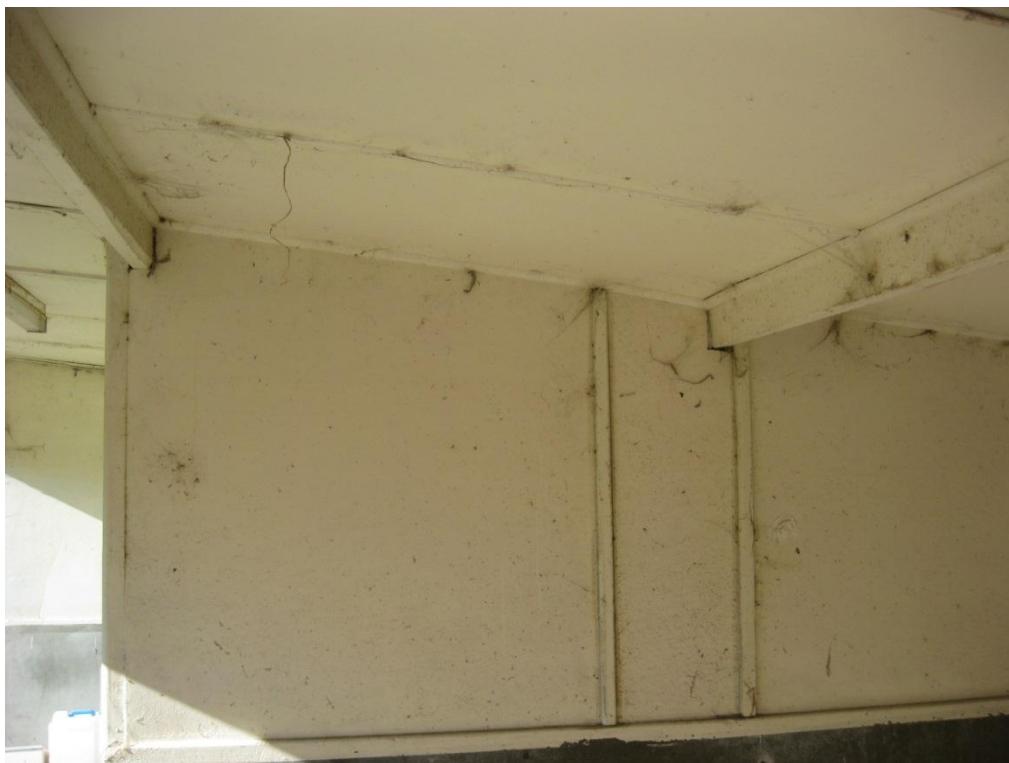
**Photograph 7 Timber roof joists in the original portion of the building.**

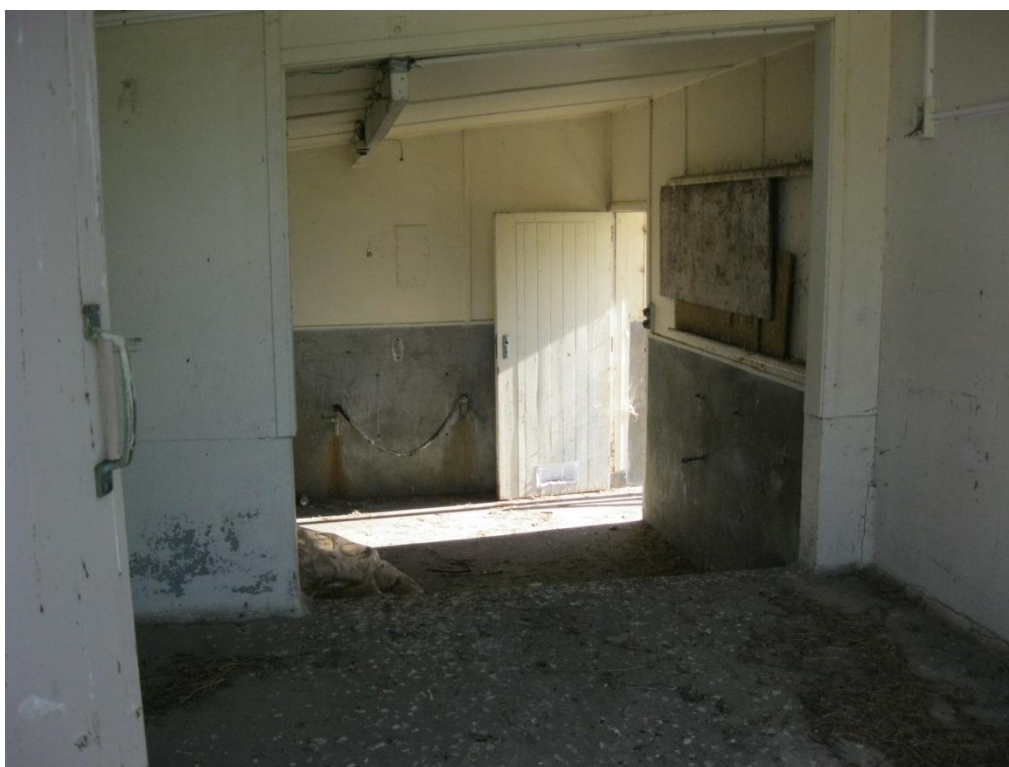
**Photograph 8 Interior of the 1963 extension showing opening into the original portion of the building.**
