**Double Garage**  
**PRK 2635 BLDG 002 EQ2**  
Detailed Engineering Evaluation  
Qualitative Report  
Version FINAL

51 Lower Styx Road, Styx River Reserve

Christchurch City Council

**Date**  
17/09/2013

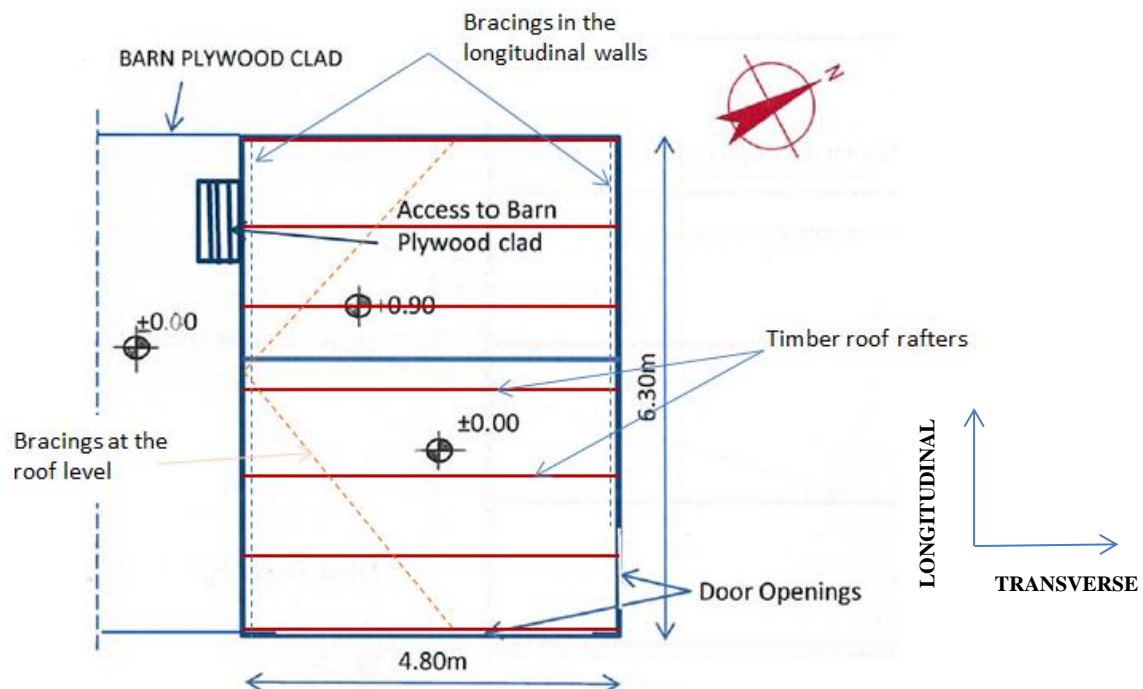
Figure 2 Plan Sketch Showing Key Structural Elements

The vertical load resisting system of building is straightforward. The timber rafters span between the load bearing side walls. Loads are supported by the perimeter strip foundation. There is a central beam beneath the rafters but this appears to be redundant and suspended from the rafters.

The timber framed external walls transfer the lateral load down to the concrete perimeter strip foundation via diaphragm/sheet action of the external metal and timber cladding. Some nominal load resistance to is provided by diagonal timber bracing within the timber framed walls, however this is discontinuous in some locations.

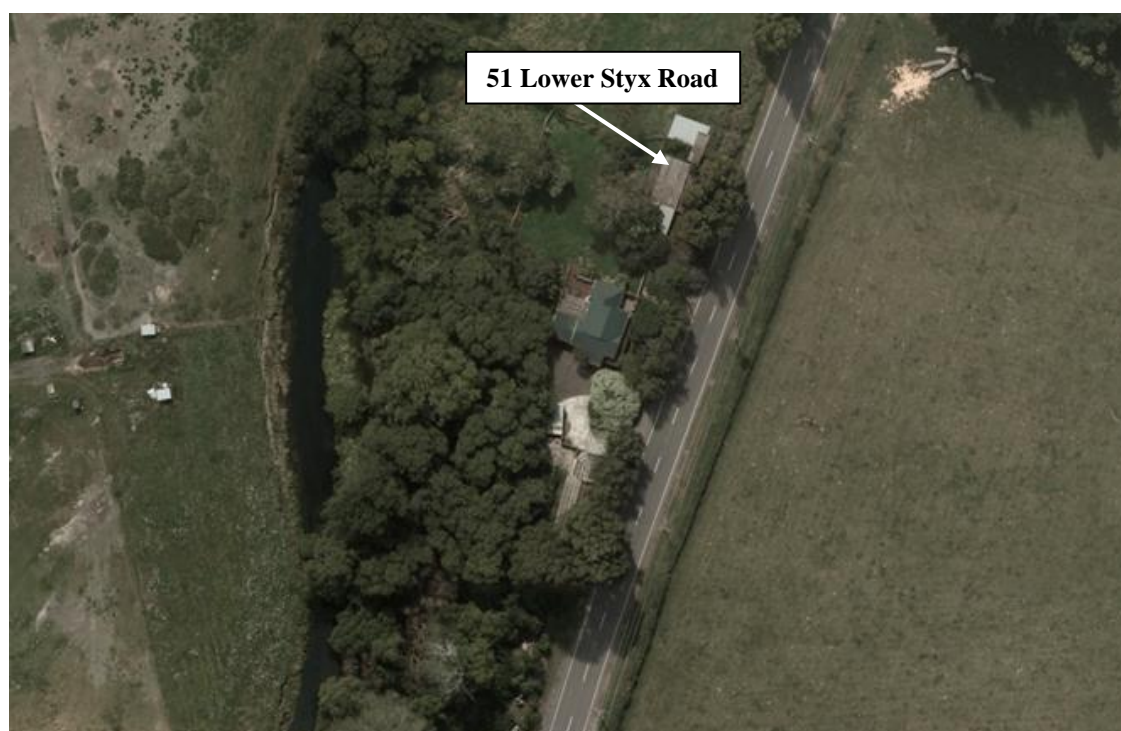
**Figure 3 Post February 2011 Earthquake Aerial Photography** <sup>2</sup>

Aerial photography taken following the 22 February 2011 earthquake shows no signs of liquefaction visible within the property boundary as shown in Figure 3. However, liquefaction in the form of sand boils and lateral spreading is evident on the western side of the Styx River (subject property is to the east).

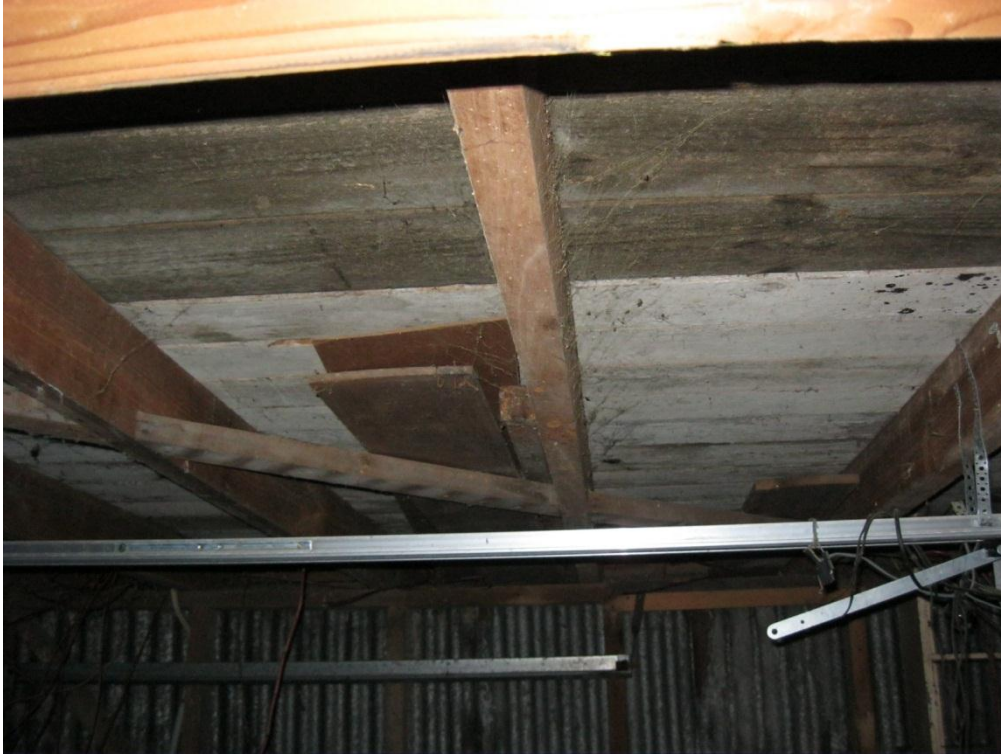
**Photograph 7 Bracing at the roof level.**

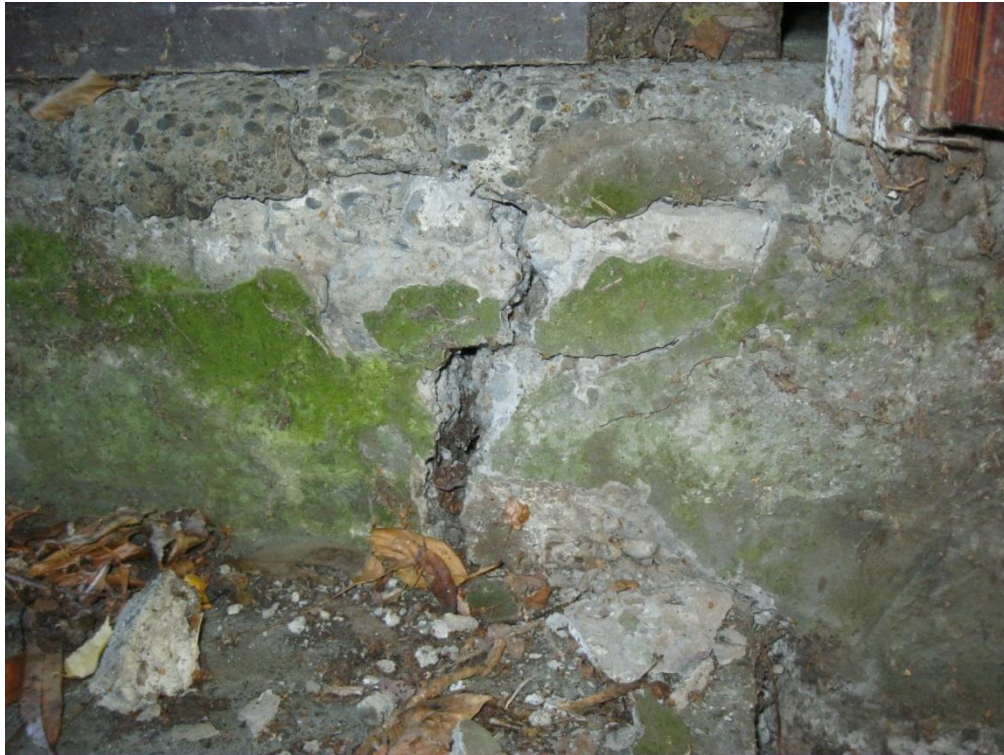
During the inspection some cracks were noted in the perimeter concrete strip foundation (see the photograph 9 and 10).

**Photograph 9 Cracking of the concrete perimeter beam foundation- longitudinal wall**

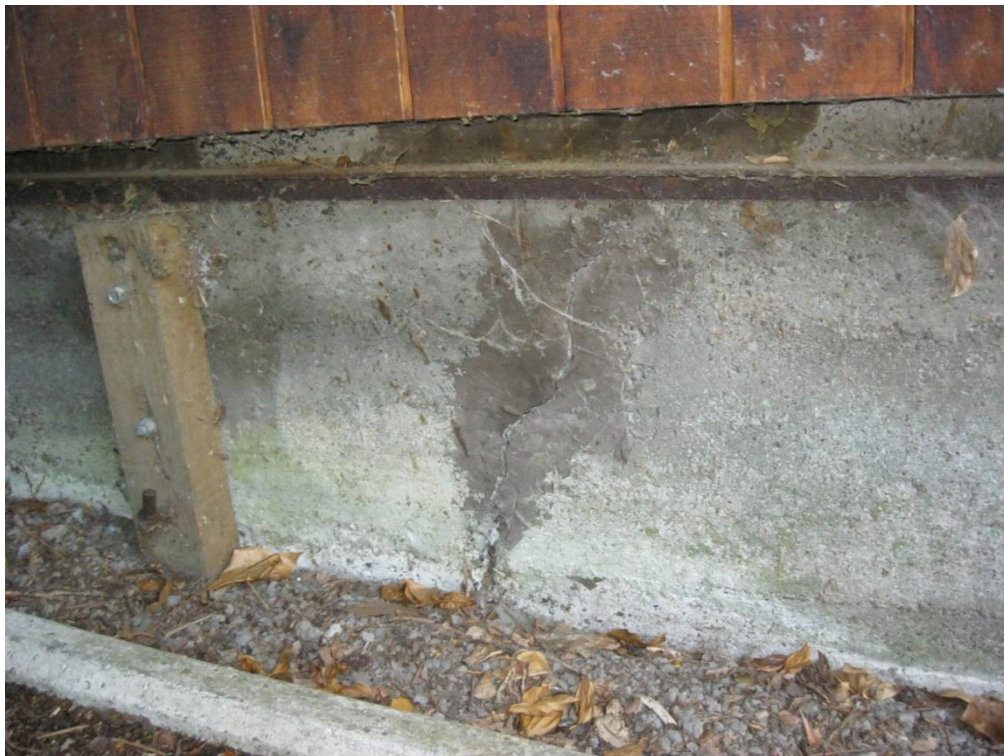
**Photograph 10 Cracking of the concrete perimeter beam foundation- longitudinal wall**

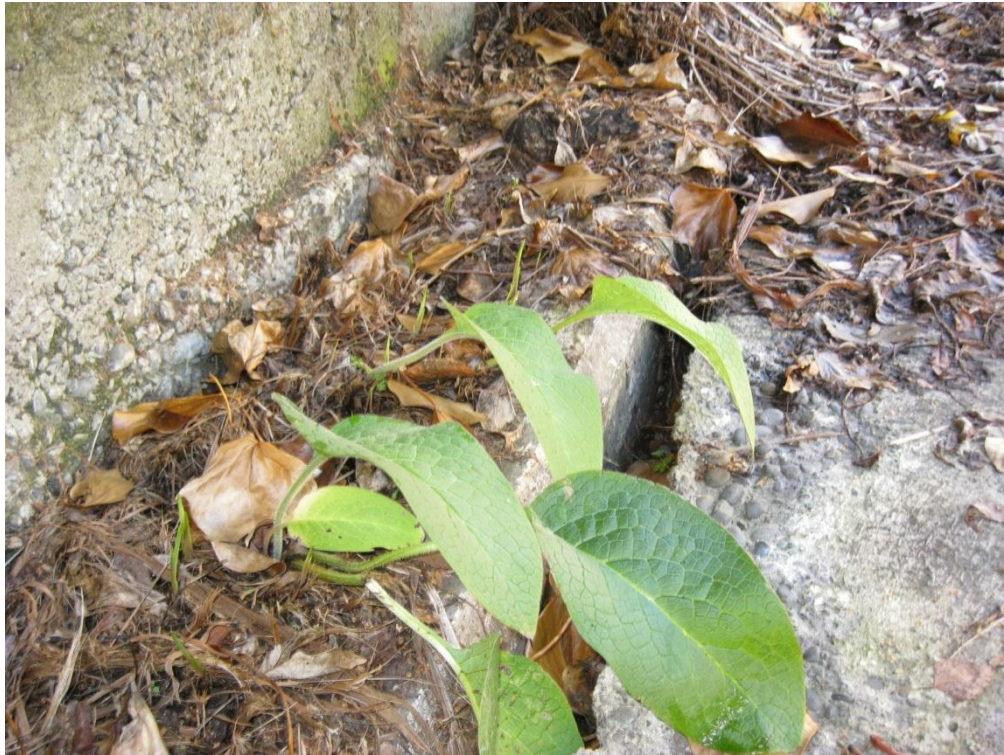
The surrounding ground was severely affected by the lateral spreading and ground differential settlement. The spreading was noted between the building foundation and surrounded pathway (see the photograph 11).

The site is severely affected by the lateral spreading and differential settlement. Following the geotechnical appraisal it was found that the site has a severe potential for liquefaction. As the building has perimeter concrete beam, the effects of liquefaction are likely to affect the structure of the building. For the purposes of the IEP assessment of the building and the determination of the %NBS score, the effects of soil liquefaction on the performance of the building has been assessed as a 'significant' site characteristic in accordance with the NZSEE guidelines.

**Photograph 11 Lateral spreading between foundation of the building and surrounded pathway.**

Given the anticipated ground conditions and proximity to local waterways, we recommend that further investigation is undertaken. Specifically, two CPT investigations should be conducted to a target depth of 20m bgl. From this a numerical liquefaction assessment can be undertaken.
