**Dwelling**  
**PRK 2561 BLDG 001**  
Detailed Engineering Evaluation  
Qualitative Report  
Version FINAL

75 Lower Styx Road, Bottle Lake

Christchurch City Council

**Date**  
30<sup>th</sup> May 2012

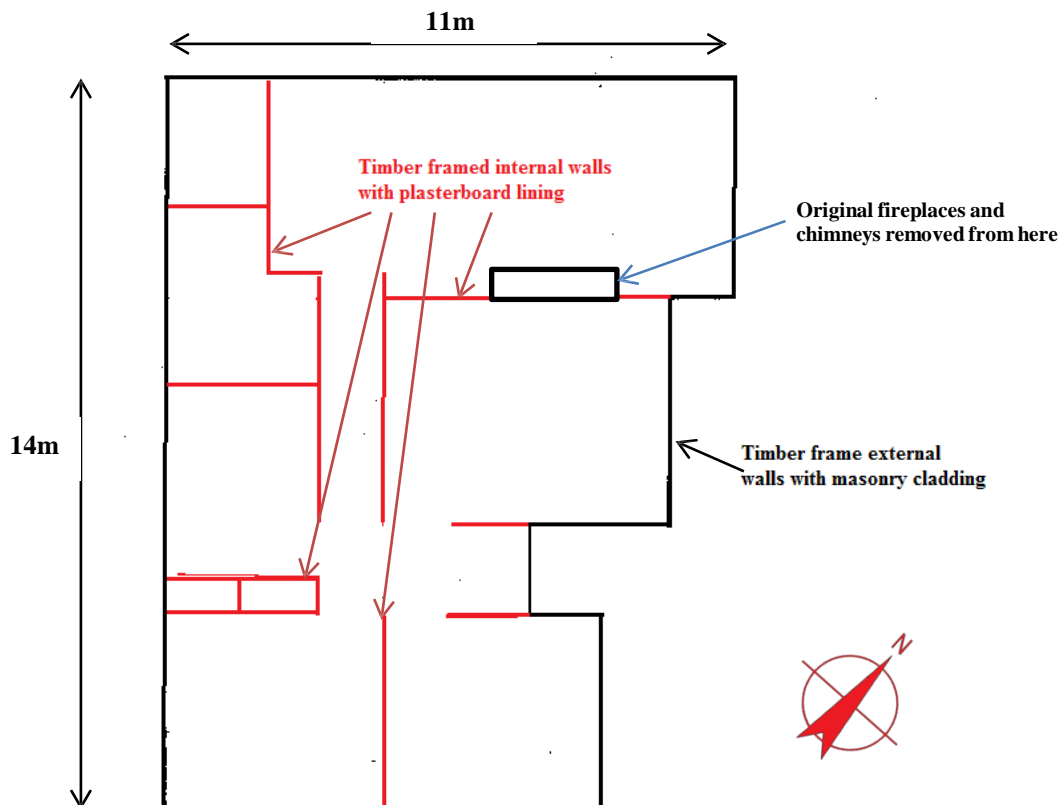
**Figure 2 Plan Sketch Showing Key Structural Elements**

The dimensions of the building are approximately 14m in length, 11m in width and 5.5m in height. The plan area of the building is approximately 150m<sup>2</sup>.

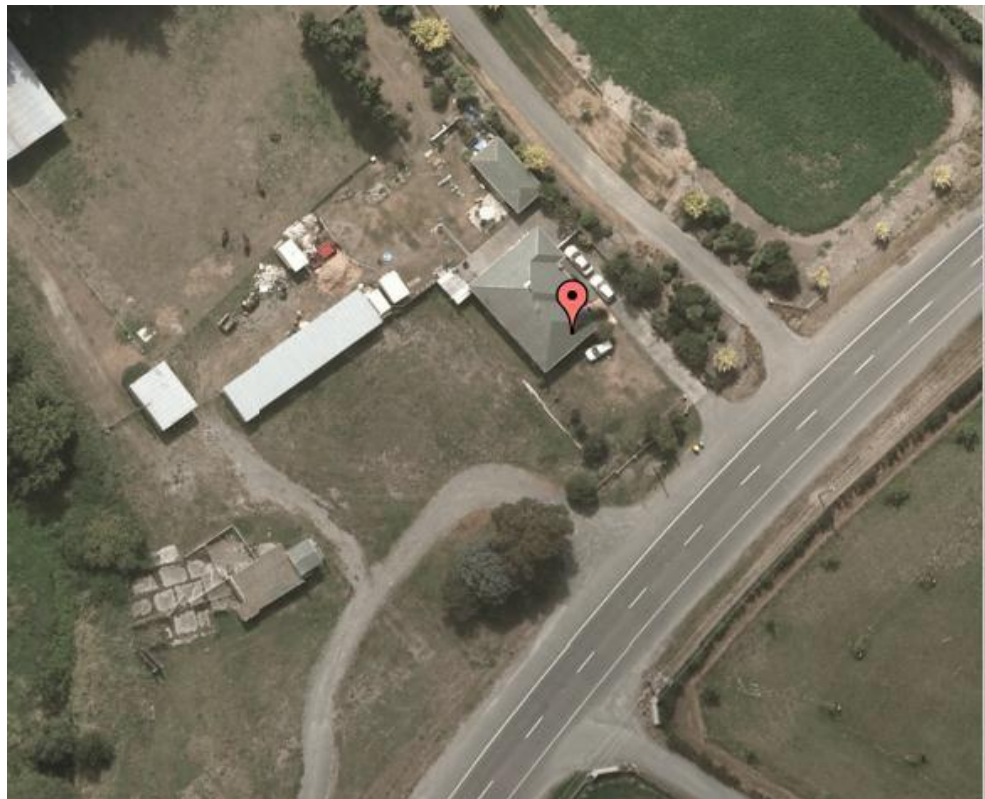
**Figure 3 Post February 2011 Earthquake Aerial Photography<sup>2</sup>**

Aerial photography taken following the 22 February 2011 earthquake doesn't show clear signs of liquefaction (see Figure 3), however, liquefaction was observed close to the property.

Due to the anticipated presence of sand at the shallow depth, and the sites proximity to a local water course, it is considered possible that liquefaction will occur at the site. It is not clear from the post-earthquake aerial photography (Figure 3) whether liquefaction has occurred at the site, however, it was observed close to the property. The site is considered to have a moderate-high liquefaction potential at this stage of investigation.

It is recommended that three piezocone CPTs be conducted to target depths of 20m. This will allow a liquefaction assessment to be carried out.

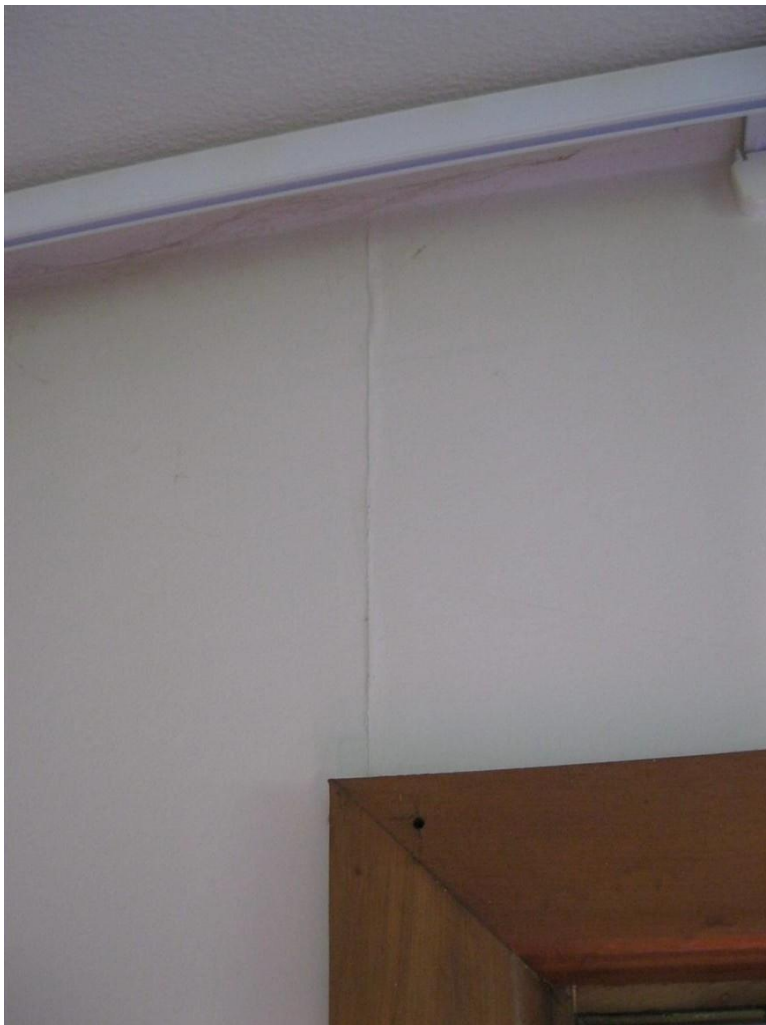
Cracking as a result of earthquake forces was noted to the internal plasterboard linings above a door opening. See photograph 6. This damage is not considered to be significant.

**Photograph 6 Vertical cracking in plasterboard wall lining.**

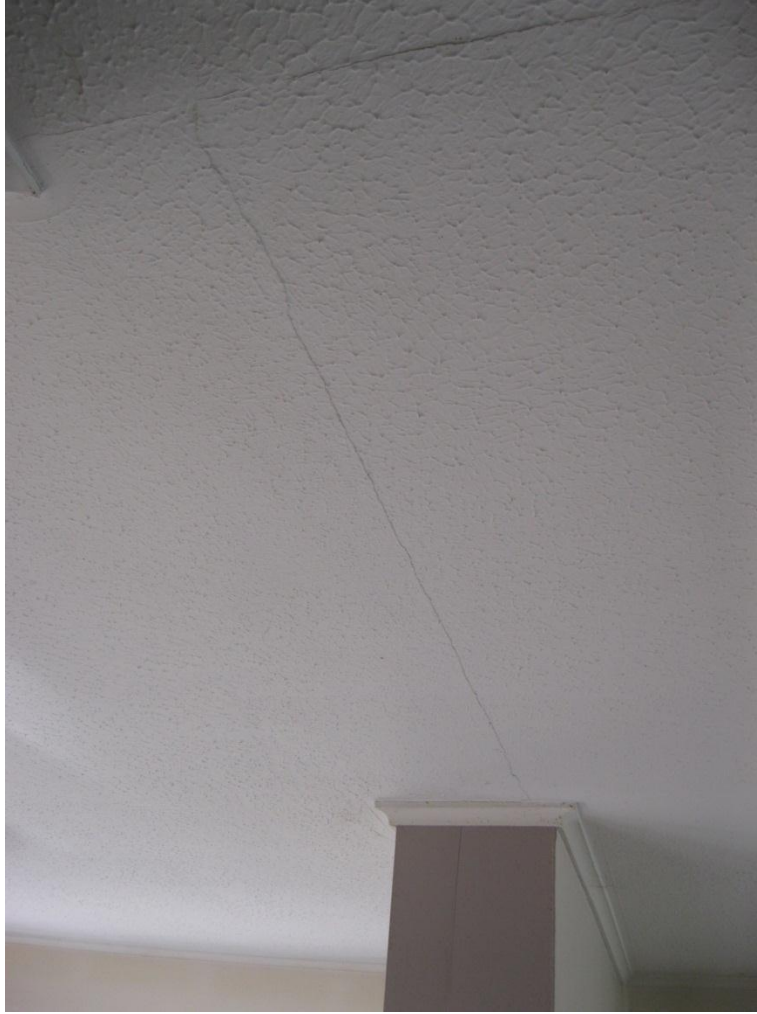
**Photograph 7 Cracking to plasterboard ceiling lining where the original chimneys were removed.**
