Iron Clad Barn
PRK 2635 BLDG 005
Detailed Engineering Evaluation
Qualitative Report
Version Final

51 Lower Styx Road, Styx River Reserve

Christchurch City Council

Date
23rd May 2013

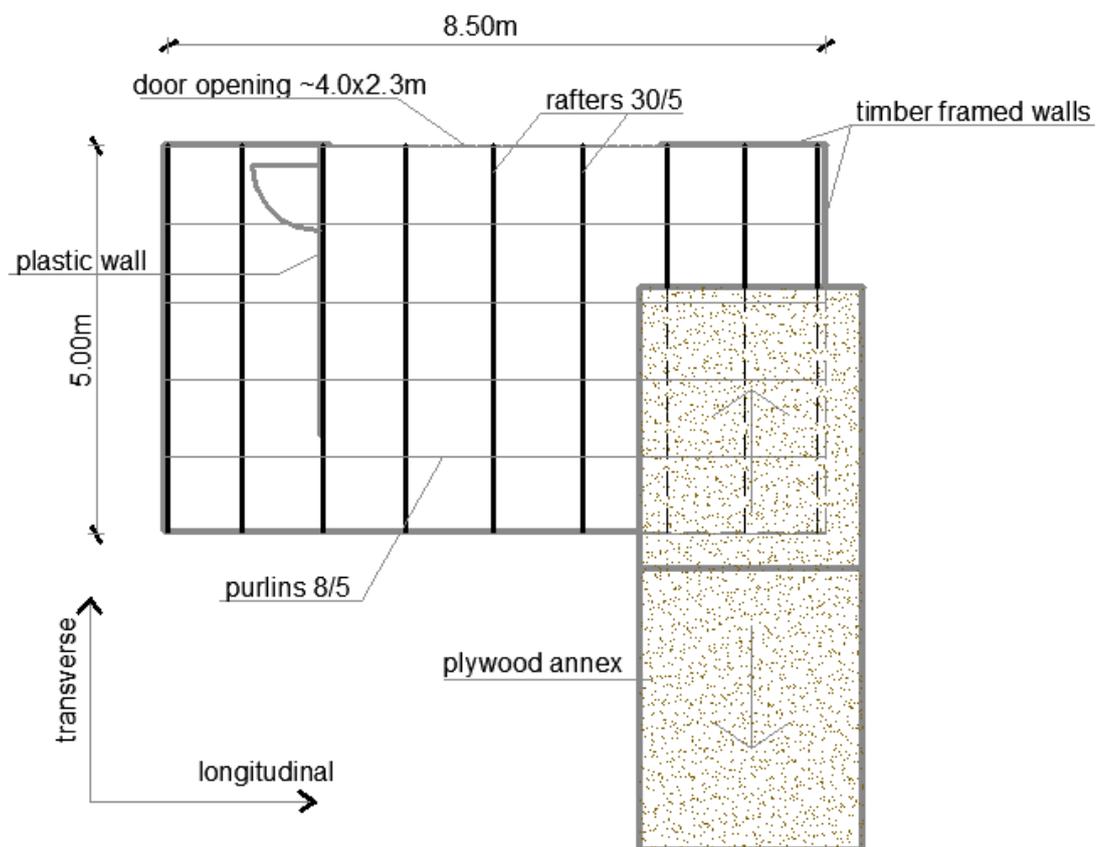
Figure 2 Plan Sketch Showing Key Structural Elements

- ▶ The building has a mono pitch corrugated steel roof supported on timber purlins 8/5 and timber rafters 30/5 (30/4⁵) which span in the transverse direction (no cross bracing is evident in the roof structure). The rafters are supported by timber frame wall structure clad by the corrugated steel.
- ▶ Floor is unreinforced concrete slab on grade with no apparent perimeter thickening

At roof level no cross bracing was visible. The combination of the roof cladding, timber purlins and rafters form some nominal diaphragm action, which provide significant bracing to the structure.

No diagonal wall bracing was visible in the walls and lateral load resistance in these walls is provided only by the fixings of the iron cladding to the timber studs.

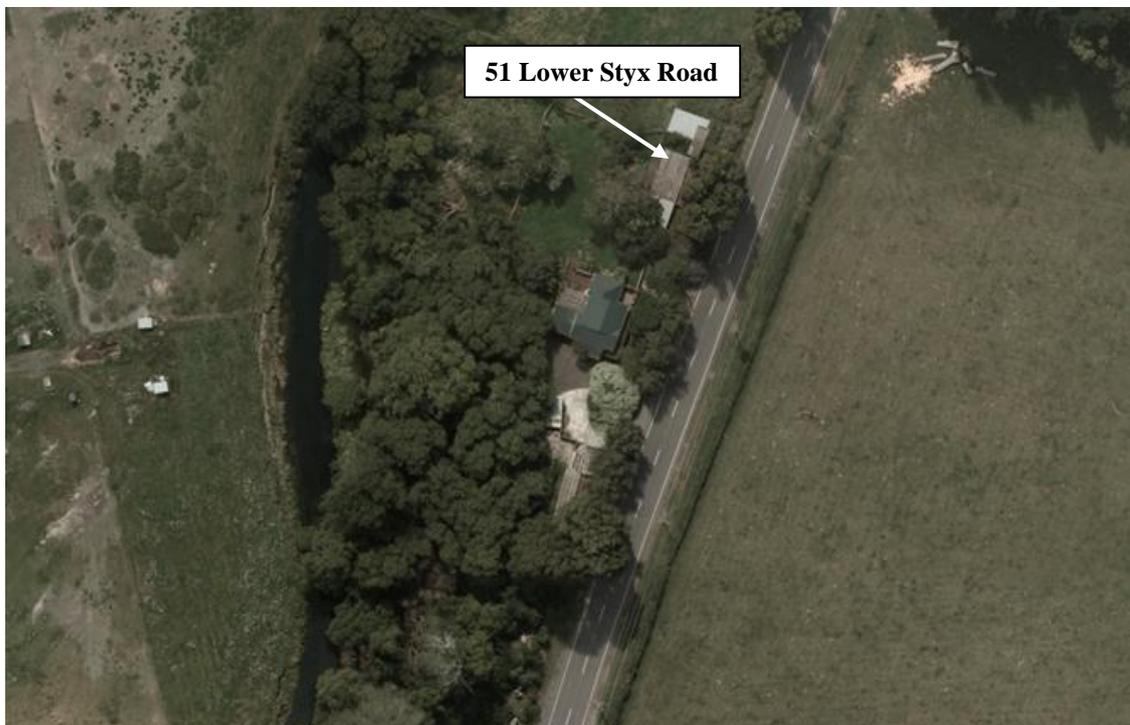
Figure 3 Post February 2011 Earthquake Aerial Photography ²

Aerial photography taken following the 22 February 2011 earthquake shows no signs of liquefaction visible within the property boundary as shown in Figure 3. However, liquefaction in the form of sand boils and lateral spreading is evident on the western side of the Styx River (subject property is to the east).

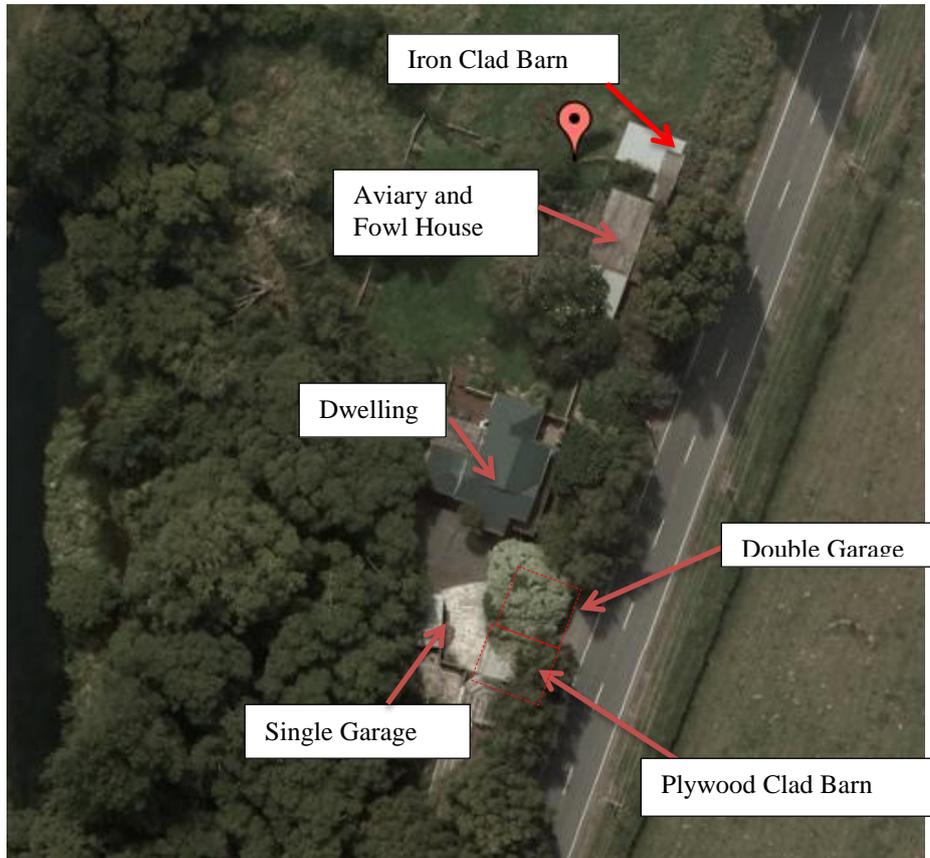
Photograph 1 Aerial photograph of site at 51 Lower Styx Road.

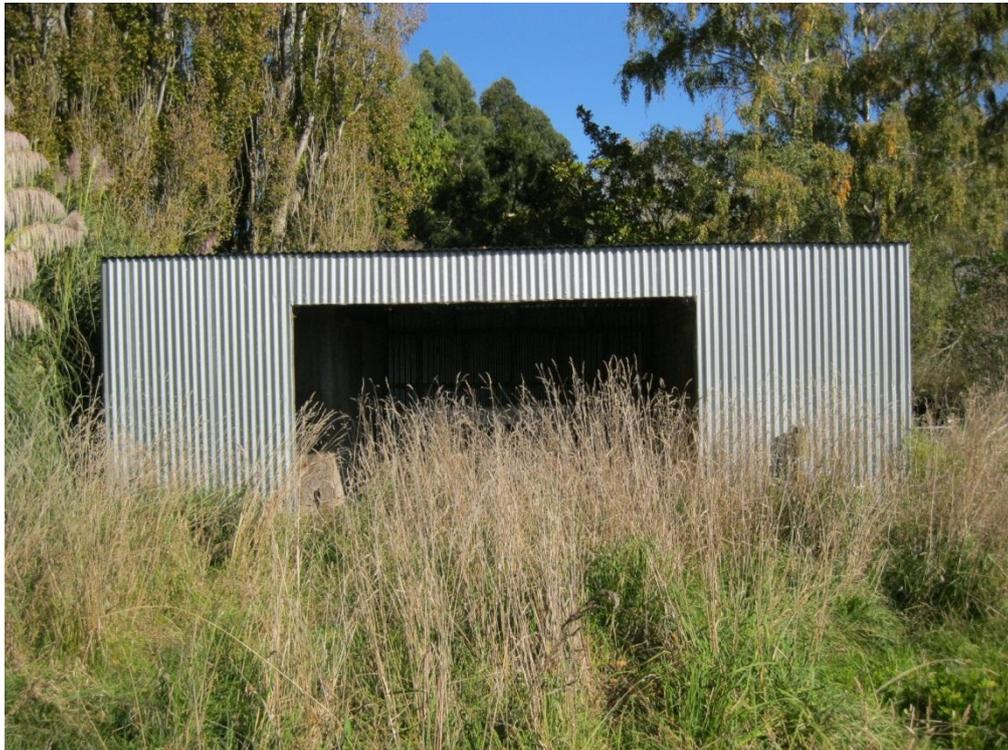
Photograph 2 View of the Iron Clad Barn from the north.

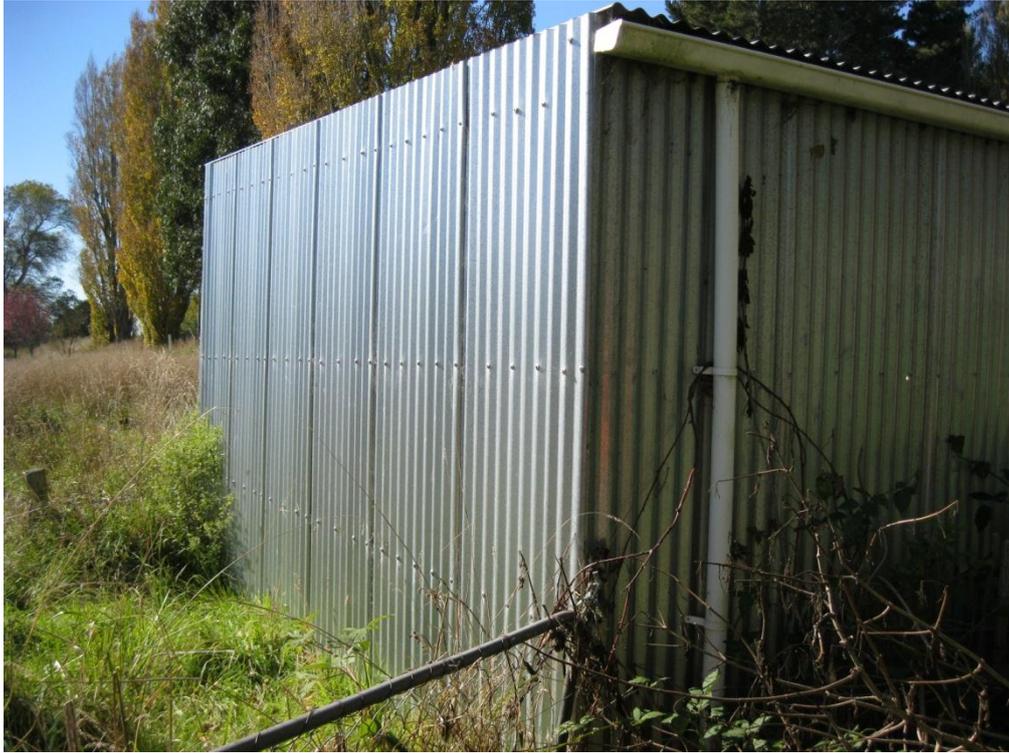
Photograph 3 View of the Iron Clad Barn from the southwest.

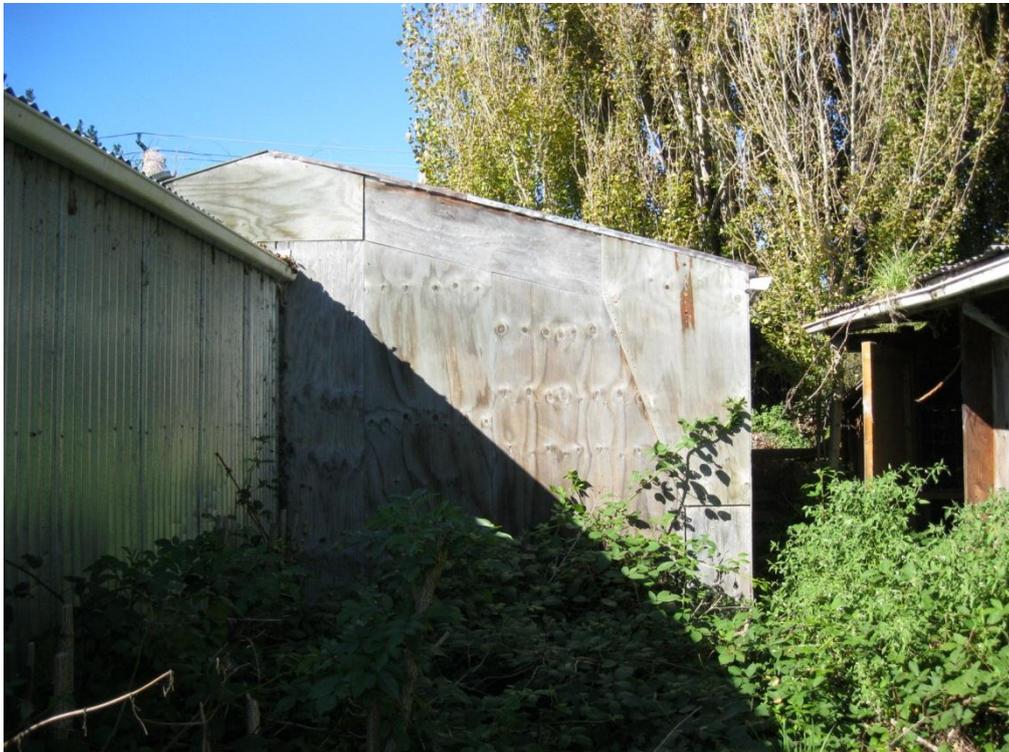
Photograph 4 View of the annex of the Iron Clad Barn- view from the west.

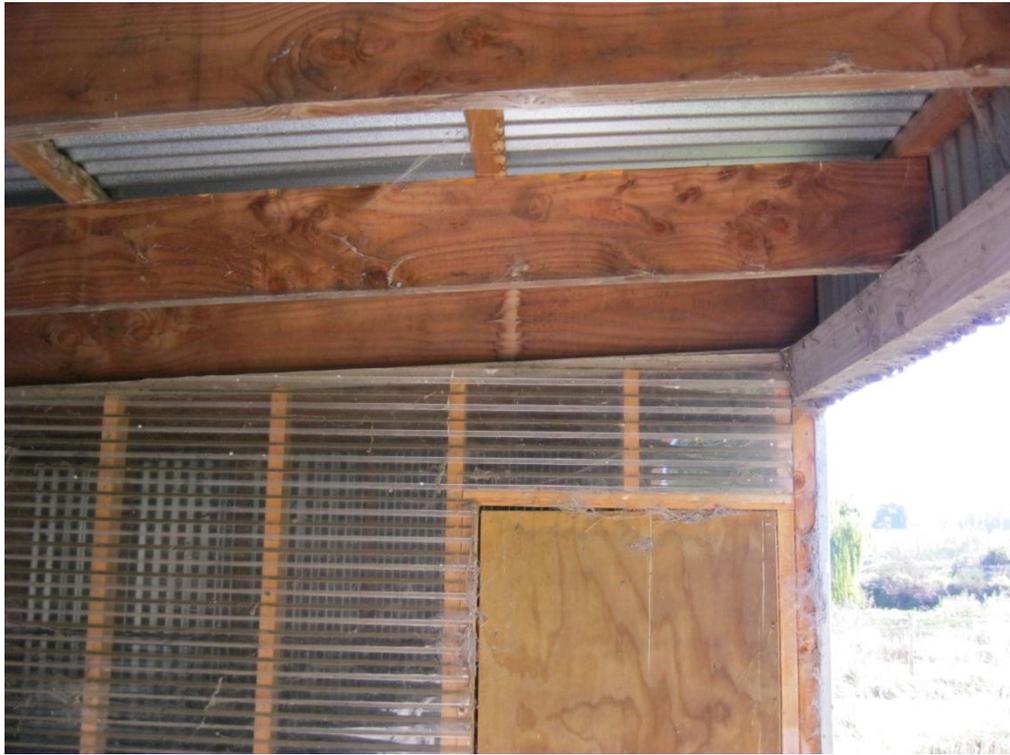
Photograph 5 Internal view of the building showing roof construction.

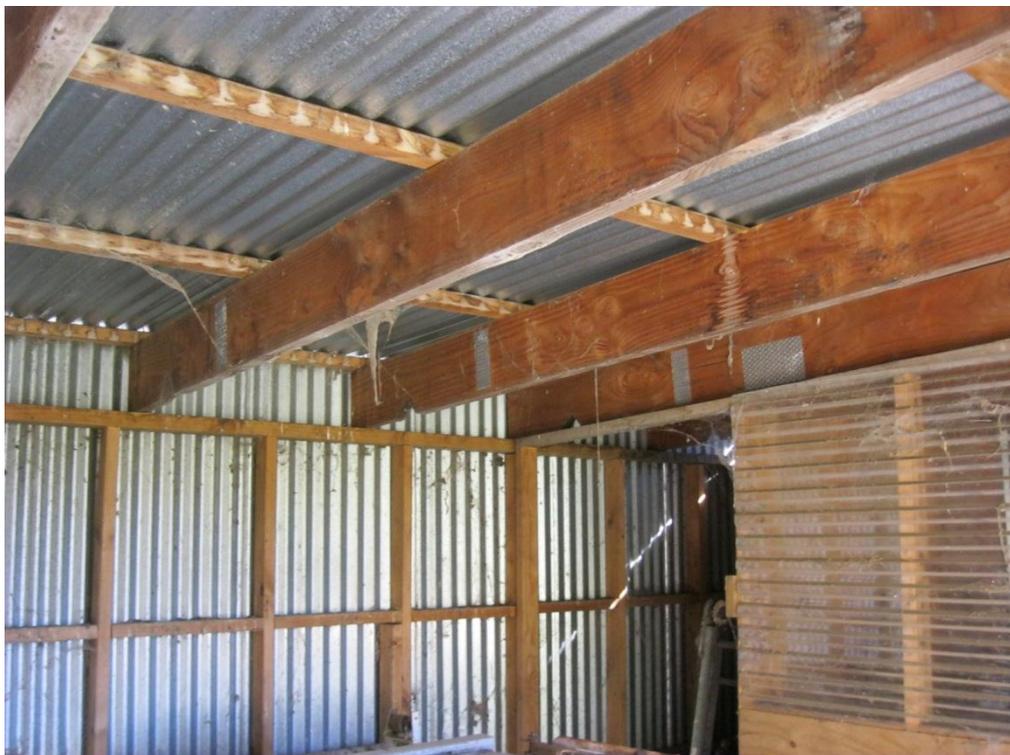
Photograph 6 Internal view of the building showing southwest corner

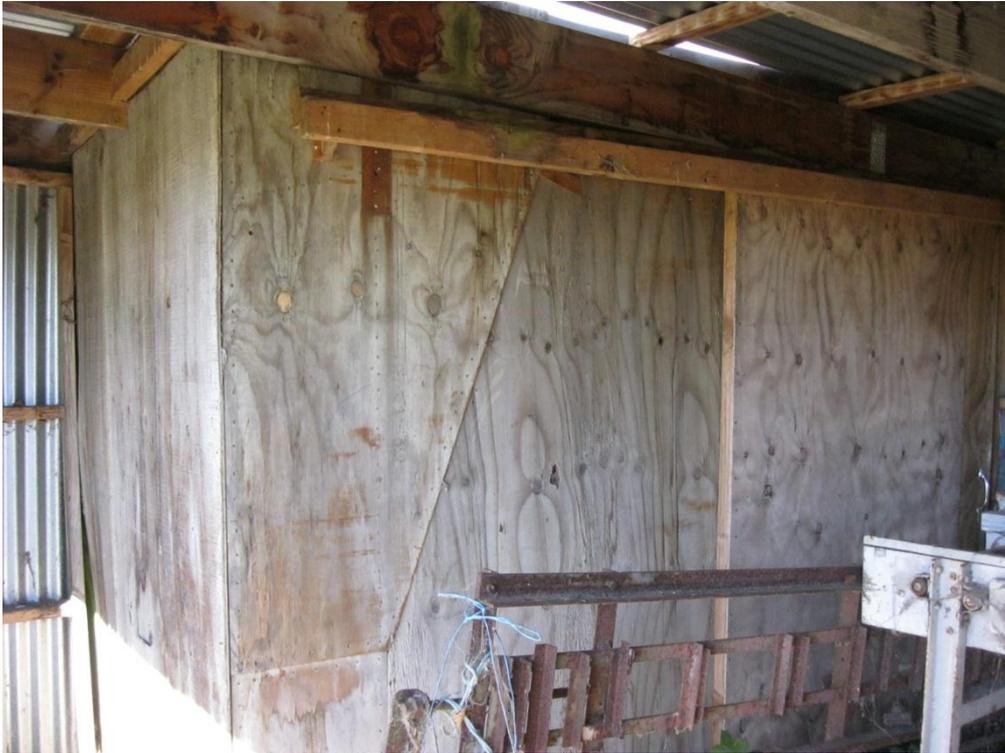
Photograph 7 Internal view of the building showing southeast corner
