**Single Garage  
PRK 2635 BLDG 003 EQ2**  
Detailed Engineering Evaluation  
Qualitative Report  
Version FINAL

51 Lower Styx Road, Styx River Reserve

**Christchurch City Council**

**Date  
20 September 2013**

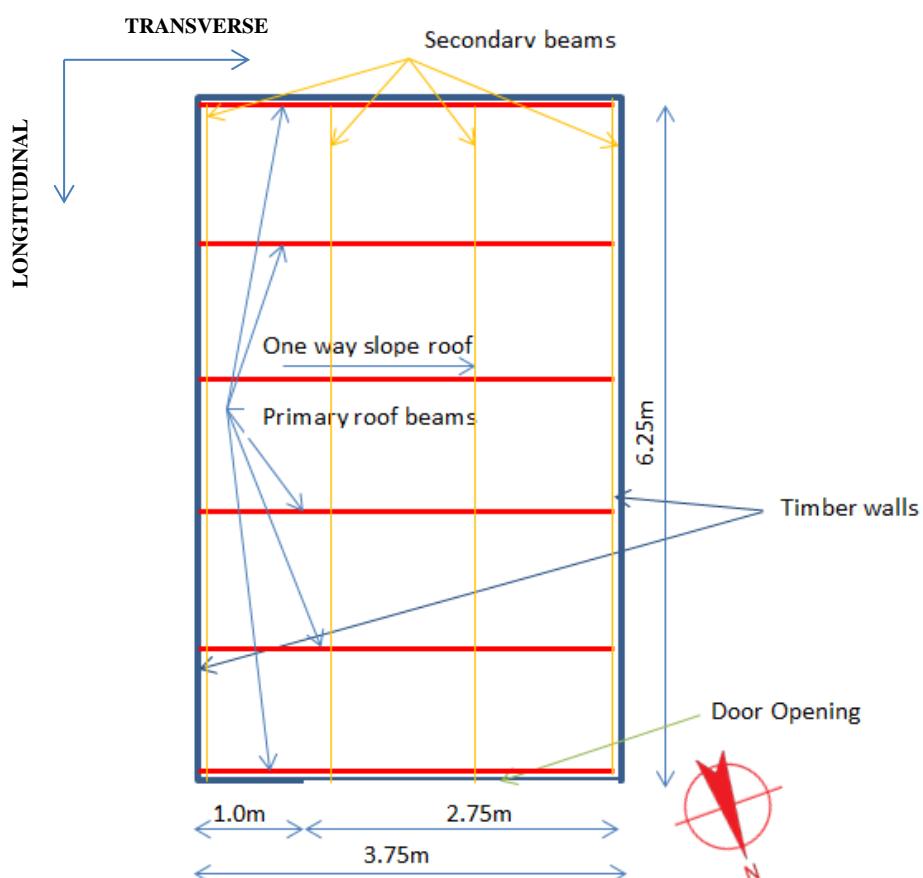
Figure 2 Plan Sketch Showing Key Structural Elements

The presence of a large opening causes a 'significant' critical structural weakness in the form of plan irregularity.

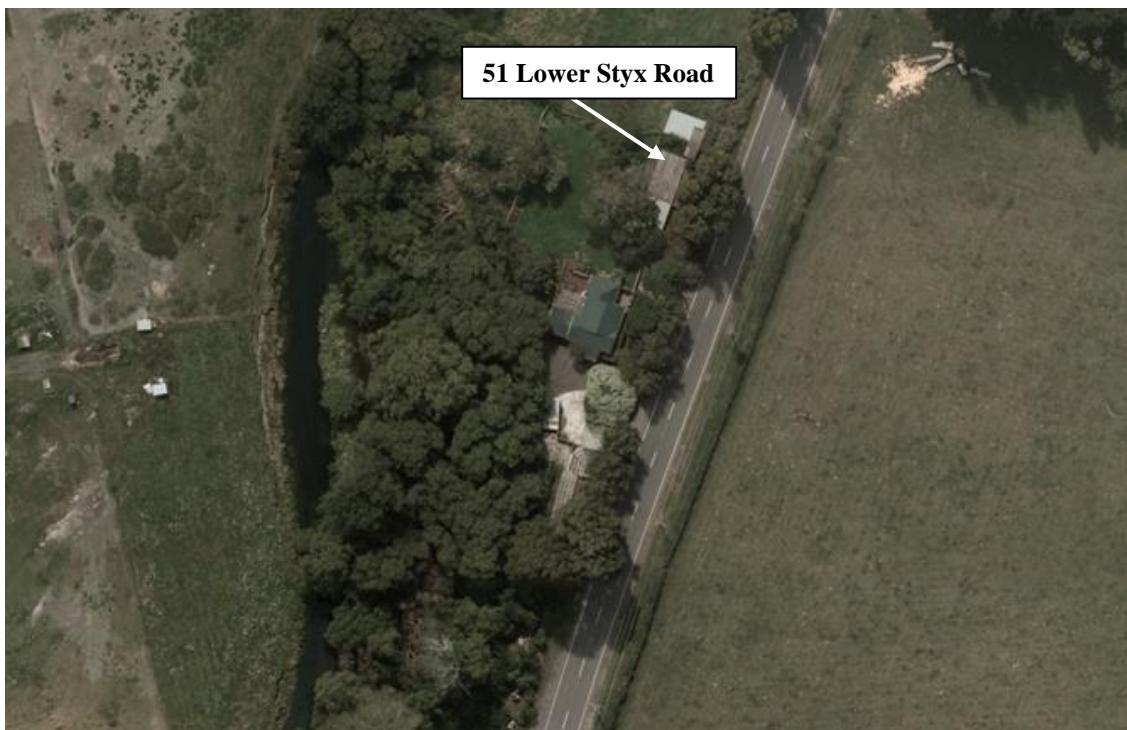
**Figure 3 Post February 2011 Earthquake Aerial Photography<sup>2</sup>**

Aerial photography taken following the 22 February 2011 earthquake shows no signs of liquefaction visible within the property boundary as shown in Figure 3. However, liquefaction in the form of sand boils and lateral spreading is evident on the western side of the Styx River (subject property is to the east).

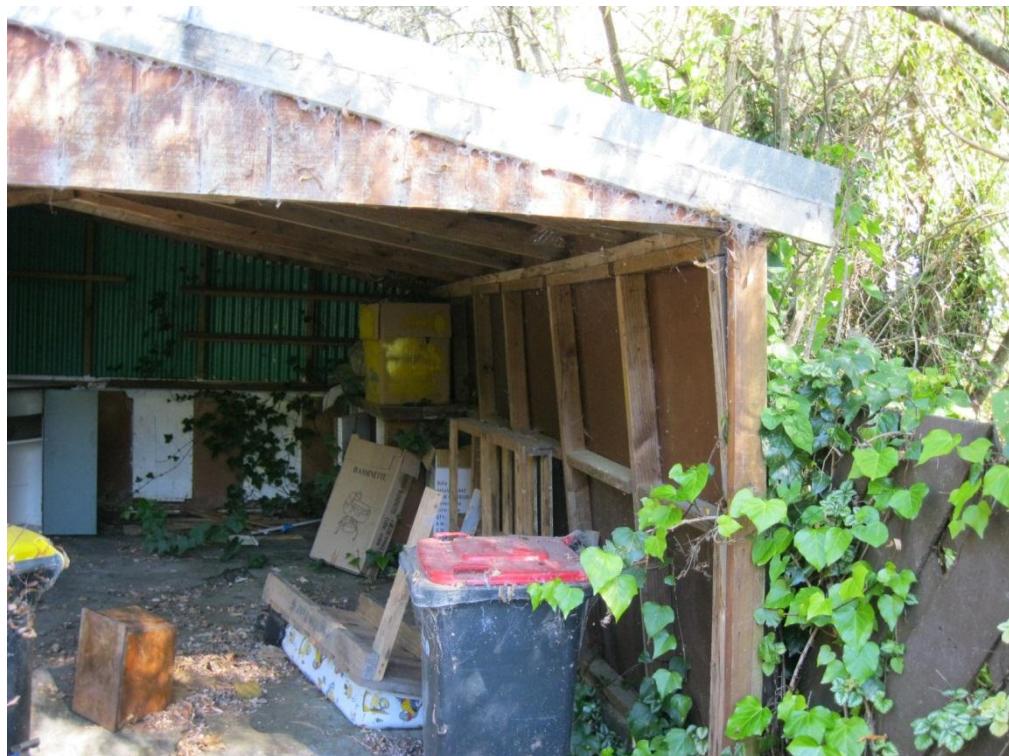
During the inspection it was noted that lateral displacement of the western wall has occurred (see the photograph 5). This displacement has resulted in rotation of the load bearing wall. This rotation is likely to severely affect the load carrying capacity of the structure.

**Photograph 5** View of the lateral wall- view from the north.

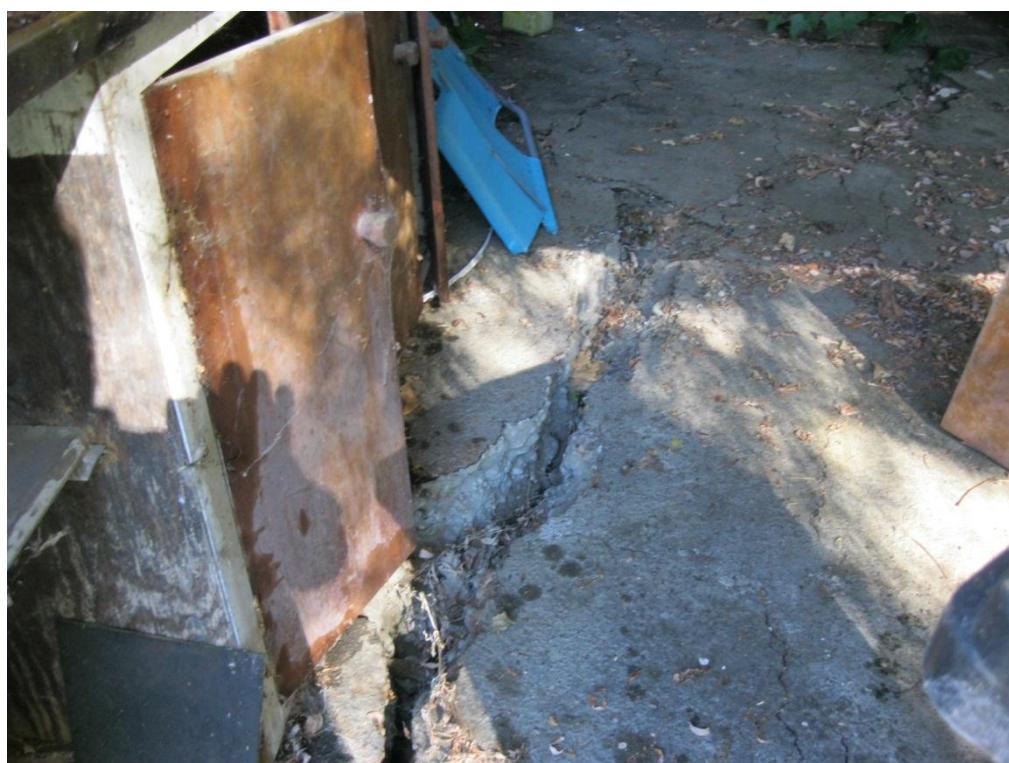
Severe cracking was noted in the slab on grade (see the photograph 6).

**Photograph 6** Cracking of the slab on grade.
