# **Lyn Christie Place Complex BE 0727 EQ2**

**Detailed Engineering Evaluation  
Quantitative Assessment Report**

**30 Wildwood Ave, Wainoni, Christchurch**

Date: January 2013  
Reference: 6-QUCC2.13  
Status: Final

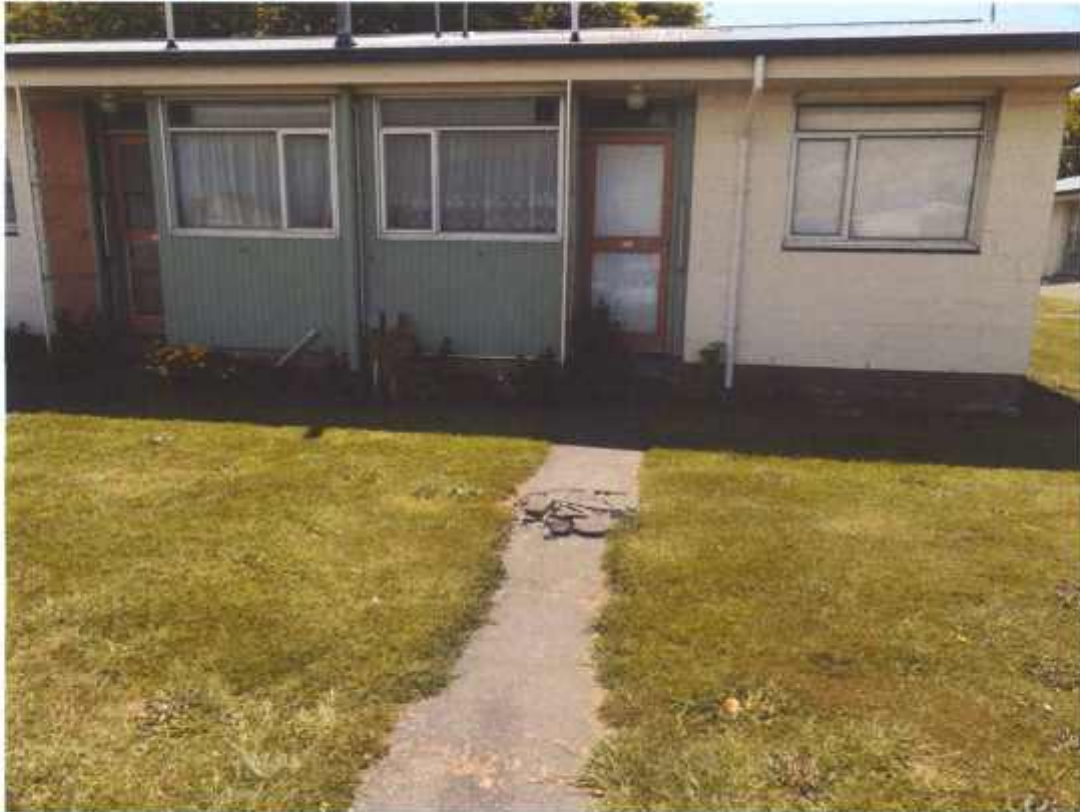
Figure 3 Close-up of sand bulge and cracks in the pavement (footpath towards unit No 1 southside of block A, facing north)

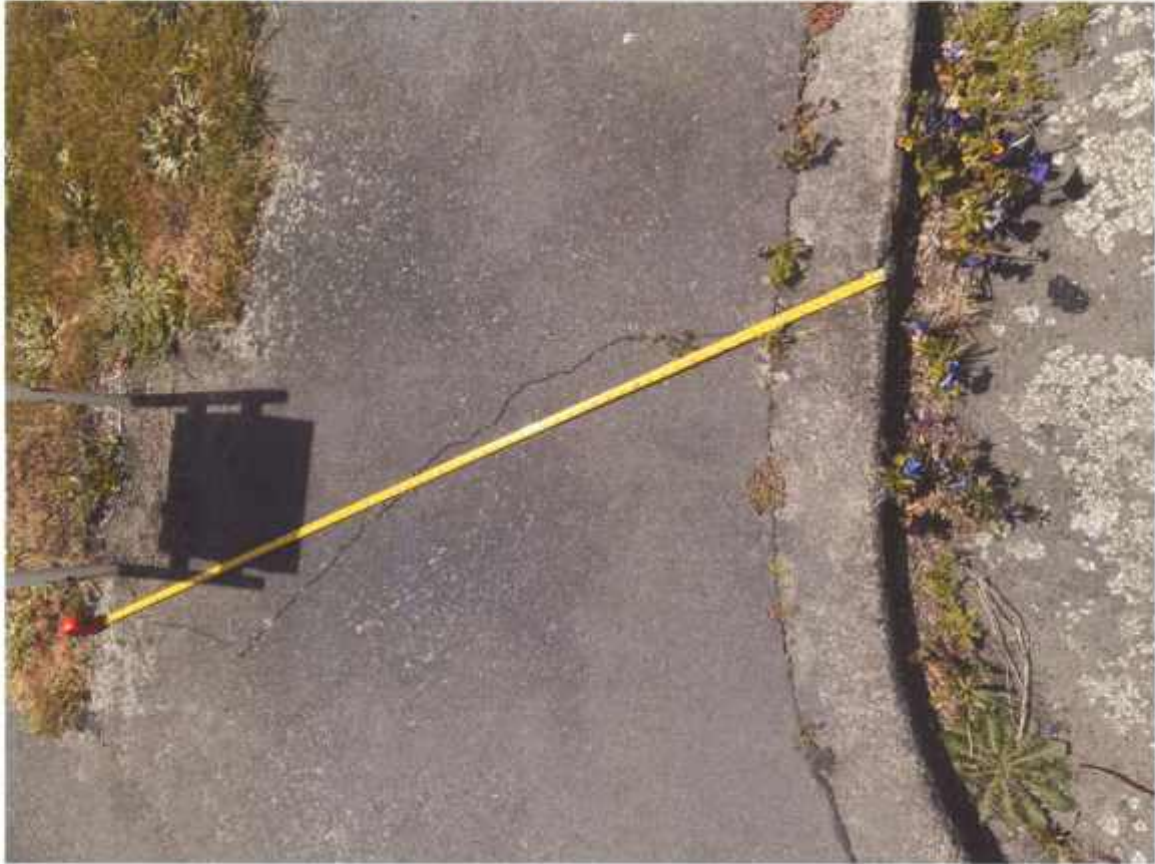
Figure 10 Crack of the pavement (unit No2 Block A, facing south-west)

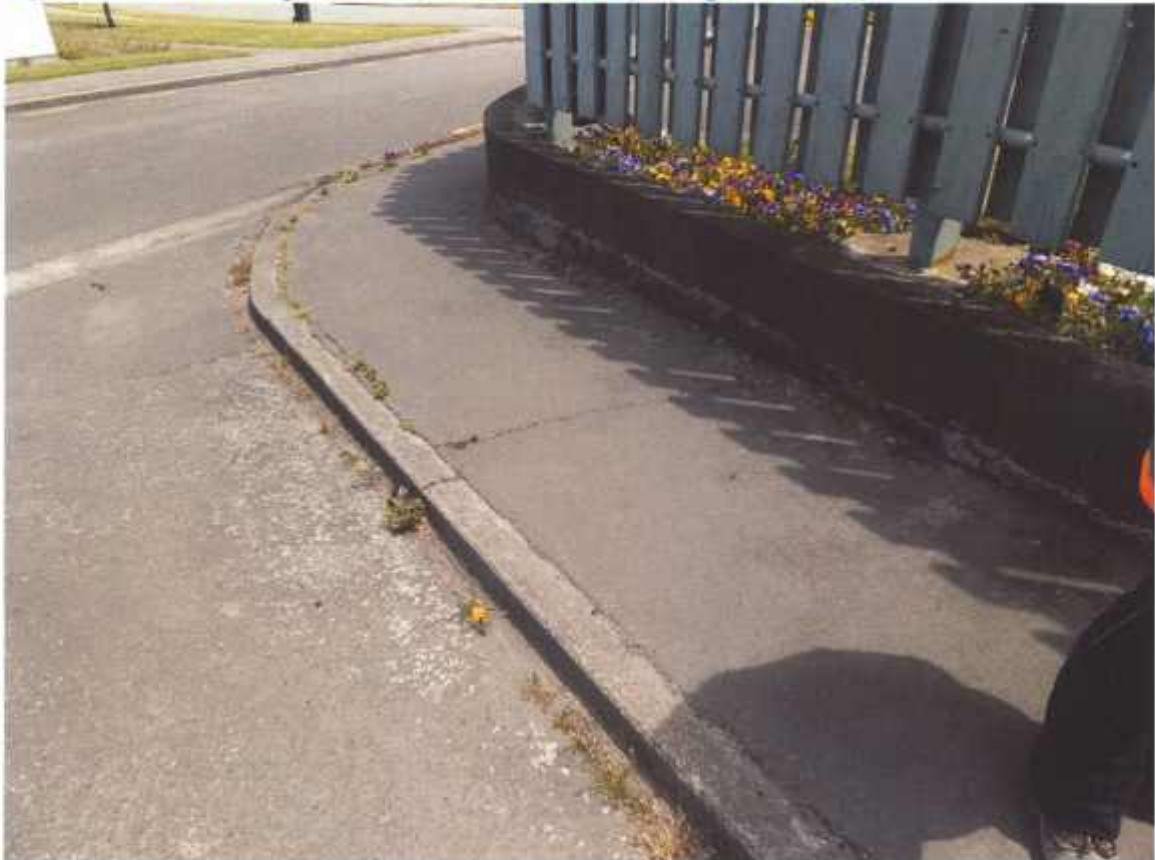
Figure 11 Cracks of drive way and repair (Block B, unit No 3 facing south)

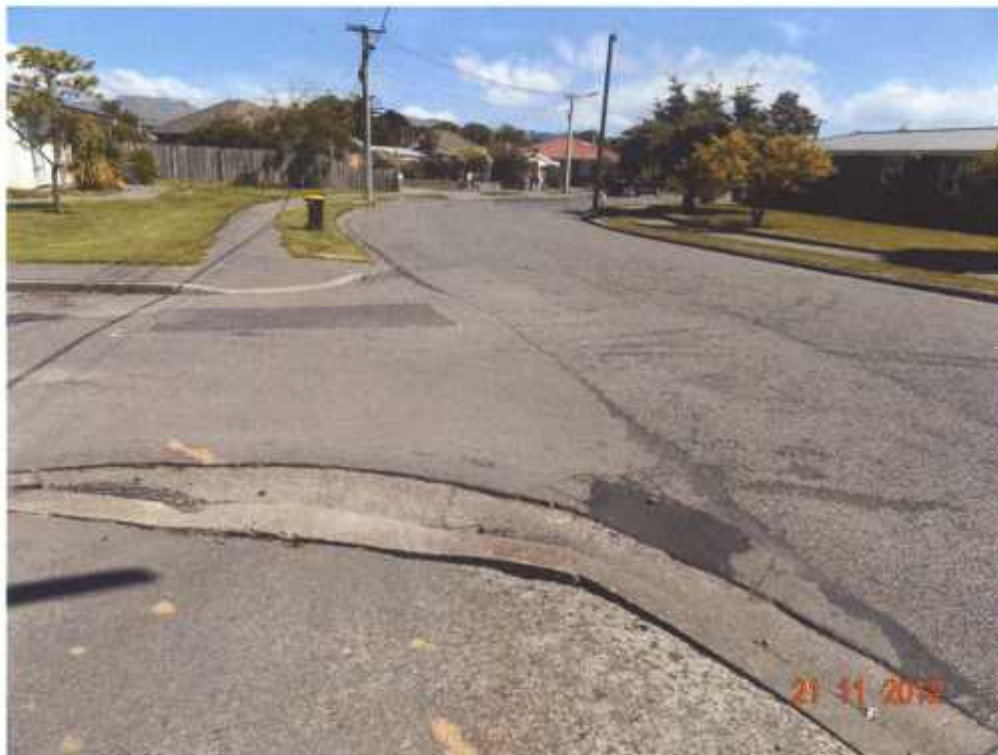
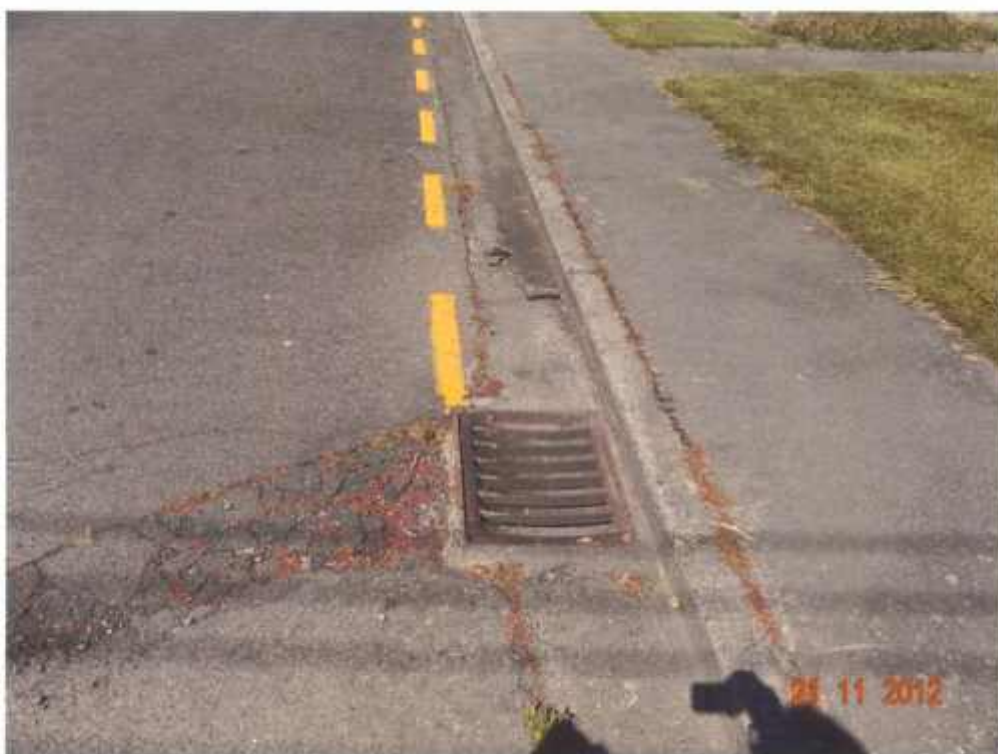
Figure 12 End of the drive way (unit No 3 Block B facing south)

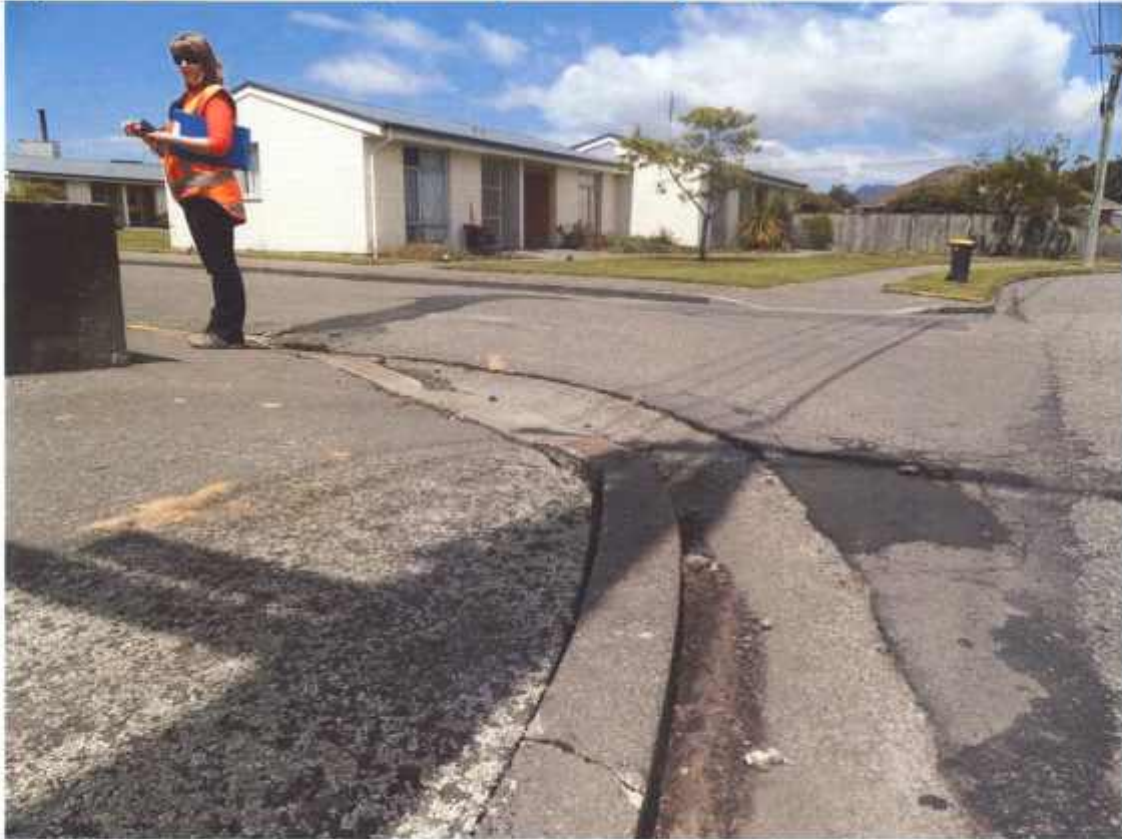
Figure 13 Bend on the end of the drive way, repairs of cracks visible general depression of the pavement visible (Unit No 3 of Block B facing north)

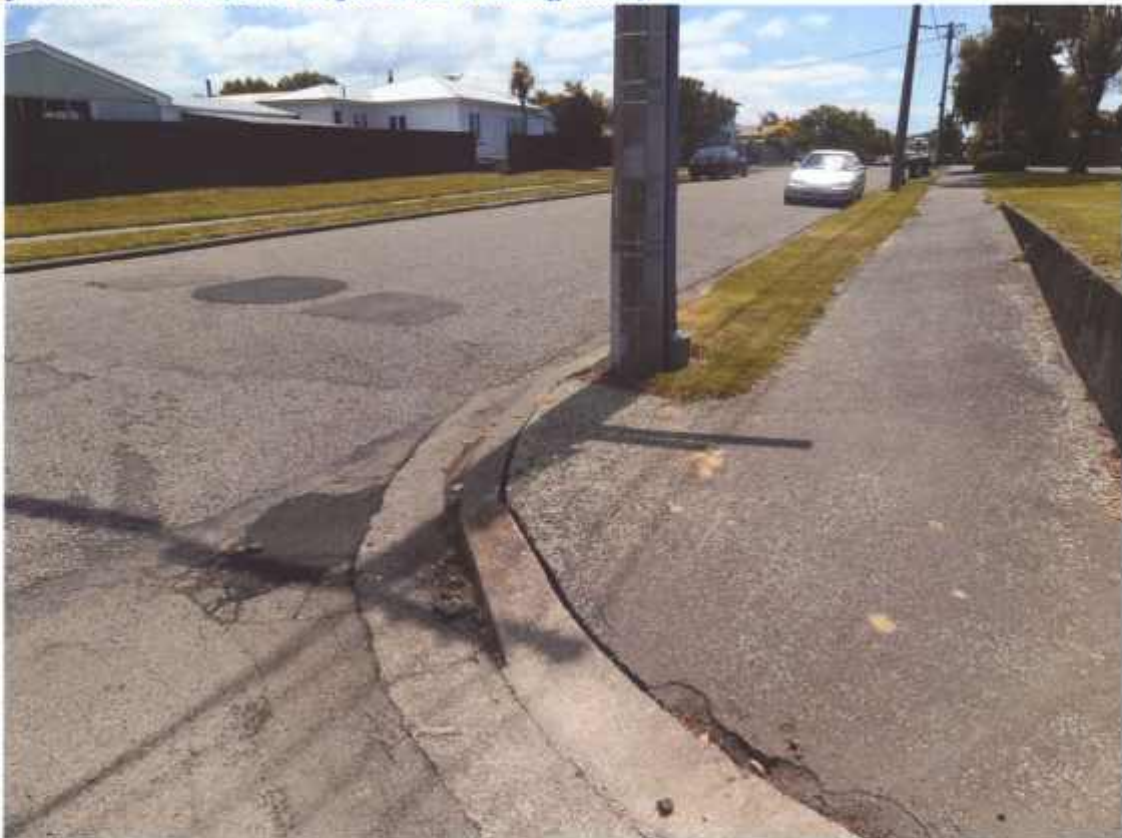
**Figure 14 Bend on the end of drive way facing east, various repair work of asphalt cracks  
(Unit No 3 block B facing east)**

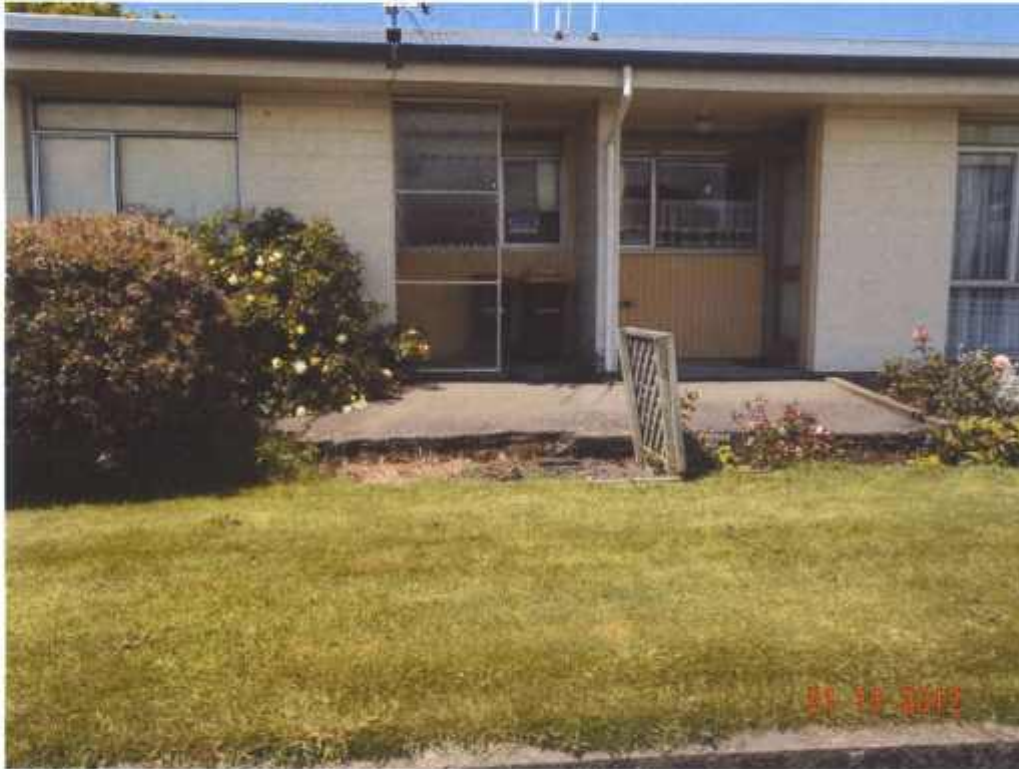
Figure 16 Cracking (at doorstep of unit 5 Block B facing south)

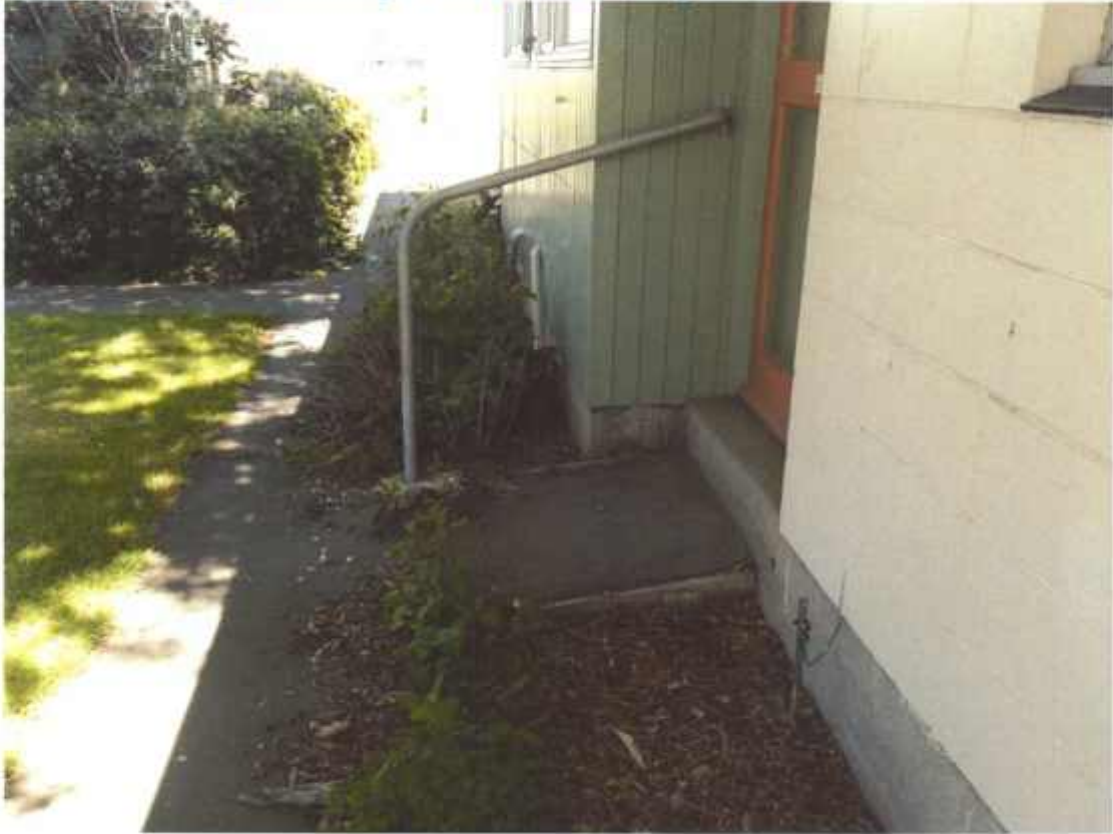
Figure 17 Detail of cracking (at doorstep of unit 5 Block B facing south)

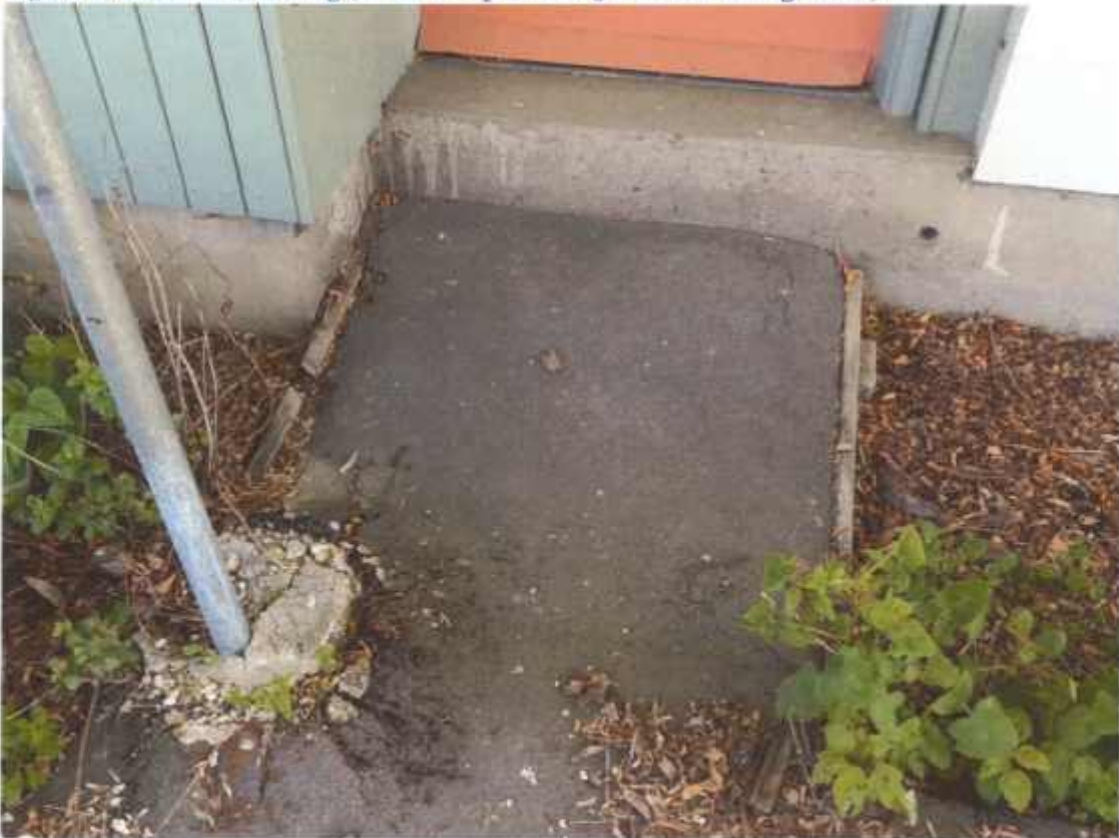
The level survey found evidence of differential settlement in the foundation slabs of Blocks A and B, resulting in a floor slope in the order of 0.5%-0.7%. The results are outlined in more detail in Section 8.

Figure 18 Close-up of the concrete foundation; depression of +/- 10 cm along the concrete foundation slab (unit No 5 and No 6 Block B)

Remediation of the foundations of Blocks A and B should be considered.

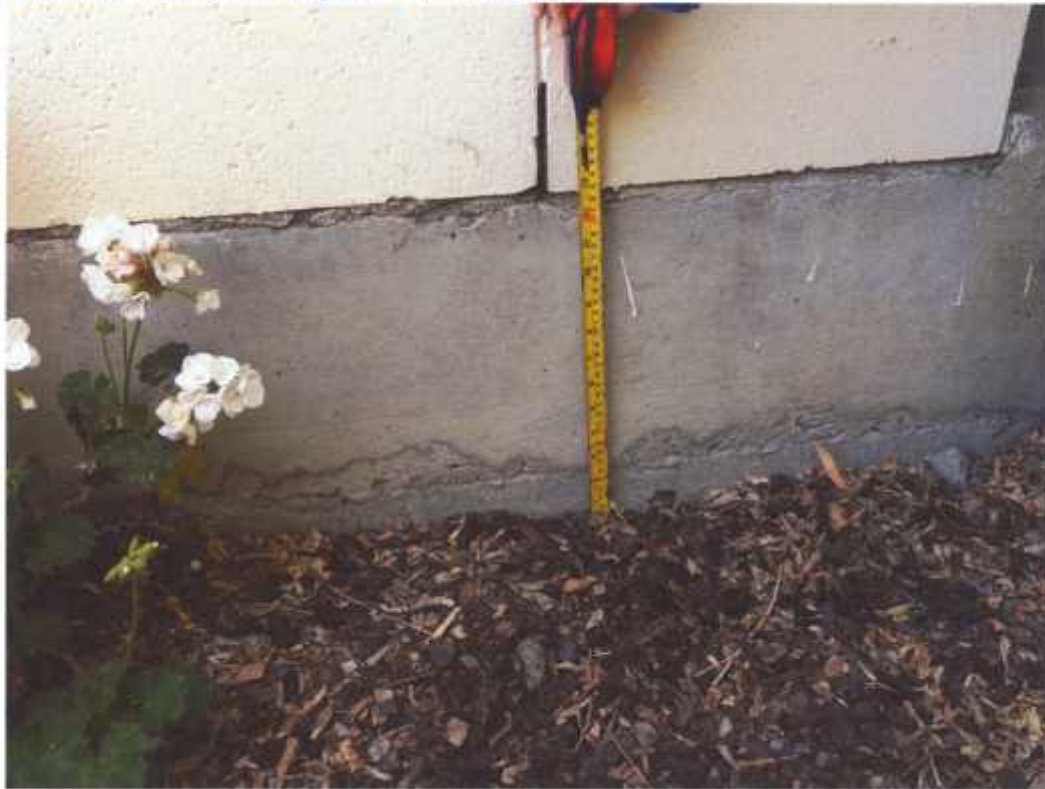
Figure 19 Cross cracks around the corner of the pavement of footpath (unit No 5 and No 6 of Block B)

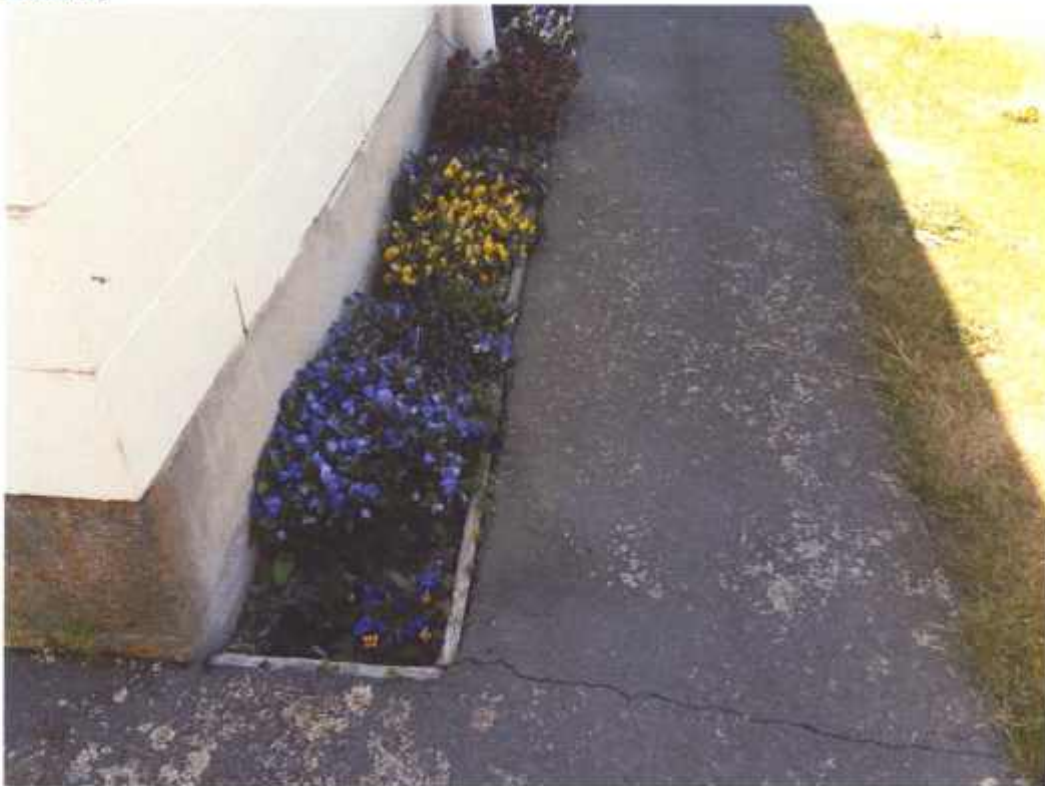
Figure 20 Differential settlement (total  $\pm 10$  cm) of doorstep unit No 5 Block B

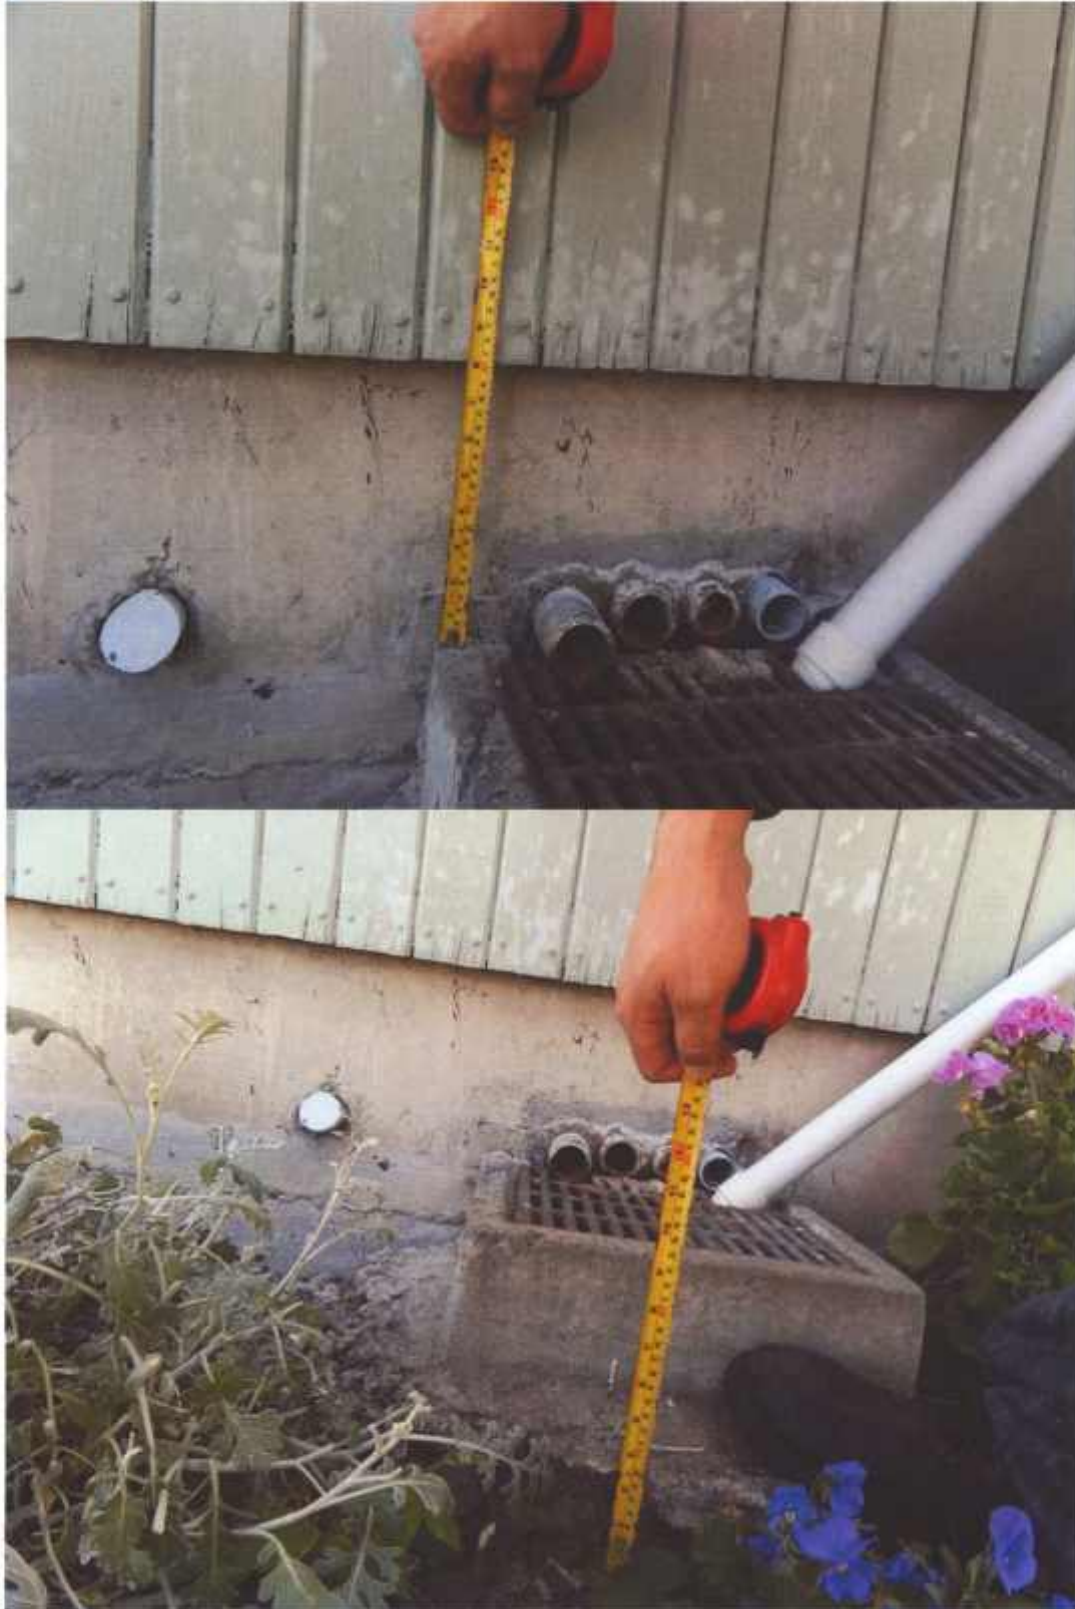
Figure 22 Defect of a waste water trap (unit No 4 block B)

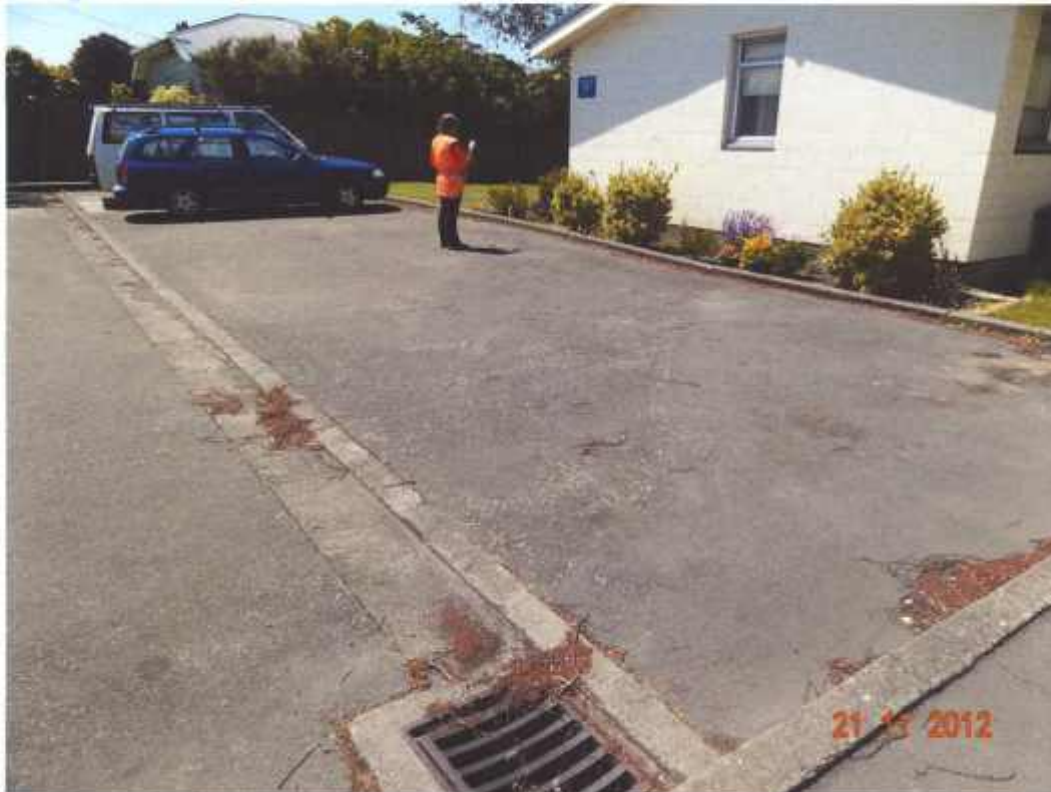
Figure 30 idem (Car parking in front of No 7 (Block B), facing south-east)

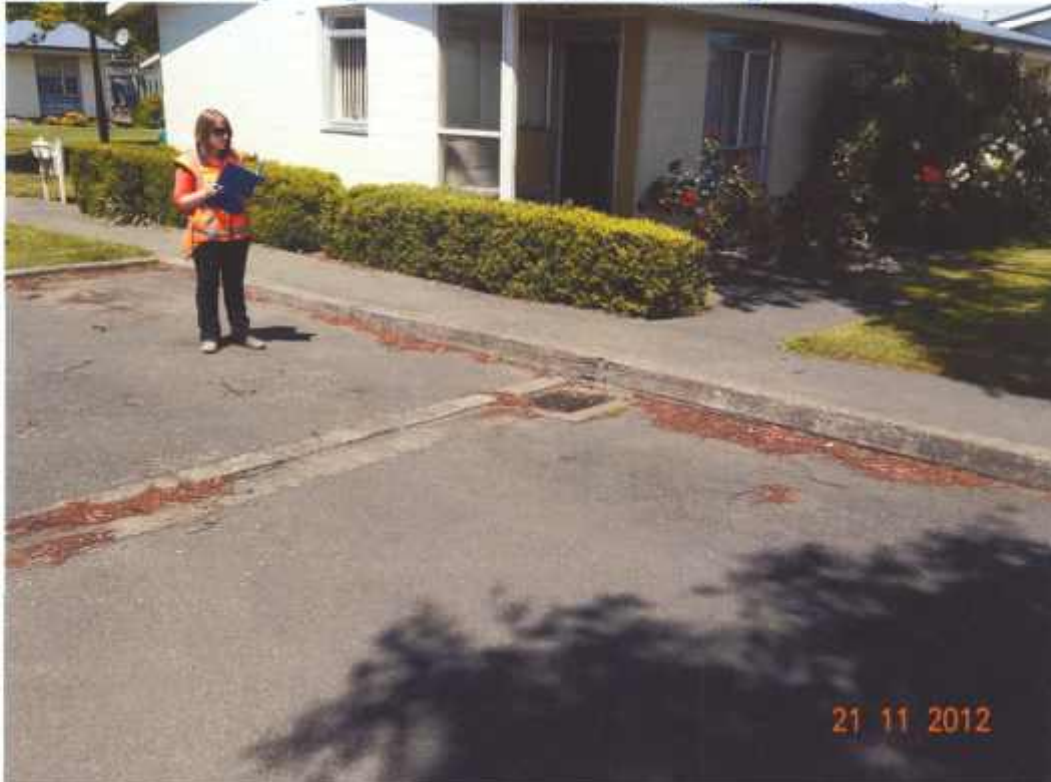
Figure 31 Detail of a crack in the kerb, 1.0 cm wide (Car parking next to No 8, west of Block C, facing East)

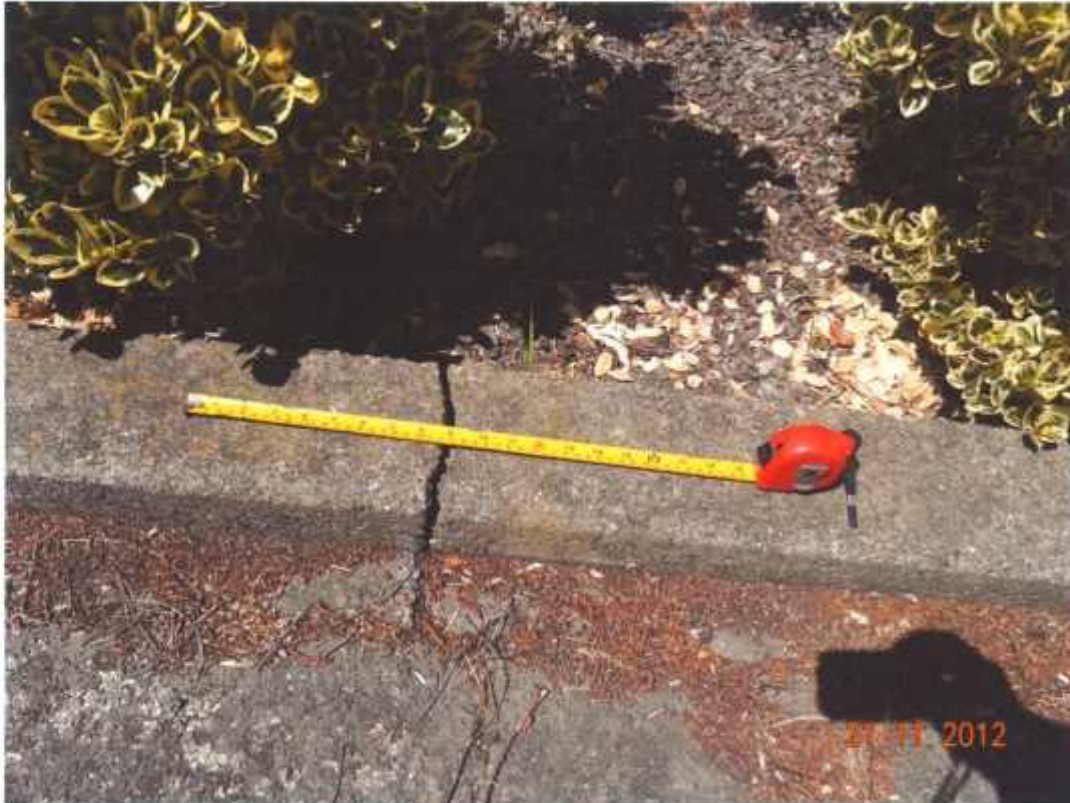
Figure 32 Other detail of crack in kerb (to No 8, west of Block C, facing East)

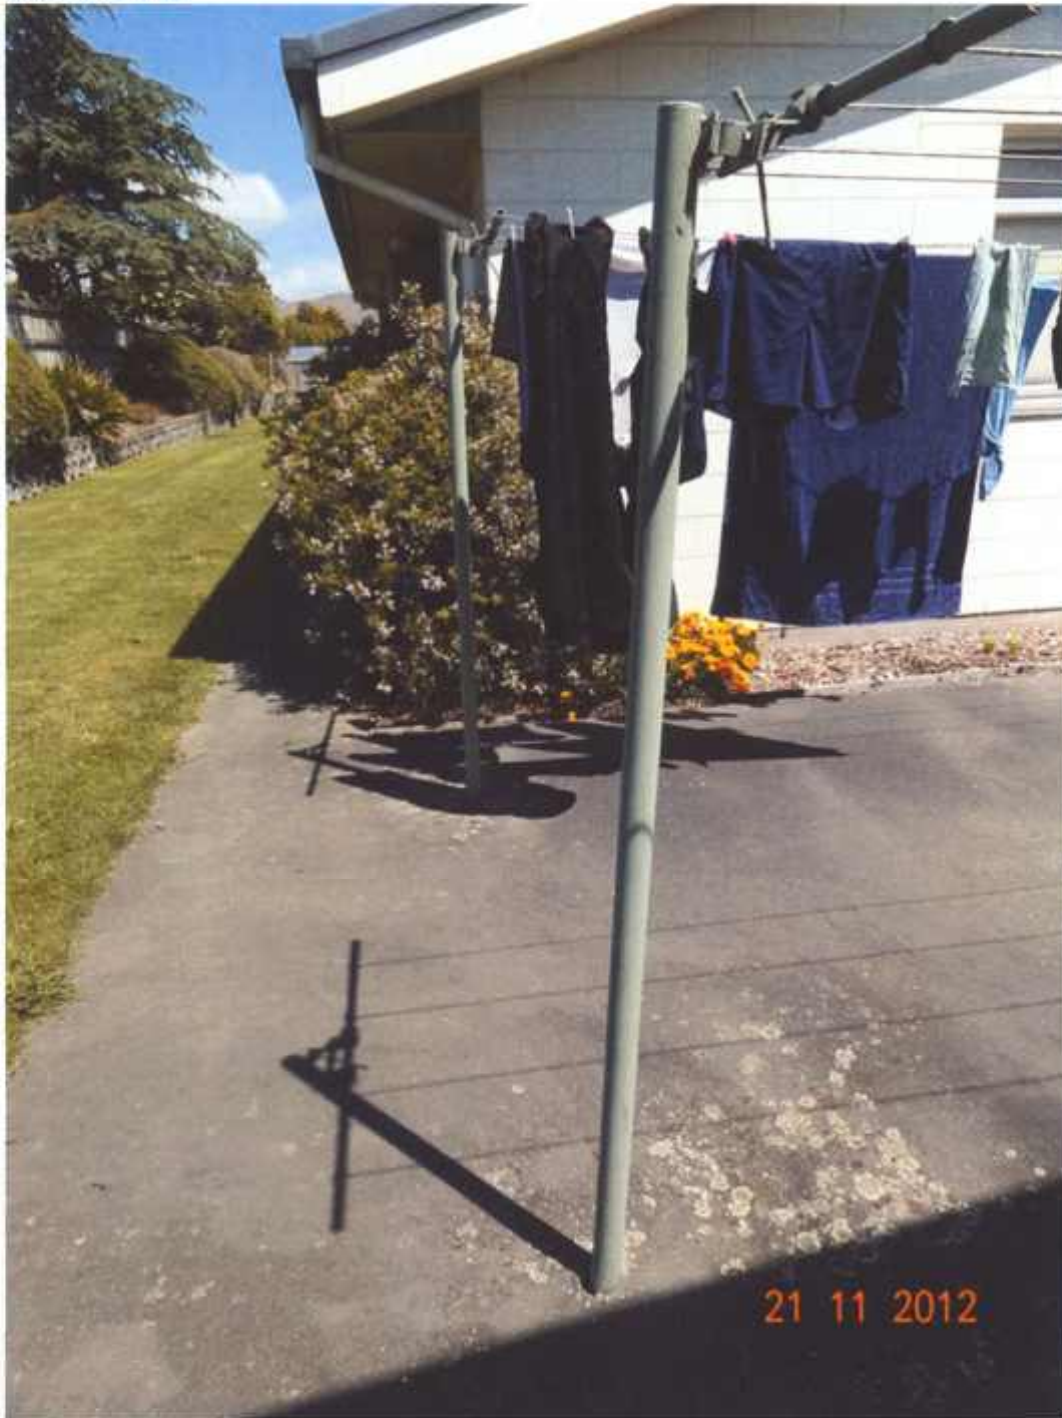
Figure 48 Crack in asphalt of the doorstep (No 18 Block E, facing east)

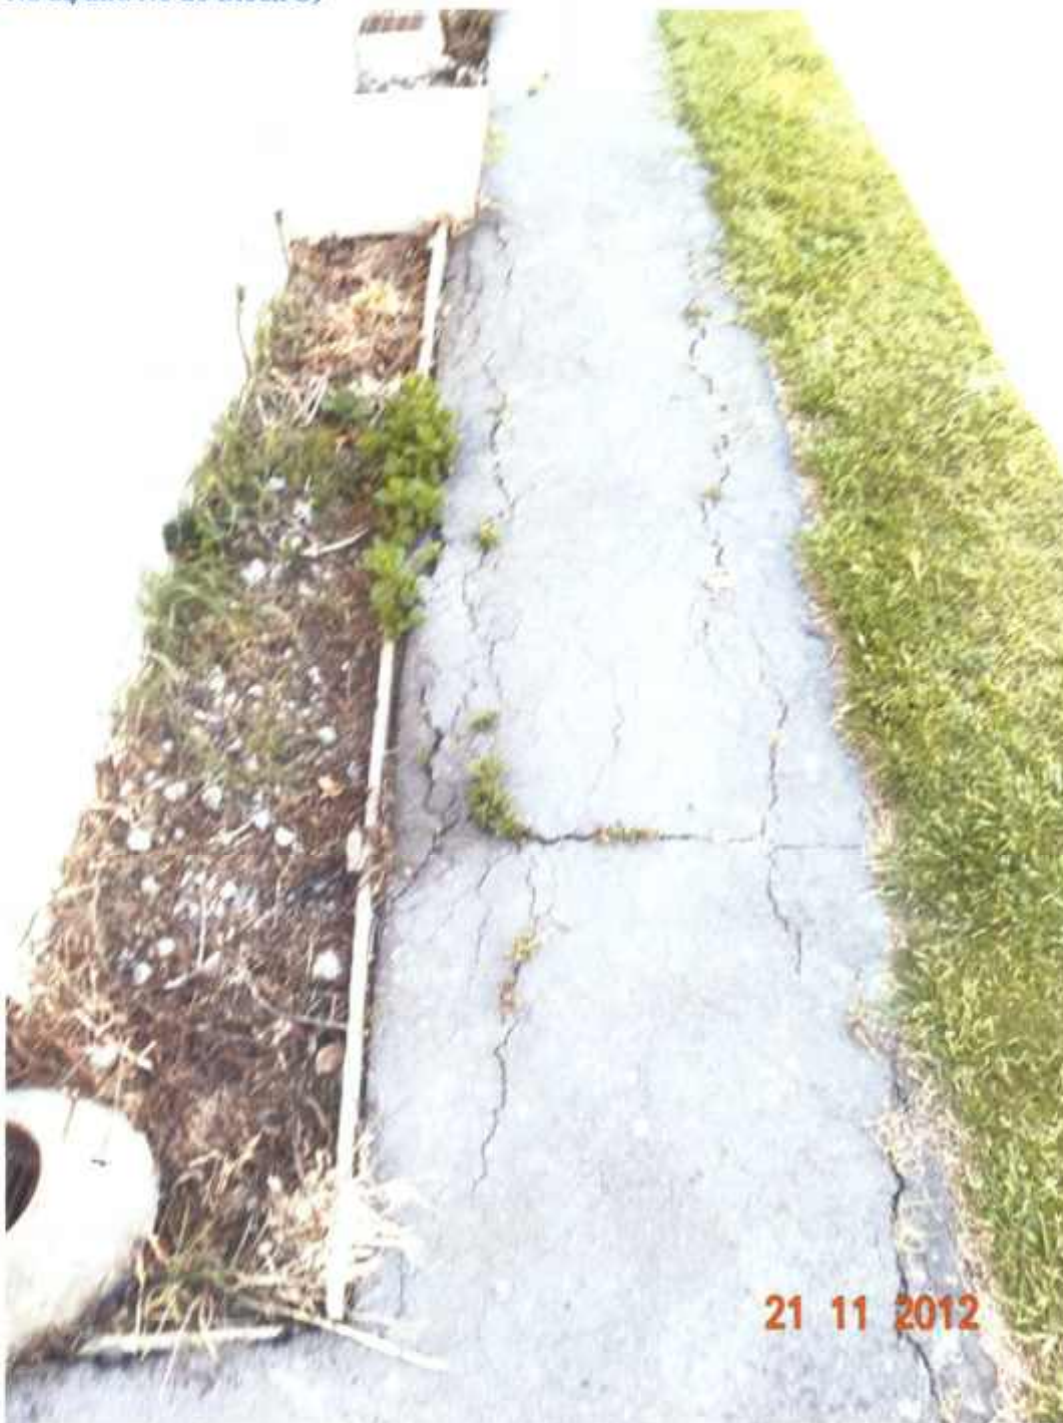
Figure 53 Some minor cracks on along the edge of the footpath (between unit No 24 – No 26 of block G)

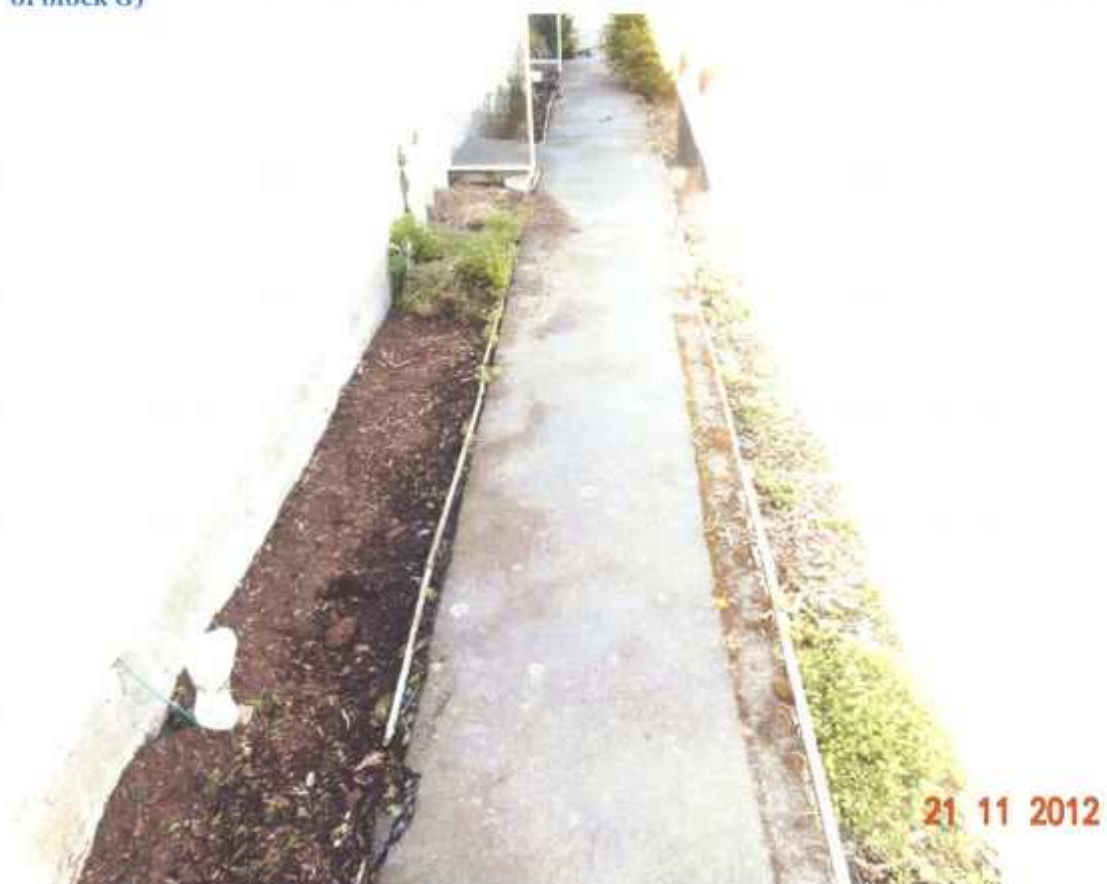
Figure 54 Existing and recent cracks in pavement footpath (between No 24 – 26 block G)

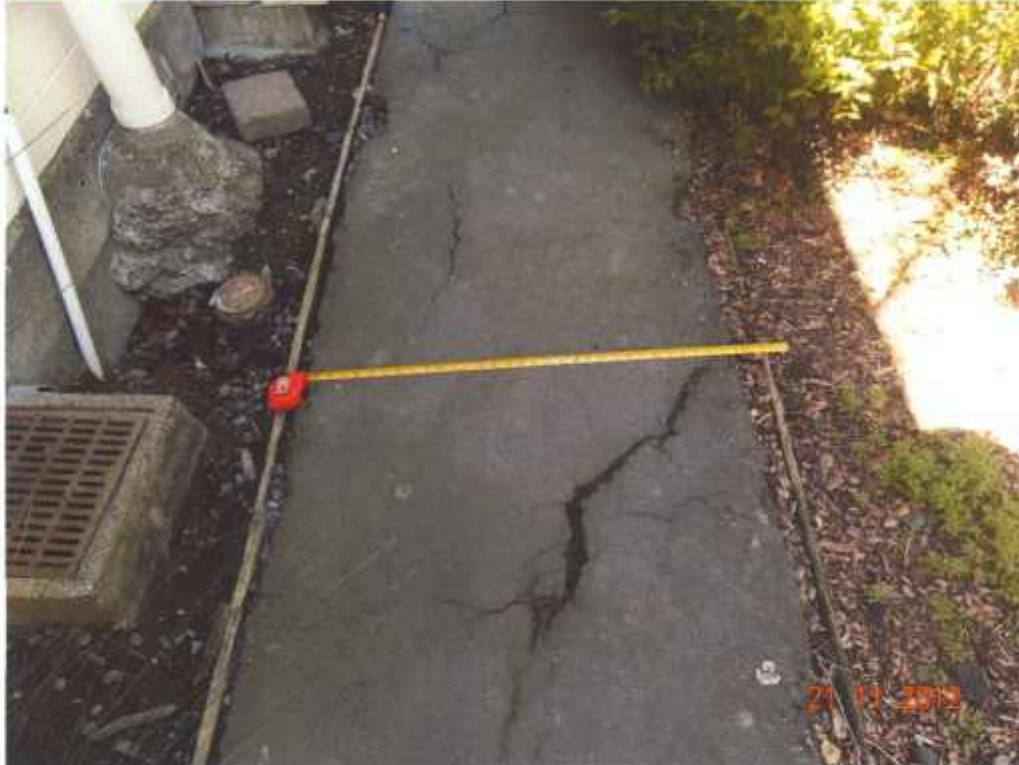
Figure 55 Recent crack along the footpath (unit No 24 – No 26, block G)

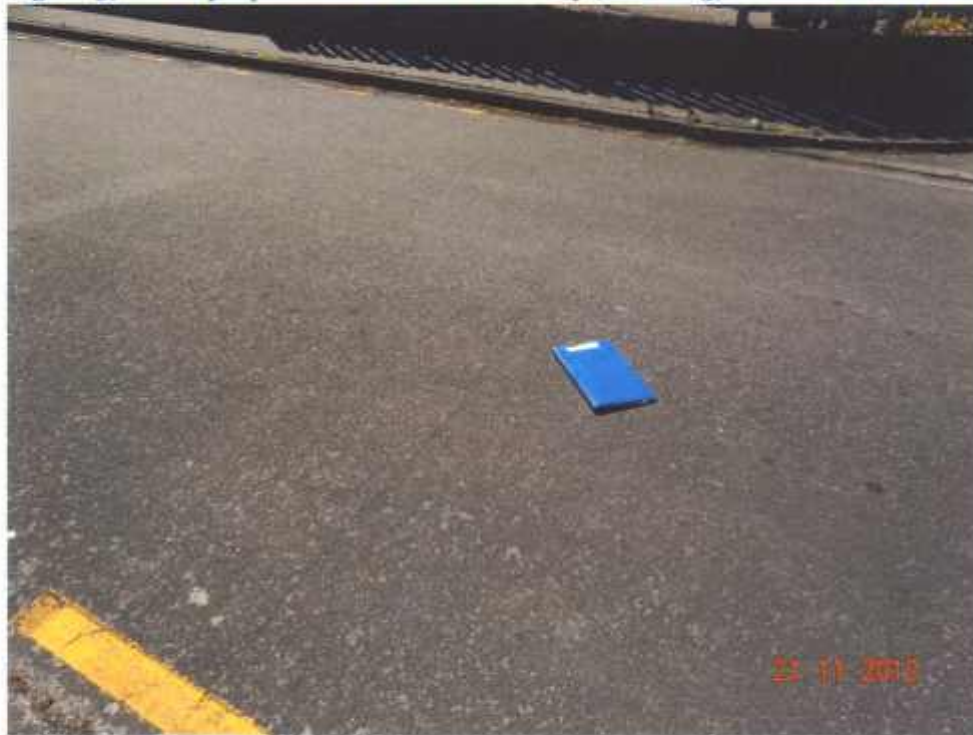
Figure 58 Minor cracks in pavement (No 27, Block H, facing north-east)

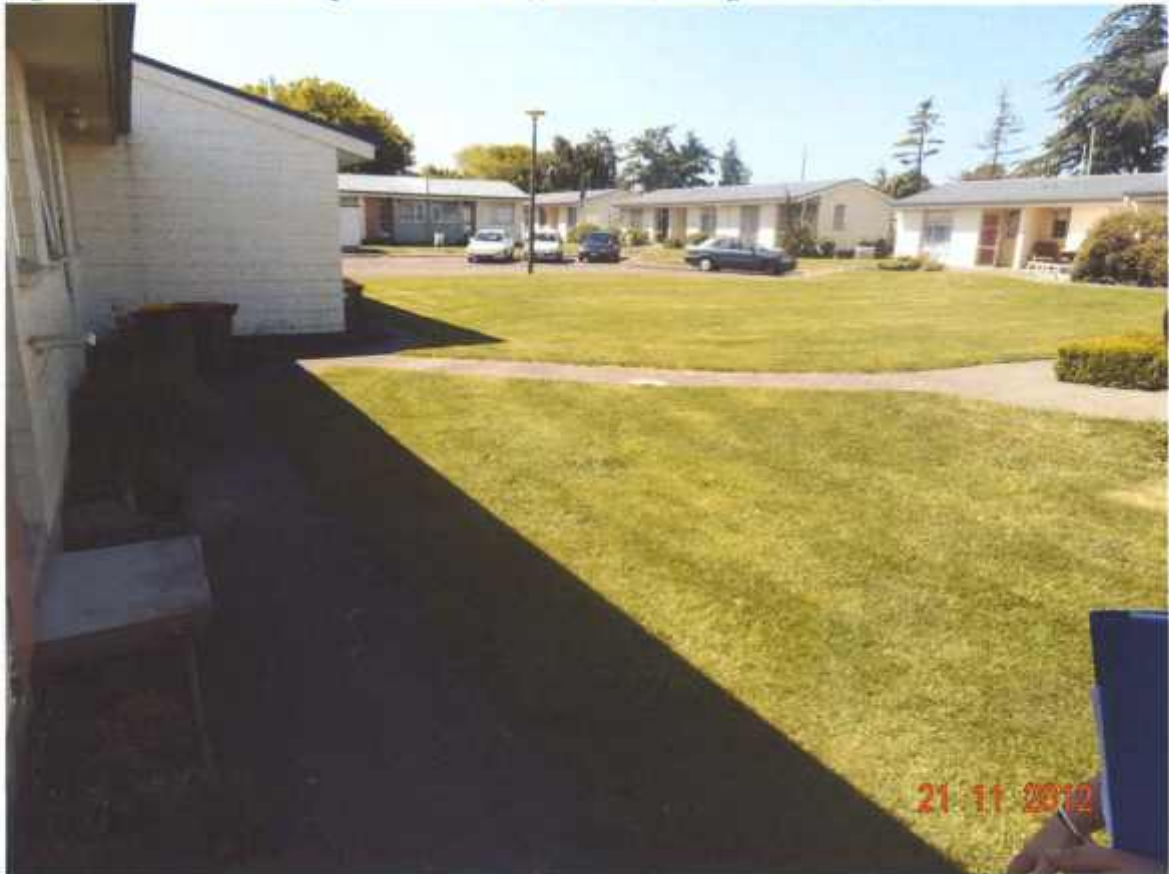
Figure 59 Visible rotation of the street light towards east (unit 30 facing north east)
