Lyttelton Recreation Centre

Detailed Engineering Evaluation Report Stage 2: Quantitative Assessment *

**Re: 1984 Lyttelton Recreation Centre
Detailed Engineering Evaluation – Quantitative Assessment**

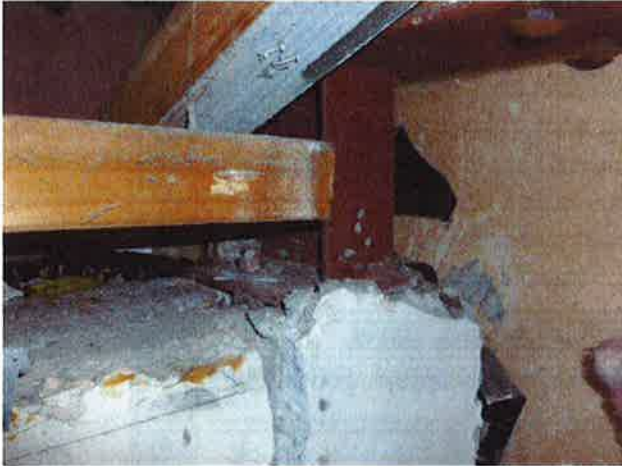
- Cracking to north-west masonry wall in gymnasium where portal frame column is seated on top of the wall.
- A masonry block at the north-east corner of the squash courts has dislodged where the portal frame is seated on top of the wall.
- Cracking and spalling damage to masonry walls in squash courts area, in at least two locations, where portal frame columns are seated on masonry walls.

Dislodgement of masonry block at connection with steel portal frame – north-east corner of squash courts.

- Undertake vertical alignment survey of wall.
- If the lean to the wall is within construction tolerance limits, break-out loose concrete, and patch repair spalled areas using Sika MonoTop-412N and Sika MonoTop-910N primer in accordance with Sika specifications. For smaller patch repairs, use Sikadur 41 with Sikadur 32 tie coat. Re-render and paint to match existing.
- If the lean is outside construction tolerance limits, attempt to re-align wall. Failing this the wall will need to be replaced.

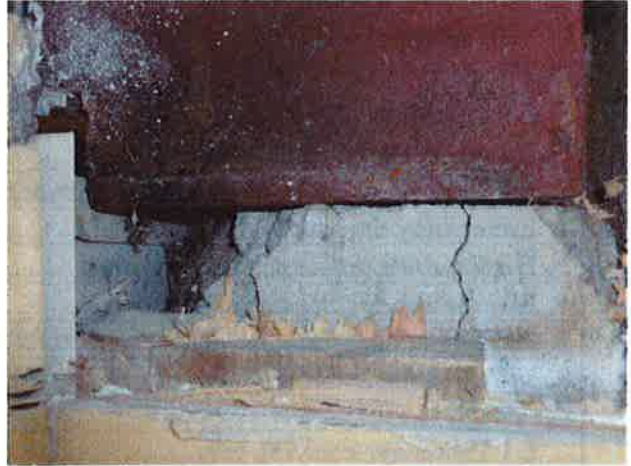
Cracking and spalling to masonry at connection with steel portal frame – south-east corner of squash courts

- Rake-out cracked mortar and re-grout/re-point.

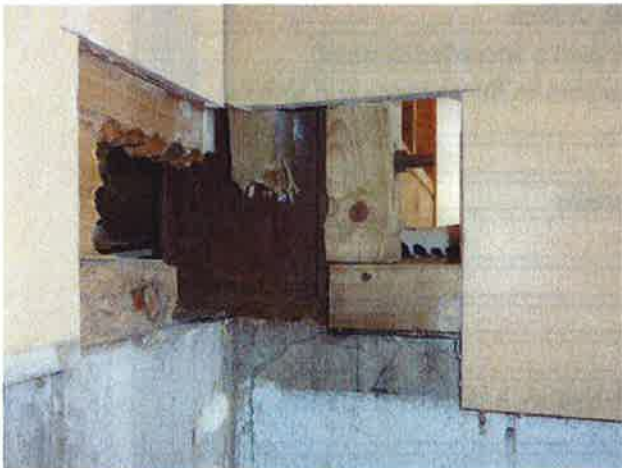
Cracking to masonry wall at connection with steel portal frame – north-west corner of gymnasium

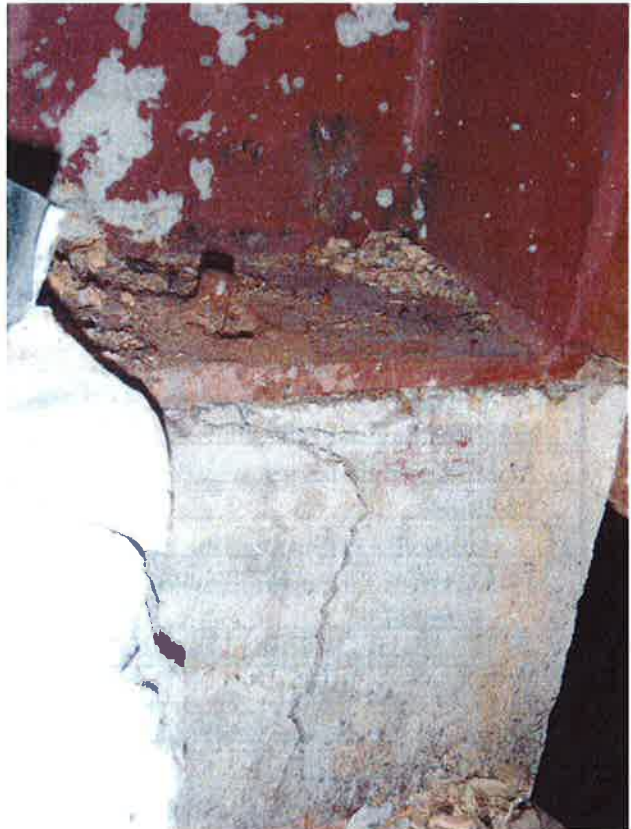
Cracking to masonry at connection with steel portal frame – squash court area

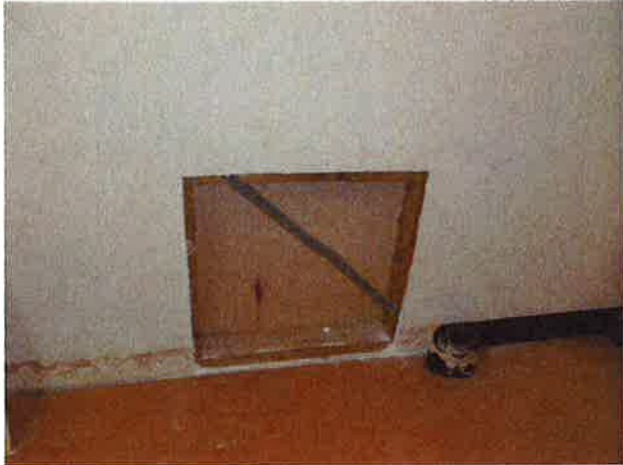
Diagonal steel brace present where detailed on original drawings.

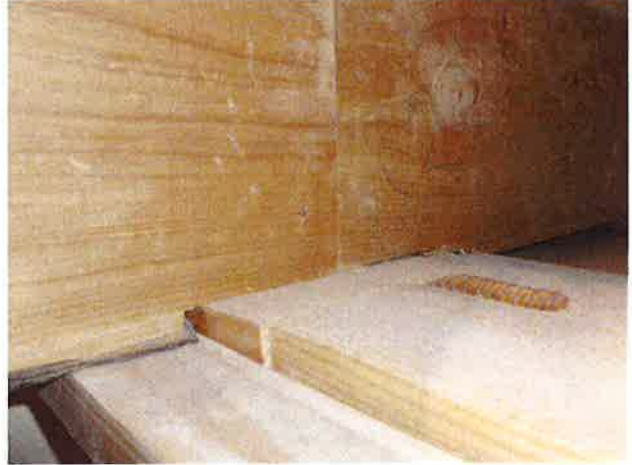
Joists fixed to top plate with 2 skew nails. Top plate fixed to masonry wall below with bent D12 bar at 600mm centres.

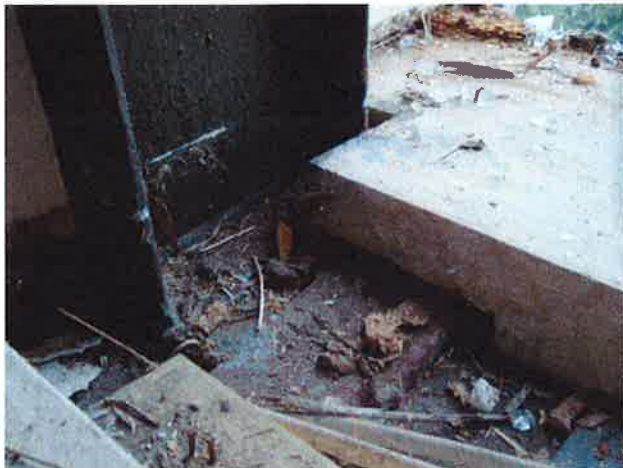
- Steel portal columns are poorly fixed to masonry walls. Typically baseplates are fixed to the wall with single M10/M12 anchors. However, in some cases these fixings are missing and the baseplate is instead welded to reinforcement cast into the wall below. Failure of these fixings could result in portal frames detaching from the wall below, causing local or total collapse of the gymnasium or squash court roof structure.
- Intrusive investigations revealed unreliable return reinforcement around corners in masonry walls – reinforcement was sometimes present, or sometimes present but incorrectly detailed. This could result in masonry walls detaching from returning walls as observed in the squash courts area. Worst case would be out-of-plane collapse of a wall should it detach completely.

South-east gymnasium portal column: No bolt fixing into masonry wall. Base plate welded to bar cast into the wall.

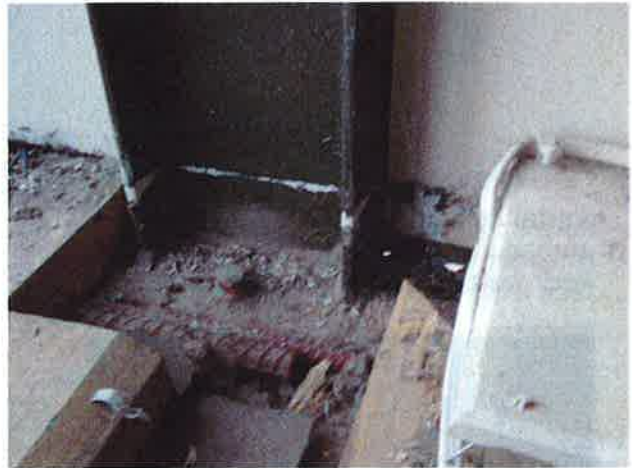
South-west gymnasium portal column: One M10 or M12 bolt fixing portal base plate to masonry wall. Base plate also welded to a bar, welded to another bar, and welded to a vertical bar cast into the wall.

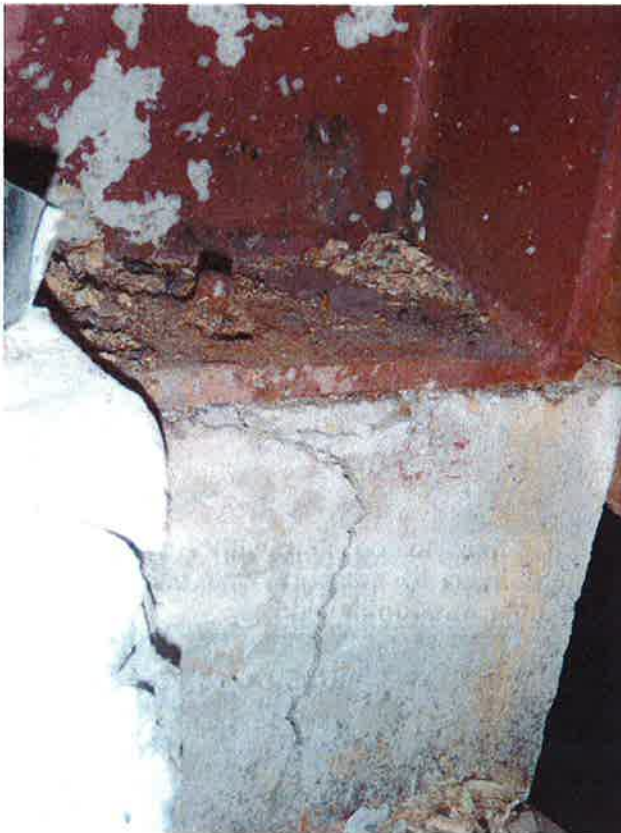
Portal column in squash courts area: No nut to threaded rod cast into masonry wall. Base plate tack welded to threaded rod instead.

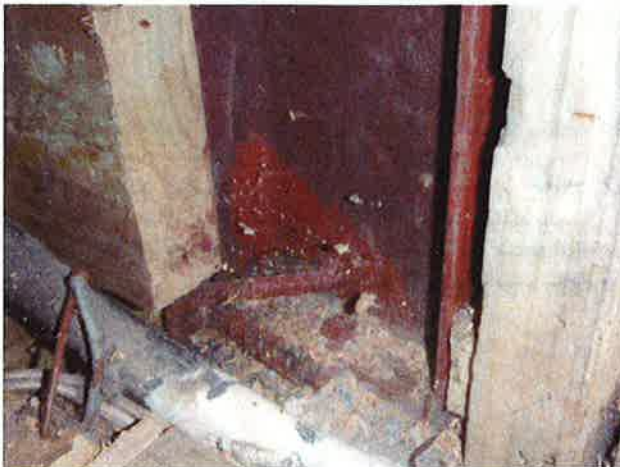
Portal column in squash courts area: Appears to be no bolt fixing into masonry wall below. Base plate welded to reinforcing bar cast into masonry wall instead.

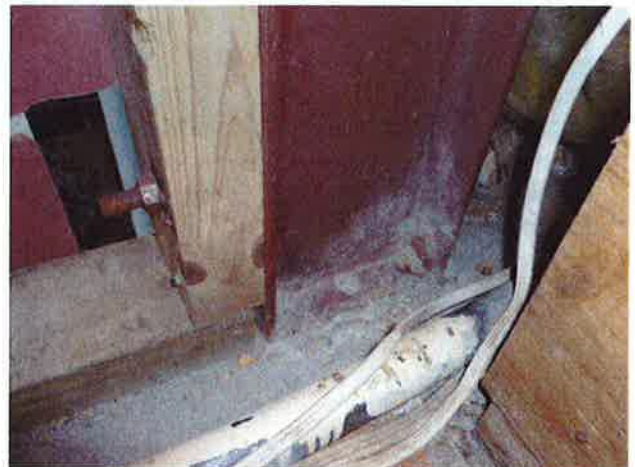
Portal column north-west column of gymnasium: No bolt fixing base plate to masonry wall below.

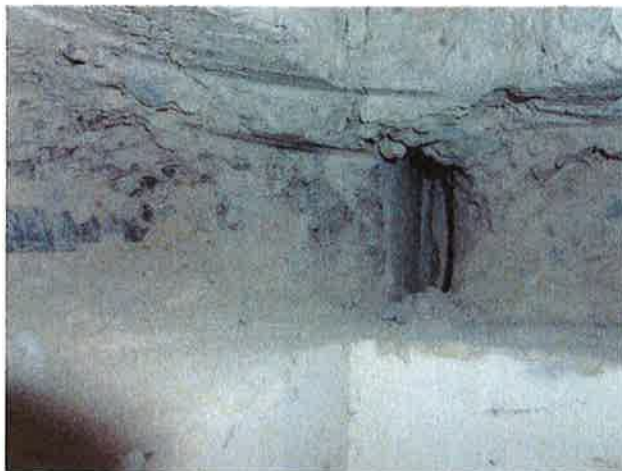
- Intrusive investigations revealed unreliable return reinforcement around corners in masonry walls – reinforcement was sometimes present, or sometimes present but incorrectly detailed. Given this, the separation of return walls in the squash courts is likely the result of poor detailing.
- Damage to masonry walls where steel columns are seated on the wall was expected and observed. Fixings appeared to be inadequate, and engaged insufficient blockwork such that failure was likely to occur in the wall.

South-west corner of squash courts area: No reinforcement tying external wall into return wall.

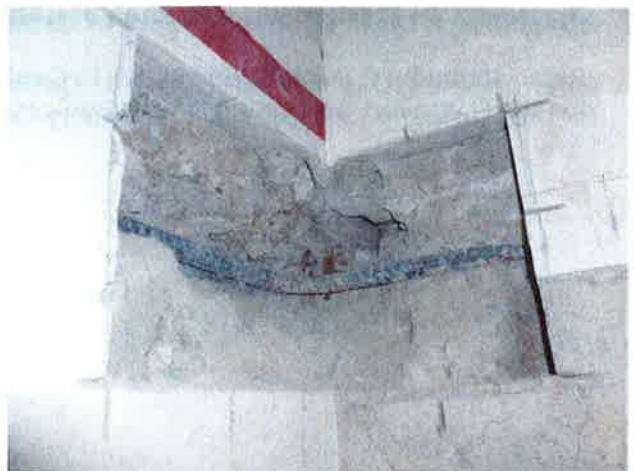
North wall of squash courts area: Return bar around corner not bent around vertical reinforcement.

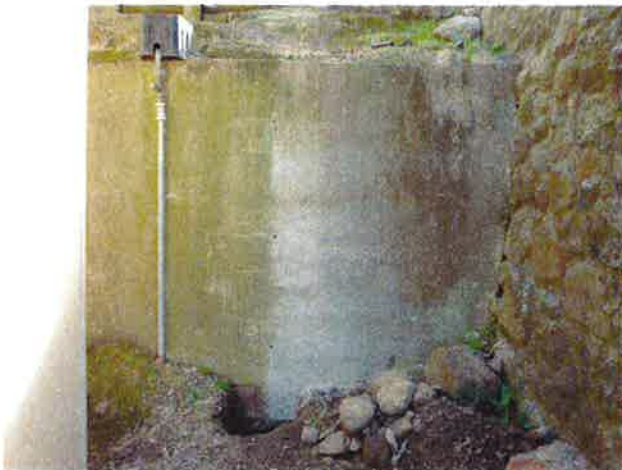
Concrete retaining wall on north side. Drilling indicates the wall is 250mm-300mm thick and reinforced.

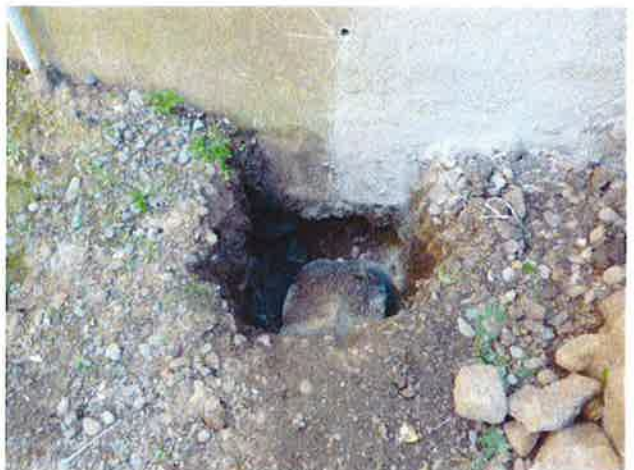
Excavation of the retaining wall footing revealed no toe footing. Drilling suggested there was no heel extending behind the wall either.

- Continue with investigations and determine construction, or;
- Replace/retrofit the wall to provide code compliant retaining structure, or;
- Leave the wall in-place as it appears undamaged by the earthquakes.

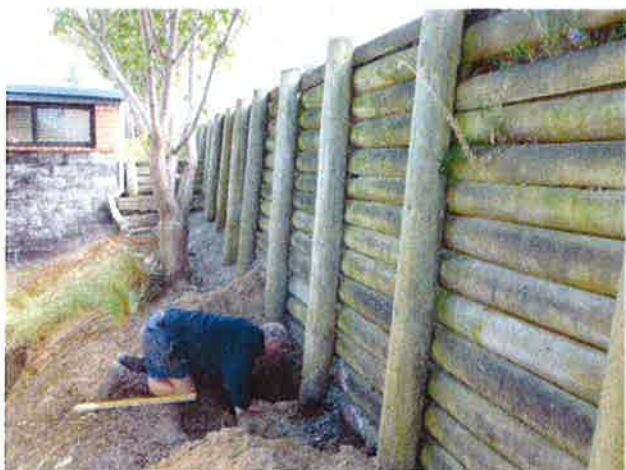
Timber poles embedded 1.85m into ground.

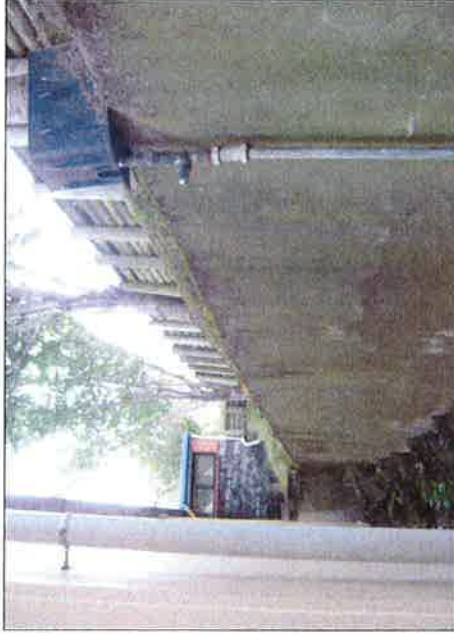
The upper wall on the north side below Winchester Street does not appear to have been significantly deformed. There is minor rotation of the near vertical posts and some displacement of the horizontal elements. The asphalt pavement behind the upper wall has cracked and settled and the back fill behind the walls is visible. At the base of the wall there are small talus cones of granular backfill that have settled out from behind the wall as a result of earthquake shaking.

Photo 2: Northern retaining wall

The northern retaining walls below Winchester Street do not appear to have been significantly deformed however we recommend that they are inspected, and their designs checked, by a Structural Engineer.

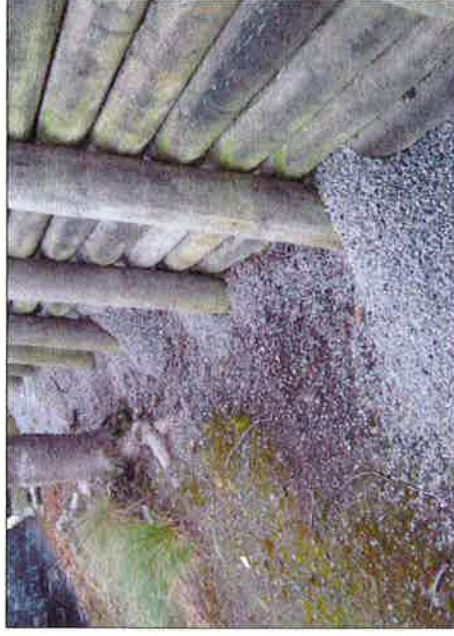
Photo 3: Talus cones of granular fill at base of upper level of northern retaining wall

- Northern timber pole retaining wall: Excavate backfill and re-lay free draining, well-graded, granular backfill to re-level footpath.
- Stacked stone retaining walls: Reinstall fallen blocks and re-grout. This repair should reinstate the strength of the wall prior to the earthquakes. However, if an engineered structure is desired, the wall will likely require replacement.

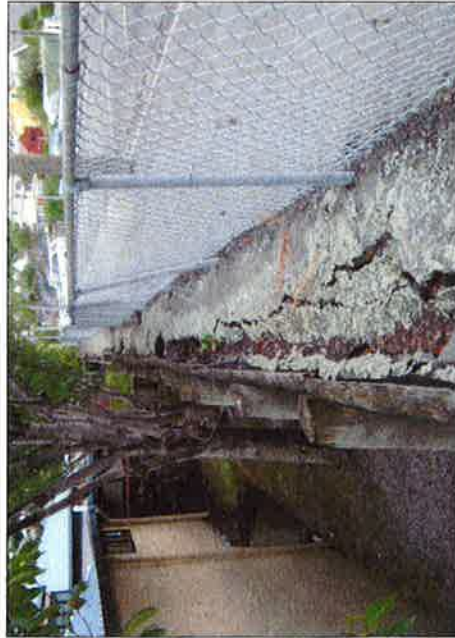
Photo 4: Cracks and subsidence above northern retaining wall

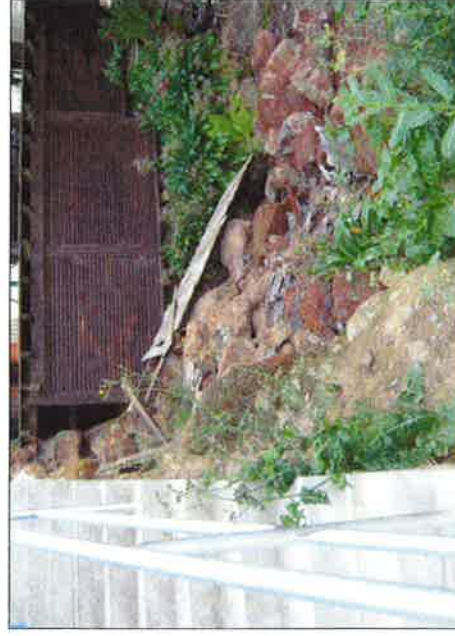
- The basalt block retaining wall on the east side of the centre is approximately 10 m long and has collapsed at its southern end. The debris remains and the subsurface material is exposed. Services for the centre, uncertified fill and two cavities (diameter up to 500 mm) are visible.
- The south west retaining wall is a timber wall that has been constructed as two tiers. The wall is approximately 10 m long and each tier is approximately 0.6 m high. There has been minor rotation and deformation of the upper tier and the lower tier does not appear to be damaged.

Photo 5: Failed basalt block wall on the east side

The existing fill below the wall is not suitable for the wall foundation and we recommend the following options, in conjunction with the design parameters set out below:

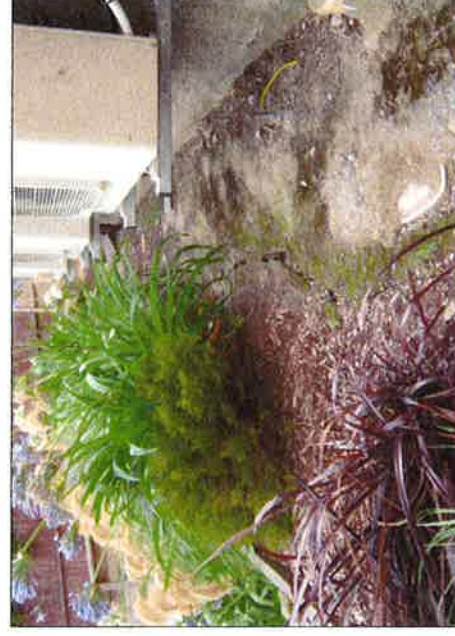
Above the upper tier of the south west wall there are tension cracks that are up to 50 mm wide and within 800 mm of the community hall.

Photo 6: Tension cracks above south west wall
