Christchurch City Council
PRK_3527_BLDG_001 EQ2
Lyttelton Rec Ground - Pavilion
Godley Quay, Lyttelton

QUANTITATIVE ASSESSMENT REPORT
FINAL

- Rev B
- 04 February 2013

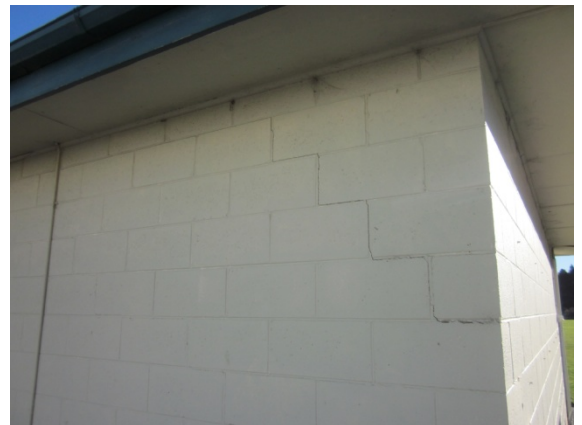
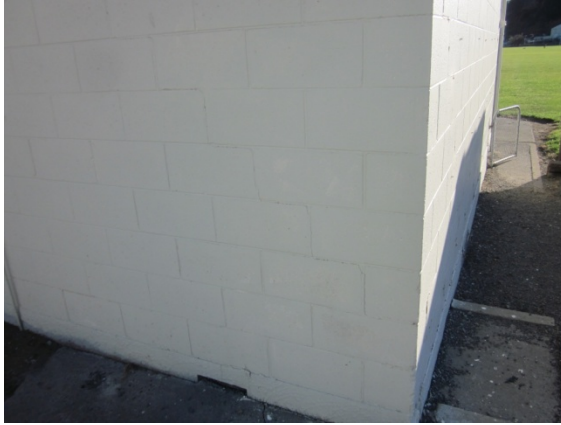
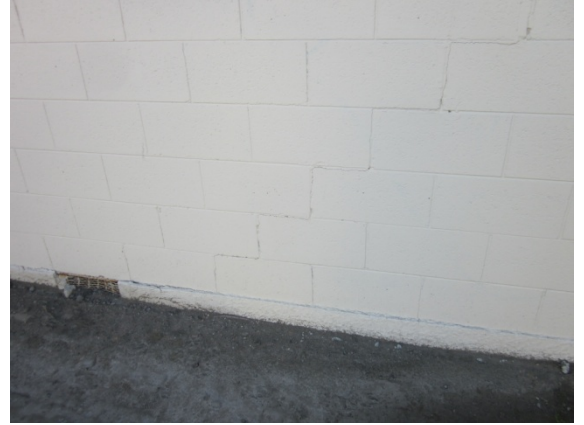
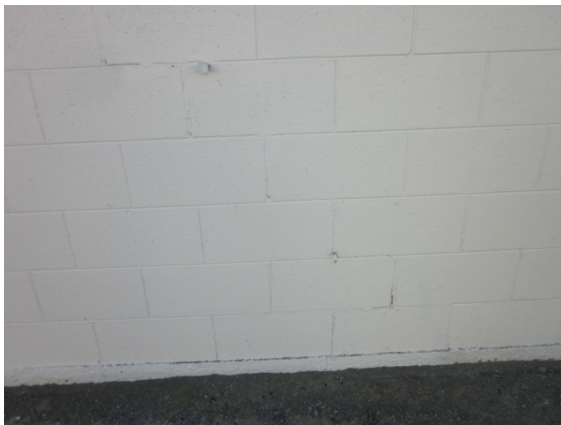
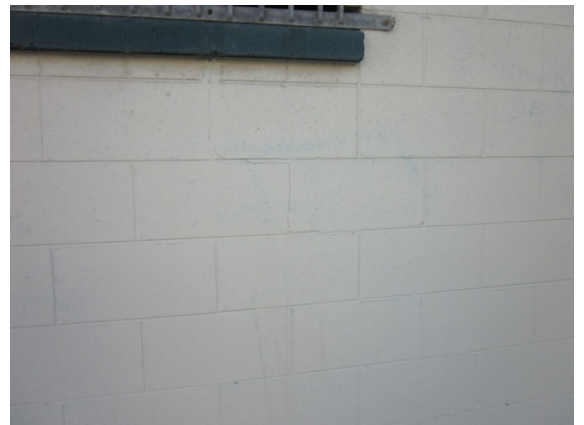
- 1) There are cracking in the bed joints of the concrete block shear walls all around the building. These vary in thickness with approximate maximum thickness of around 0.5mm. Refer Photo 4 to Photo 12.

Photo 4: Blockwork cracking on the eastern facade.

Photo 5: Blockwork cracking on the eastern facade.

Photo 6: Blockwork cracking on the eastern facade.

Photo 7: Blockwork cracking on the eastern facade.

Photo 8: Blockwork cracking on the eastern facade.

Recommendations		Level of repair/strengthening required: minor structural	Describe: Cracking repairs to blockwork
Building Consent required: no		Interim occupancy recommendations: full occupancy	Describe: Like for like repair
			Describe: No restrictions required
Along	Assessed %NBS before: 46%	%NBS from IEP below	If IEP not used, please detail assessment methodology: Quantitative Assessment
	Assessed %NBS after: 46%		
Across	Assessed %NBS before: 46%	%NBS from IEP below	
	Assessed %NBS after: 46%

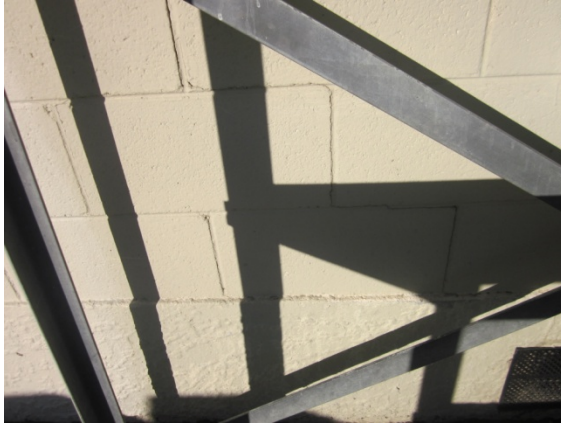
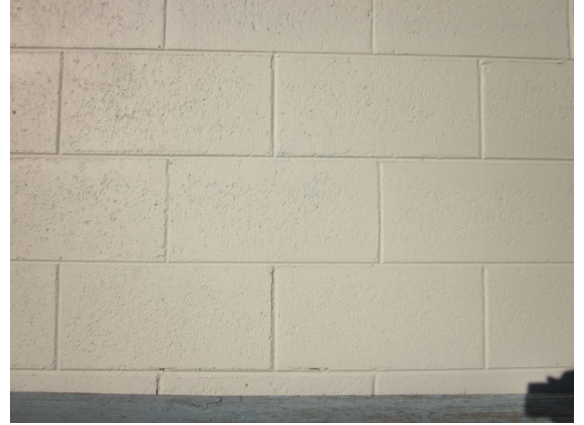
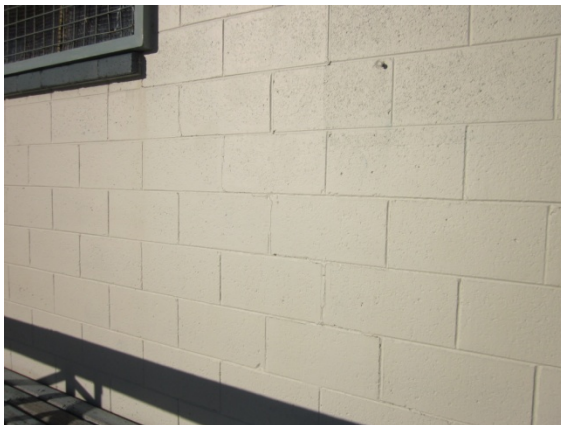
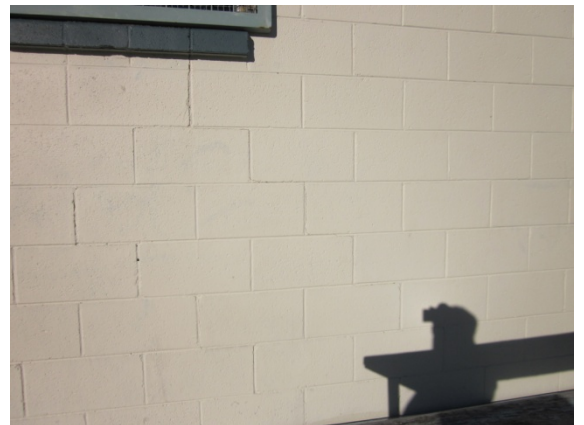
Photo 9: Blockwork cracking on the western facade.

Photo 10: Blockwork cracking on the western facade.

Photo 11: Blockwork cracking on the western facade.

Photo 12: Blockwork cracking on the western facade.
