Mabel Howard Place Housing Complex PRO 0699

**Detailed Engineering Evaluation
Quantitative Assessment Report**

**Mabel Howard Place, Dallington,
Christchurch**

Date: November 2013
Reference: 6-QC372.00
Status: Final

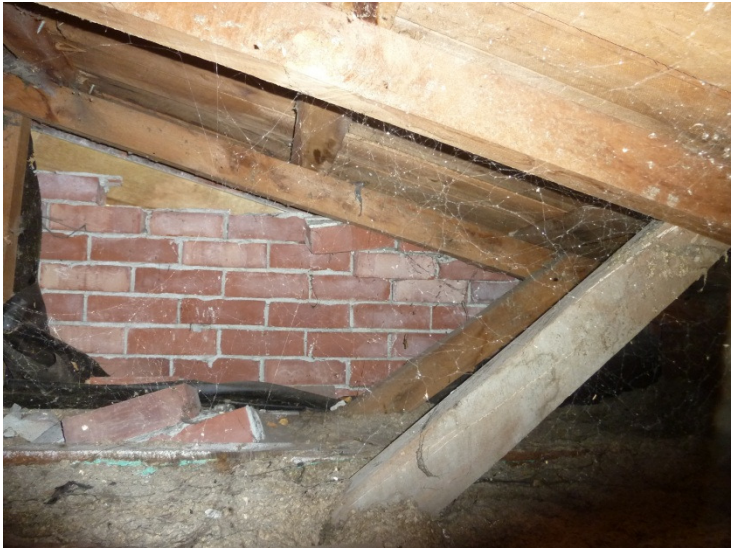
4	Roof space in residents lounge showing gable ends.

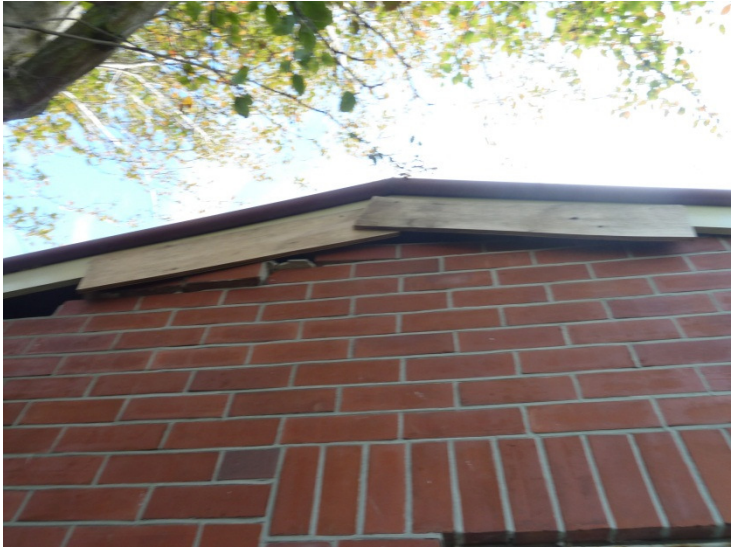
5	Exterior of resident's lounge showing gable end.

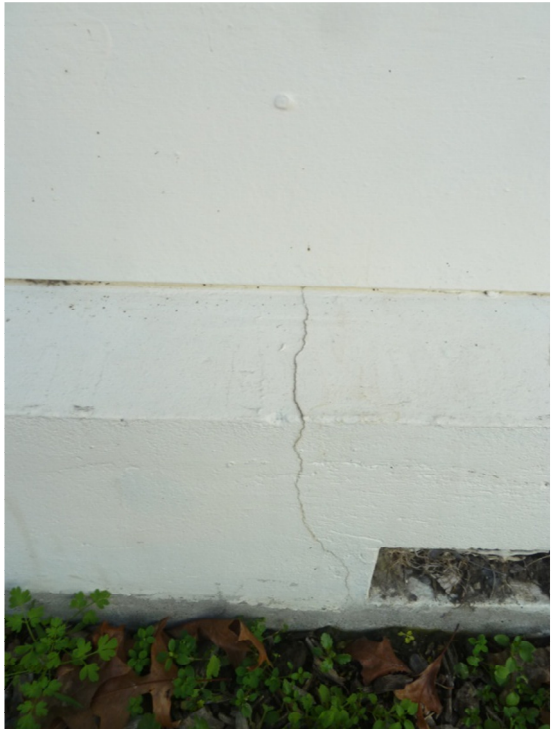
Minor cracking (photo 12) was observed around the vents in the perimeter foundations of most units.

12	Typical cracking of perimeter footing.

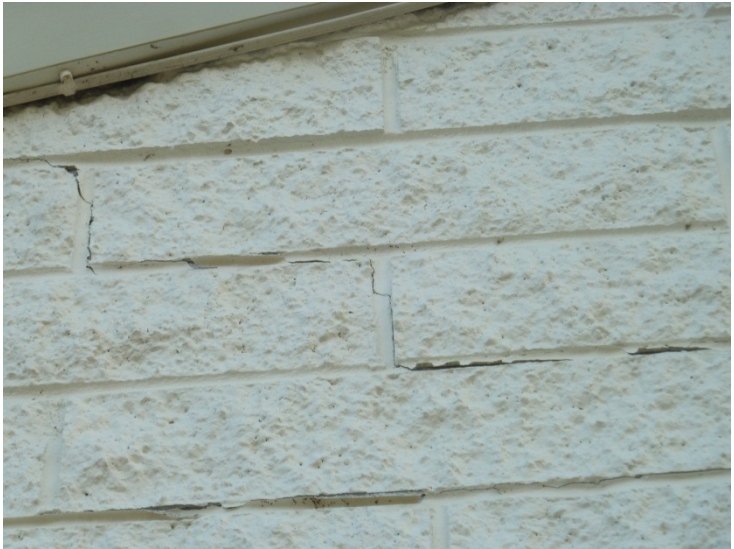
13	Typical cracking of Summerhill Stone veneers at gable ends.

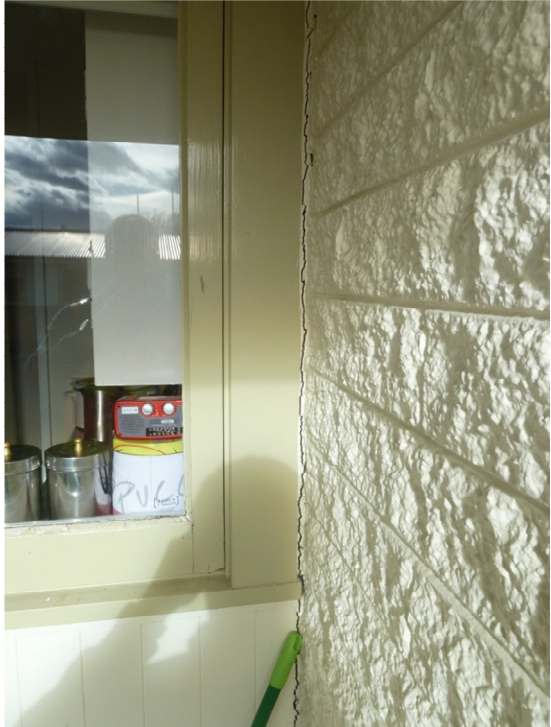
14	Cracking in interface of Summerhill Stone veneer and window frames.

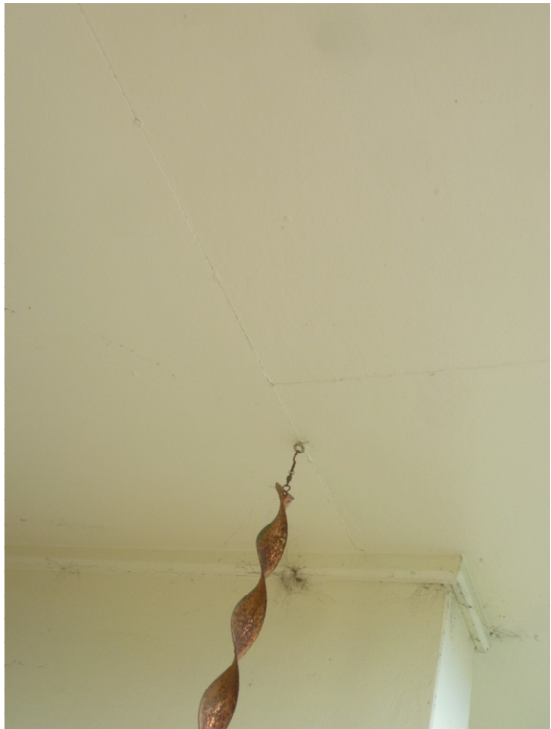
15	Typical cracking of plasterboard ceilings.

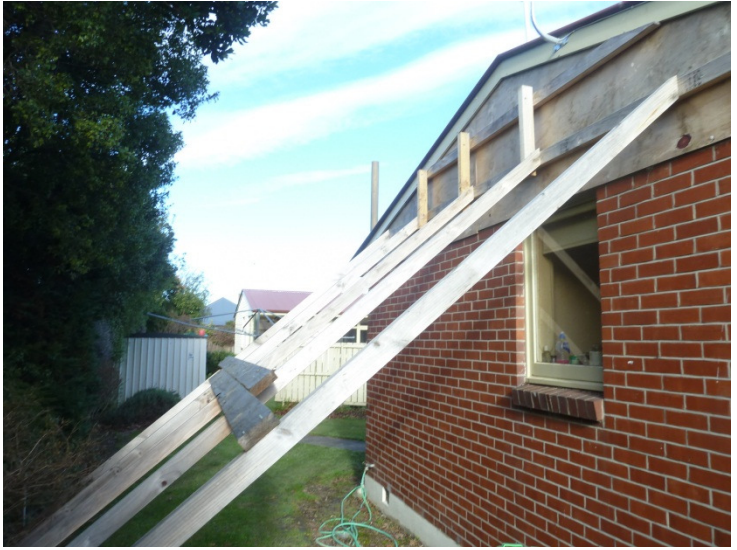
Unit 40 and the residents lounge suffered damage and fall out of the cladding at height in the gable ends of the units. This indicates insufficient framing and ties in this area. This area has been temporarily propped as shown in photo 18. Some of the bricks fell inwards and are still sitting on the ceiling of the residents lounge.

18	Temporary propping of gable ends on Unit 40.

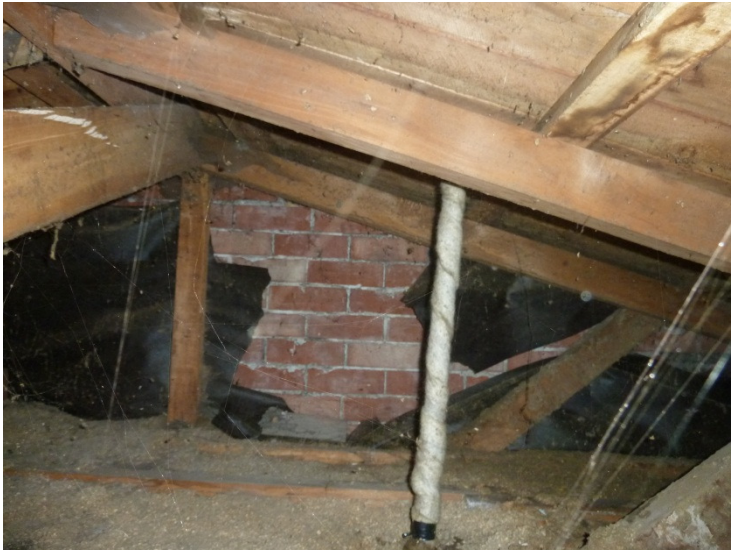
19	Typical roof space of residential units showing gable ends with lack of continuous framing.

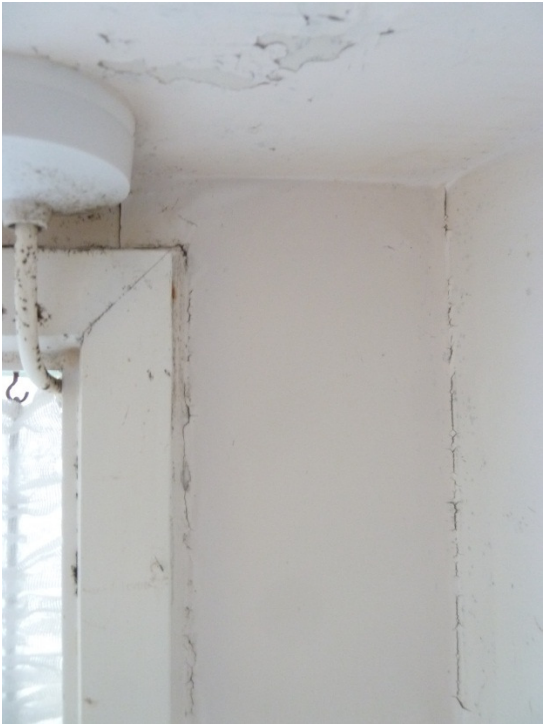
21	Typical cracking to plasterboard wall cladding.

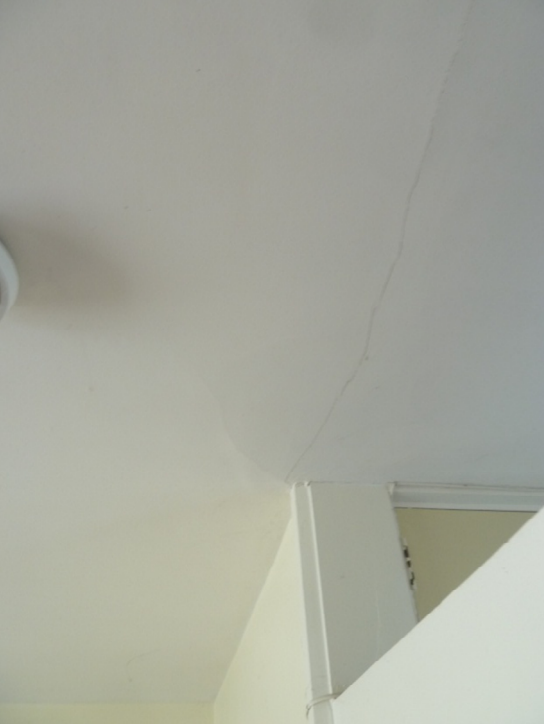
22	Typical cracking to plasterboard roof cladding.
