Macfarlane Park Toilets  
Qualitative Engineering Evaluation

**Prepared for:**  
Christchurch City  
Council

Functional Location ID: PRK 0663 BLDG 003

**Date:** 14 April 2014

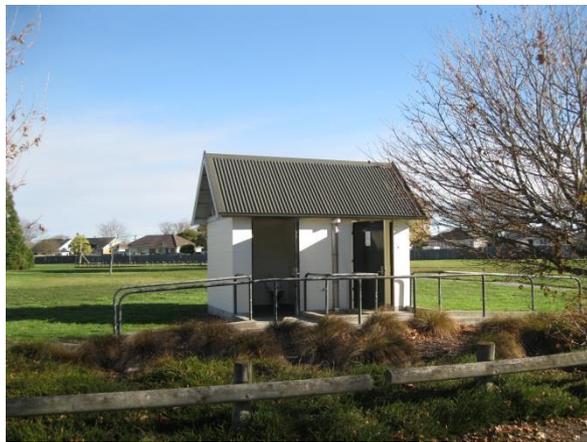
Northern elevation of the Macfarlane Park Toilets.

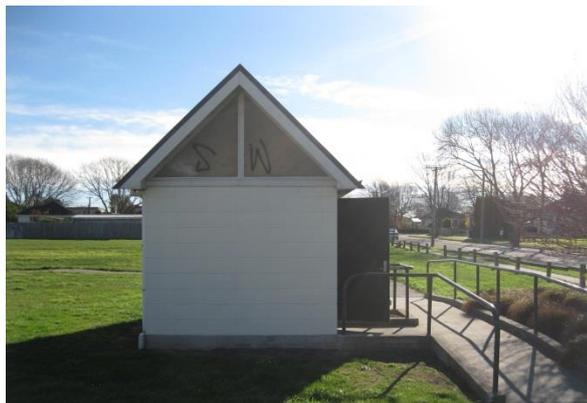
Eastern elevation of the Macfarlane Park Toilets.

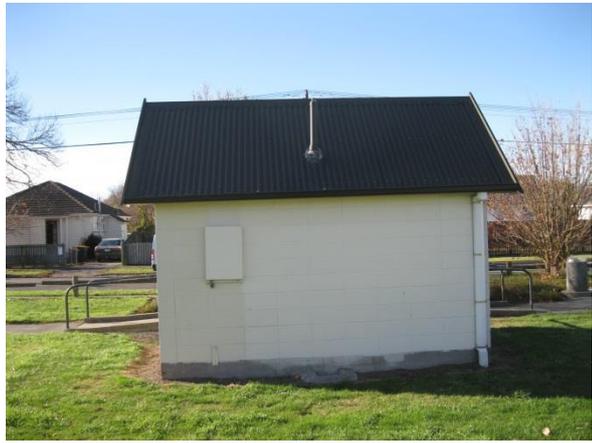
Southern elevation of the Macfarlane Park Toilets.

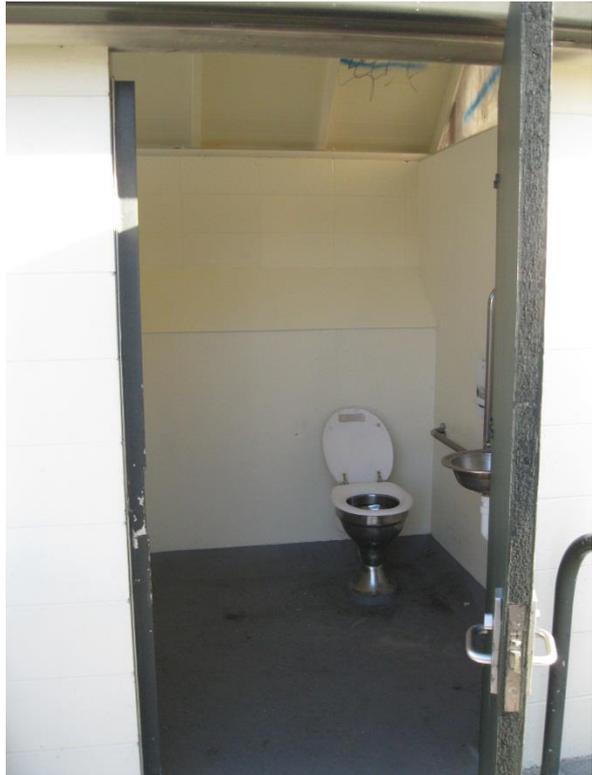
Internal view of the Macfarlane Park Toilets.

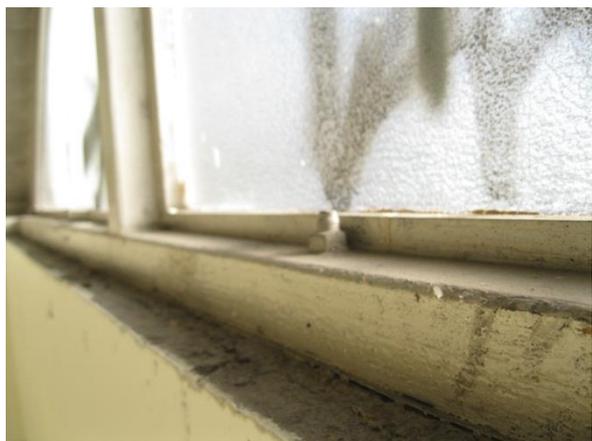
Typical roof to wall connection detail.
