Mairehau Public Library
Qualitative Engineering Evaluation

Reference: 227678

Prepared for:
Christchurch City Council

Date: 18 December 2012

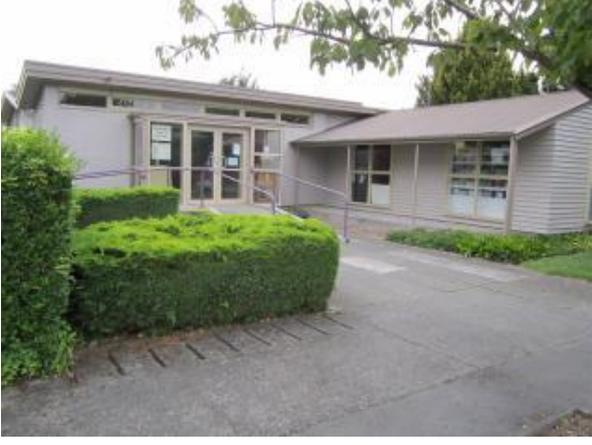
<p>South-West elevation of the Mairehau Public Library.</p>

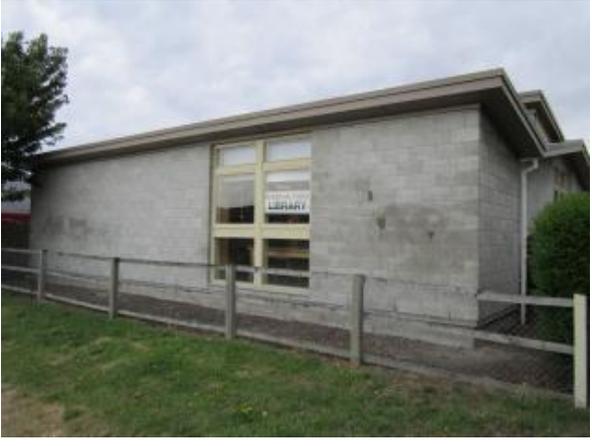
<p>North-East elevation of the Mairehau Public Library.</p>

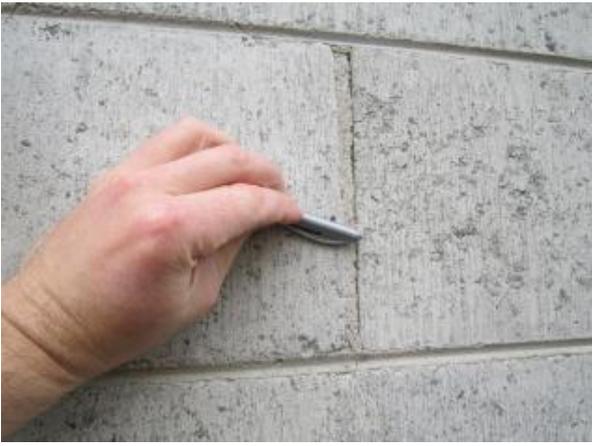
Cracking identified on the slab was localised and most likely due to differential settlement over time and unrelated to the earthquakes. The minor damage to the foundation is not considered significant will not influence the structure's ability to resist the gravity and lateral loads. Minor cracking in the block work veneer does not affect structural seismic capacity.

<p>Minor cracking on masonry veneer.</p>

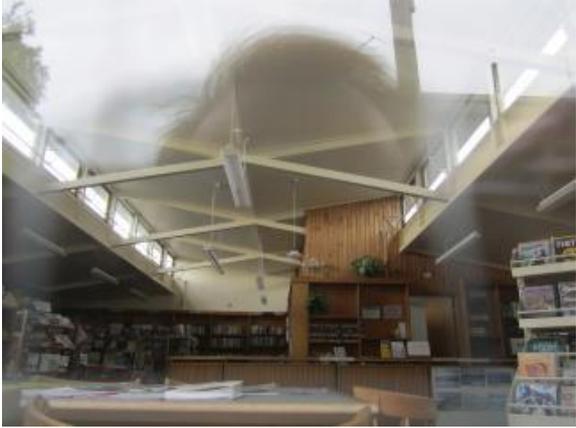
<p>Steel secondary beams.</p>

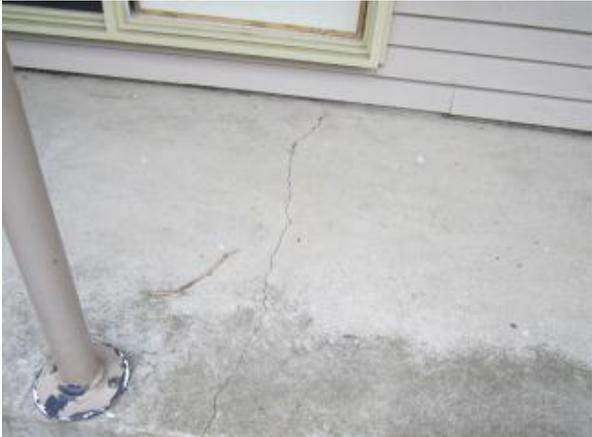
<p>Tension cracking on footpath.</p>

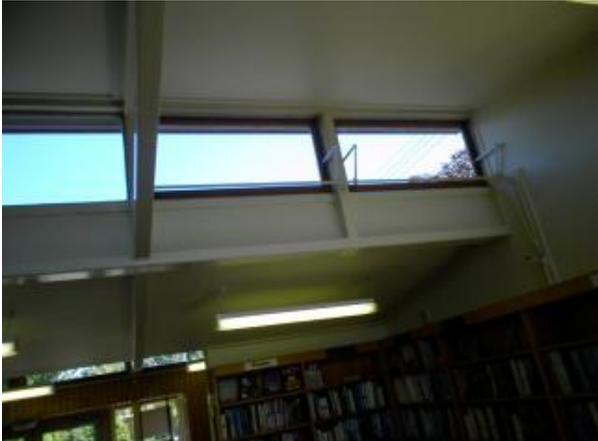
<p>Clearspan of beams</p>

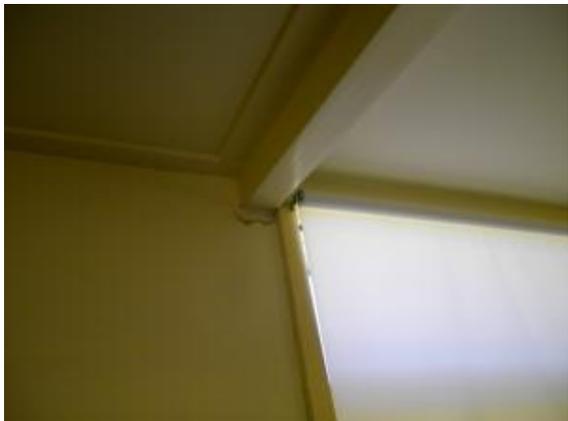
<p>Minor damage to gypsum at the beam-column connection (recently painted).</p>

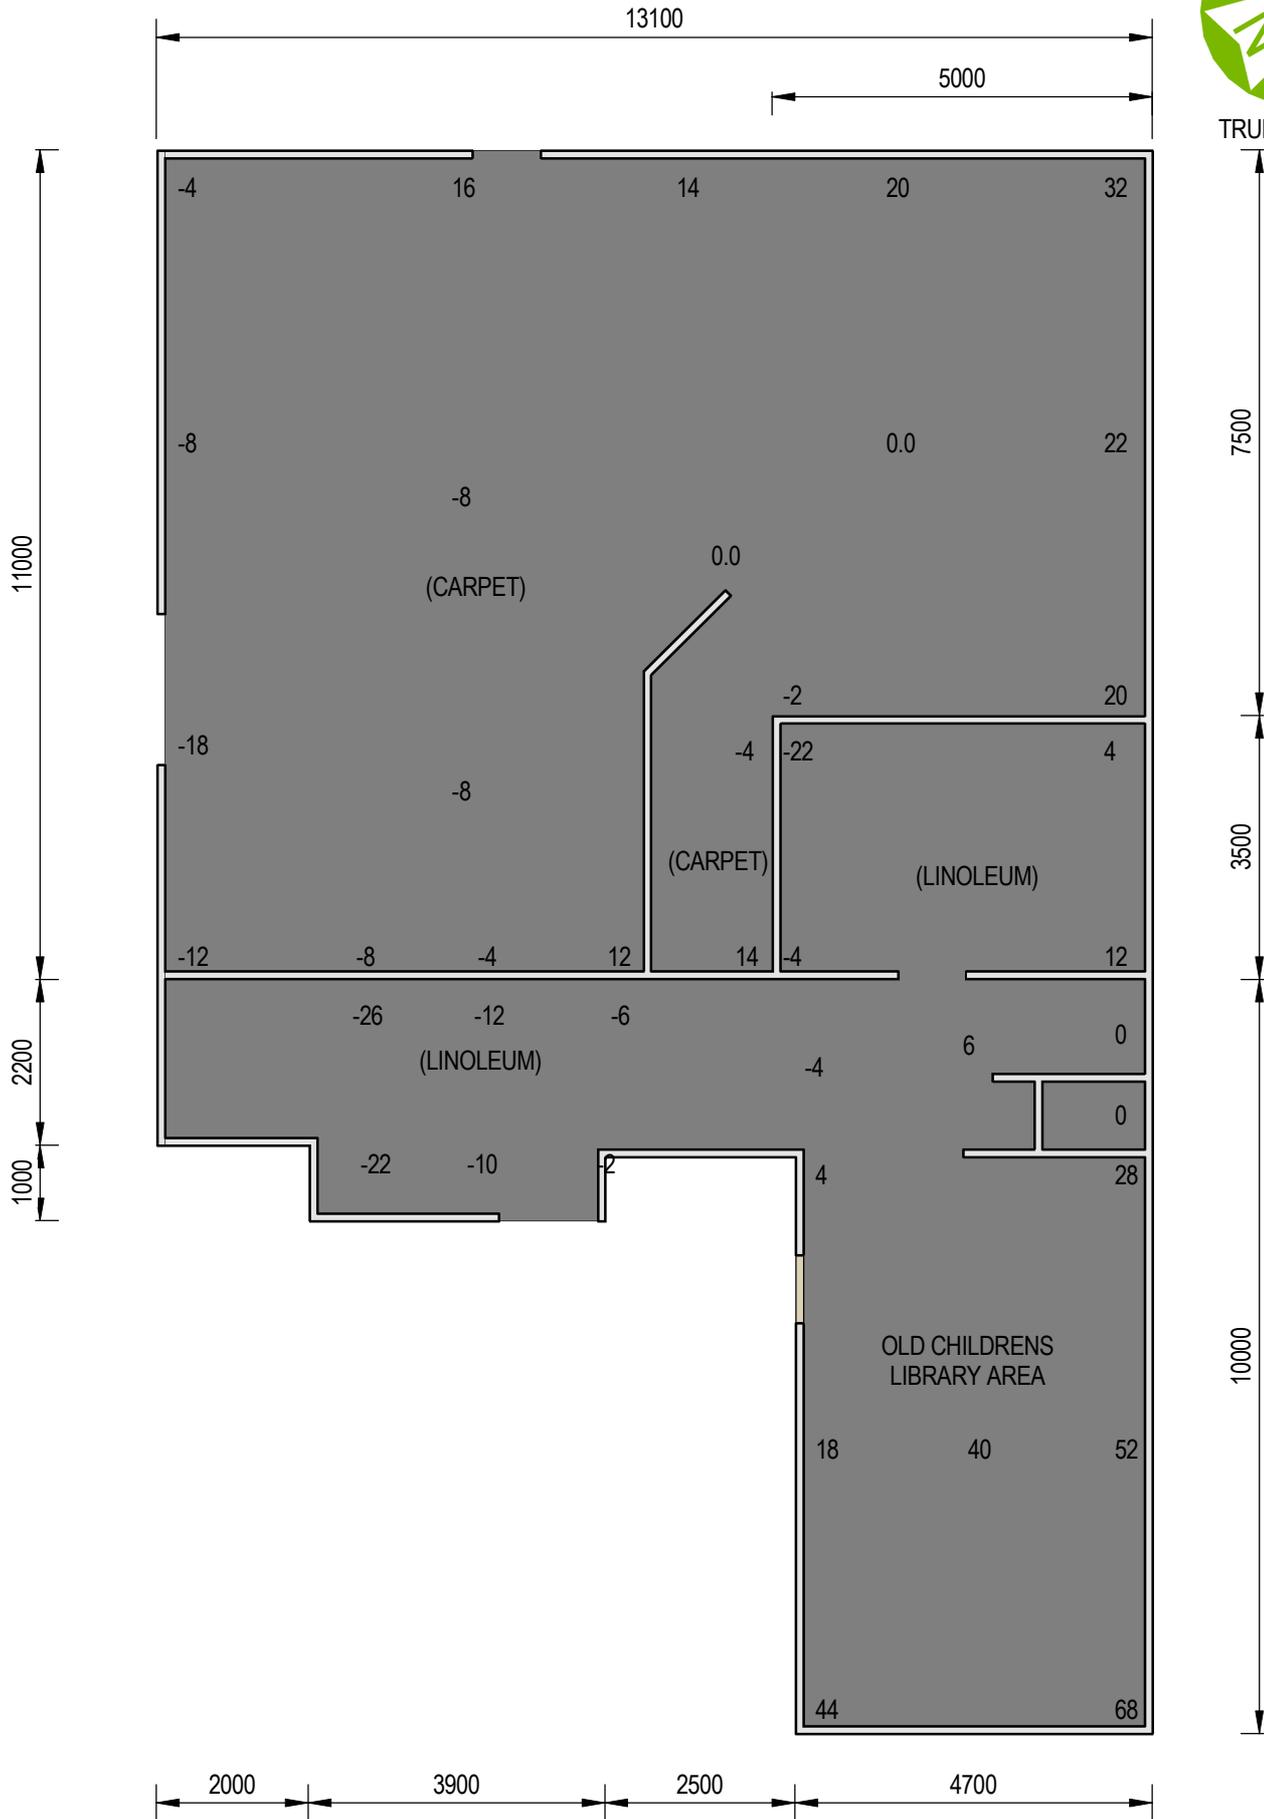
PROJECT
MAREHAU PUBLIC LIBRARY CHRISTCHURCH
TITLE
FLOOR LEVELS PLAN

A levels survey was carried and the results of the survey are attached in Appendix A. The survey results indicate that the 1964 library extension floor levels are within acceptable limits. The earlier original children's library, although with acceptable limits, shows sign of significant settlement. Due to the age of the part of the library the condition of the floor is very likely due to the age of this small older part of the library rather than due to the effect of the earthquakes.
