Toilets Marshland Reserve
PRK 0084 BLDG 001 EQ2
Detailed Engineering Evaluation
Quantitative Report
Version FINAL REV1

420 Prestons Road, Marshland

Christchurch City Council

Date
01 August 2013

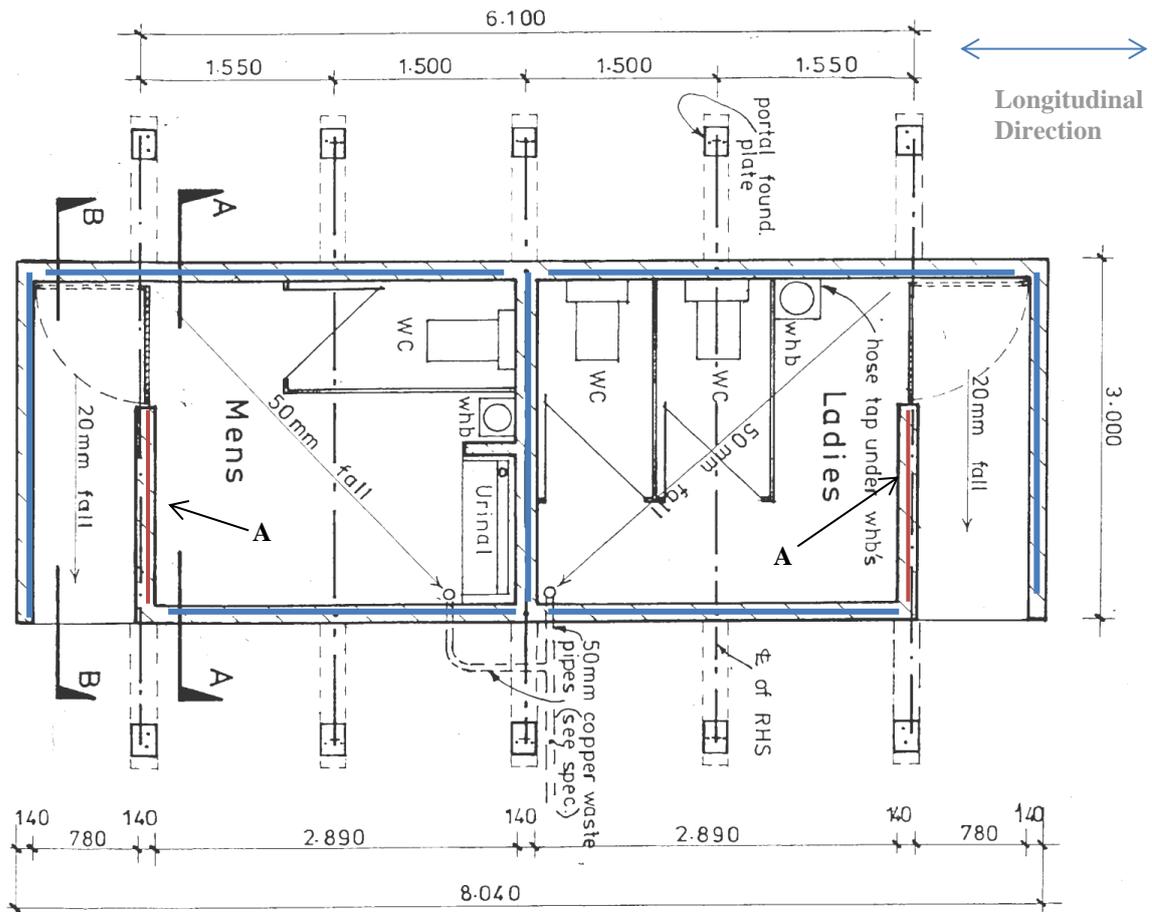
Figure 6 Plan showing wall panels as considered.

The critical loading condition for concrete masonry panels in this structure is lateral loading perpendicular to the wall panels. The critical load condition for Wall A is lateral loads in the longitudinal direction. Both loading directions are considered critical for RHS (Rectangular Hollow Sections).

All structural elements except Wall A has been found to have a %NBS greater than 100%. Wall A, the two gable walls, were found to have a %NBS of 52%. The wall is unrestrained along the top and one vertical edge, requiring the wall to cantilever from the foundations beneath. The out-of-plane moment and shear capacity of the wall was found to be greater than 100% in this condition, however the reinforced concrete strip footing could not provide adequate restraint. The strip footing was found to fail in torsion with a %NBS of 52%.

Currently the two concrete masonry gable walls are failing with a %NBS of 52%. Design concepts may be considered to strengthen these walls to 100% NBS.

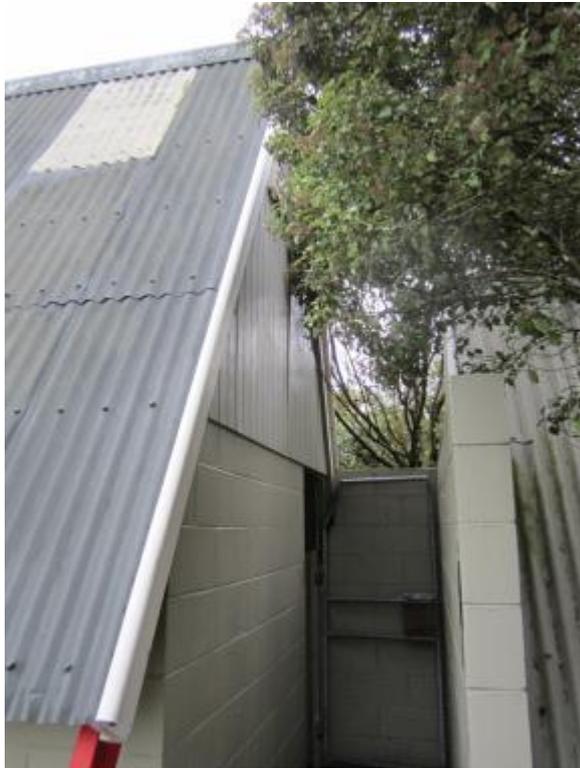
Photo 2. Gable and entrance wing walls.

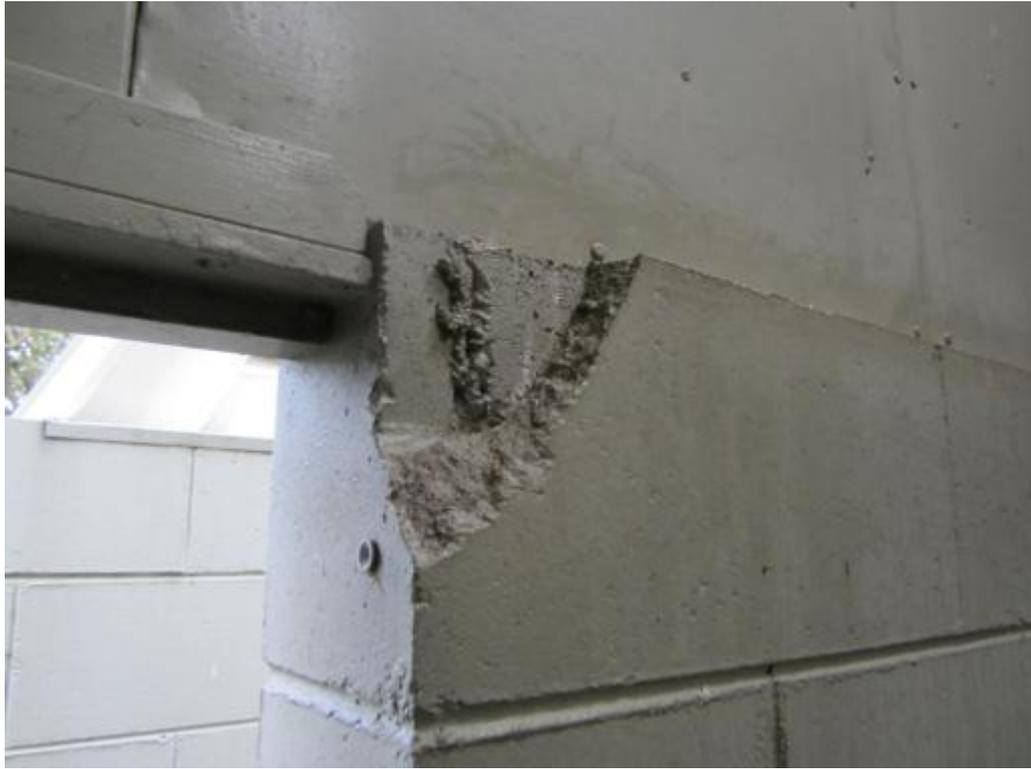
Photo 3. Broken block corner exposing concrete of bond beam within.

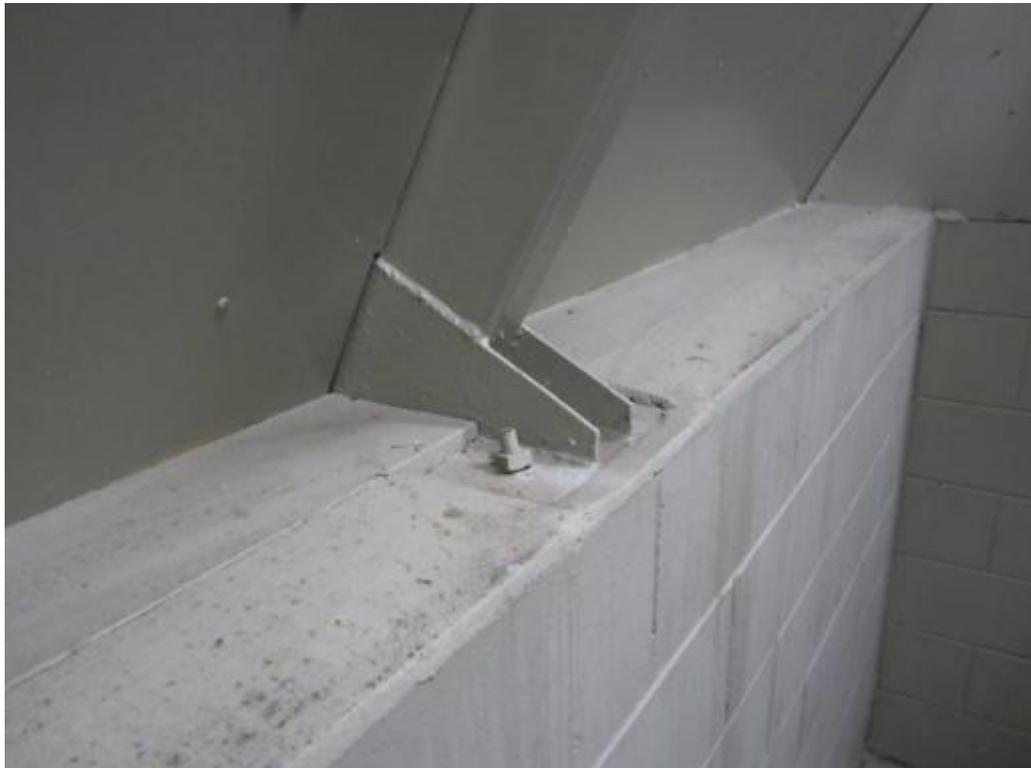
Photo 4. A-frame connection to bond beam.

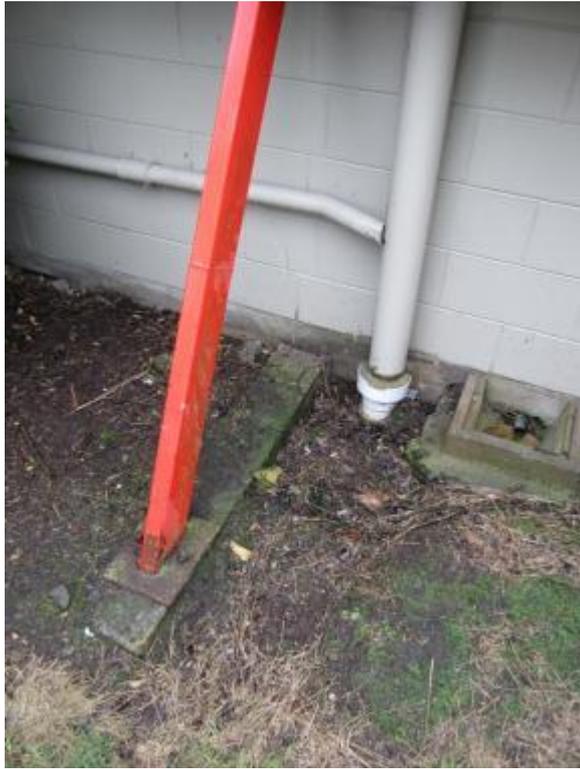
Photo 5. A-frame RHS supported on tip of ground beam.

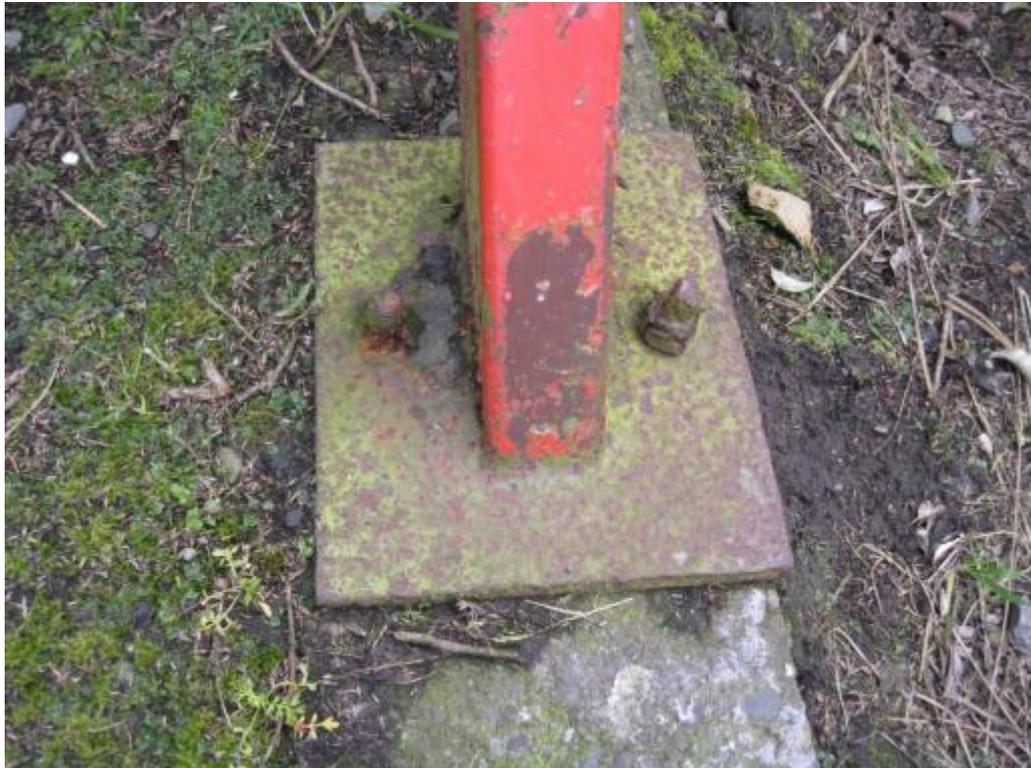
There were no settlement or damage issues identified during the inspection of the Marshland reserve toilets. The baseplate bolts of the A-frame have suffered substantial corrosion at some locations. These bolts have been assumed to provide adequate support to resist seismic demand.

Photo 6. Excessive corrosion of base-plate bolts.

Bolts suffering from excessive corrosion should be replaced as best practice.

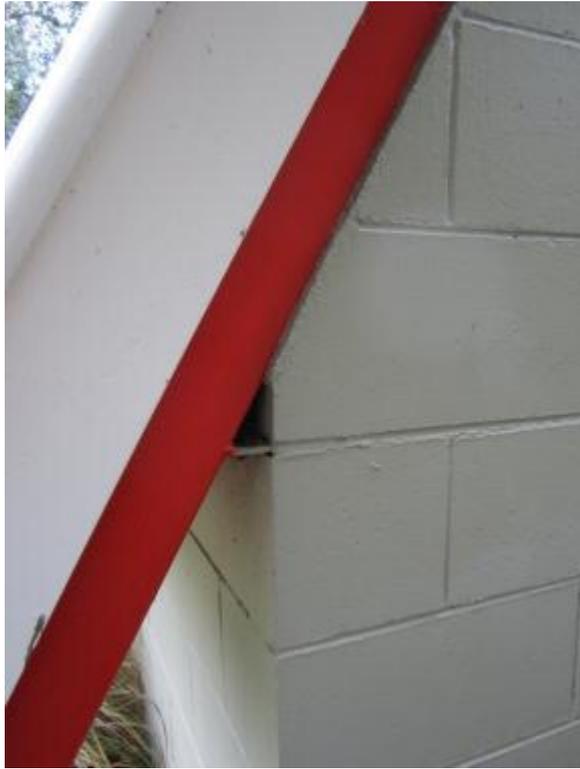
Photo 7. RHS framing gable wall at corner of building.
