Christchurch City Council

Martindales Road Housing Complex PRO 1731

**Detailed Engineering Evaluation
Quantitative Assessment Report**

Date: March 2014
Reference: 6-QC377.00
Status: Final

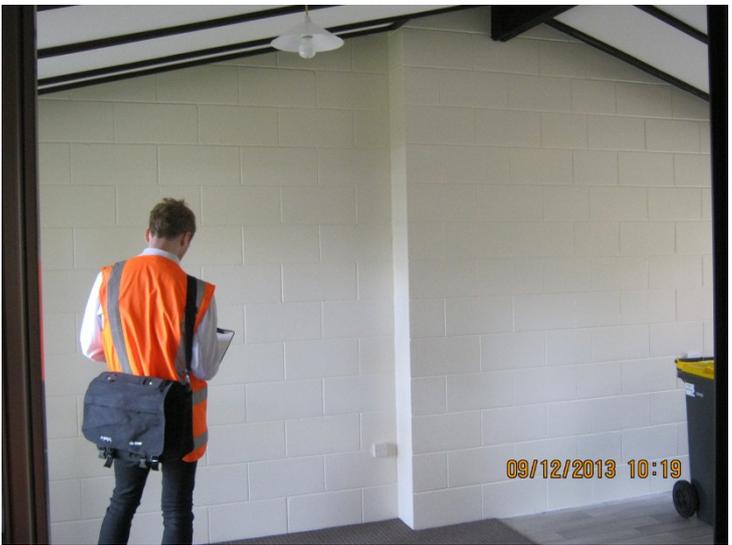
10.	Offset firewall in Blocks C and D

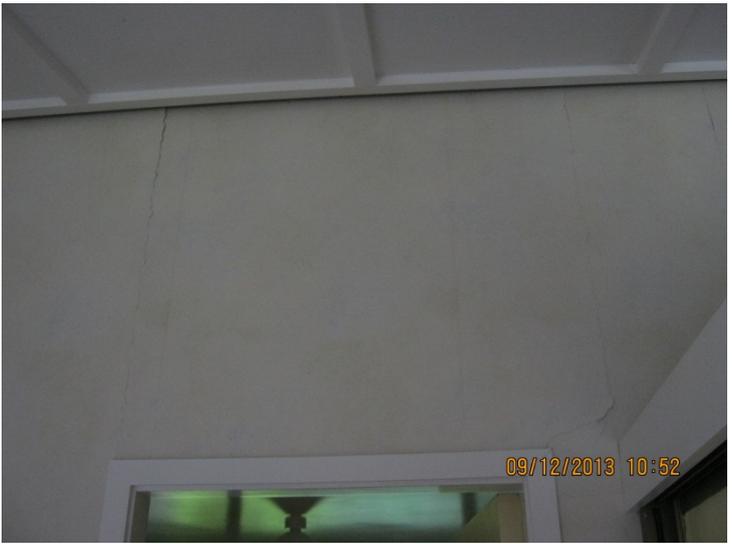
Minor plasterboard cracking was observed, typically above doorways and window frames. Slight splitting was observed between the block work and the weatherboard veneer. Minor cracking in the concrete retaining walls on site was observed.

11.	Typical cracking above doorways

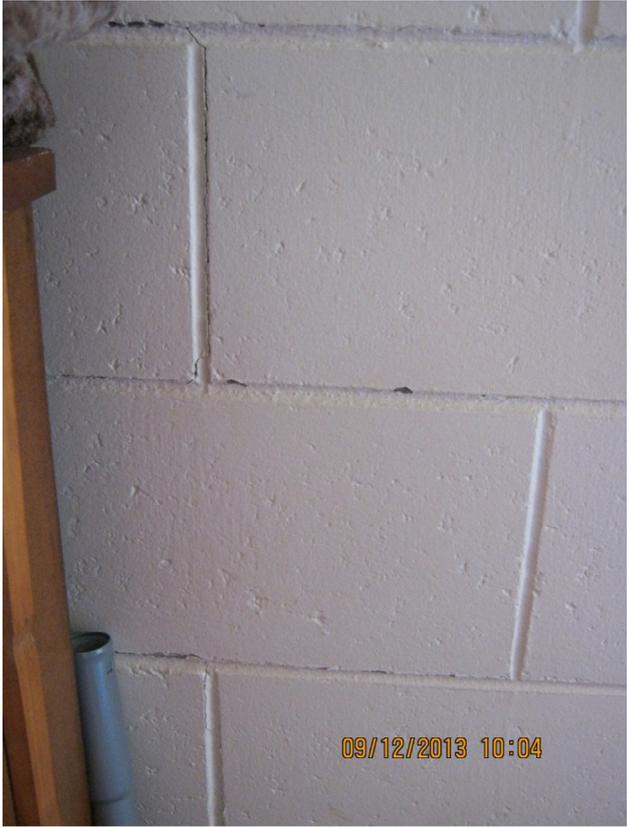
Hairline cracking was observed in the concrete block work in all units. This damage is deemed minor and not to affect the gravity structure.

<p>12.</p>	<p>Typical cracking of the block work (interior)</p>

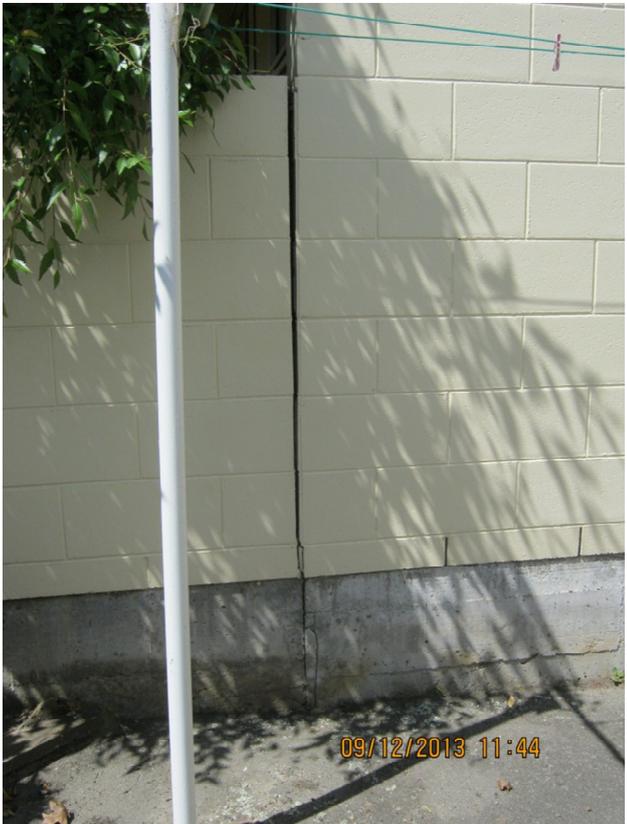
<p>13.</p>	<p>Splitting of exterior garden walls (due to tilt of garden wall) and unit blockwork</p>

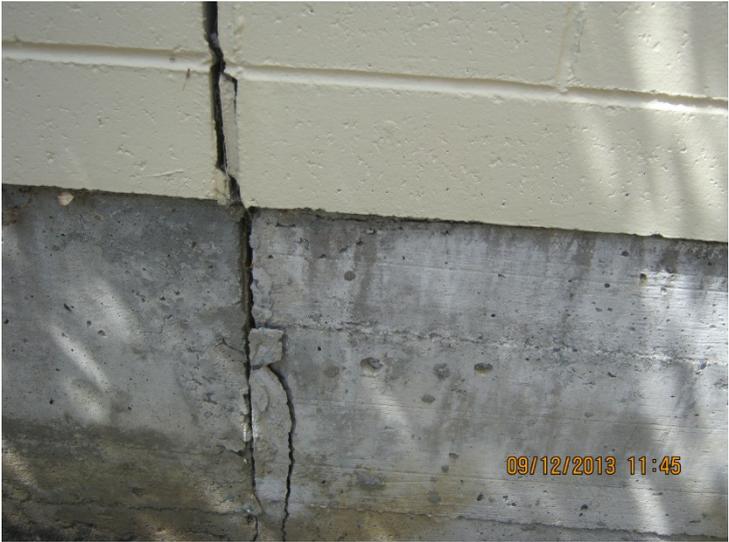
Minor hairline cracking was observed in the foundation of Block B (photo 15). Spalling of the concrete foundation was observed in the corner of Block E (photo 14), this has been caused by tilting of the footing of the concrete block 'garden' wall. This damage is deemed to not affect the structural performance of the foundation.

14.	Spilt in footing between garden wall and units (Block E) causing spalling for foundation of unit.

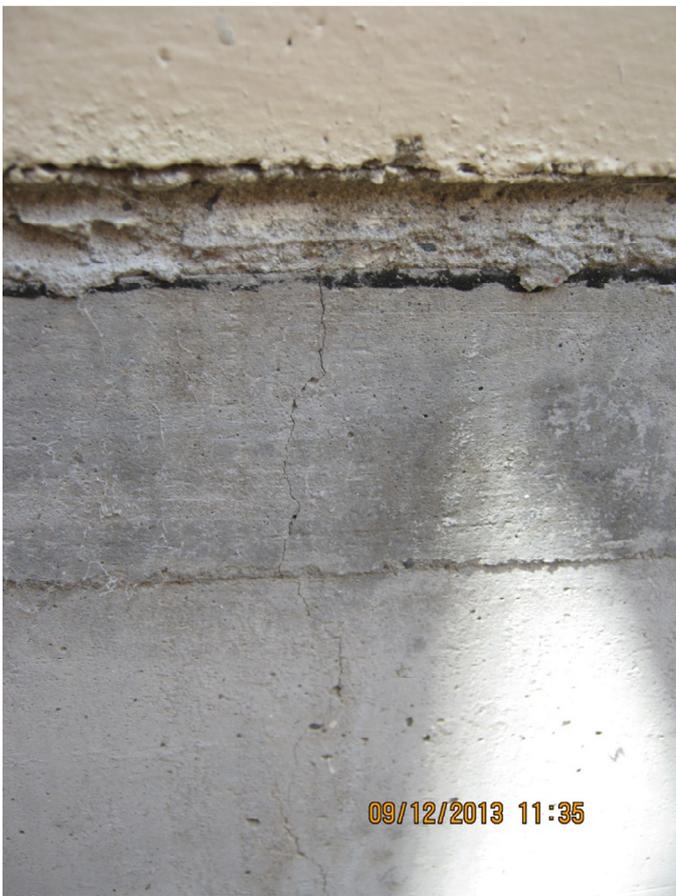
15.	Cracking in foundation (Block B)
