Christchurch City Council
PRK_1419_BLDG_002 EQ2
Pavilion/Toilet - McCormacks Bay
3 McCormacks Bay Rd

QUANTITATIVE REPORT
FINAL

- Rev C
- 08 March 2013

QUANTITATIVE ASSESSMENT REPORT

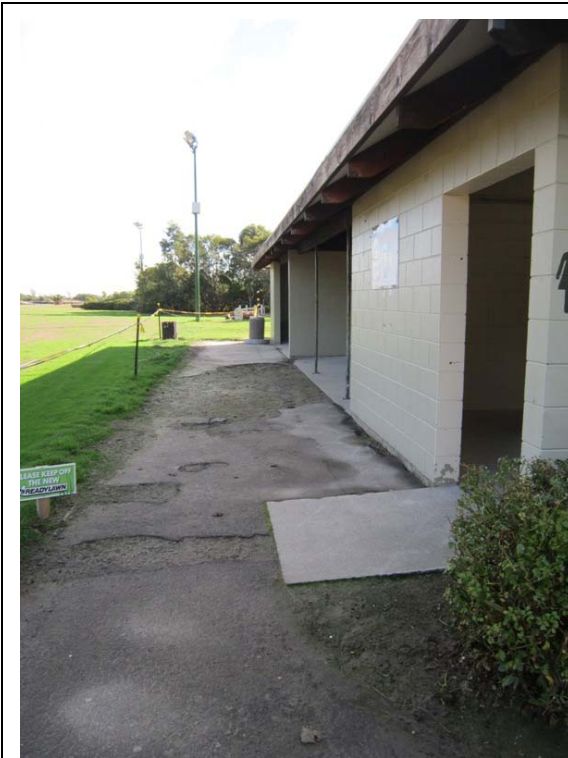
Photo 5: Ground in front of the south wall.

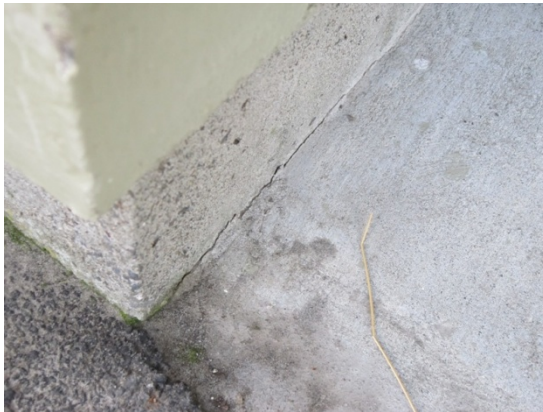
Photo 9: Crack between concrete strip footing and concrete ground slab.

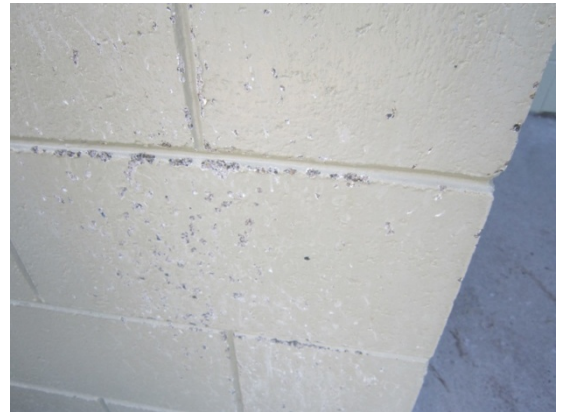
- 6) Gap opening up between the timber doorframe in the centre of the south wall and the masonry wall.
- 7) Paint damage was noted on the south wall, but this is not earthquake-related damage.
- 8) Liquefaction was noted around the building.

Photo 10: Paint removal on south wall.

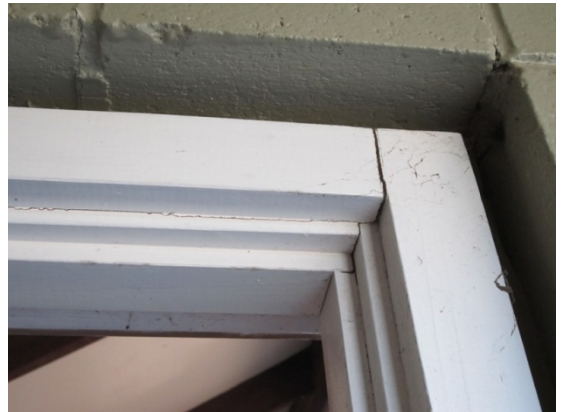
- 1) Step cracking along mortar joints on the south and west walls.
- 2) Vertical crack along mortar joint between perpendicular walls on the south side.
- 3) Hairline cracks in masonry blocks on the south and west walls.
- 4) Crack between concrete footing under masonry wall and concrete ground slab on south side.
- 5) Gaps opening up between timber elements in the southeast doorframe

Photo 14: Gaps opening up between timber elements on the changing room doorframe.

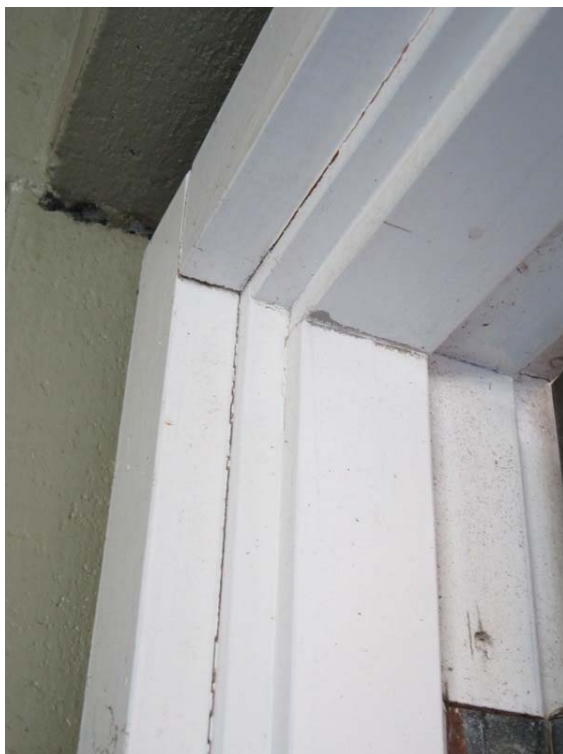
Photo 15: Gaps opening up between timber elements on the changing room doorframe.

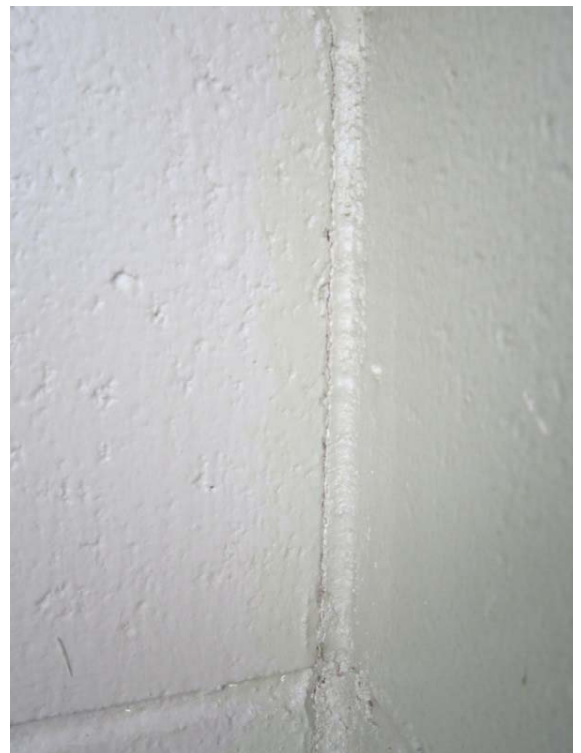
Photo 20: Crack in mortar joint at intersection of perpendicular walls on the south side.

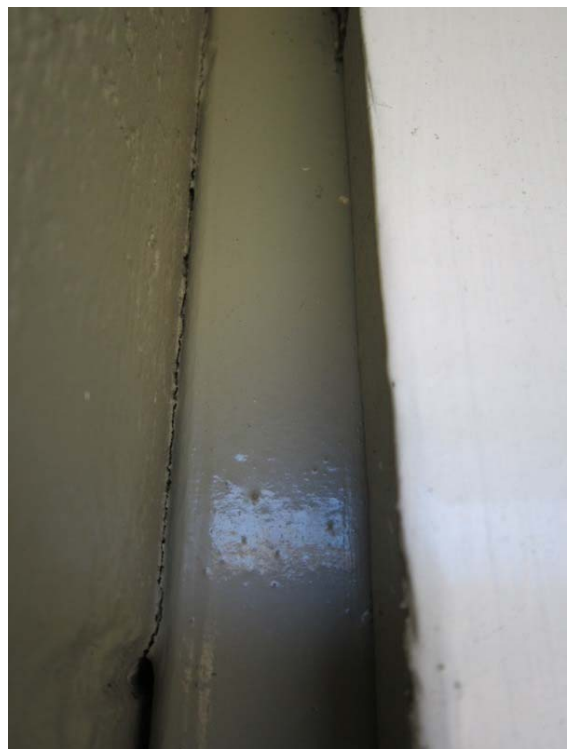
Photo 23: Gaps opening up between timber elements in the doorframe and the masonry wall on the south side

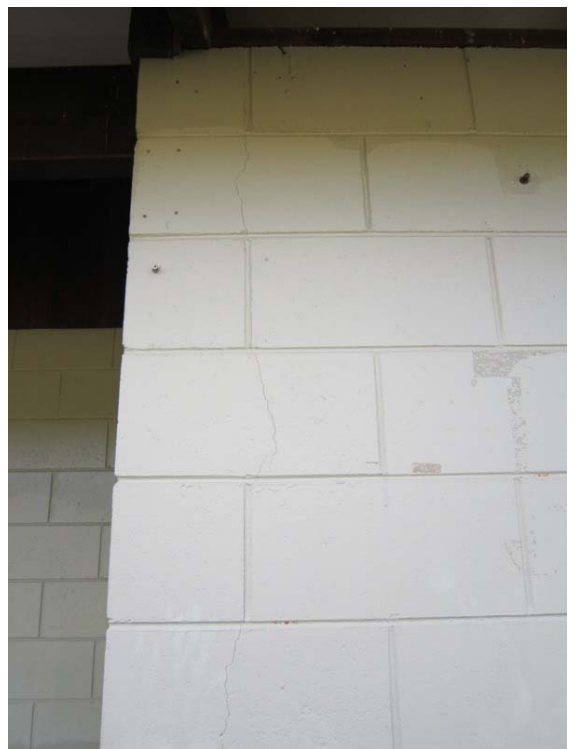
Photo 24: Cracking through masonry elements and mortar joints on the south side.

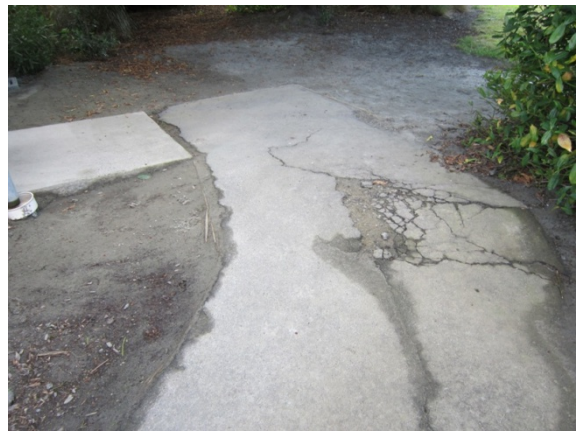
Photo 38: Cracking in footpath on the east side of the building.

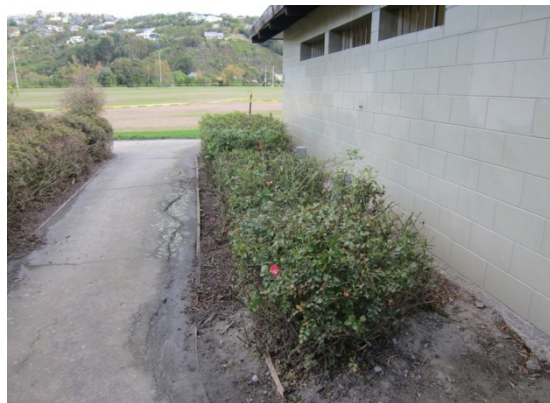
Photo 39: Cracking in footpath on the east side of the building.

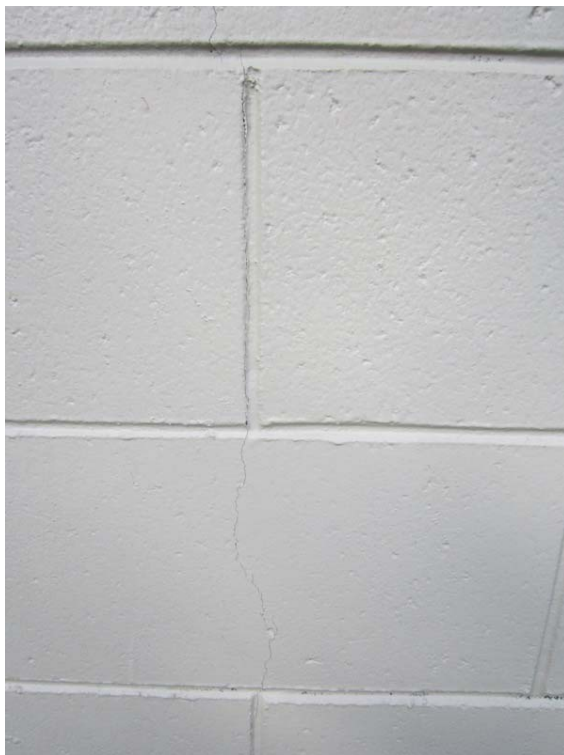
Photo 43: Crack through masonry elements and mortar joints on the west wall.

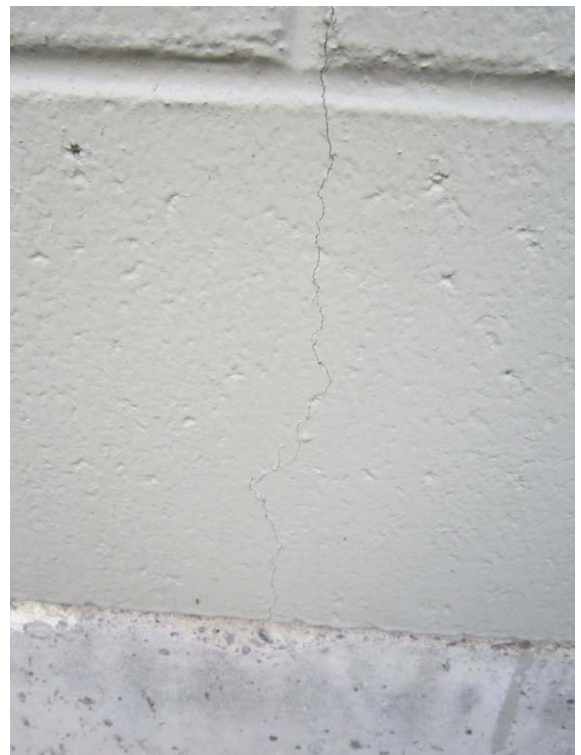
Photo 44: Crack through masonry elements and mortar joints on the west wall.

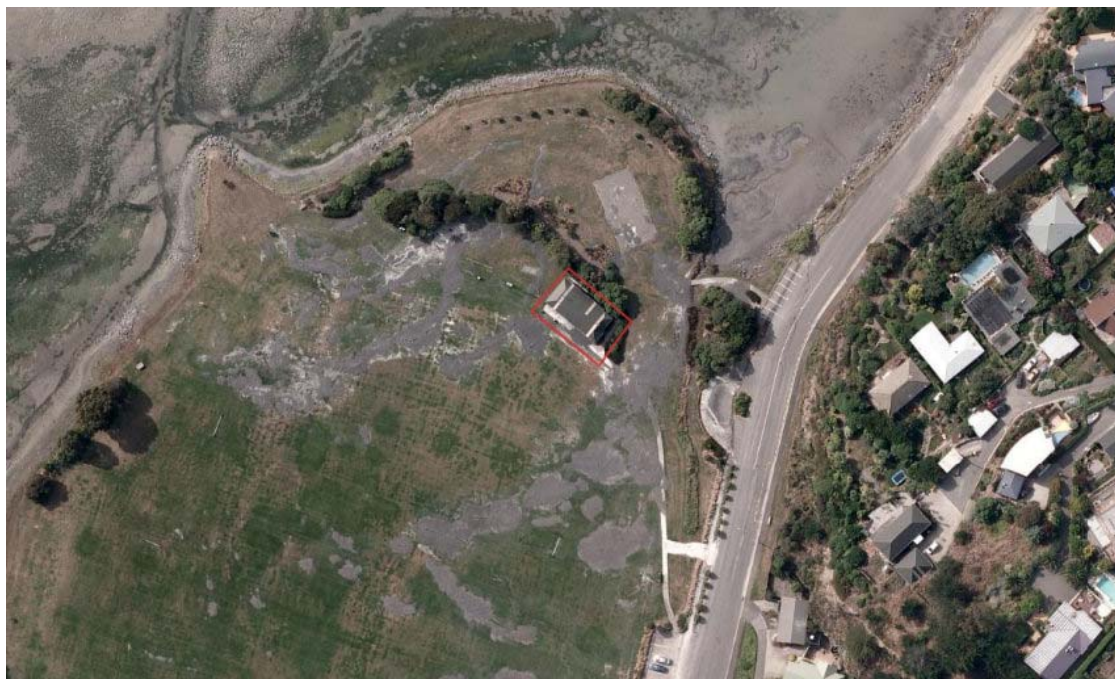
- **Figure 4 – Aerial photography from 24 Feb 2011 (<http://viewers.geospatial.govt.nz/>)**

Aerial photography shows significant liquefaction after the 22 Feb 2011 event.
