Memorial Park Cemetery Shed
PRK 0880-BLDG-002 EQ2
Detailed Engineering Evaluation
Qualitative Report
Version FINAL

31 Ruru Road
Bromley

Christchurch City Council

Date
14 March 2013

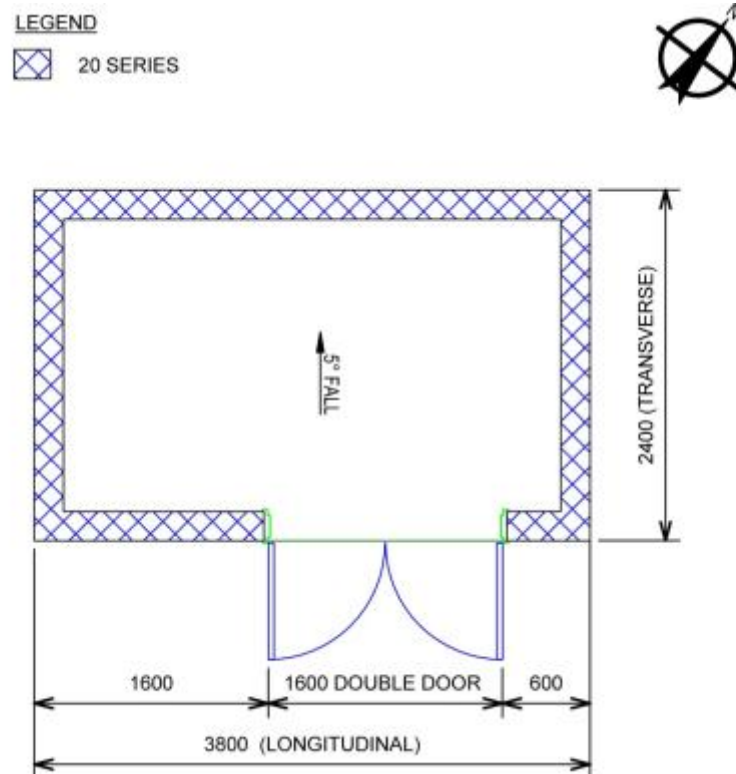
Figure 2 Plan Sketch Showing Key Structural Elements

The building is approximately 3.8m long, 2.4m wide and 2.6m in height. The overall footprint of the building is approximately 9.12m². A sketch of the key structural elements are shown in Figure 2.

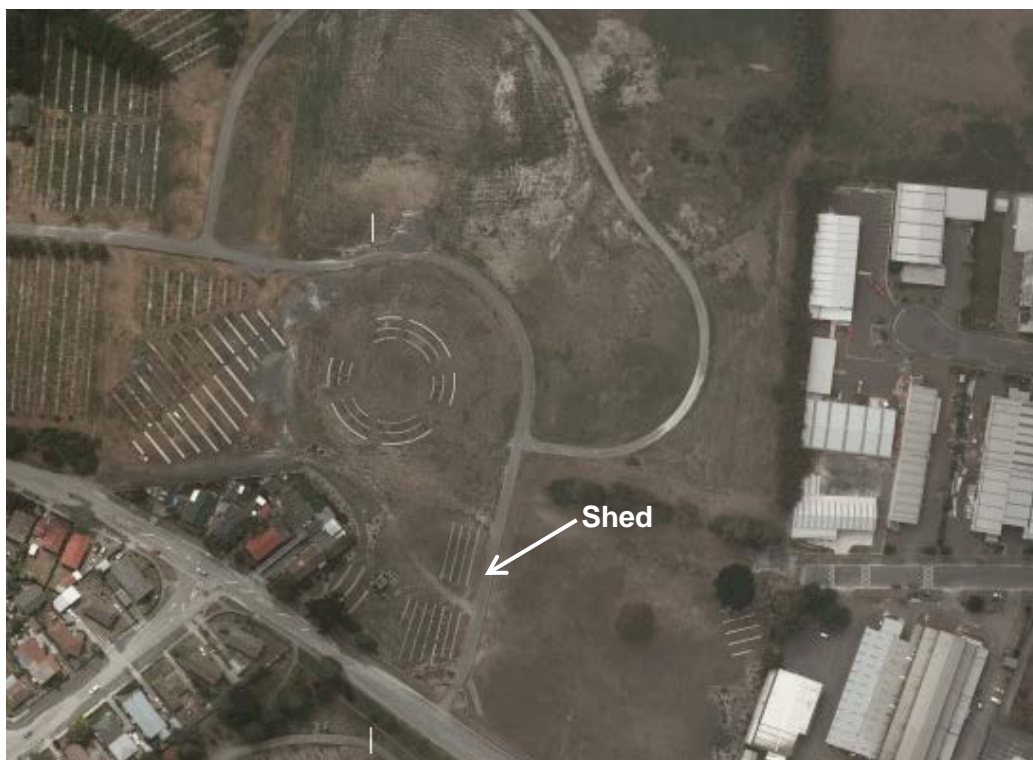
Figure 3 Post February 2011 Earthquake Aerial Photography³

Aerial photography taken following the 22 February 2011 earthquake shows signs of liquefaction close to the site, as shown in Figure 3.

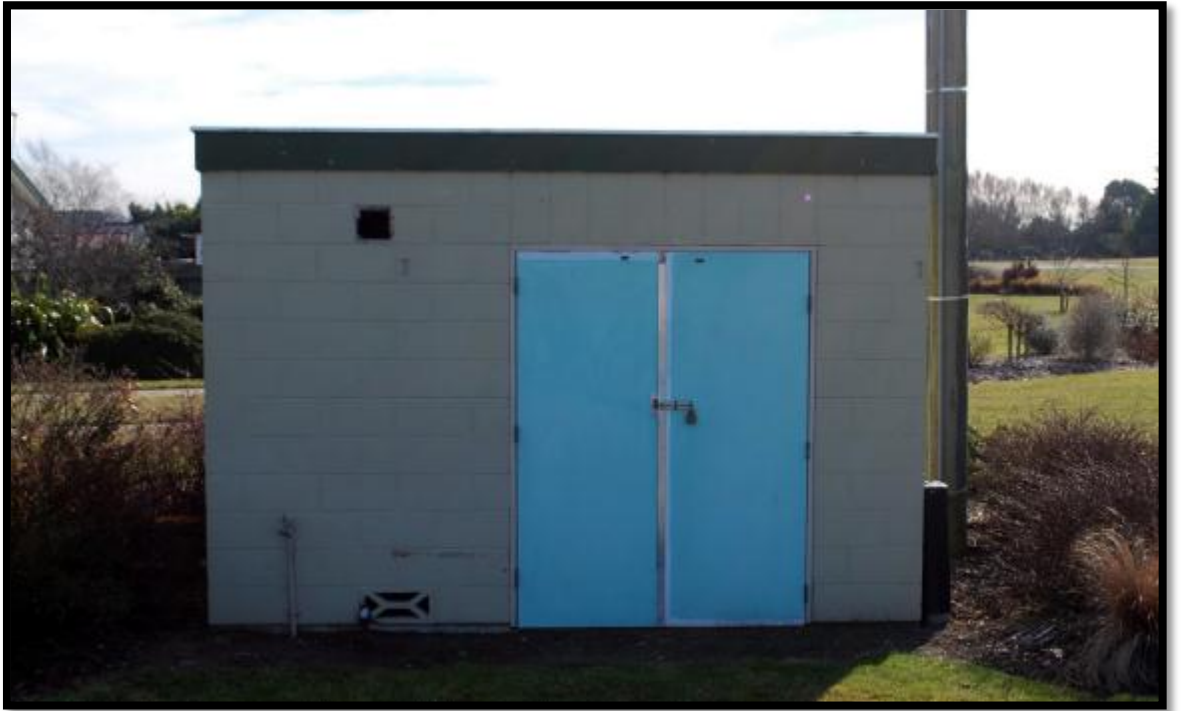
Photograph 1 Southeast front elevation.

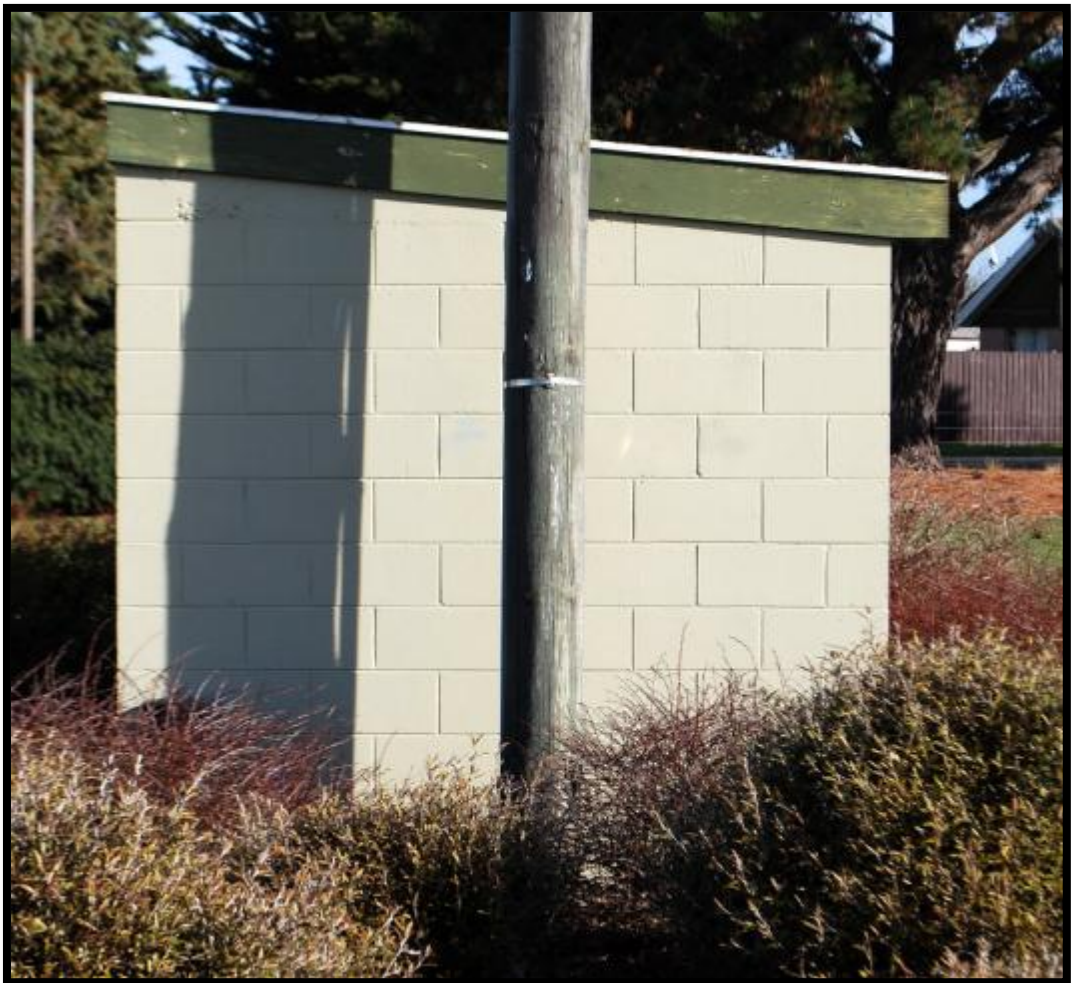
Photograph 2 Northeast side elevation.

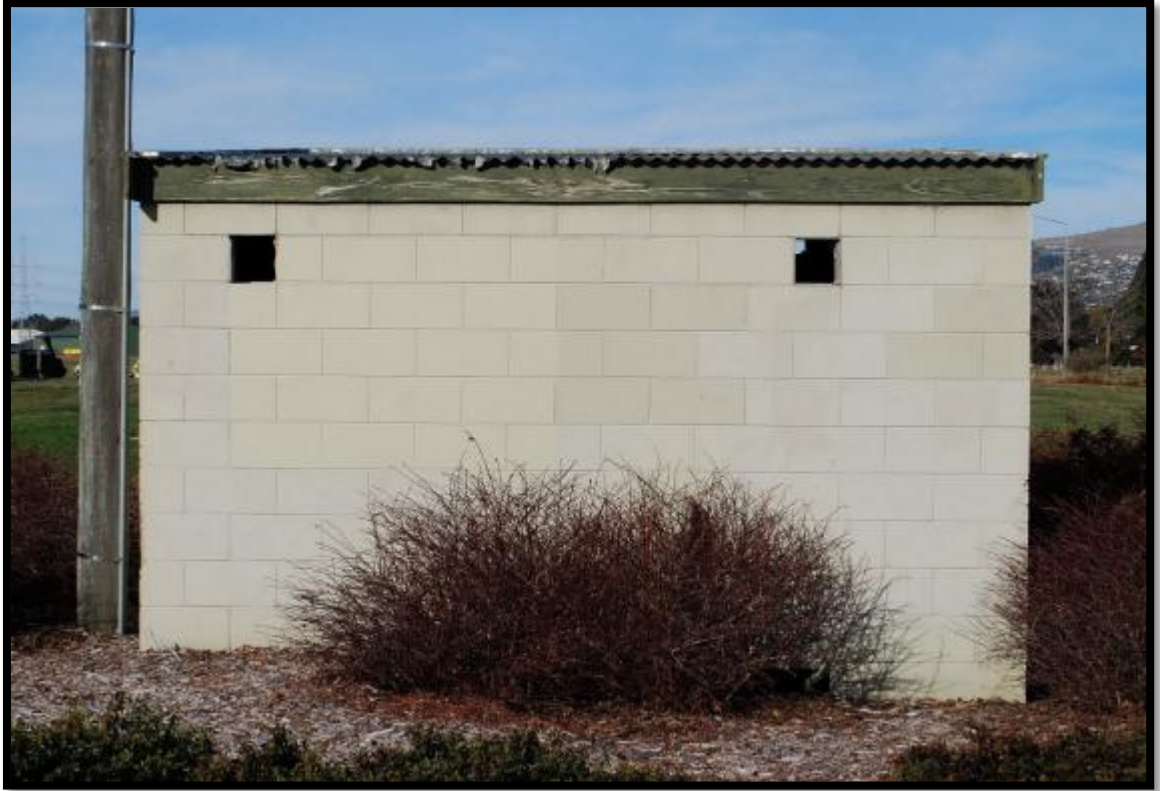
Photograph 3 Northwest rear elevation.

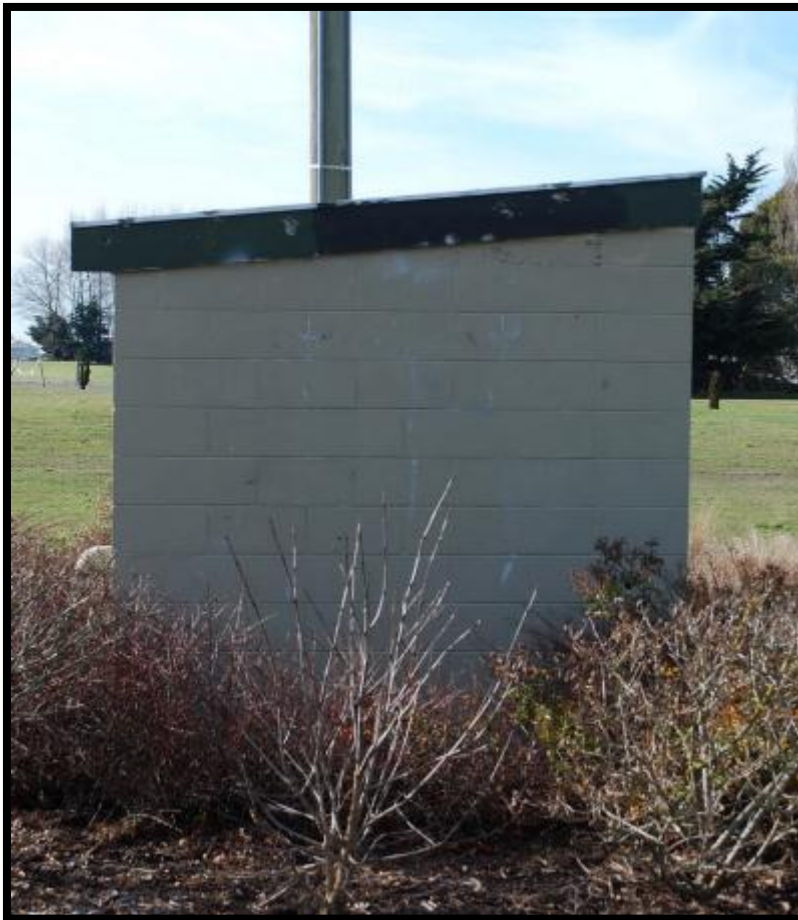
Photograph 4 Southwest side elevation.

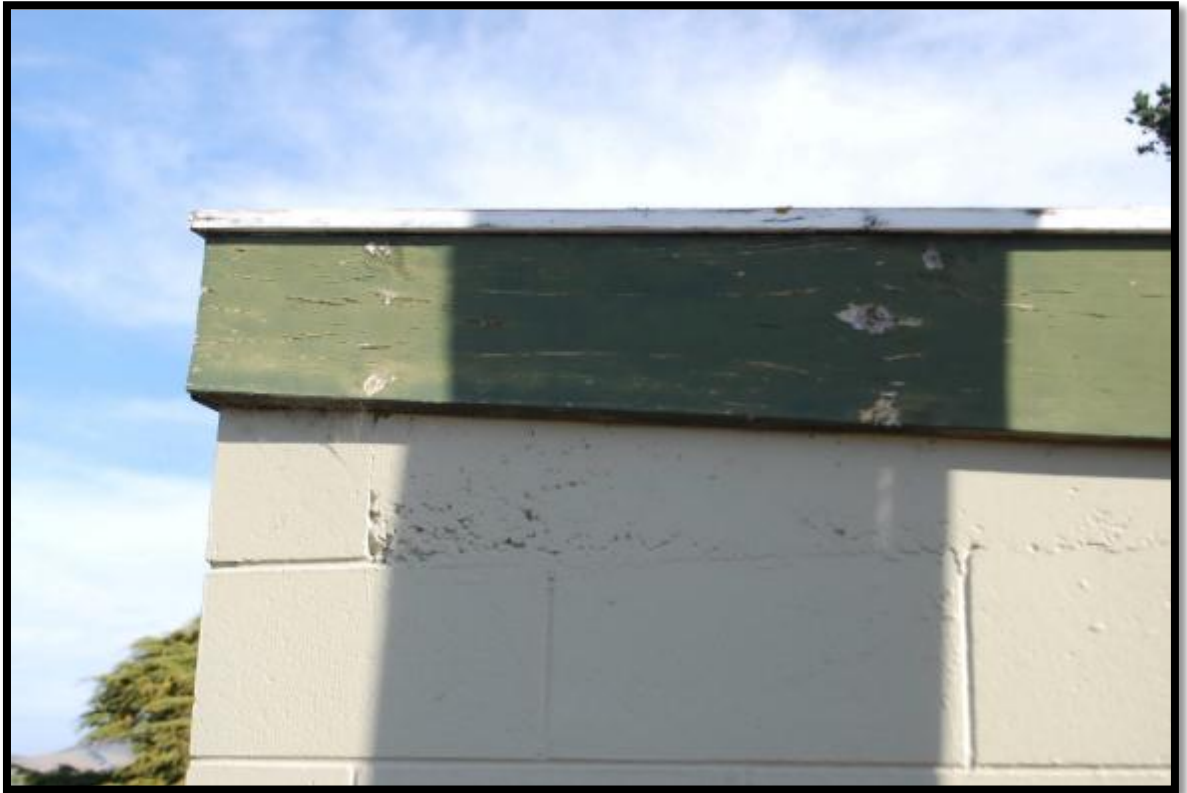
Photograph 5 Roof detail showing block work with in-situ cement.

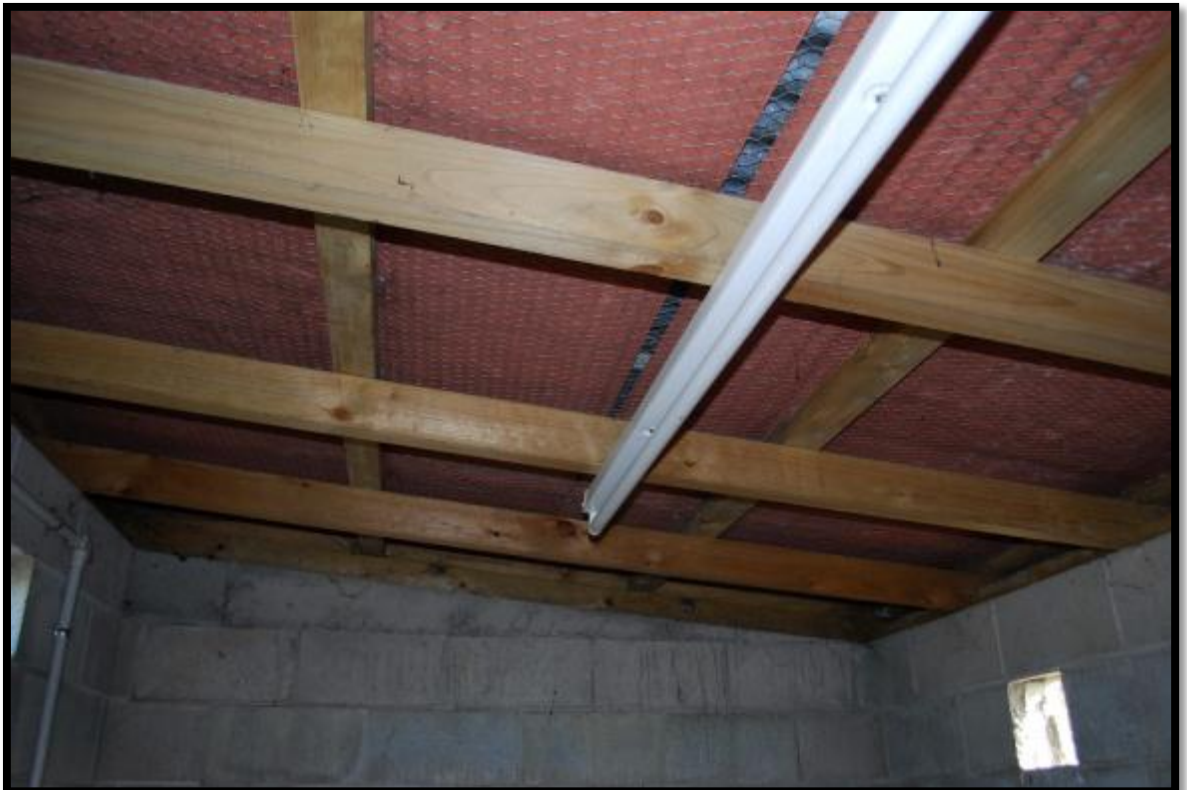
Photograph 6 Timber roof structure.

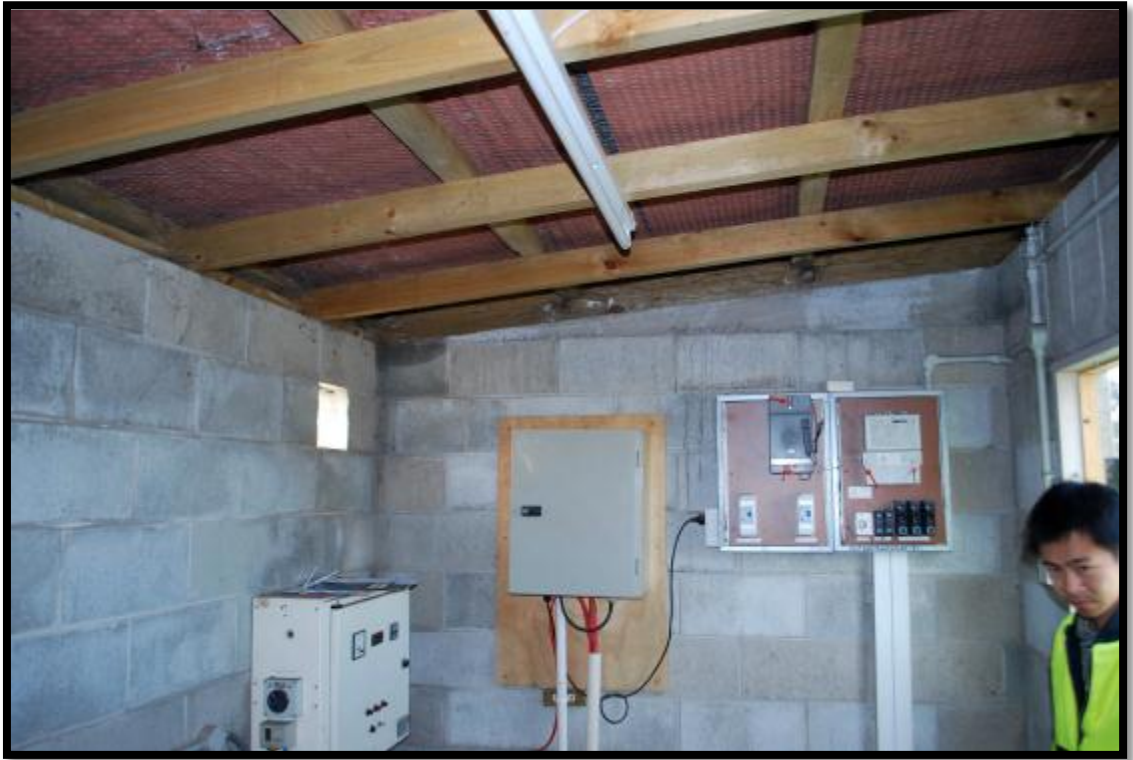
Photograph 7 Timber roof structure.

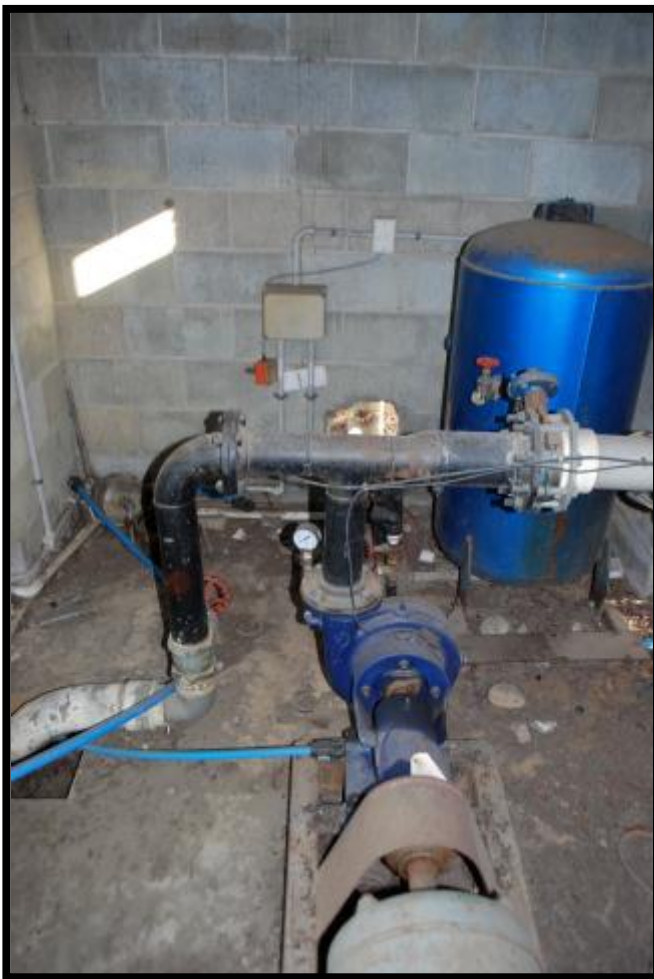
Photograph 8 Slab on grade.
