Christchurch City Council

**Middleton Park Toilet and
Changing Shed
PRK 0478 BLDG 001 EQ2**

Detailed Engineering Evaluation

Quantitative Assessment Report

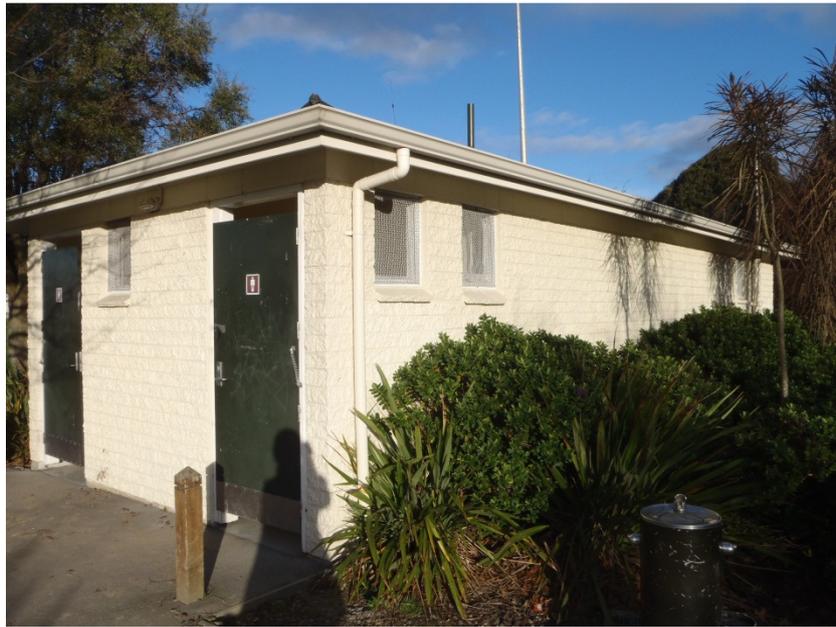
Photo 1: View of the front of the building

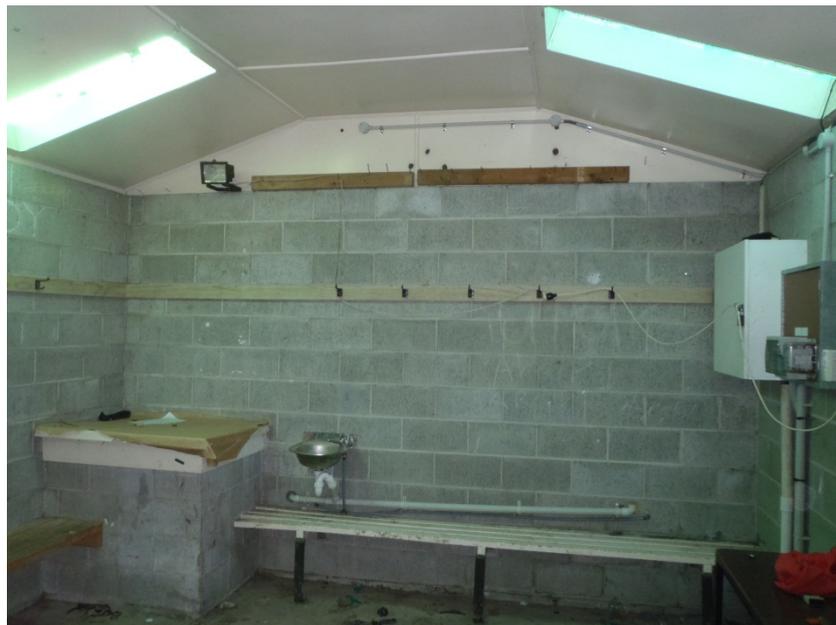
Photo 2: View of changing room

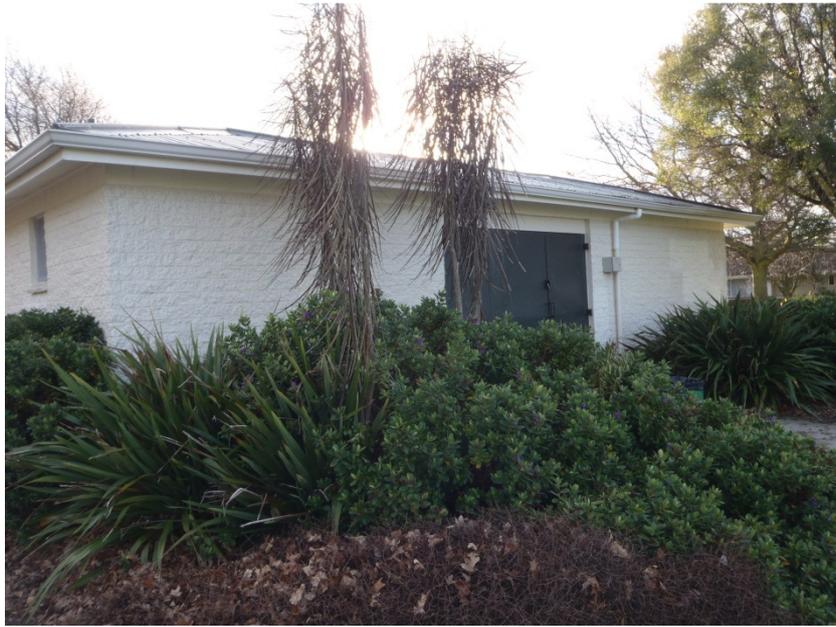
Photo 3: View of the rear of the building
