# City Care Milton Street Depot – Store No.3 Detailed Engineering Evaluation BU 1141-012 EQ2 Quantitative Report

**Prepared for Christchurch City Council (Client)**

**By Beca Carter Hollings & Ferner Ltd (Beca)**

30 January 2013

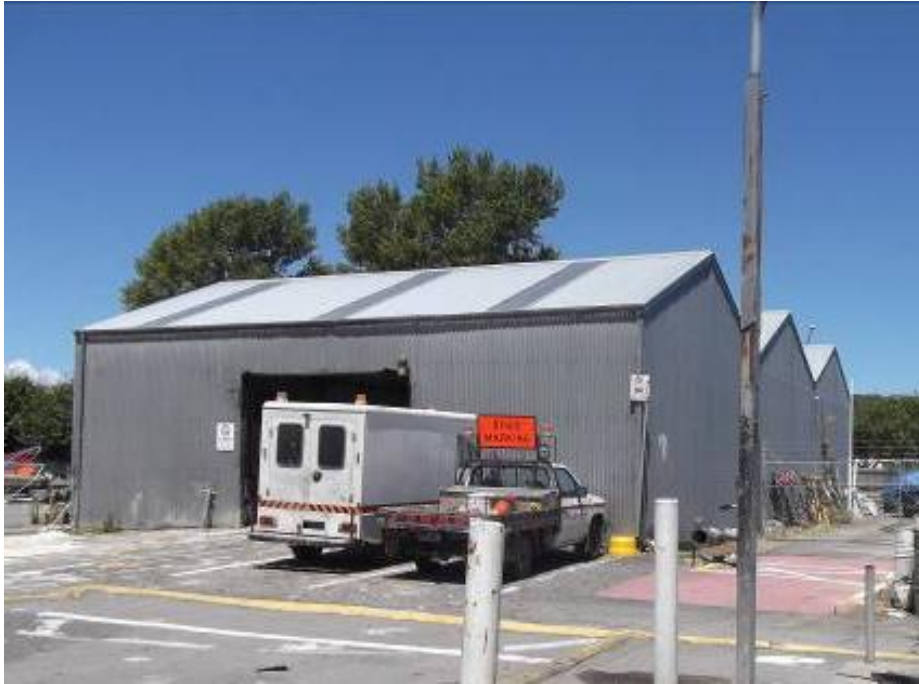
**Photo 1:** Exterior view

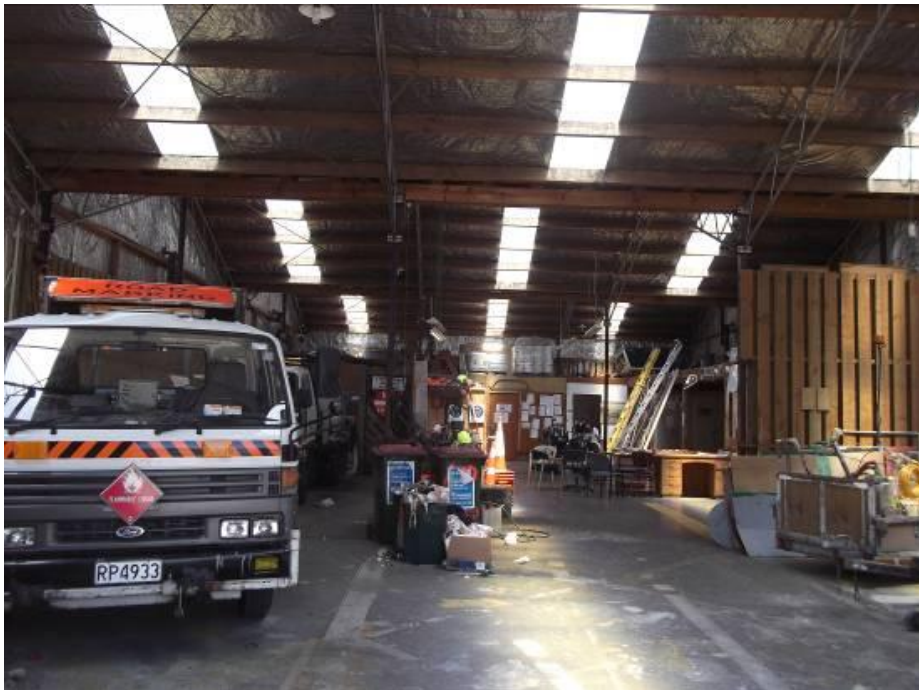
**Photo 2:** Interior view

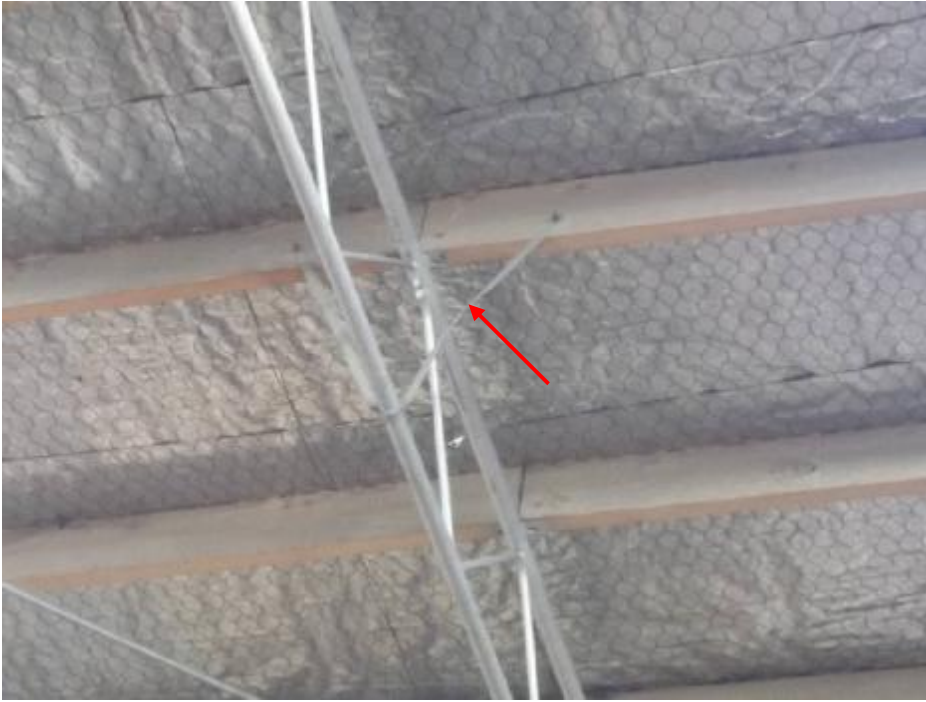
- Damaged fly braces at the southern end of the building, however these do not appear to be due to the earthquakes.

**Photo 4:** Damaged fly brace

**Damage Description:** Damaged fly brace at the southern end of the building

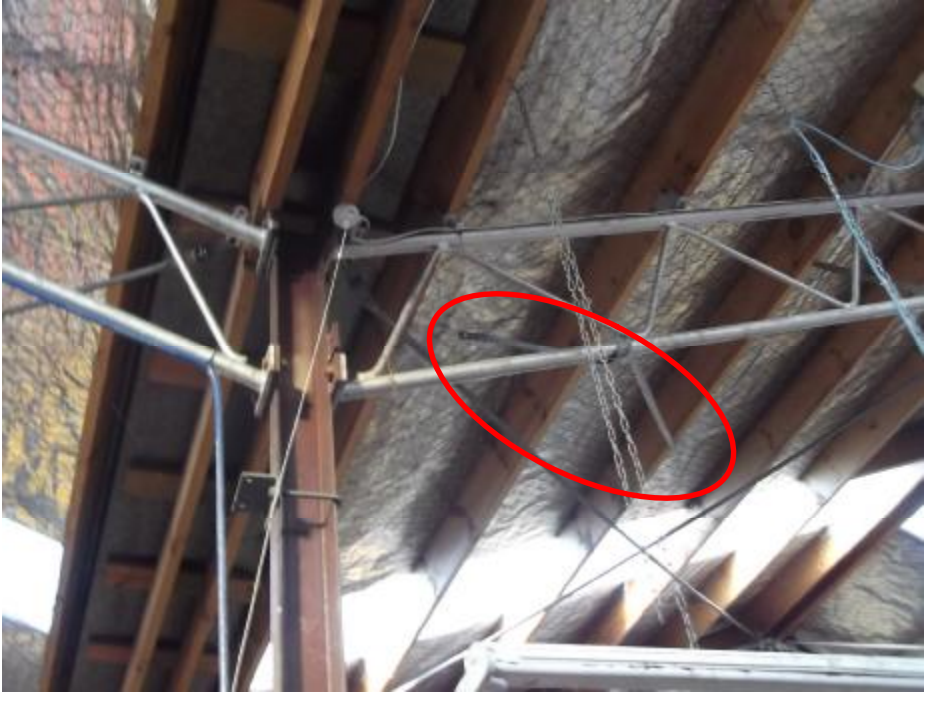
**Photo 5:** Damaged fly brace

**Damage Description:** Damaged fly brace at the southern end of the building

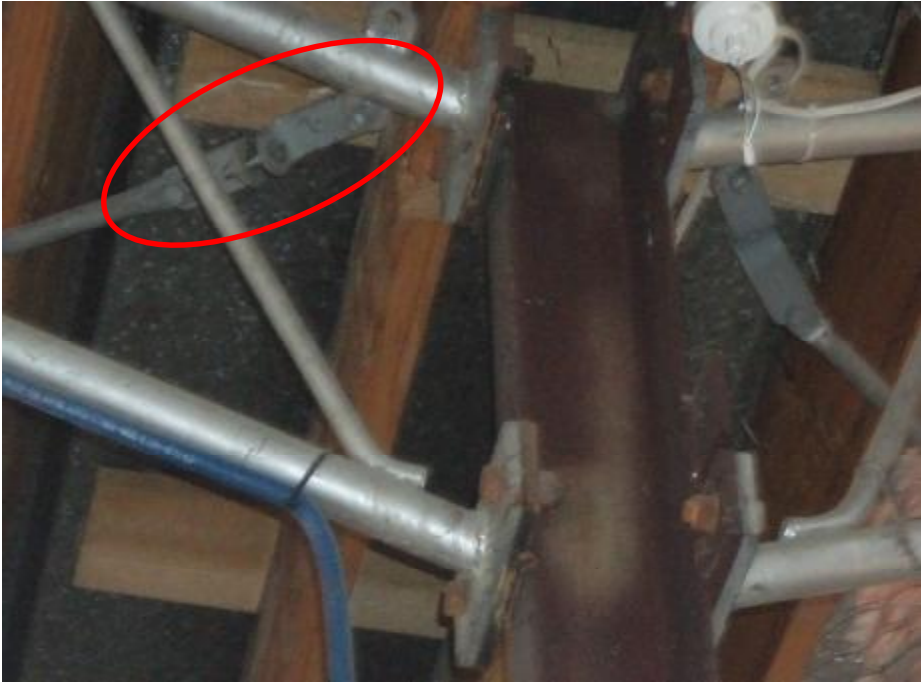
- Inadequate capacity of the roof bracing connections (6%NBS)
- Compression buckling of the timber strut at the vertical wall bracing (31%NBS)

**Photo 6:** Roof bracing connection
