City Care Milton Street Depot – Tyre Bay Detailed Engineering Evaluation BU 1141-011 EQ2 Quantitative Report

14 June 2013

City Care Milton Street Depot- Tyre Bay BU 1141-011 EQ2

Detailed Engineering Evaluation Quantitative Report – SUMMARY

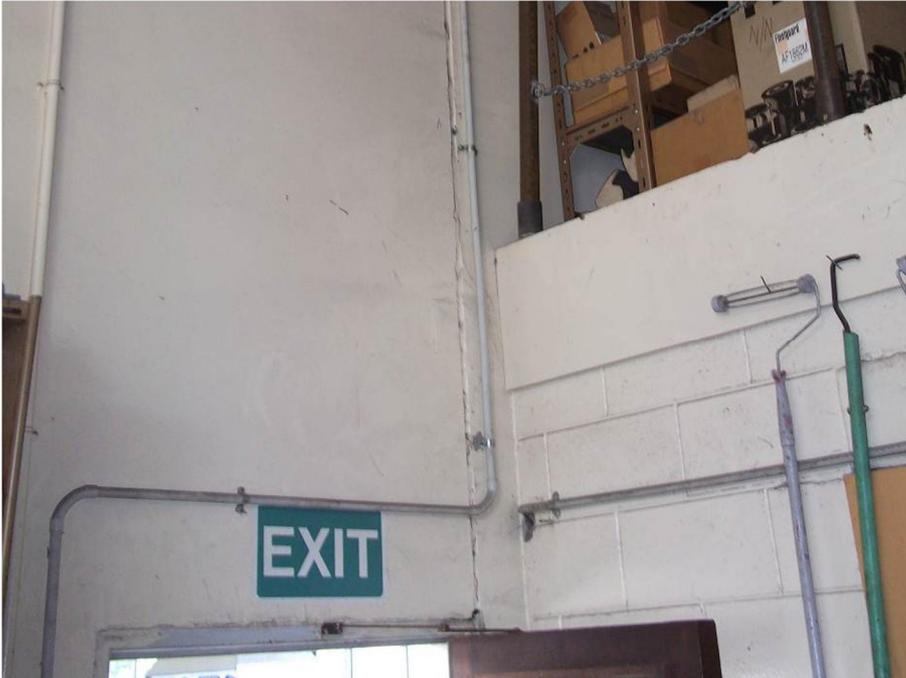
Photo 3: Typical cracking to vertical walls joints

Description of Damage: Cracking to vertical walls joints

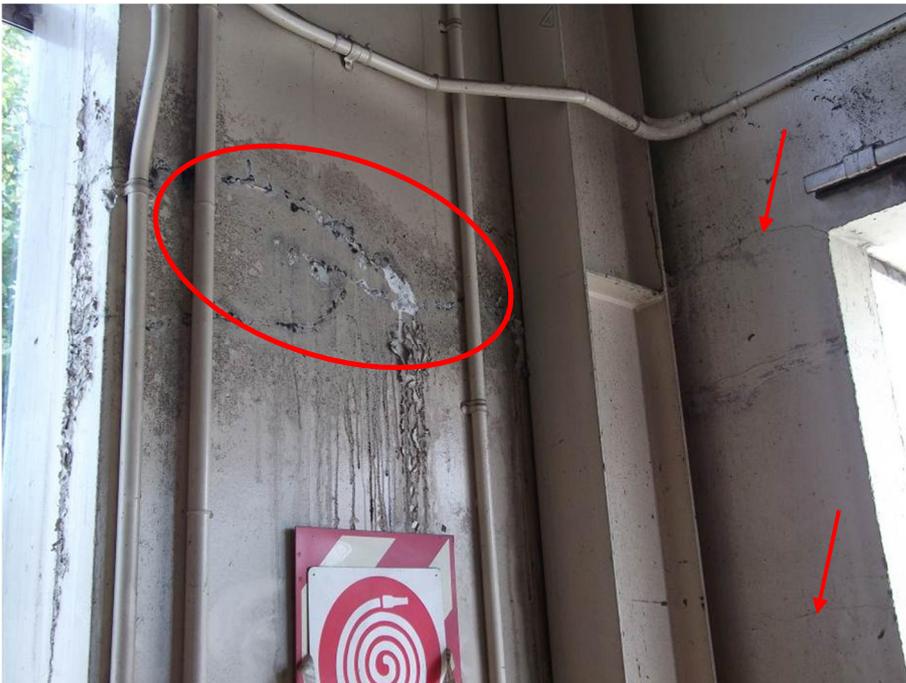
Photo 4: Cracks to concrete walls

Description of Damage: Cracking to concrete walls (some cracking may have existed prior to the earthquake and been exacerbated).

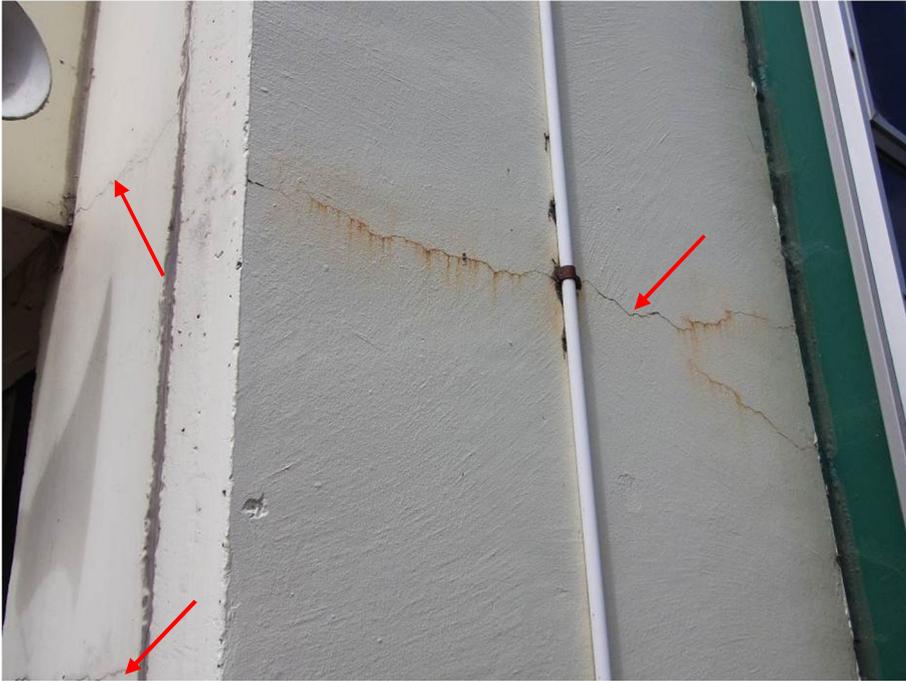
Photo 5: Typical cracking to concrete walls

Description of Damage: Cracking to concrete walls.

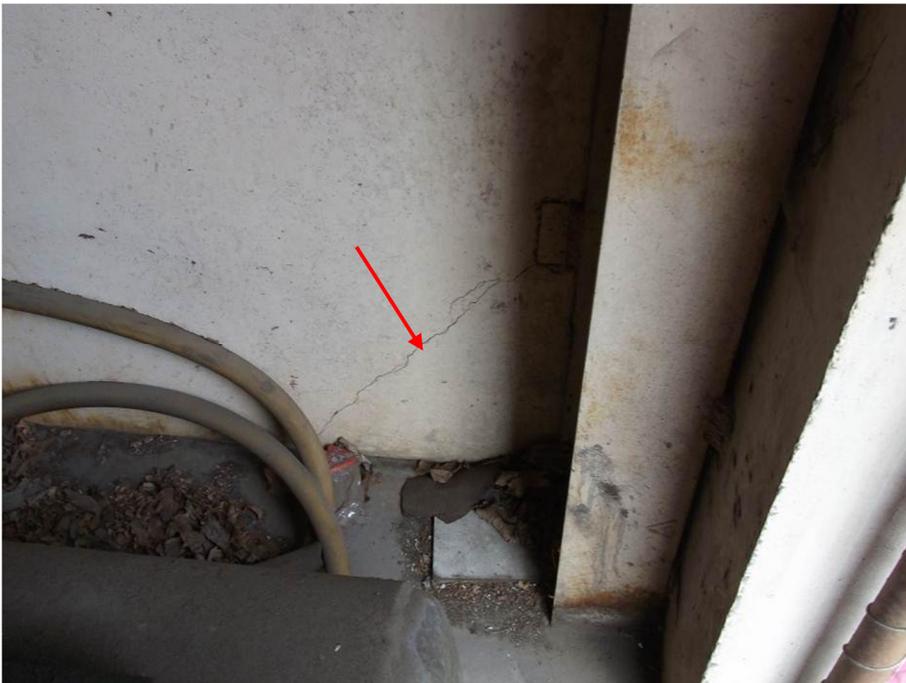
Photo 6: Typical cracking to concrete walls

Description of Damage: Shear cracking to concrete walls

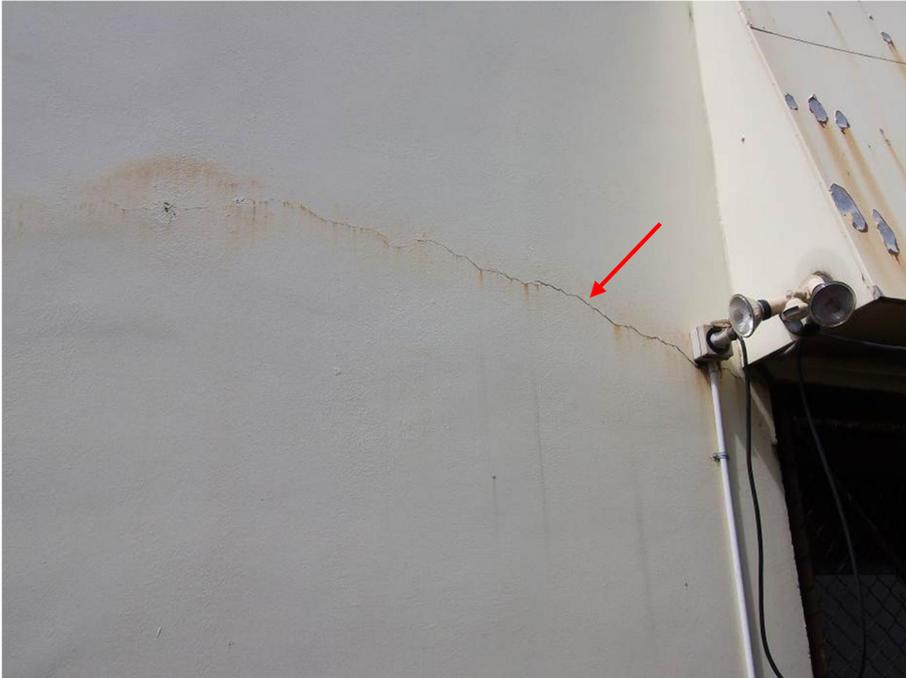
Photo 7: Typical cracking to concrete shear walls

Description of Damage: Cracking to concrete walls

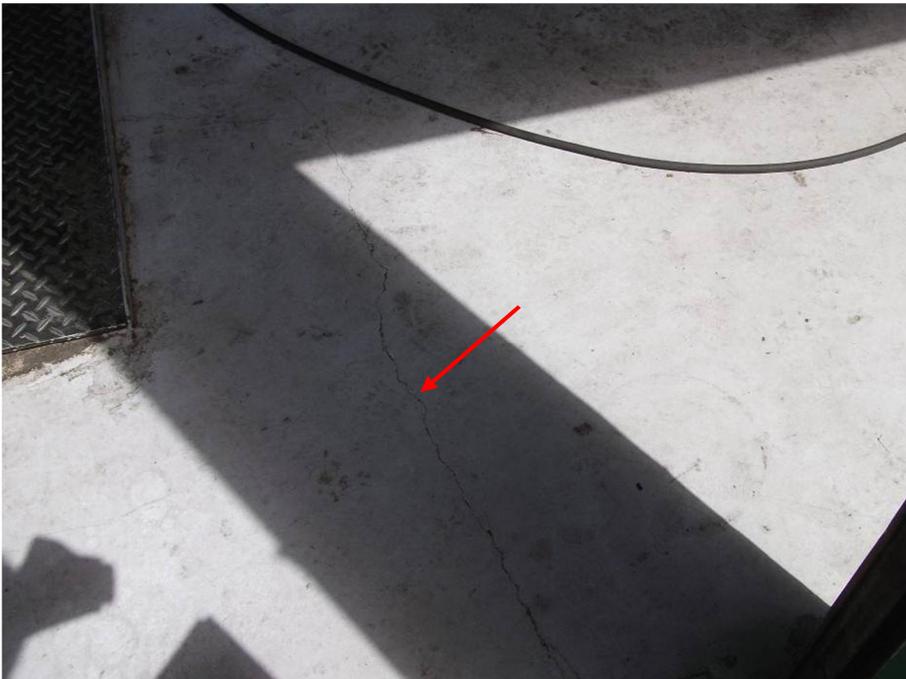
Photo 8: Typical cracking to concrete slab

Description of Damage: Cracking to concrete slab
