# City Care Milton Street Depot – Works Operation Administration Detailed Engineering Evaluation BU 1141-003 EQ2 Quantitative Report

**Prepared for Christchurch City Council (Client)**

**By Beca Carter Hollings & Ferner Ltd (Beca)**

3 July 2013

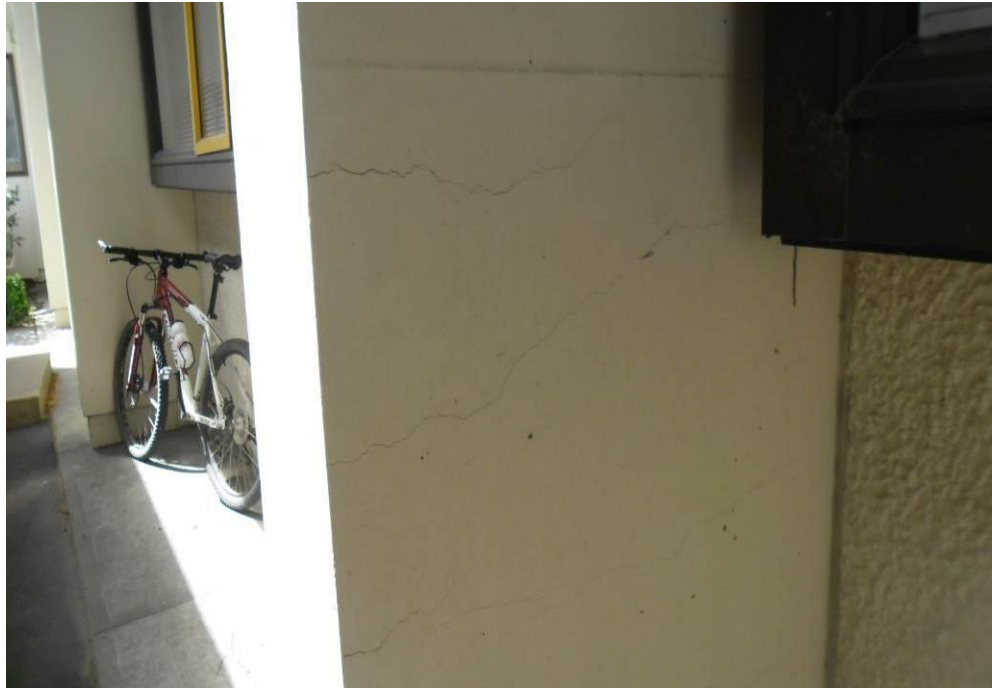
**Photo 1:** Typical crack to perimeter concrete column

**Damage description:** Cracking to concrete column with various crack width.

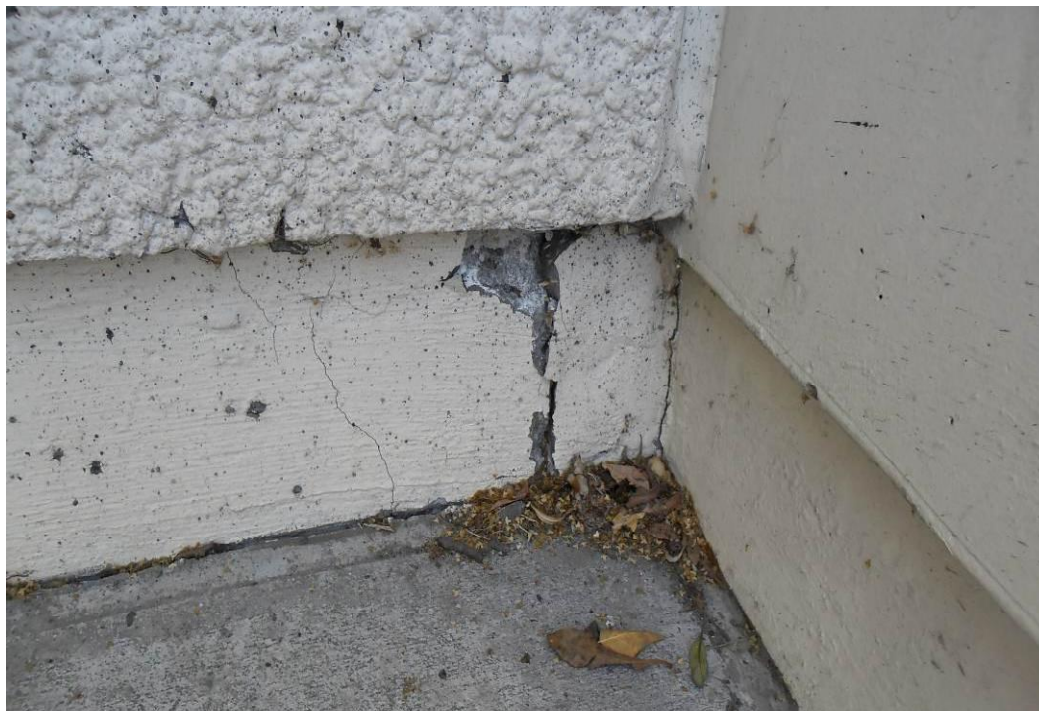
**Photo 2:** Typical cracking and spalling to concrete foundation walls

**Damage description:** Cracks in concrete foundation walls that exceed a crack width of 1mm and approximately 80mm or more in length.

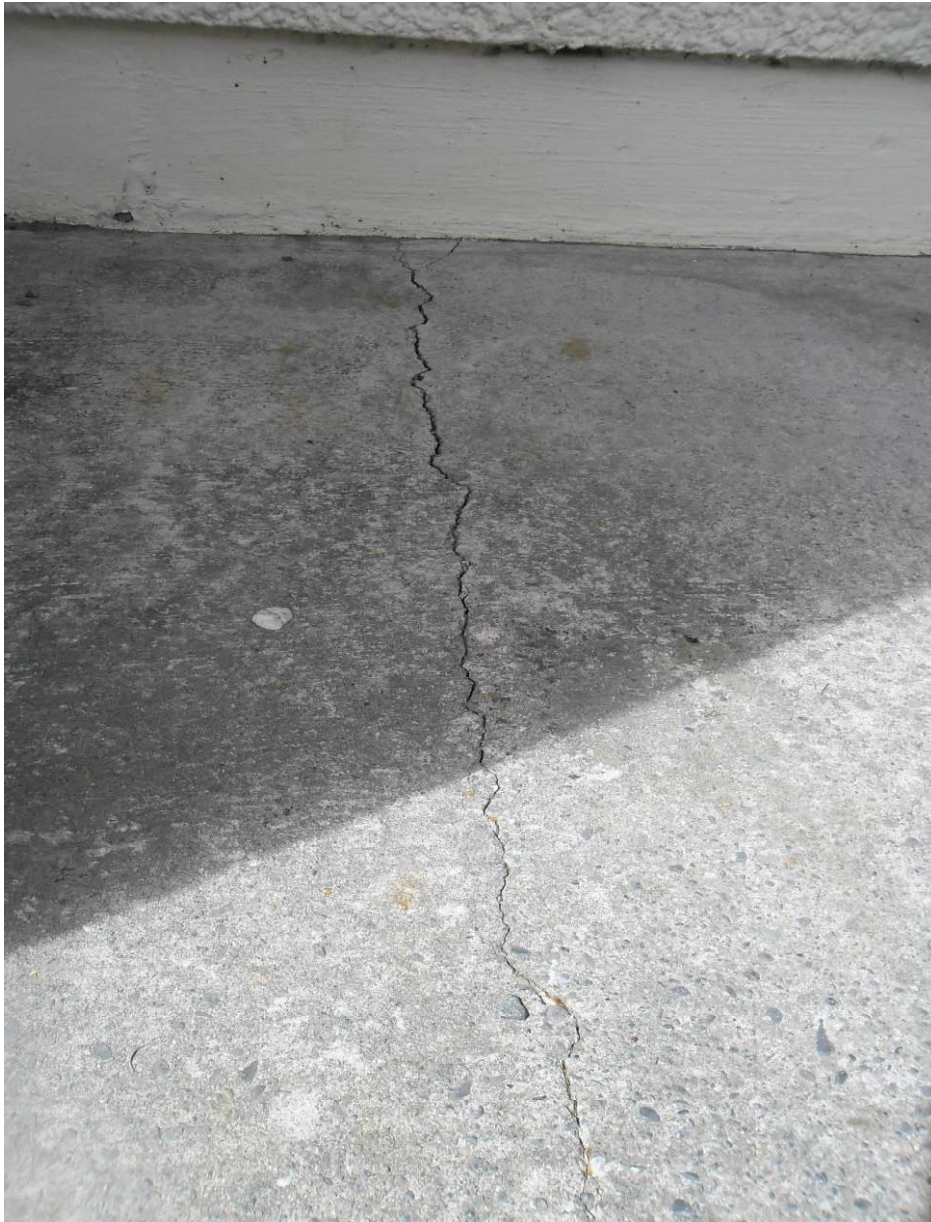
**Photo 3:** Typical cracking to concrete footpath at outside of the building

**Damage description:** Cracks in concrete structures that exceed a crack width of 0.2mm, but less than 2.0mm.

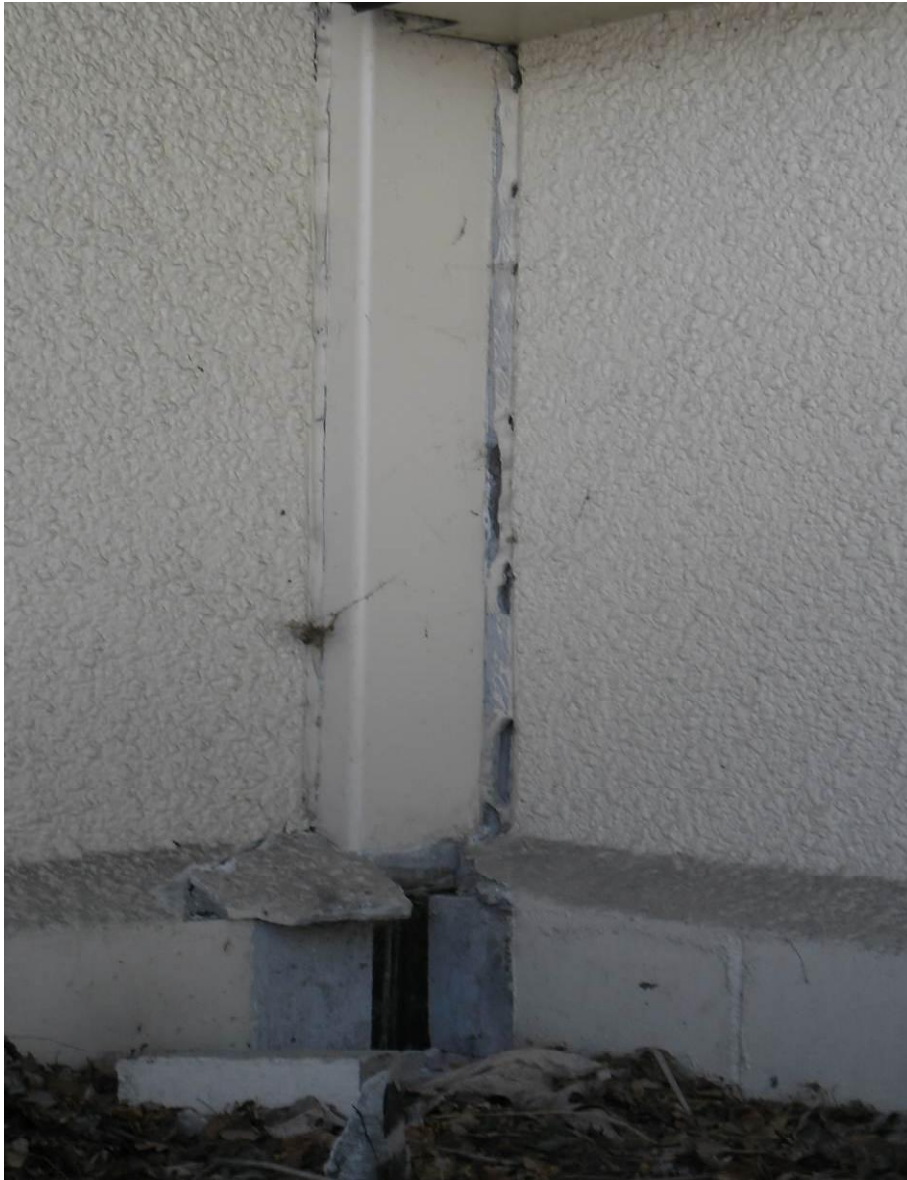
**Photo 4:** Significant separation at south face of the building

**General damage description:** Significant separation at south face of the building.

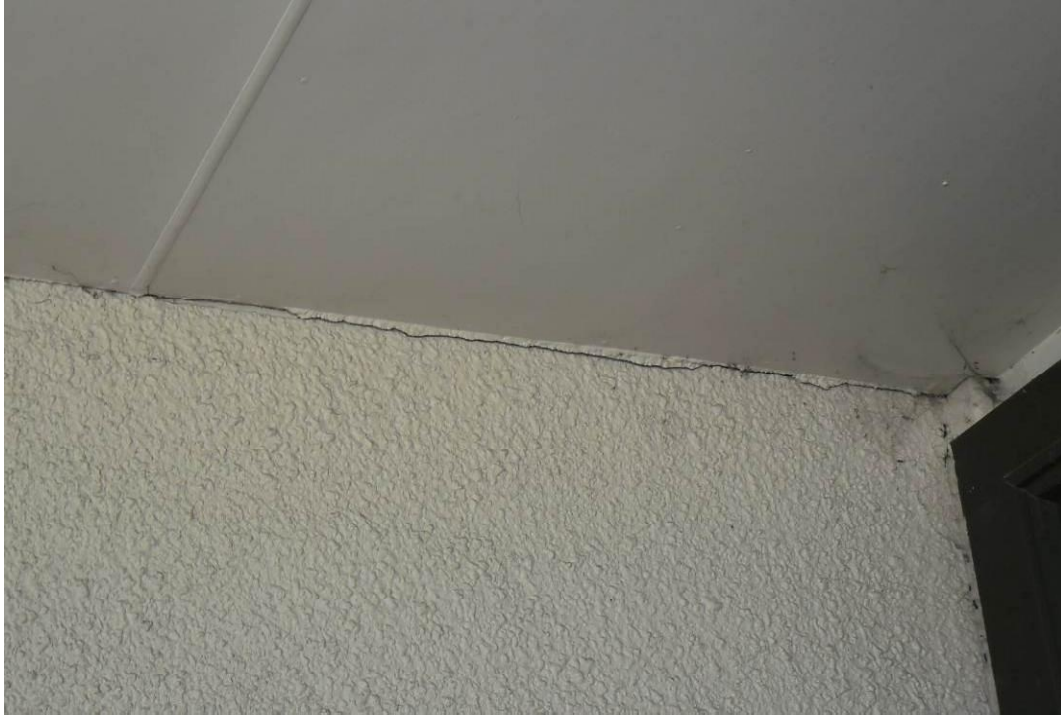
**Photo 5:** Separation between ceiling and masonry wall at the southern face of the building

**Damage description:** Separation between ceiling and masonry wall potentially due to settlement at the southern face of the building.

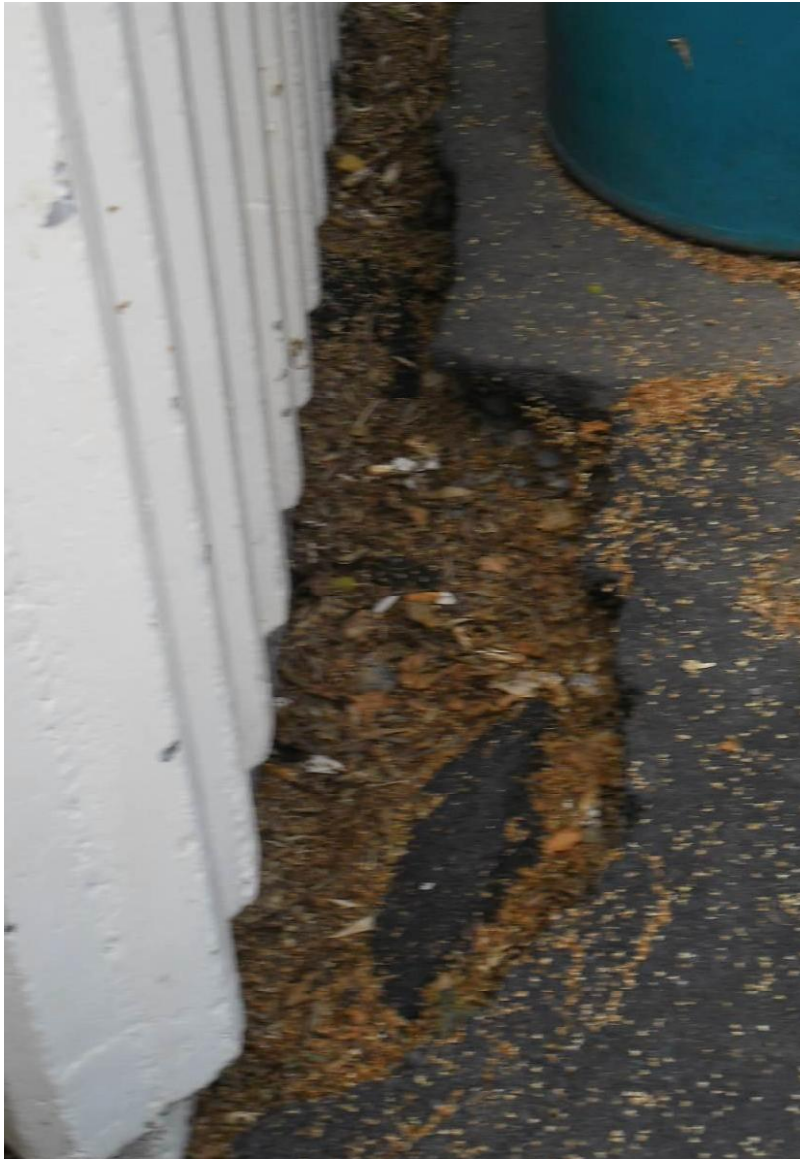
**Photo 6:** Evidence of ground movement at the southern face of the building

**Damage description:** Evidence of ground movement at the southern face of the building.

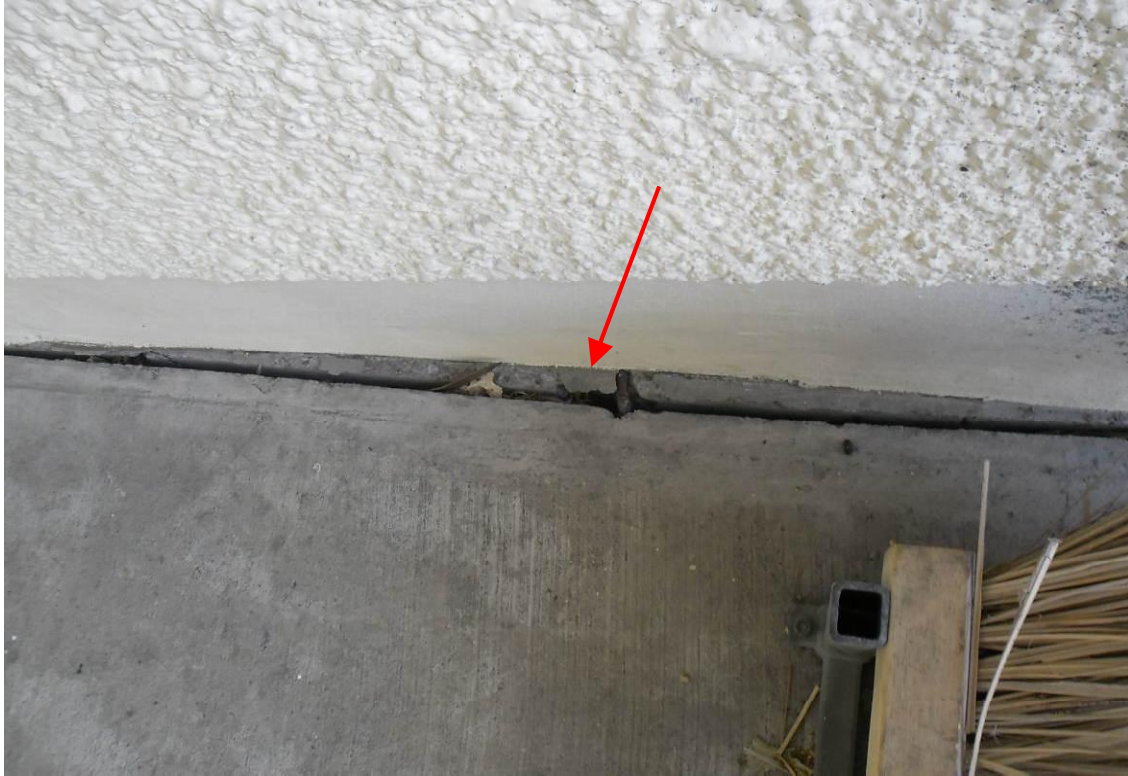
**Photo 7:** Settlement and separation at east entrance with exposed rebar

**Damage description:** Evidence of settlement at the east face of the building.

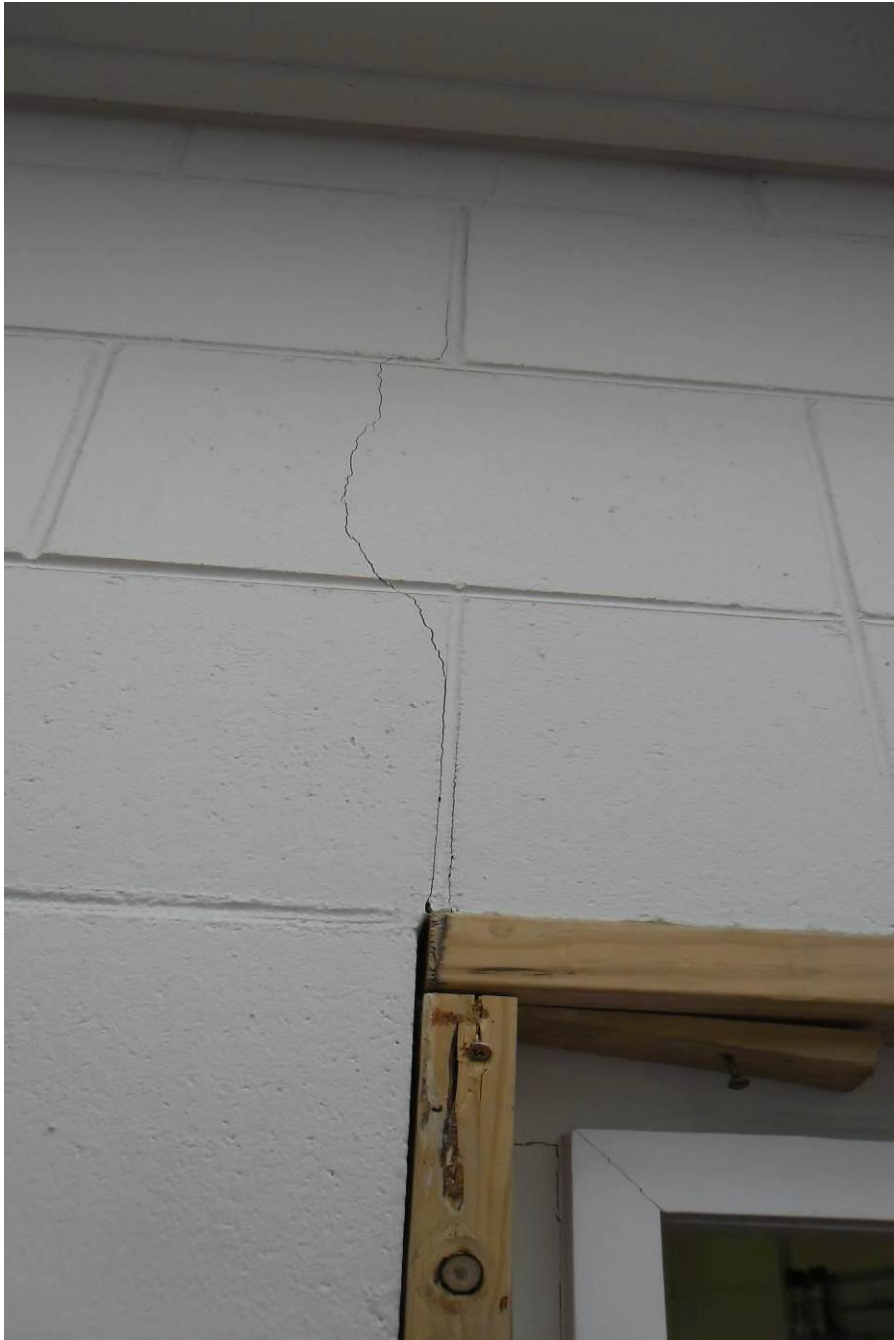
**Photo 8:** Typical cracking to masonry blocks

**Damage description:** Cracking to masonry blocks that exceed a crack width of 0.4mm.

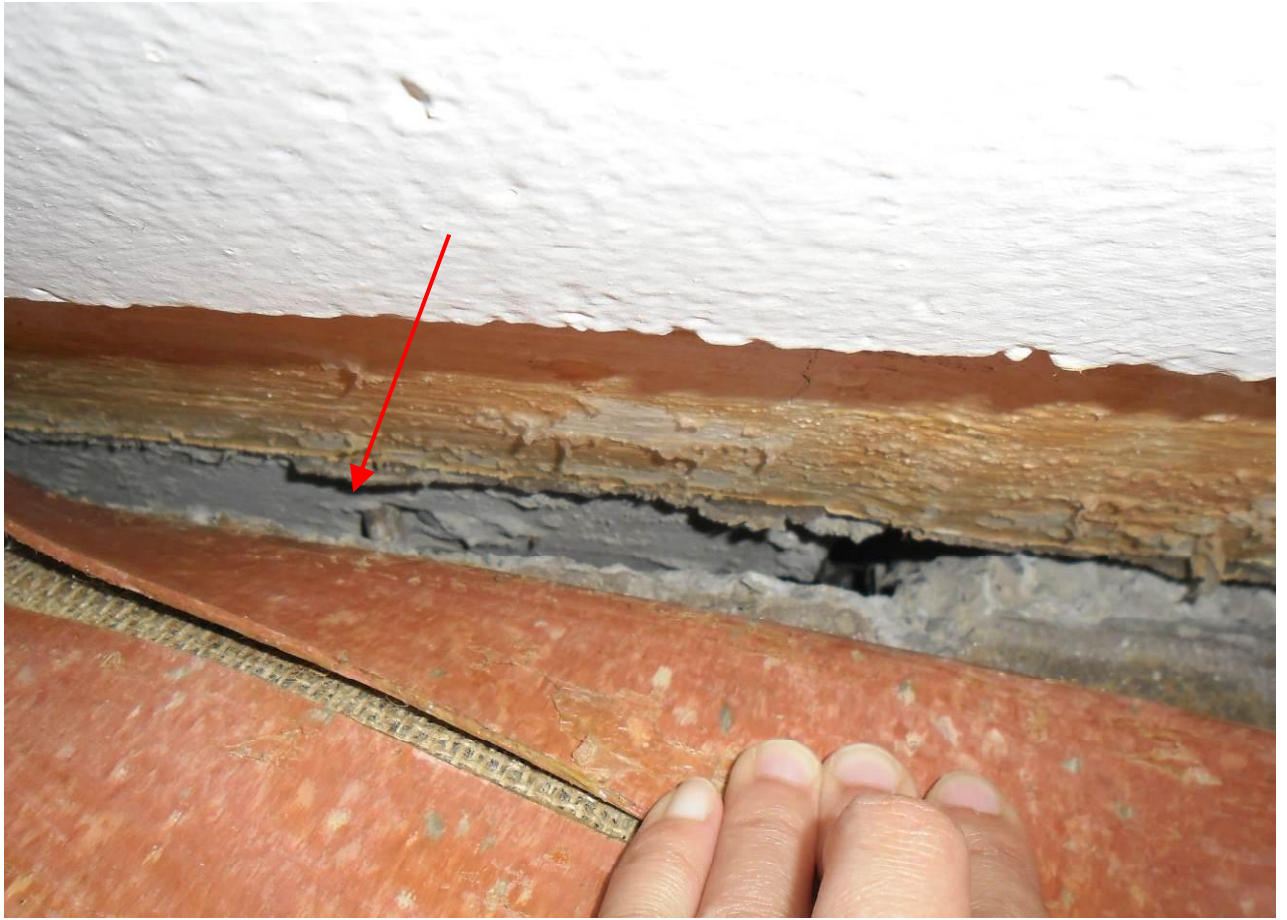
**Photo 9:** Cracking to concrete slab with exposed reinforcement at Client Service office

**Damage description:** Cracking to concrete slab at Client Service Office potentially caused by settlement and lateral spread due to earthquake shaking.

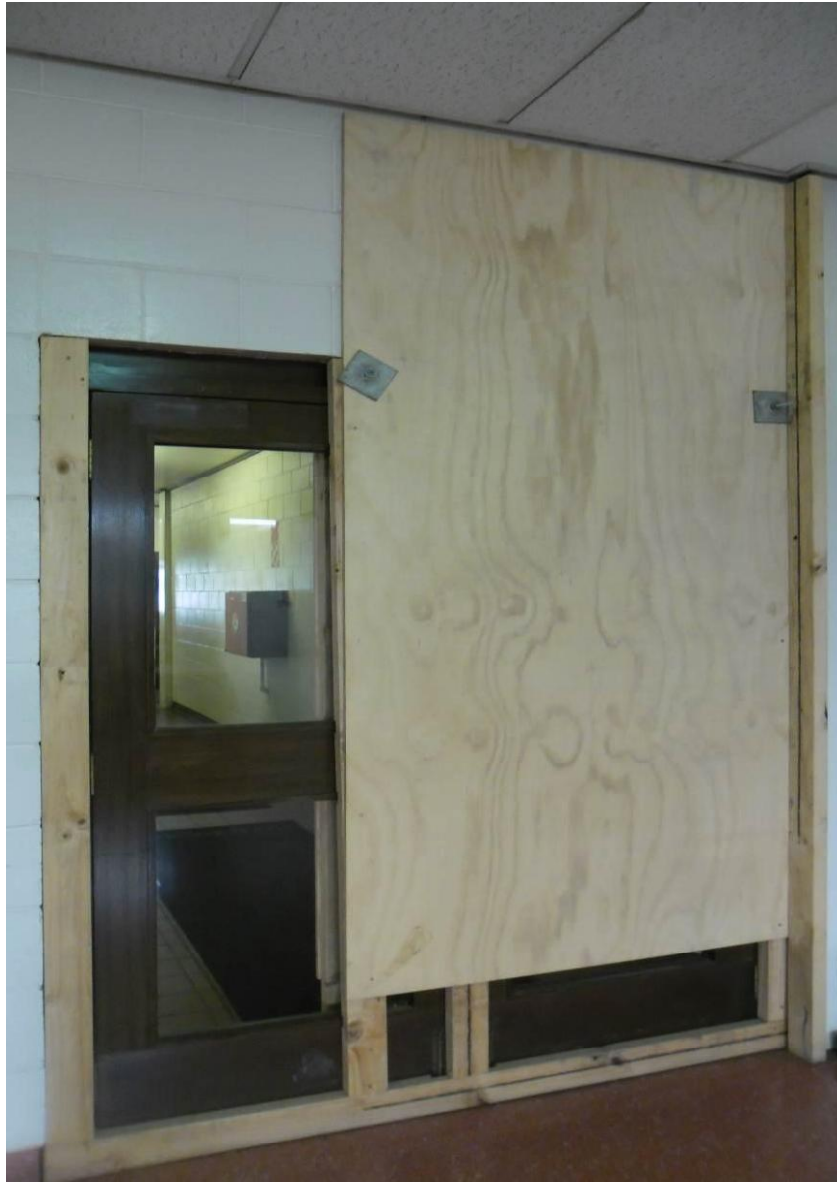
**Photo 10:** Plywood propping at lunch room

**Damage description:** Damage at lunch room has been propped by plywood. This damage is potentially due to settlement.

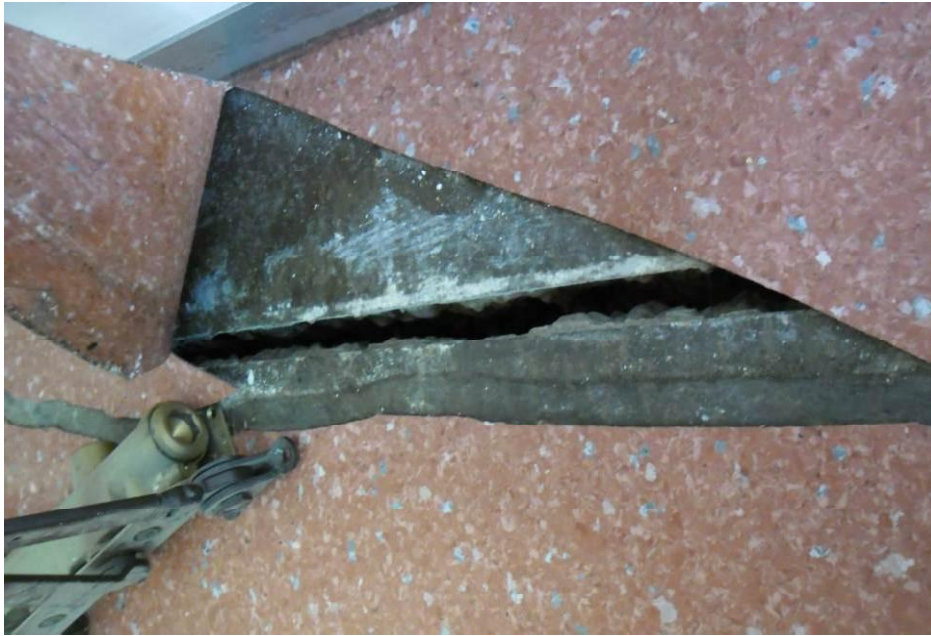
**Photo 11:** Cracking to concrete slab at the east wall of Lunch Room

**Damage description:** Cracking to concrete slab potentially due to settlement at the east wall of lunch room.

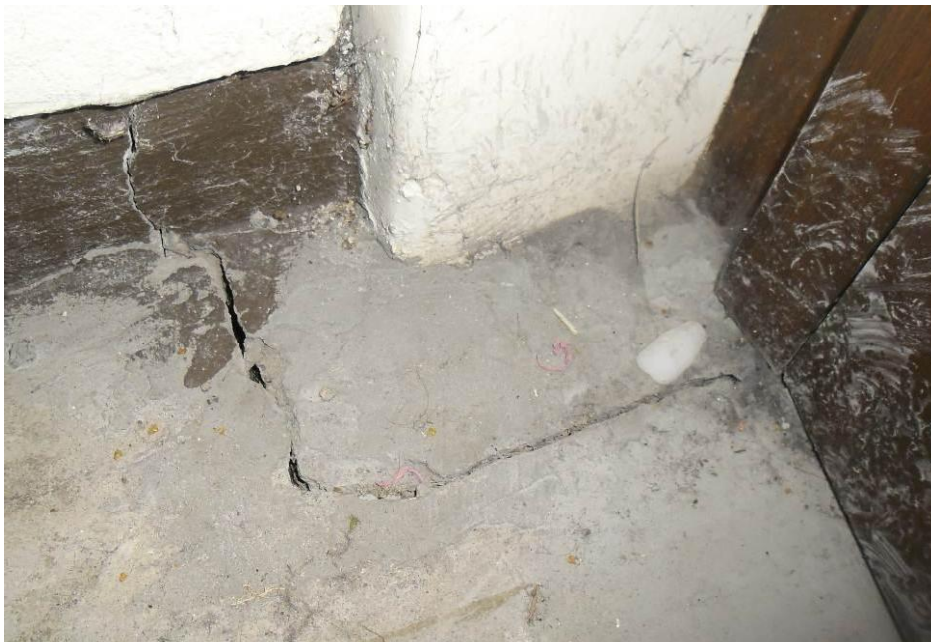
**Photo 12:** Evidence of foundation settlement below the concrete column

**Damage description:** Evidence of foundation movement and cracking below the concrete column at HR files area.

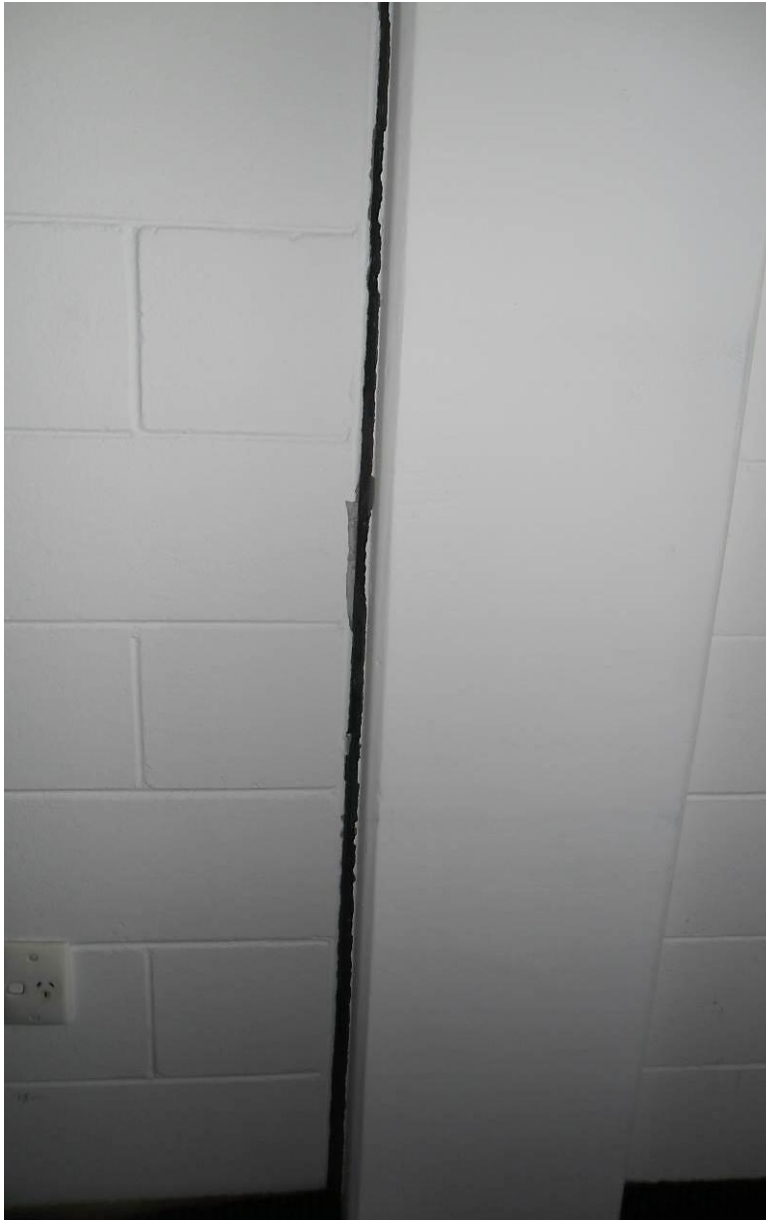
**Photo 13:** Separation between masonry and column at Client Service office

**Damage description:** Separation between masonry and column at Client service area potentially due to settlement.

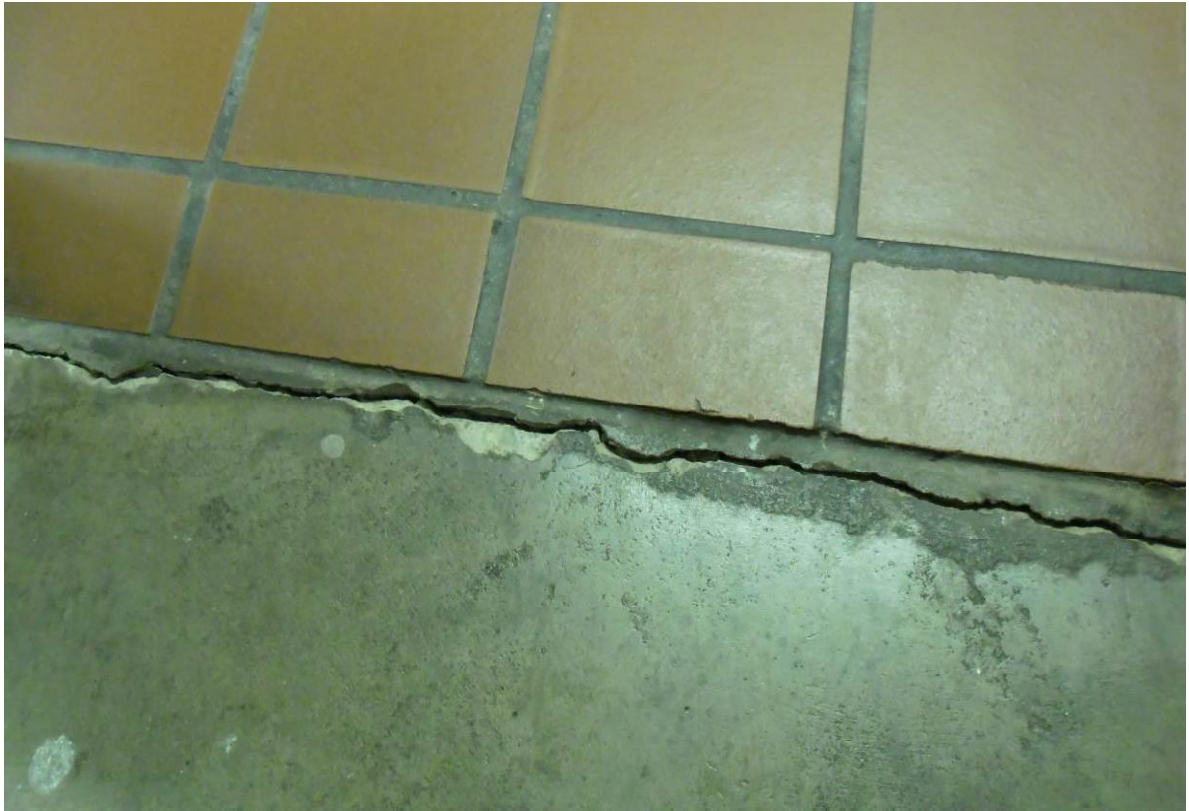
**Photo 14:** Cracking to concrete slab along the Locker Room Hallway

**Damage description:** Cracking to concrete slab along the Locker Room Hallway with cracking width more than 2mm approximately. There is possible rupture of slab reinforcement.

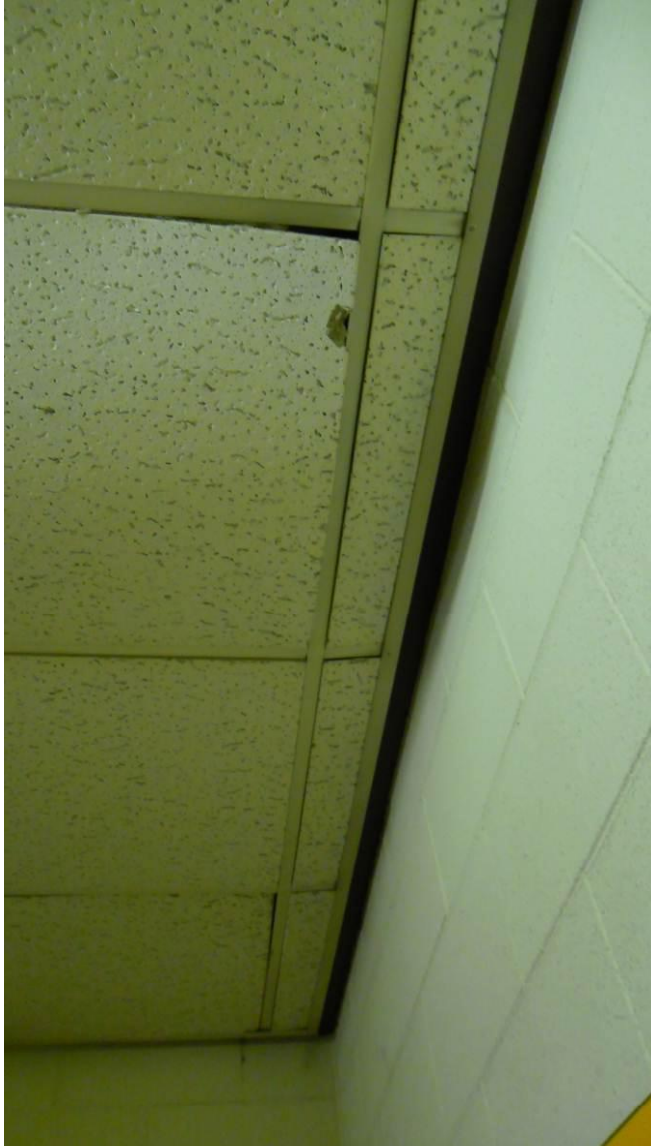
**Photo 15:** Typical damage to suspended ceiling tile and framing

**Damage description:** The ceiling grid has been bent and damaged.

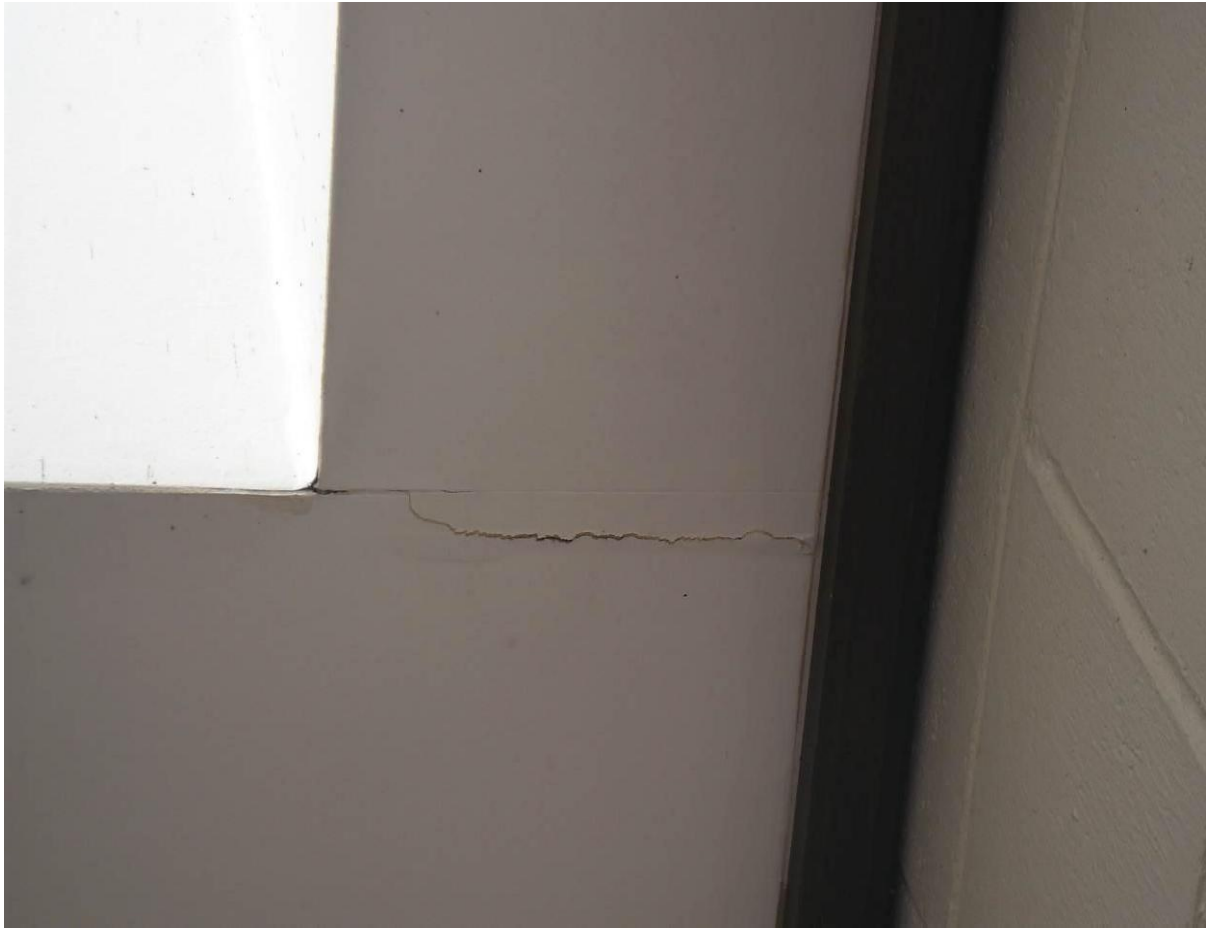
**Photo 16:** Typical cracking to gypsum plasterboard in the ceiling

**Damage description:** Cracking to plasterboard ceiling.

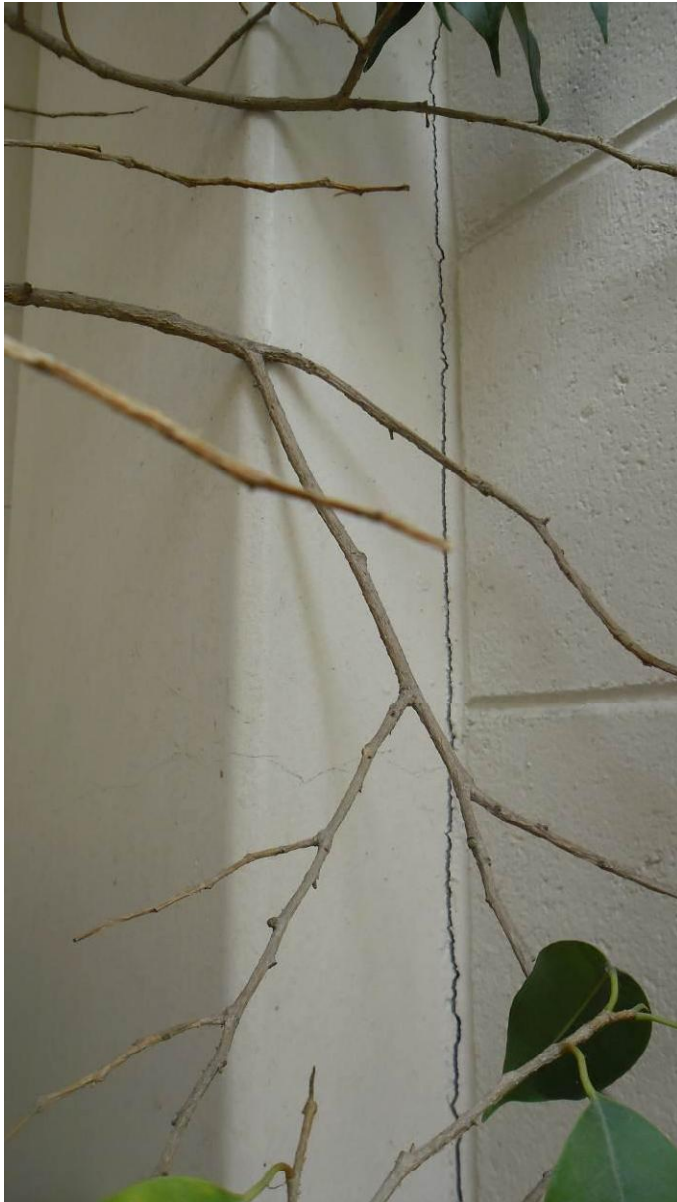
**Photo 17:** Typical separation between masonry blocks and concrete column

**Damage description:** Separation between masonry blocks and concrete column with varying crack width from 0.7mm to 15mm.
