Detailed Engineering Evaluation Quantitative Report

**Monavale Gatehouse
Fendalton Road, Christchurch**

**Prepared For:
Christchurch City Council**

Ref: 1606
31 July 2013

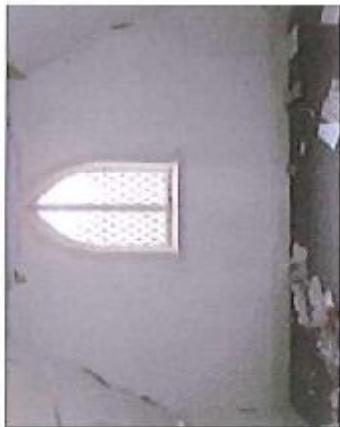
chimney and ceiling damage

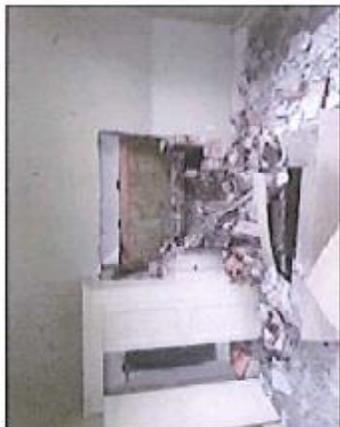
chimney and ceiling damage to bedroom 3

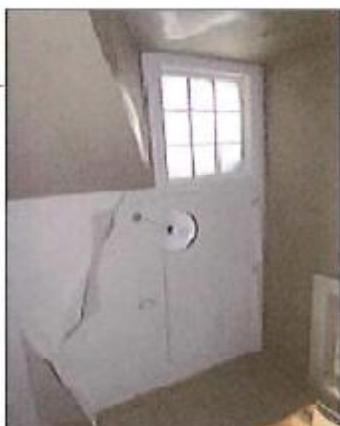
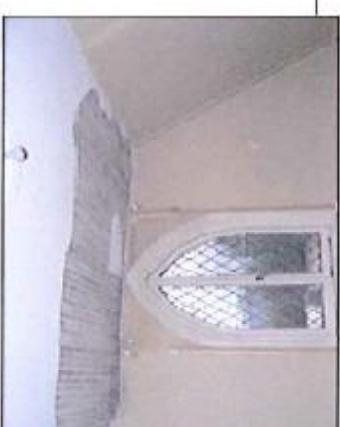
typical ceiling damage in staircase

typical ceiling damage

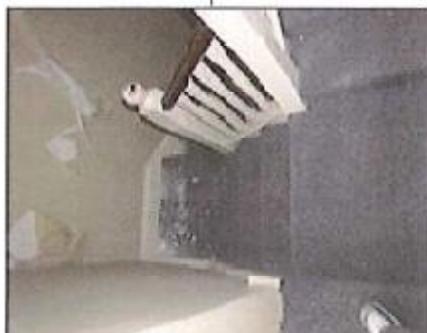
typical wall damage in staircase

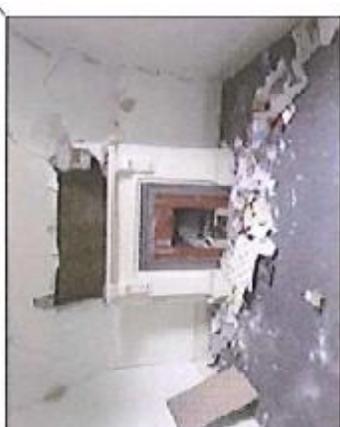
chimney damage

Reconstruct fallen chimneys using lightweight replicas in the form of plaster over plywood on timber framing with modern steel flues.
Reconstruct/repair damage gable dormer to match that which existed prior to the earthquake.

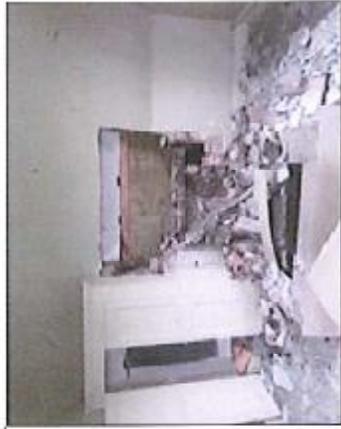
chimney and ceiling damage to bedrock 3

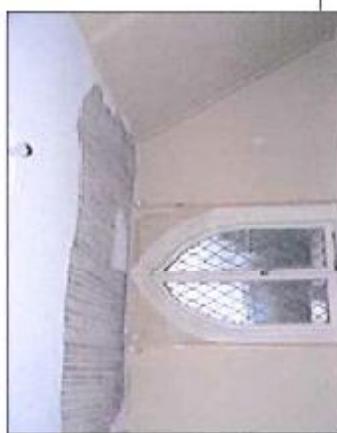
typical ceiling damage

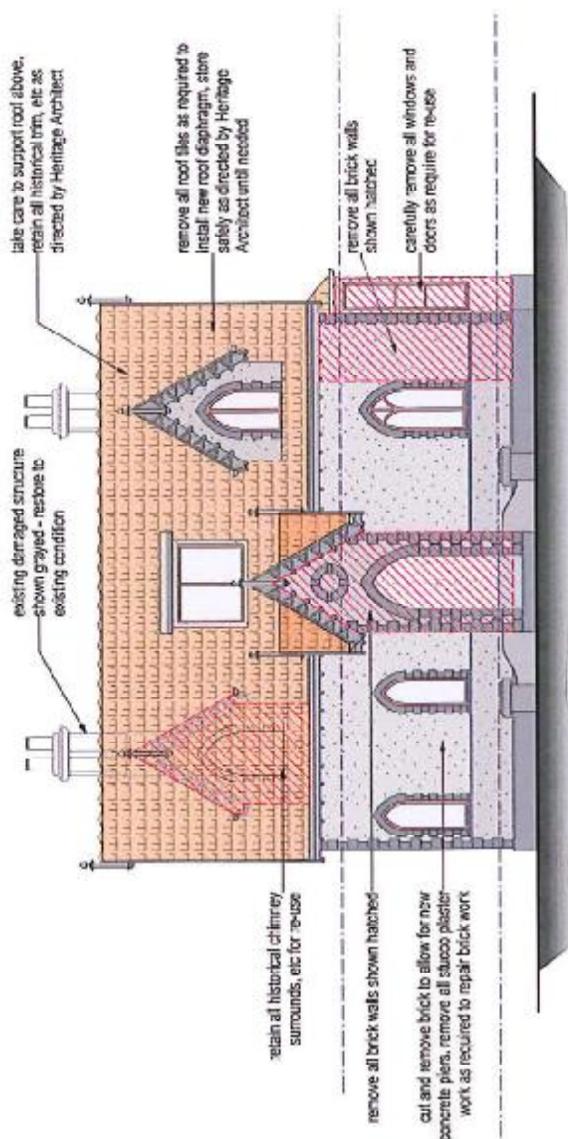
East Elevation Scale 1:100 @ A3
existing damaged structure shown greyed - restore to existing condition

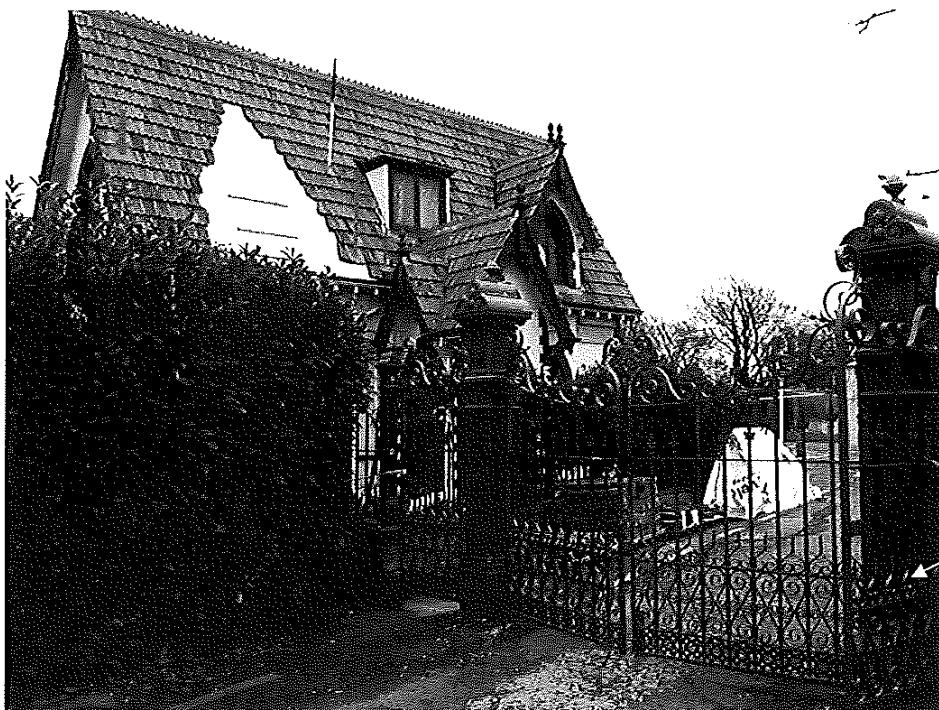
Figure 1: View of Gate House. Main tension crack from lateral spreading in foreground (arrowed).

Install a new 3.0m deep 1310UB40 steel piles (at 800crs) palisade wall just beyond the Eastern side, adjacent to the access road, down to and into the gravel layer as a minimum. See also the recommendations in the report prepared by LDE.

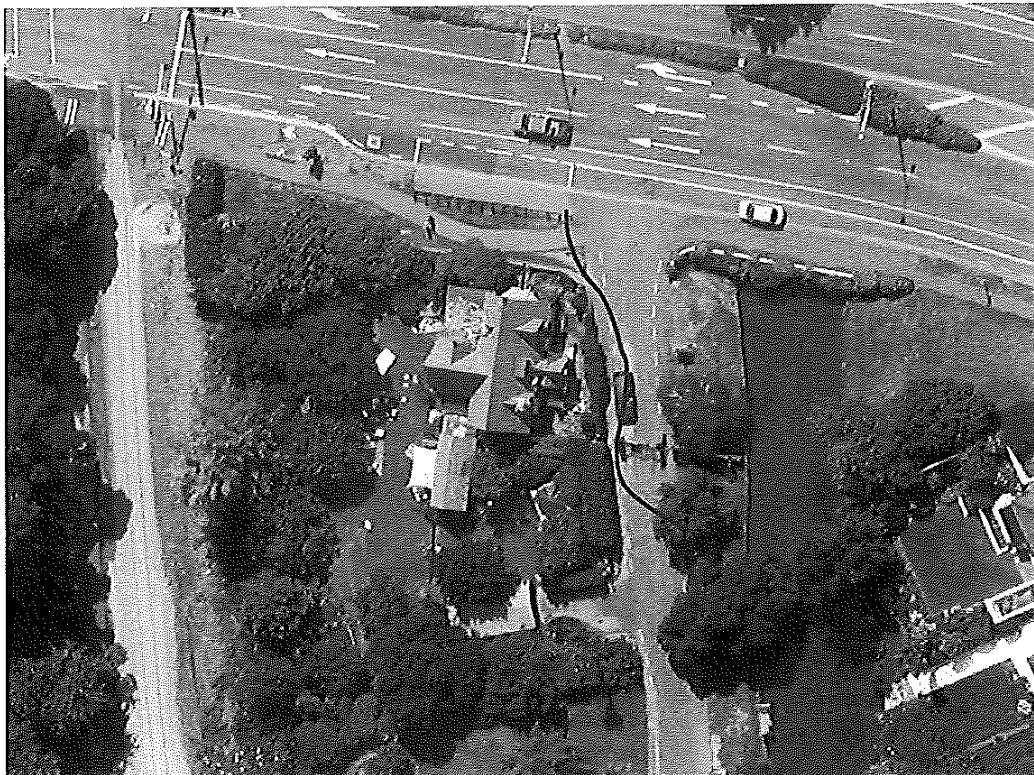
Figure 2: Aerial view of property. Fendalton Road passes along the northern side of the property and the Avon River to the right. Main tension cracks from lateral spreading shown in red.
