Gatehouse Garage – Mona Vale
PRK 0555 BLDG 014
Detailed Engineering Evaluation
Qualitative Report
FINAL Version

Mona Vale, 63 Fendalton Road,
Riccarton, Christchurch

Christchurch City Council

Date
24/05/2013

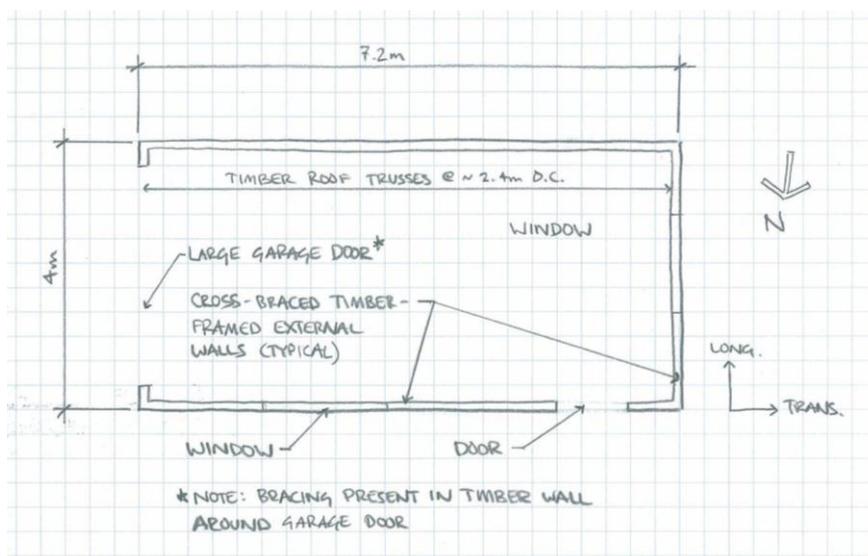
Figure 2 Plan Sketch Showing Key Structural Elements

The timber roof structure showed no evidence of cross-bracing and there is no roof cross-bracing shown on the available drawings. Flat-strap steel cross-bracing was evident in the two perpendicular walls, roughly as shown on the available drawings. Though an interior inspection of the Gatehouse Garage was not undertaken, the available drawings show diagonal cross-bracing around the roller door opening in the eastern wall. It is assumed that this cross-bracing in the walls is in place, as the rest of the structure appears to have been built in accordance with the drawings.

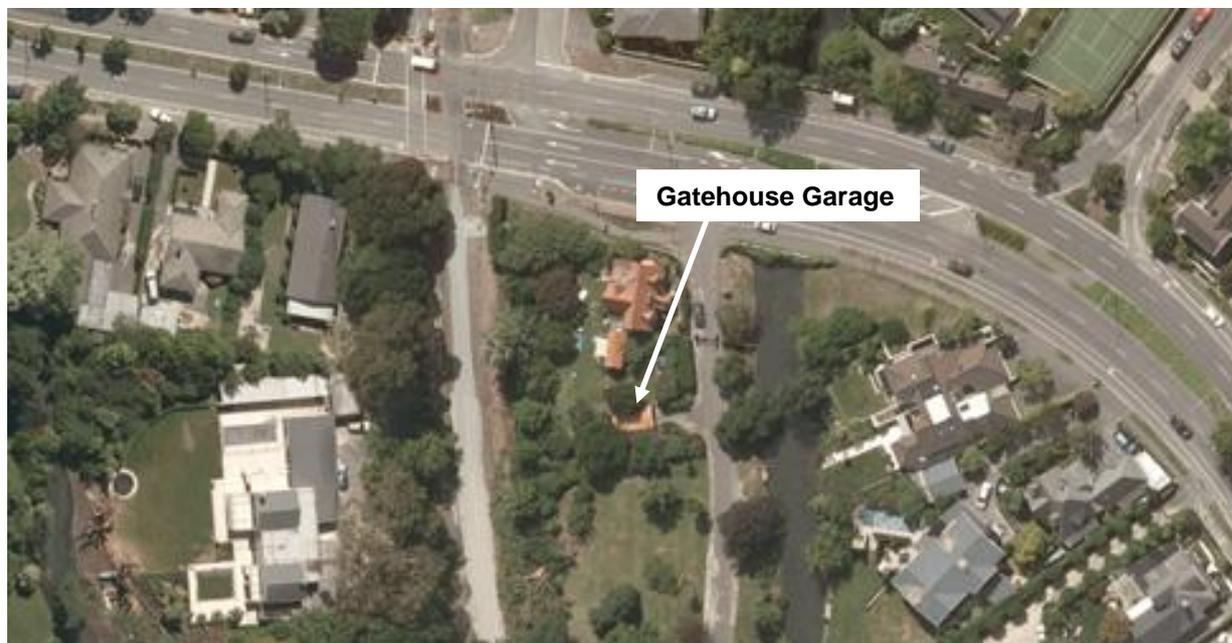
Figure 3 Post February 2011 Earthquake Aerial Photography ³

Aerial photography taken following the 22 February 2011 earthquake shows signs of moderate to high liquefaction close to the site. Significant liquefaction is particularly observed at the Main North Line Railway approximately 10m west of the site, as shown in Figure 3.

Given the anticipated ground conditions and observations following the February earthquake, we recommend that further investigation is undertaken. Specifically, one CPT investigation should be conducted to a target depth of 20m bgl.

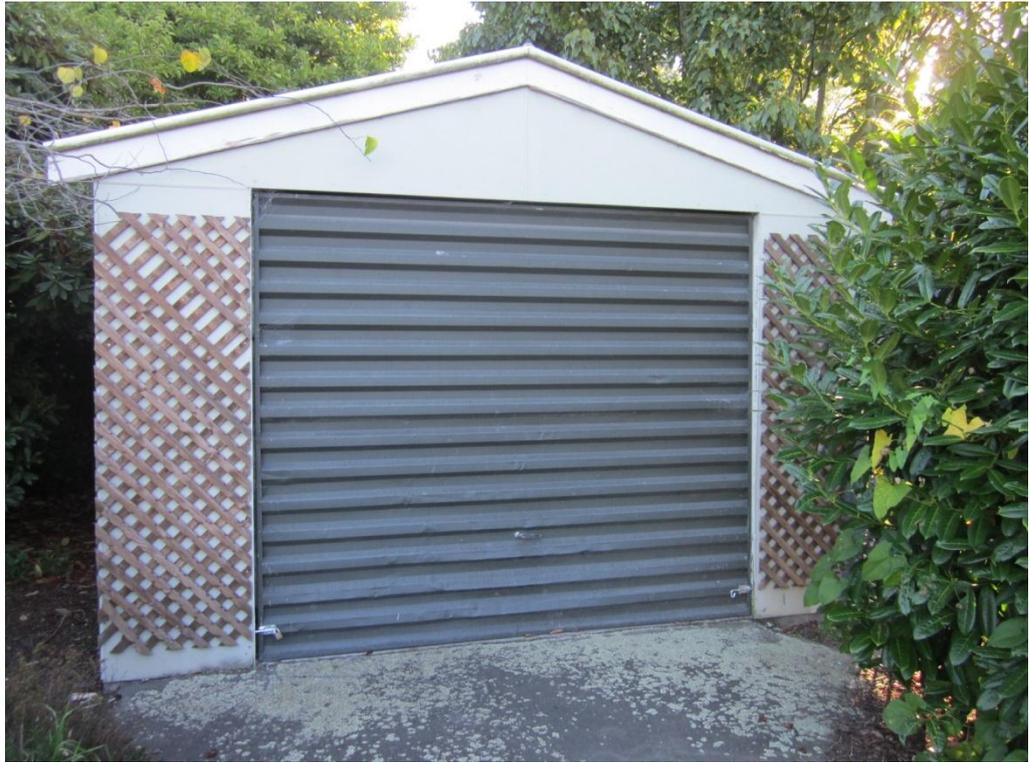
Photograph 1: East elevation.

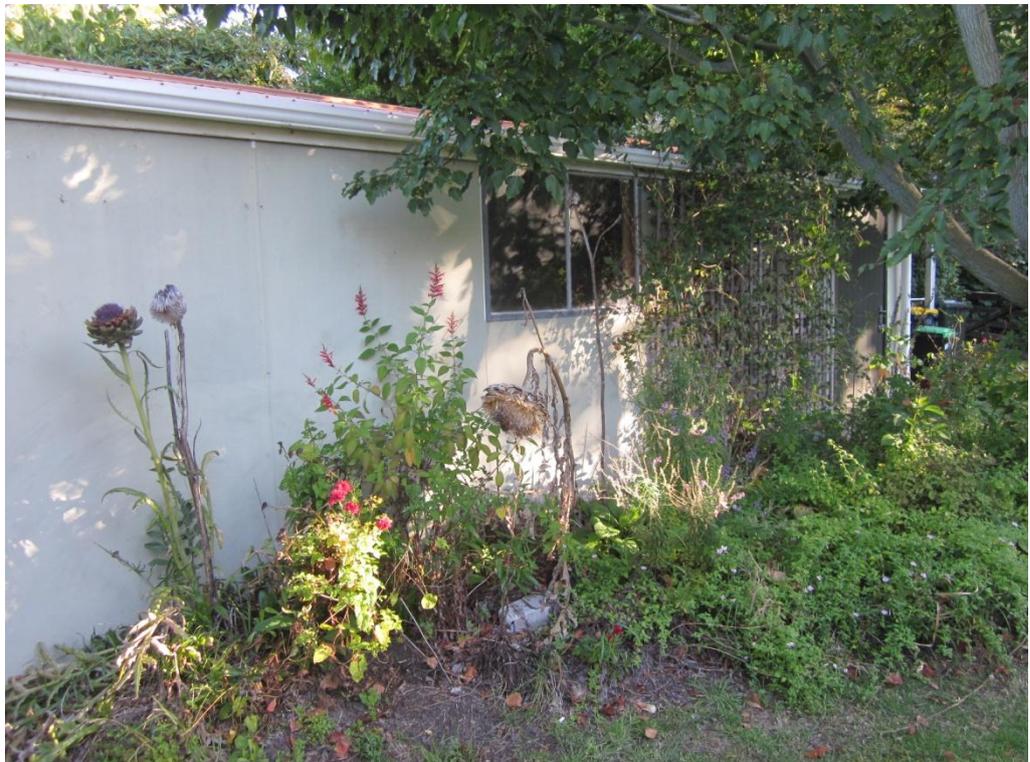
Photograph 2: Northern elevation.

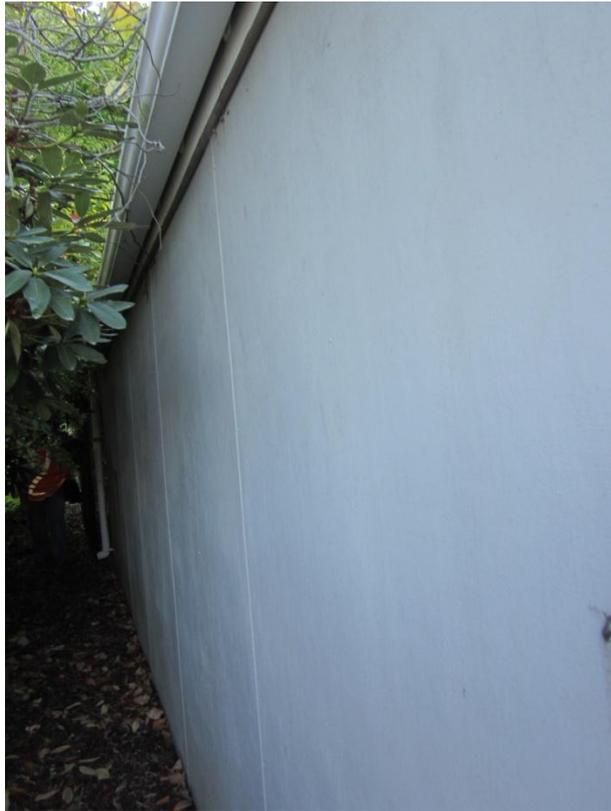
Photograph 3: Southern elevation.

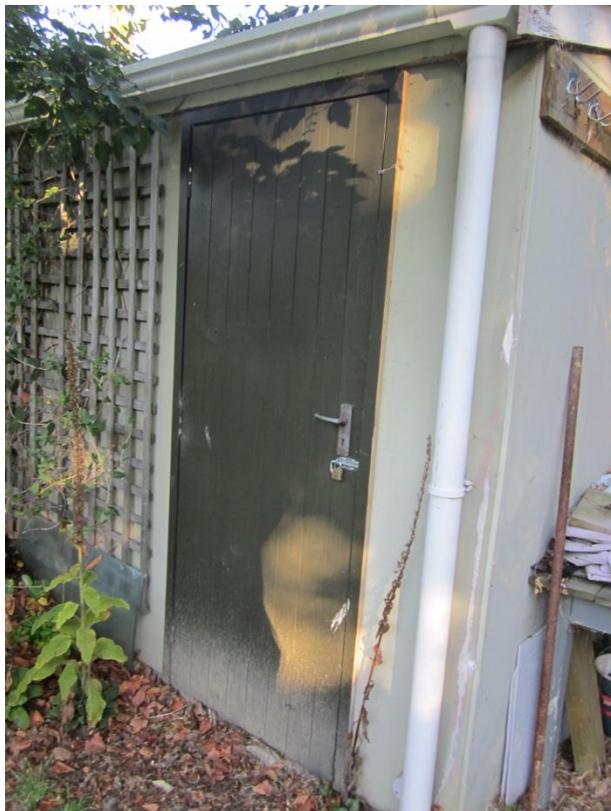
Photograph 4: Exterior door at northwest corner elevation.

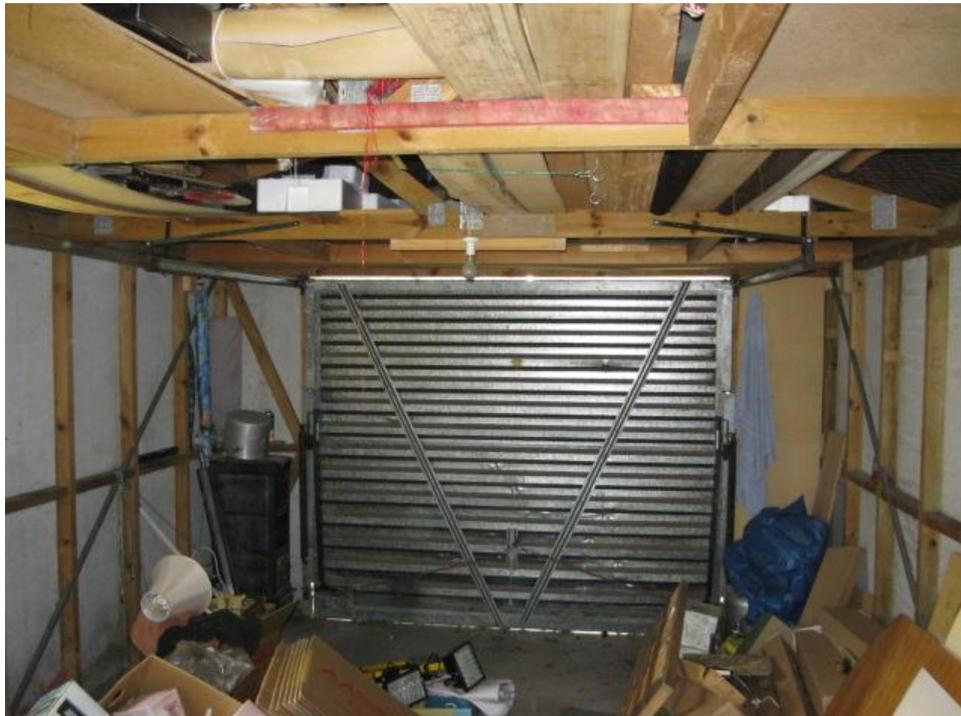
Photograph 5: Interior view of the garage showing roller door and wall bracing on longitudinal walls.

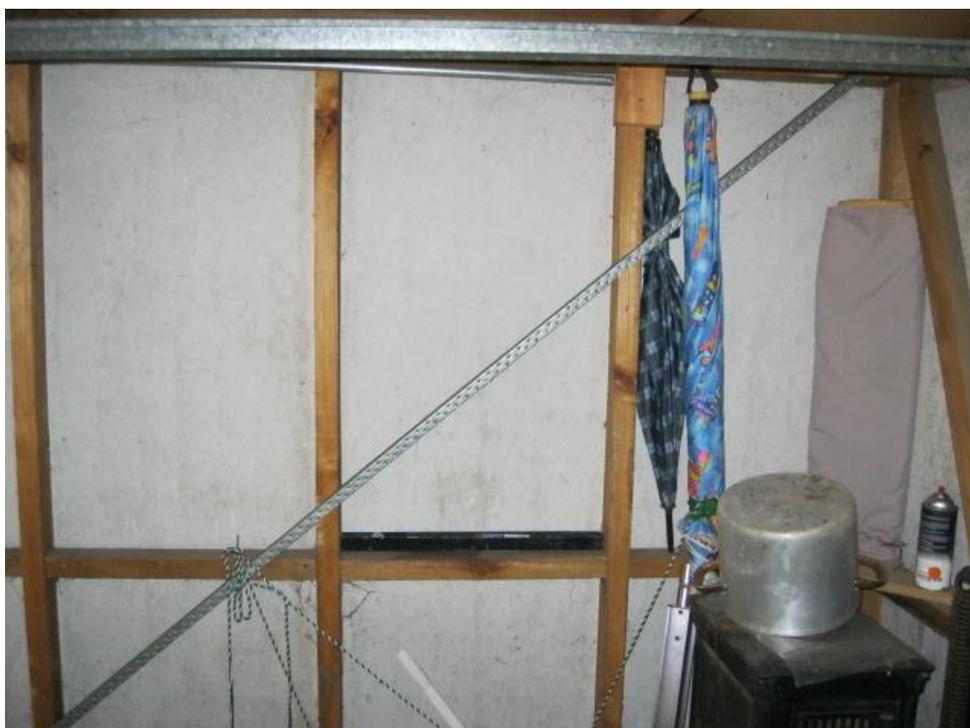
Photograph 6: Interior view of wall bracing at longitudinal wall.

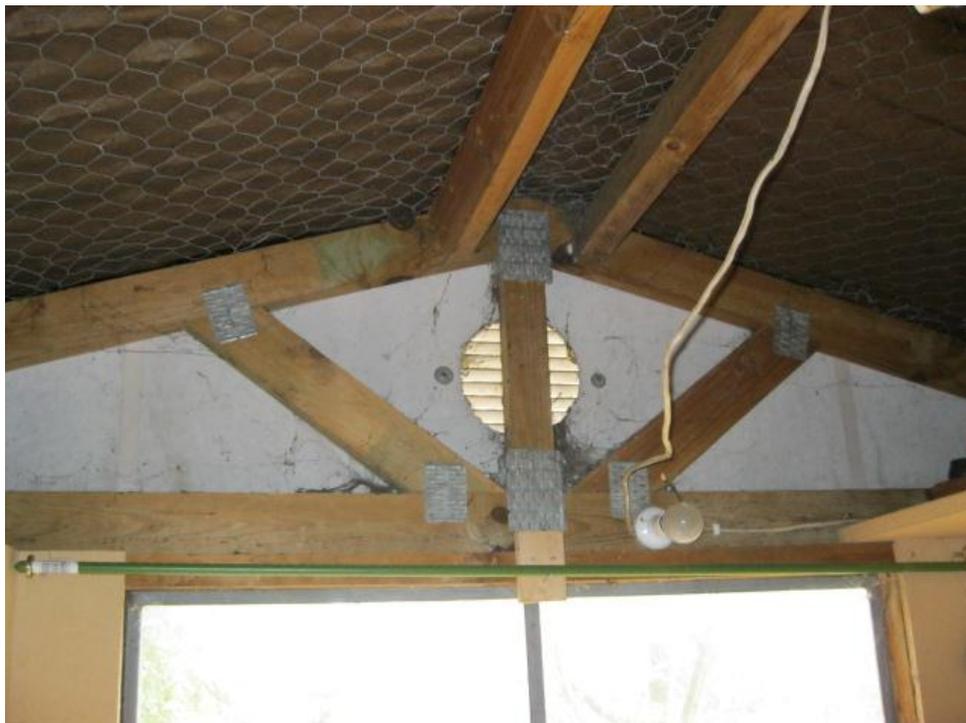
Photograph 7: Interior view of roof structure, which has no cross-bracing.
