# STRUCTURAL CONCEPTS LIMITED

Re: Mona Vale Homestead – POST-EARTHQUAKE INSPECTION

## Scope of this Report

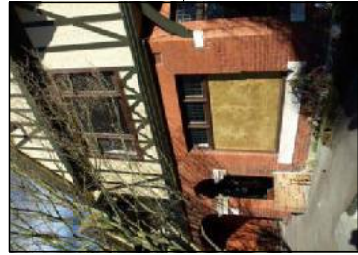
damage to walls to drawing room

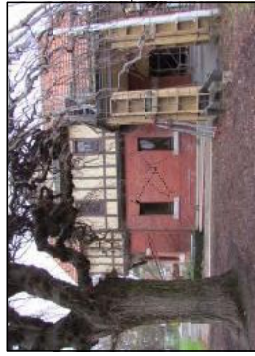
damage to walls to drawing room

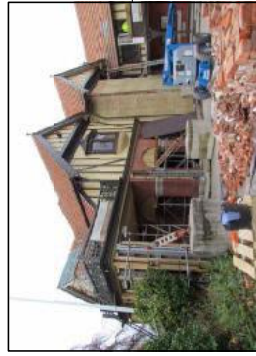
damage to columns to patio area

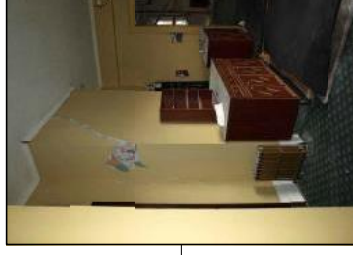
damage to chimney in entry lobby

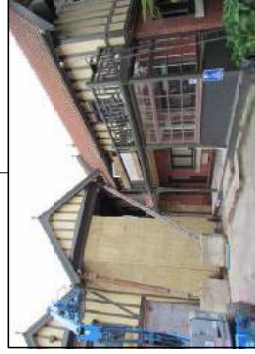
damage to wall around stair lobby
