**Mona Vale Implement Shed/Staff  
Rooms  
PRK\_0555\_BLDG\_009 EQ2  
Detailed Engineering Evaluation  
Qualitative Report  
Version FINAL**

40 Mona Vale Avenue, Fendalton

Christchurch City Council

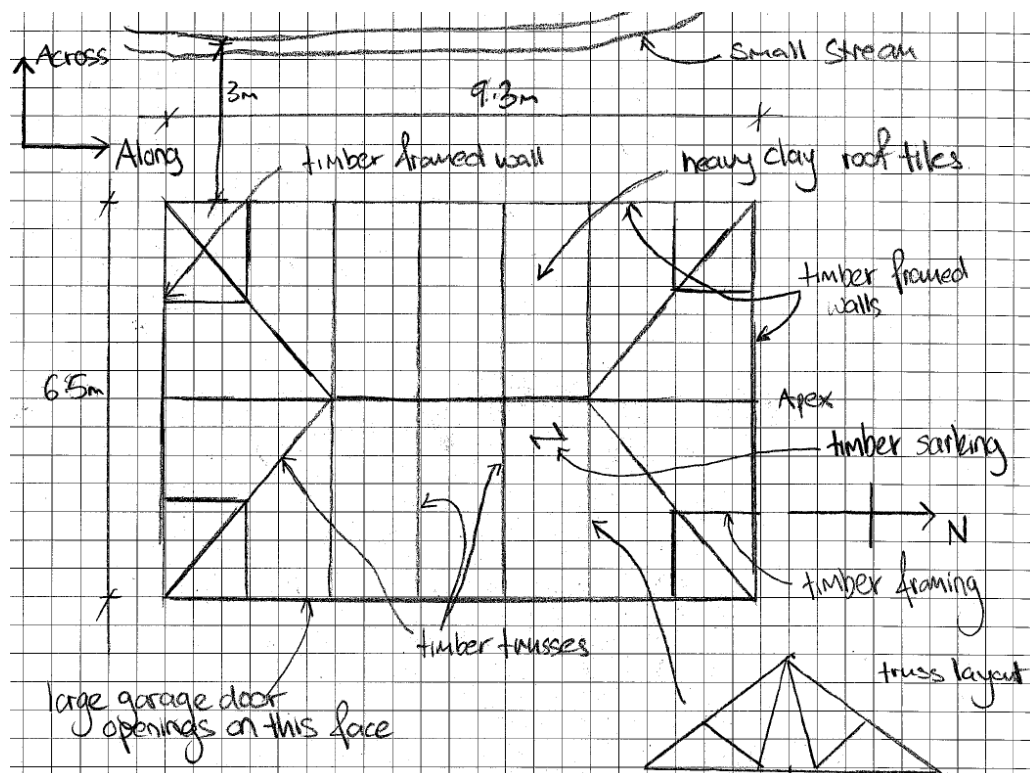
**Figure 2 Plan sketch showing key structural elements**

The dimensions of the building are approximately 6.5 m wide by 9.3 m long and 6 m tall. The overall footprint of the building is approximately 60 m<sup>2</sup>.

Lateral loads acting on the structure the building are resisted by braced timber framed walls on all four sides of the structure. Lateral forces are distributed from the roof structure to the timber framed walls through diaphragm action of the timber sarking over the roof trusses.

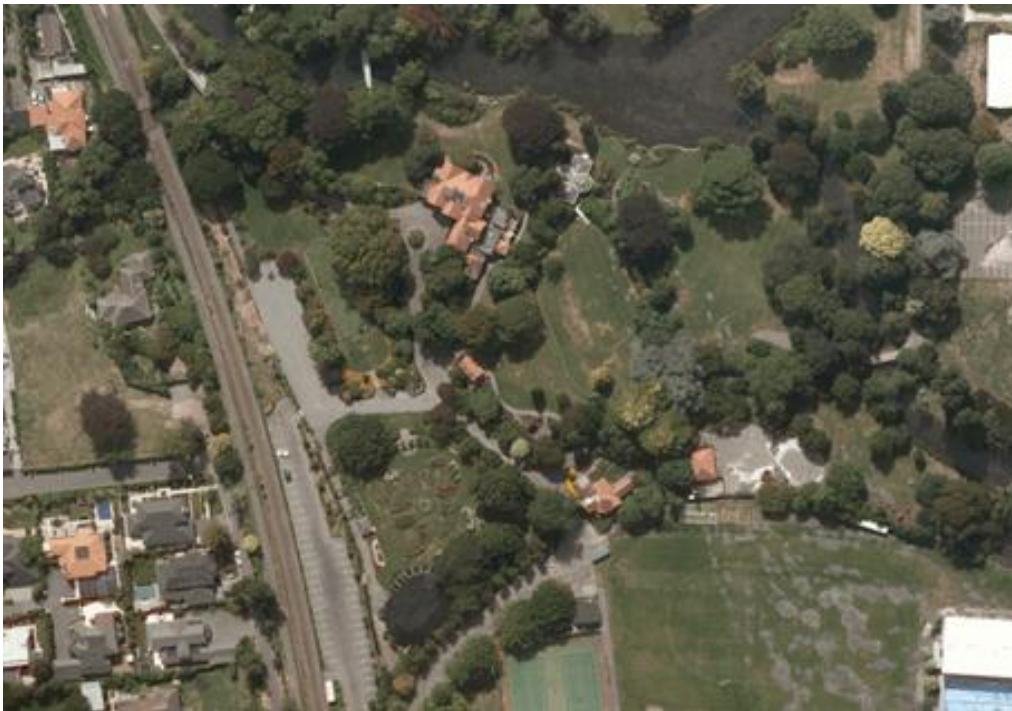
**Figure 3 Post February 2011 Earthquake Aerial Photography**<sup>3</sup>

Aerial photography taken following the 22 February 2011 earthquake shows signs of moderate liquefaction outside the building footprint, and significant liquefaction in the Christchurch Girls' High School grounds adjacent to the site, as shown in Figure 3.

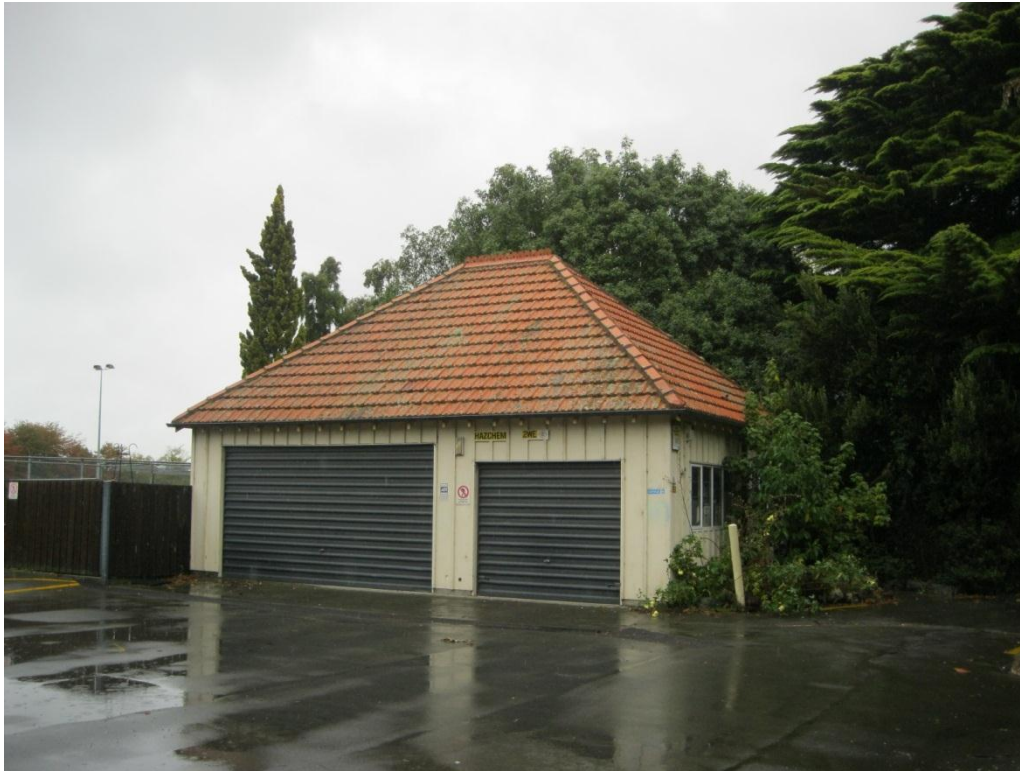
**Photograph 1      View of the eastern face of the building.**

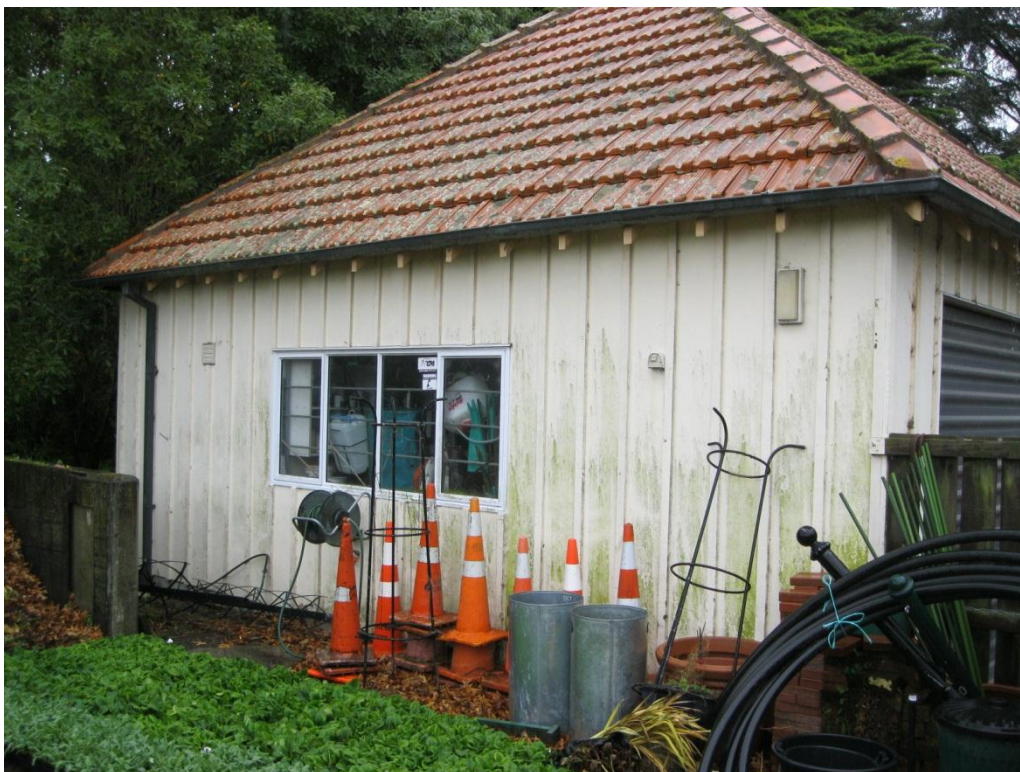
**Photograph 2      View of the western face of the building.**

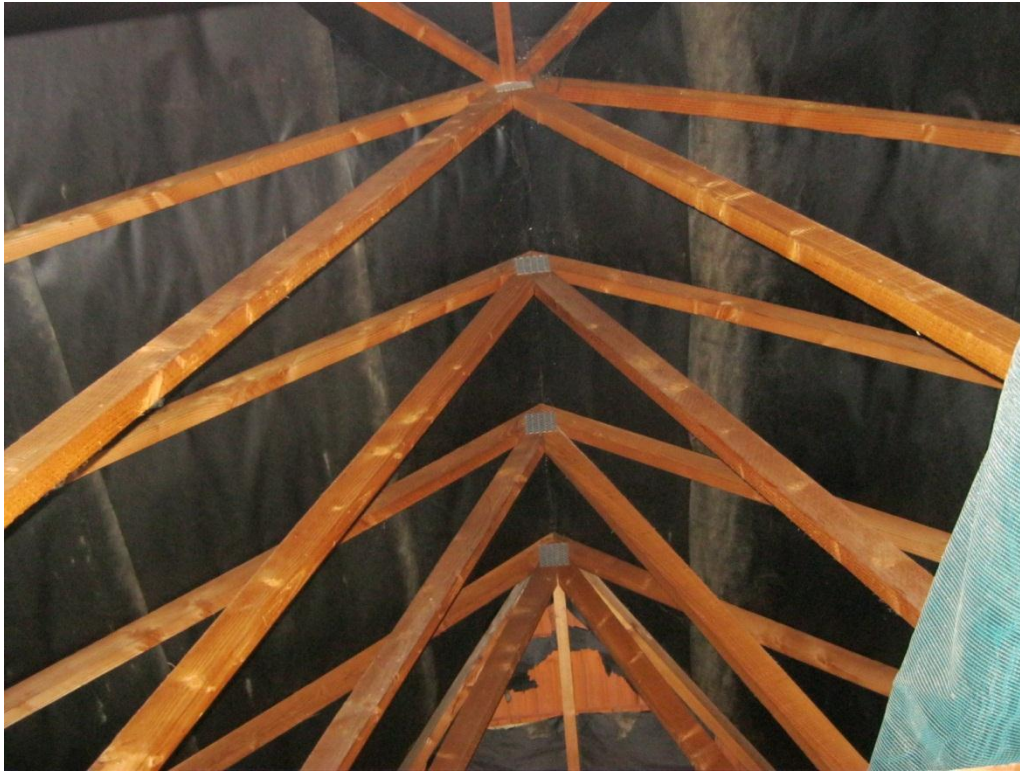
Gravity loads from the heavy clay tile roof are supported by timber sarking over timber trusses spanning across the building (trusses shown in Photographs 3, 5 and 8). The truss members are connected by steel nail plates as shown in Photograph 5. The timber trusses are connected to the timber top plates of the timber framed walls on all four sides of the building. This is shown in Photograph 7. Gravity loads are transferred through the load-bearing timber walls and into the foundations. The foundations are likely to consist of a reinforced concrete slab on grade with reinforced concrete strip footings beneath the timber

**Photograph 3      Internal roof trusses.**

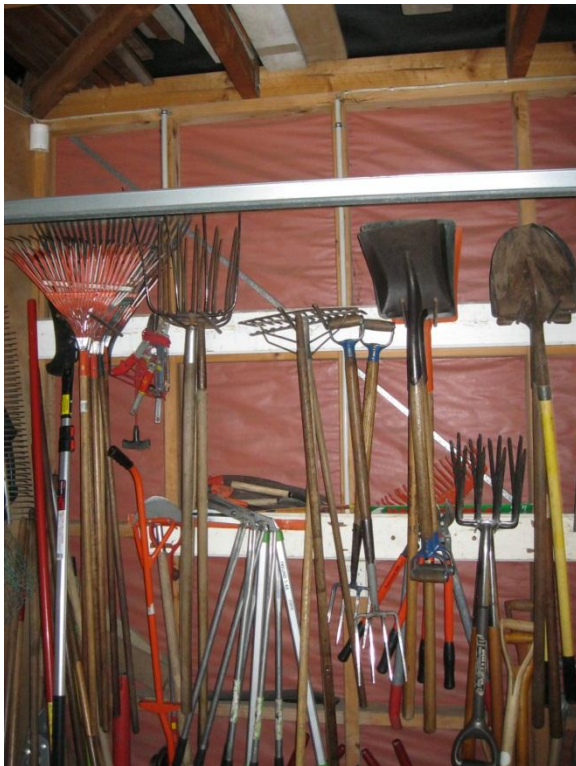
Diagonal steel strap bracing is present in the northern, southern and western walls of the building. A section of the steel strap bracing on the southern wall is shown in Photograph 4. The eastern wall has two large openings to allow vehicle access to the garage. The openings can be seen in Photograph 1. The sections of wall between the openings on this side are braced on the internal face with plywood. As the plywood bracing is reasonably stiff it is expected the eastern wall will have a similar stiffness to the other walls despite the relatively small sections of braced walls. As a result, plan irregularity has been considered insignificant for the building. All bracing details appear to be consistent with the design standard NZS 3604:1999.

**Photograph 4      Internal wall bracing.**

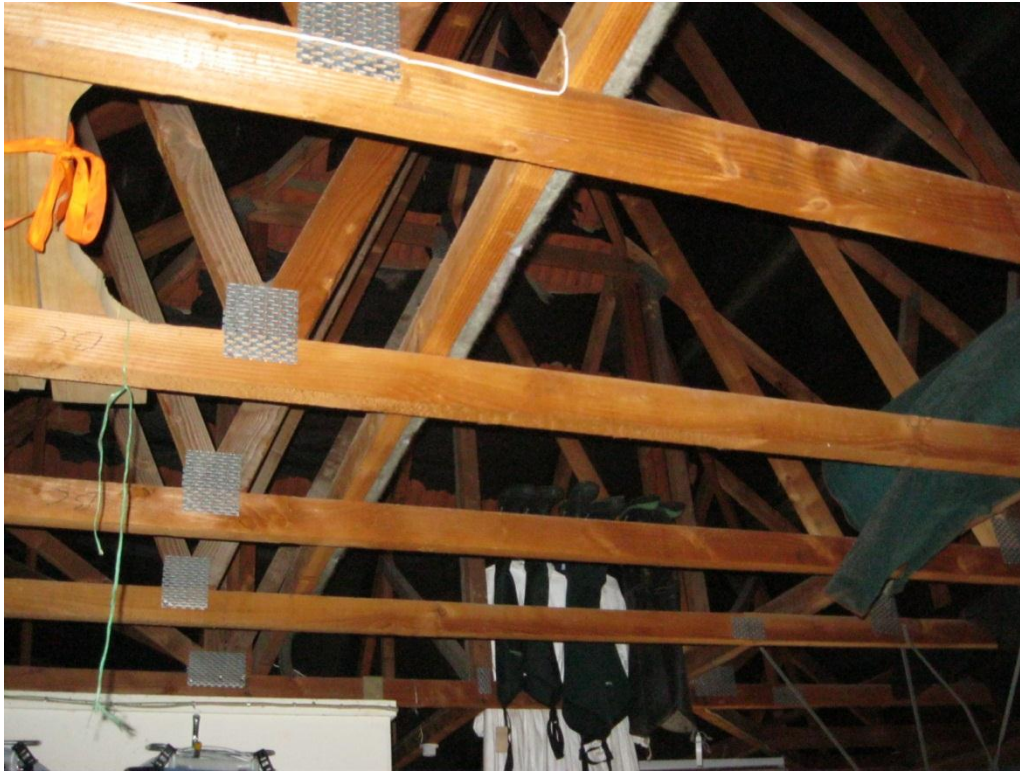
**Photograph 5**      **Roof truss nail plate connections.**

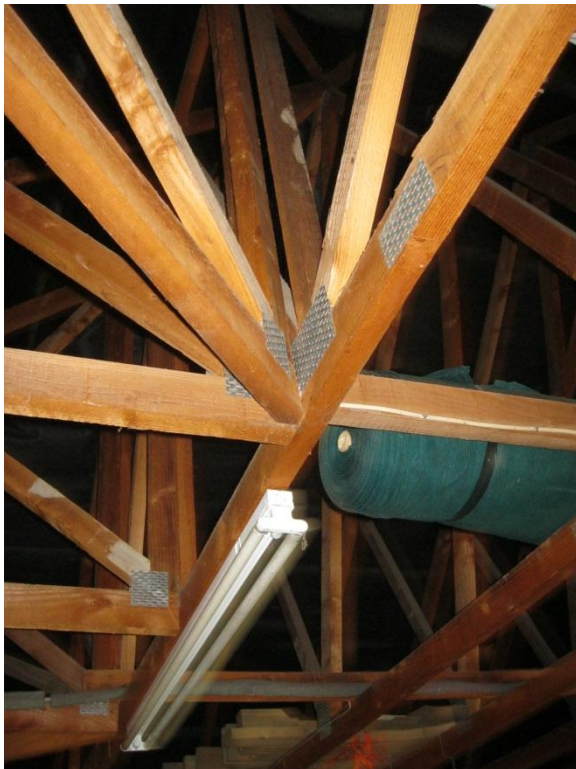
**Photograph 6**      **Internal roof trusses connection.**

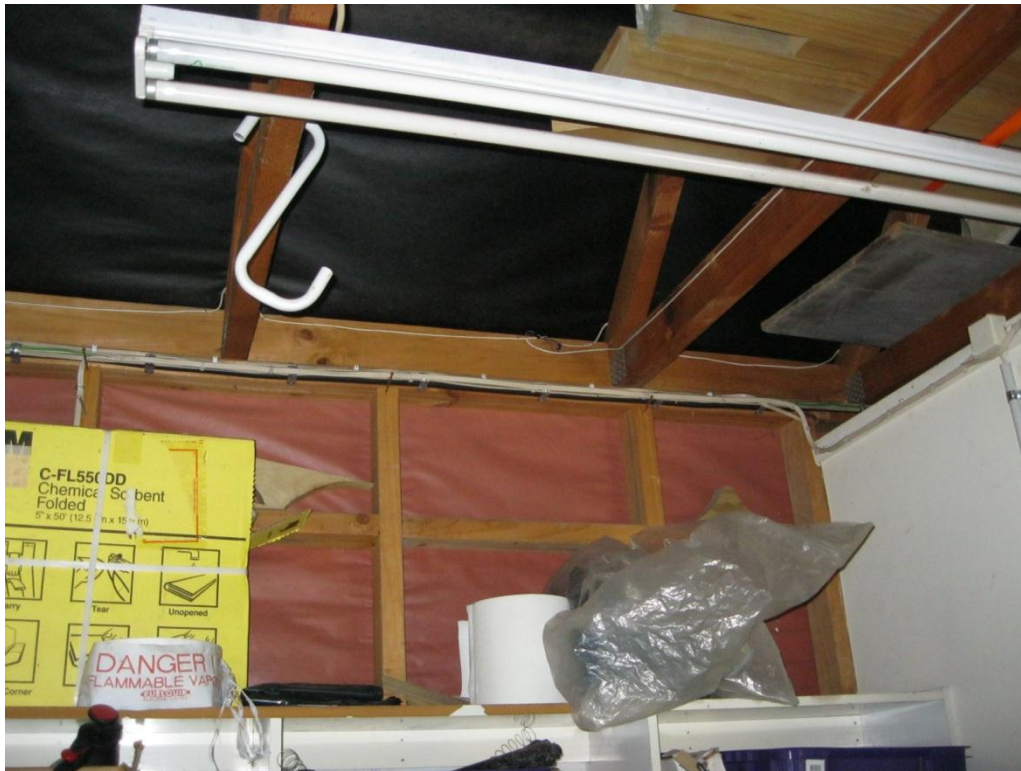
**Photograph 7** Connection between roof trusses and timber wall.

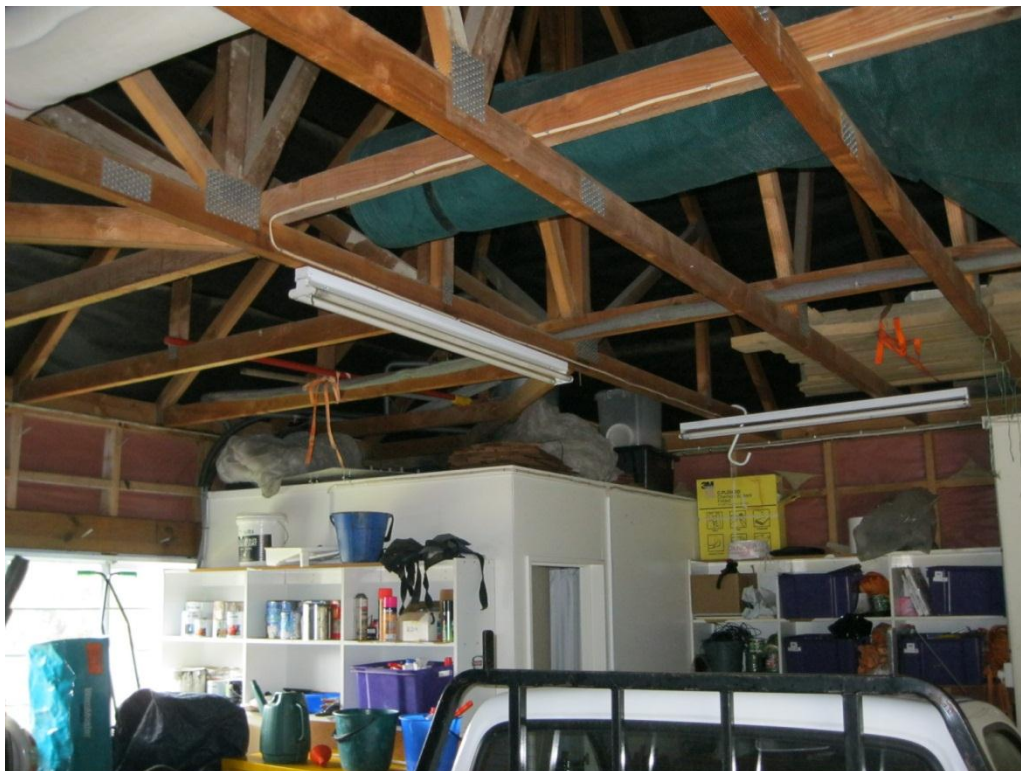
**Photograph 8** View of timber roof structure.
