Christchurch City Council
PRK_0555_BLDG_015 EQ2
Summerhouse Rose Garden
Mona Vale, 65 Fendalton Road

QUALITATIVE ASSESSMENT REPORT
FINAL

- Rev B
- 30 April 2013

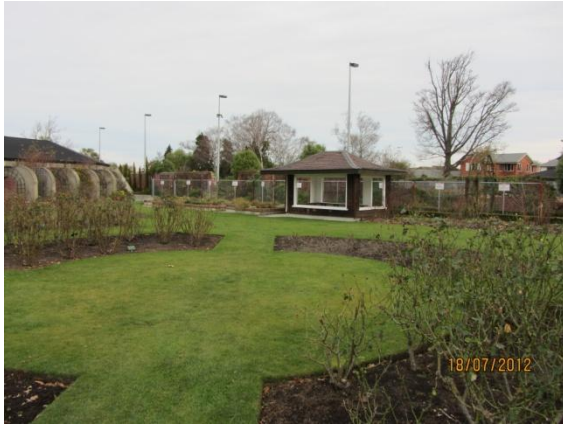
Photo 1: Rose garden with summerhouse in the background

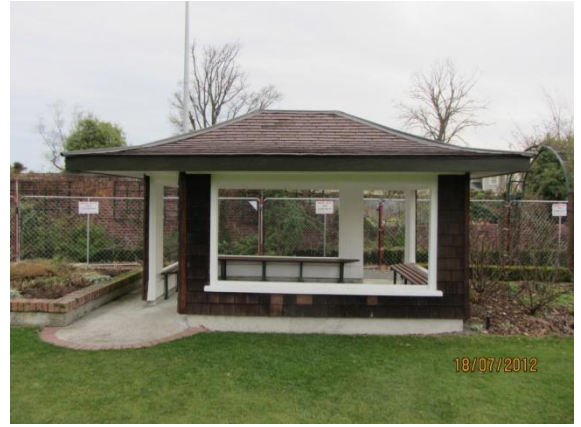
Photo 2: East Elevation

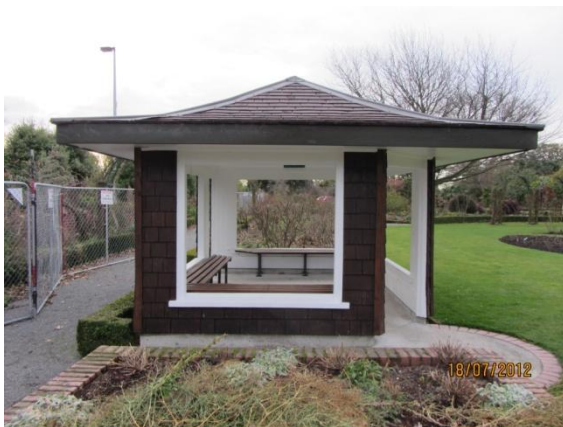
Photo 3: South Elevation

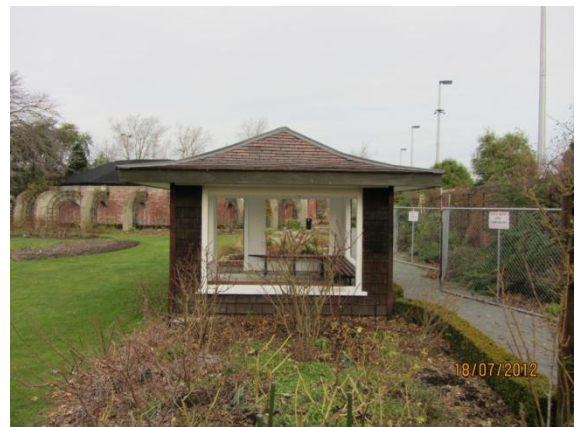
Photo 4: North Elevation

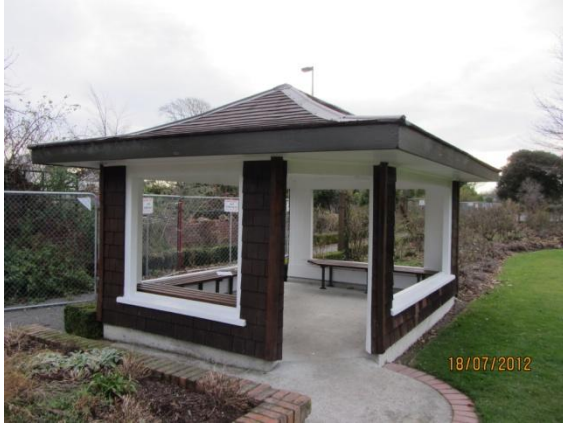
Photo 5: North East Elevation

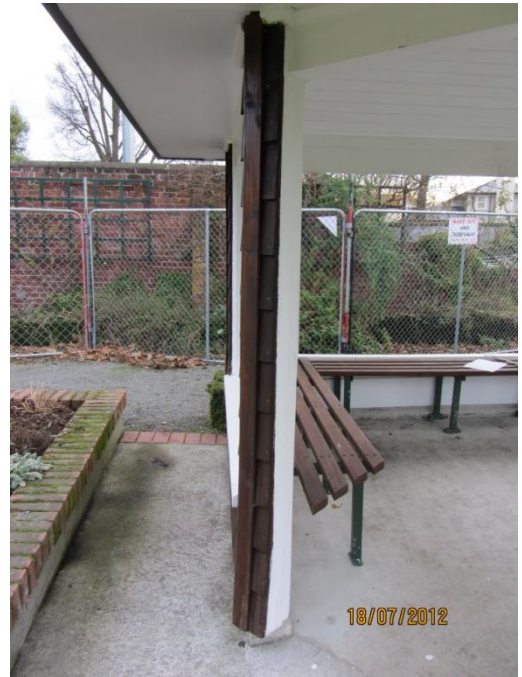
Photo 6: Timber framed wall

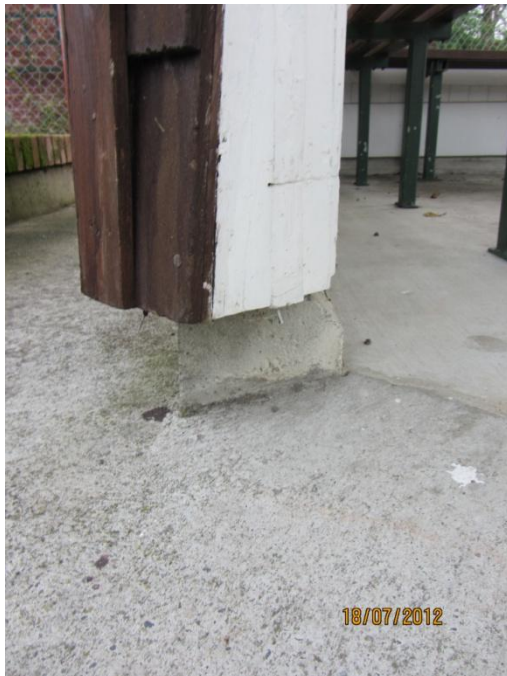
Photo 7: Concrete strip footing

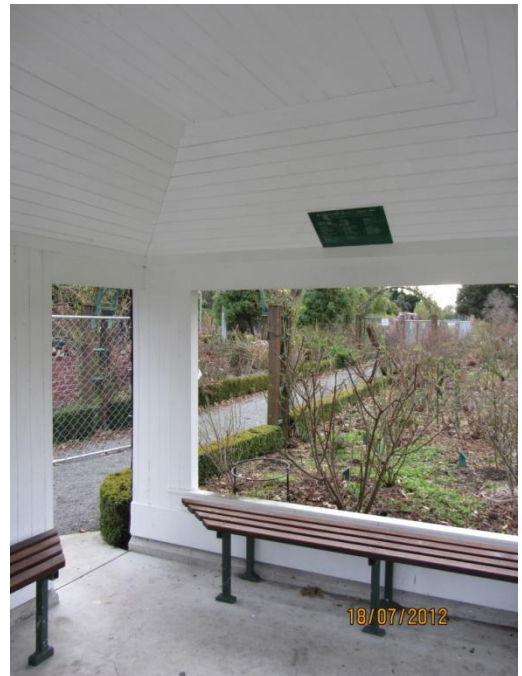
Photo 8: Internal view of the summerhouse, with plaque attached to ceiling

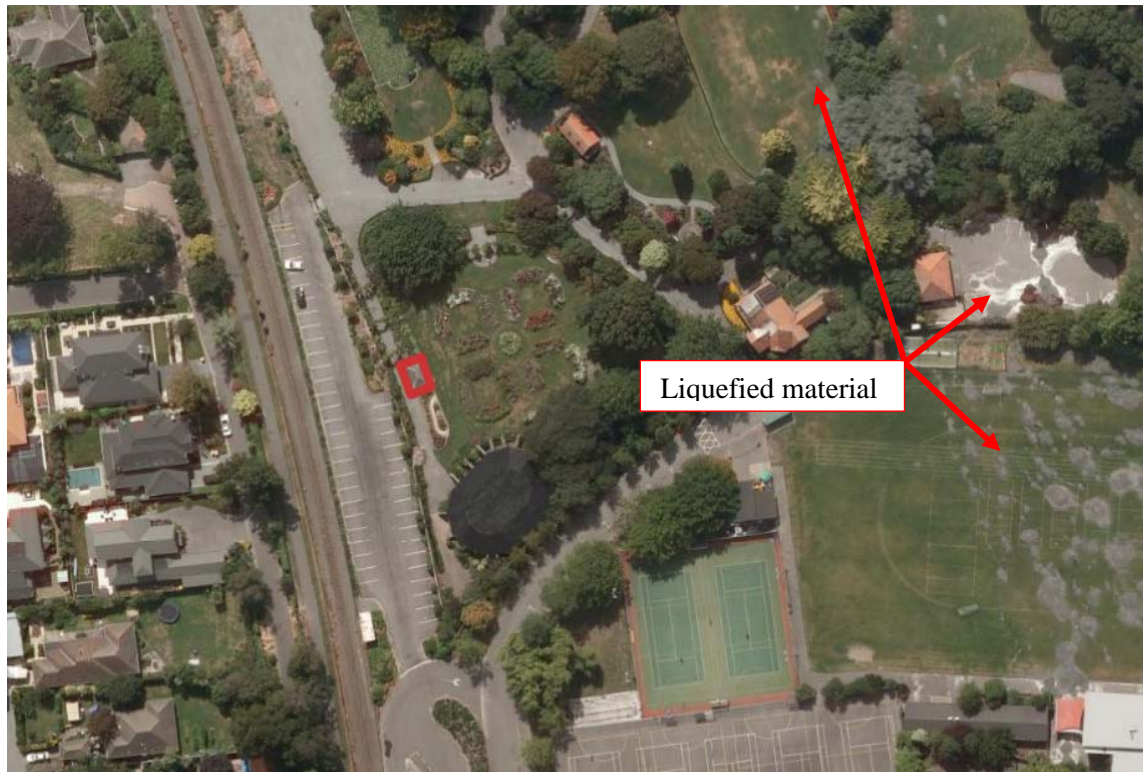
■ **Figure 5 – Aerial photography from 24 Feb 2011 (<http://viewers.geospatial.govt.nz/>)**

The location of the site is marked in red. Aerial photography shows no evidence of liquefaction at the site but an evidence of liquefaction approximately 100 m to the east of the site which coincides with the existing ground investigation data.

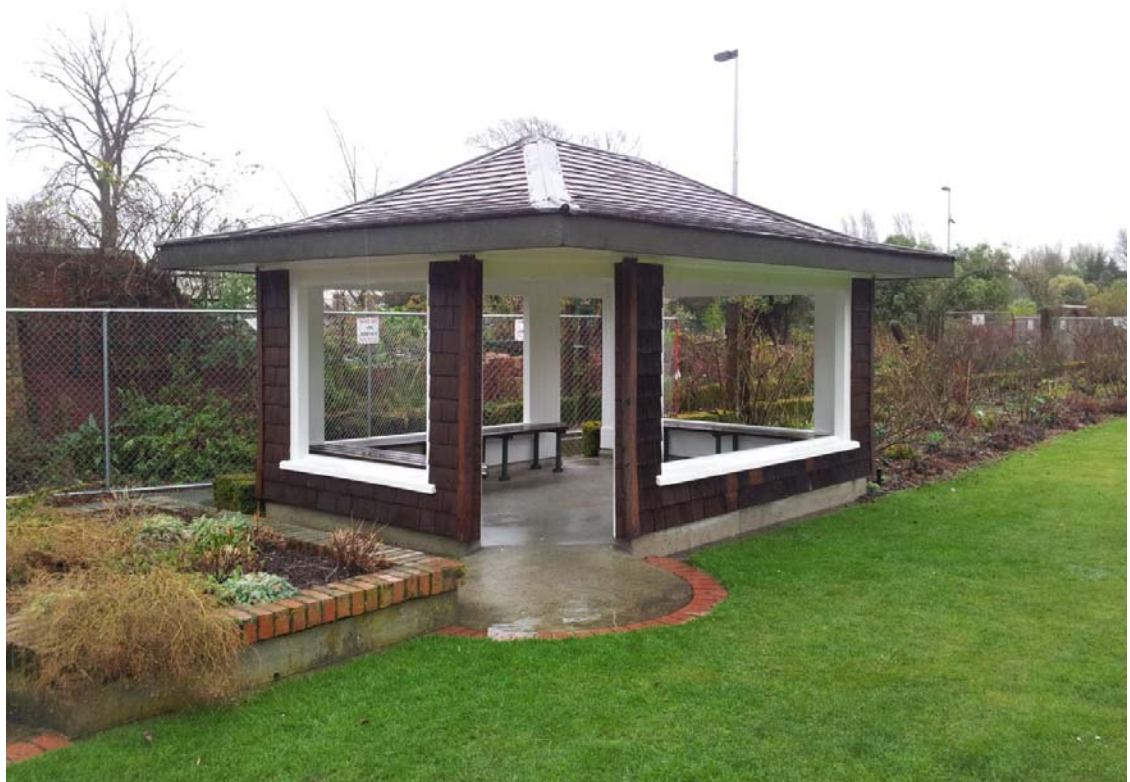
The building was a timber structure (frame and clad) with a timber framed roof that is used as a garden shelter at Mona Vale. The foundation appeared to be a concrete perimeter strip footing with a slab on grade flooring system. There was no obvious structural damage to the building, and no apparent evidence of liquefaction or settlement of the structure was observed.

■ Figure 7 - Overview of the building (north east elevation)

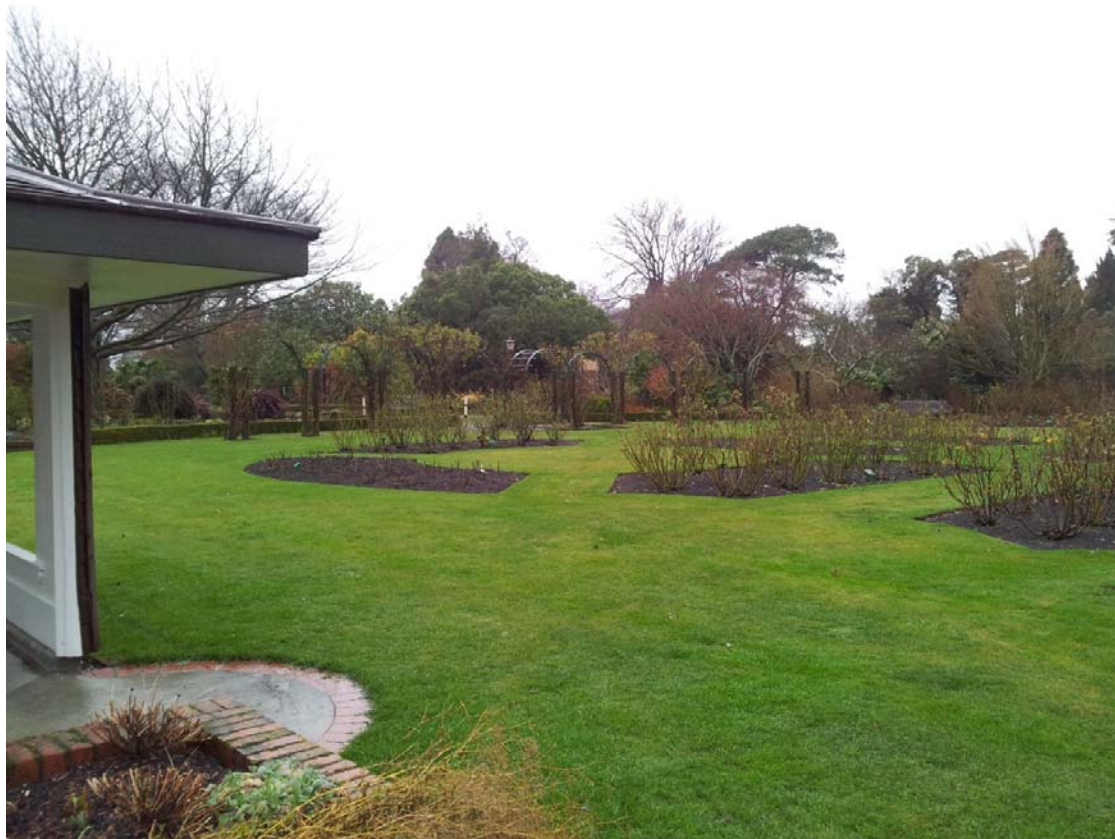
- Figure 8 - No visible liquefied material on the Rose Garden next to the building
