Moncks Spur Reserve Pump Station
#3

Qualitative Engineering Evaluation

PRK 2644 BLDG 001

177 Moncks Spur Road

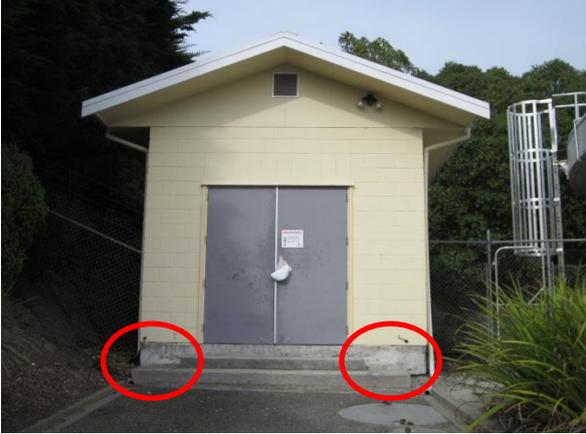
There was no observed damage to the Moncks Spur Reserve Pump Station #3 as a result of the recent seismic action. Buildings of this nature have a high bracing capacity for their weight. No damage was found on the wall linings. Very slight spalling was observed on the foundation's front façade (west elevation) however this does not affect the structural performance of the building.

<p>Building western elevation.</p> <p>Slight spalling on foundation.</p>

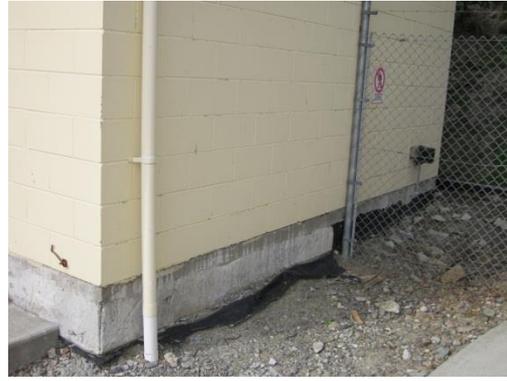
Southern elevation the Moncks Spur Reserve Pump Station #3.

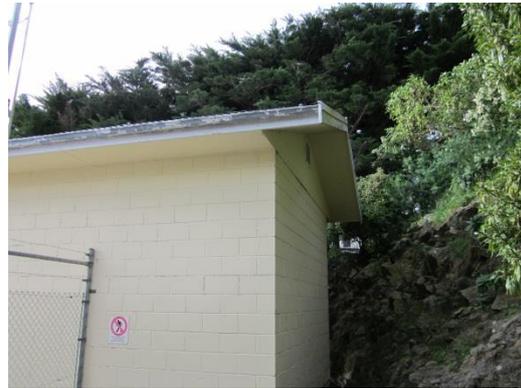
South-eastern elevation the Moncks Spur Reserve Pump Station #3.

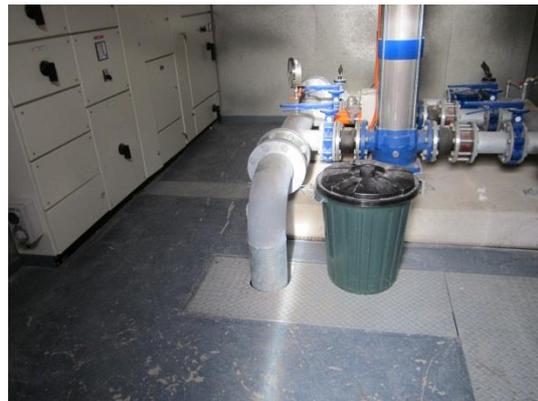
Internal view of the pump station.
