**Mooray Avenue
Housing Complex
PRO 0310**

**Detailed Engineering Evaluation
Quantitative Assessment Report**

**23 and 25 Mooray Street, Bishopdale,
Christchurch 8051**

Date: December 2013
Reference: 6-QC382.00
Status: Final

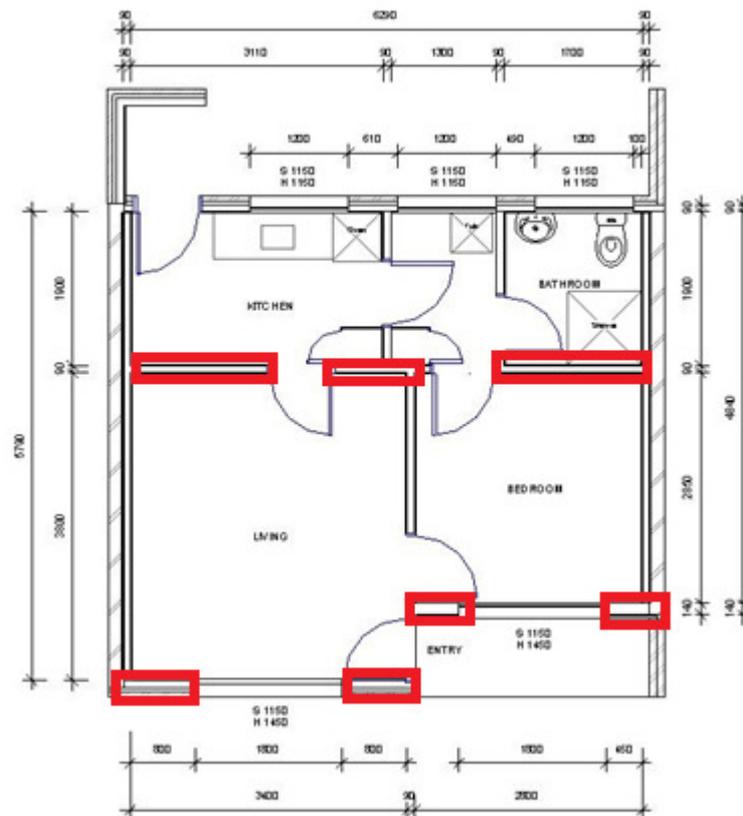
Figure 6: Walls used for bracing in the longitudinal direction.

The residential units have a capacity of 54% NBS as limited by the in-plane shear capacity of the timber-framed shear walls in the longitudinal direction. They are deemed to be a 'moderate risk' in a design seismic event according to NZSEE guidelines. Their level of risk is 5-10 times that of a 100% NBS building.

Hand calculations were performed to determine seismic forces from the current building codes. These forces were applied globally to the structure and the capacities of the walls were calculated and used to estimate the %NBS. The walls, highlighted in Figure 6 and Figure 7, were used for bracing in their respective directions.

- Strengthening schemes be developed to increase the seismic capacity of the residential units to at least 67%NBS.
- Veneer at height (gable ends) have their veneer ties checked.
- Cosmetic repairs be undertaken as required.

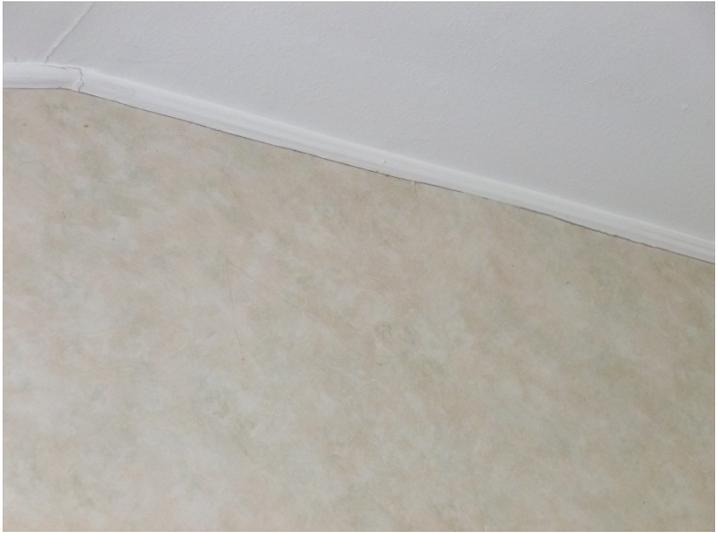
Minor cracking in the internal GIB was observed in all units (photos 3-5). This was predominantly located along the line where the ceiling changed angle and along the firewall. This was consistent through all units.

<p>3.</p>	<p>Typical cracking at ceiling line</p>

- Strengthening schemes be developed to increase the seismic capacity of the residential units to at least 67%NBS.
- Veneer at height (gable ends) have their veneer ties checked.
- Cosmetic repairs be undertaken.

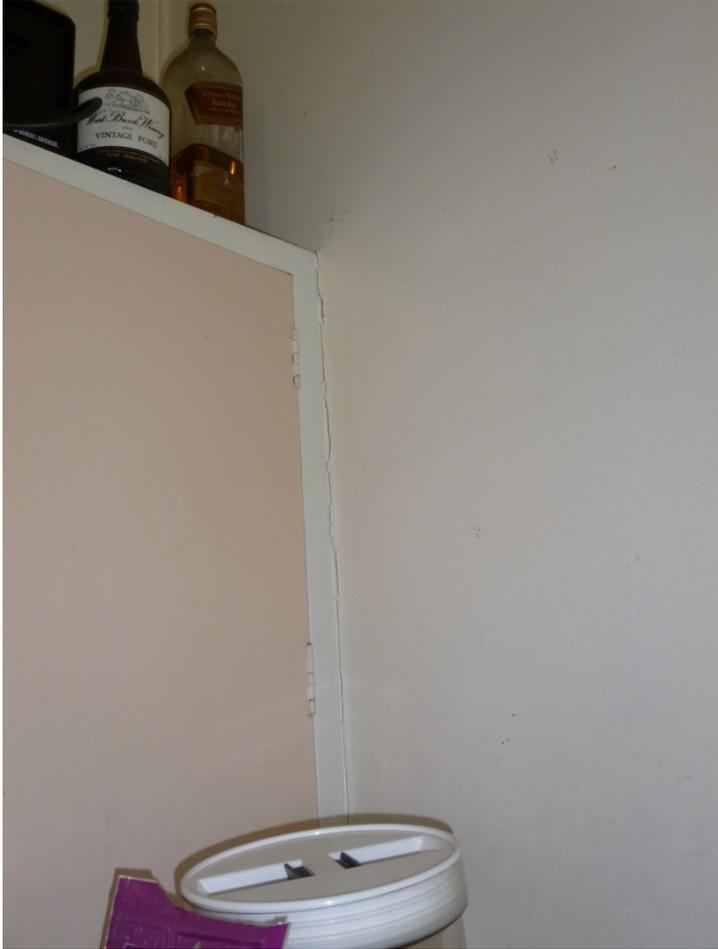
<p>4.</p>	<p>Typical cracking around joinery</p>

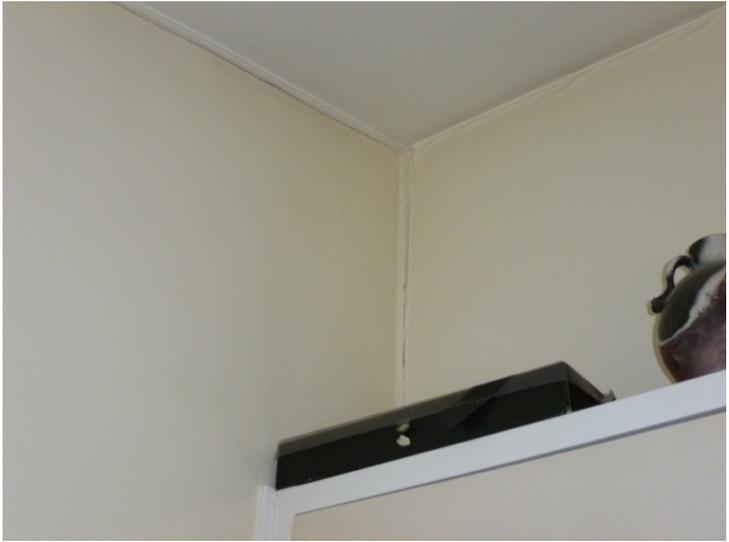
5.	Typical cracking of moulding

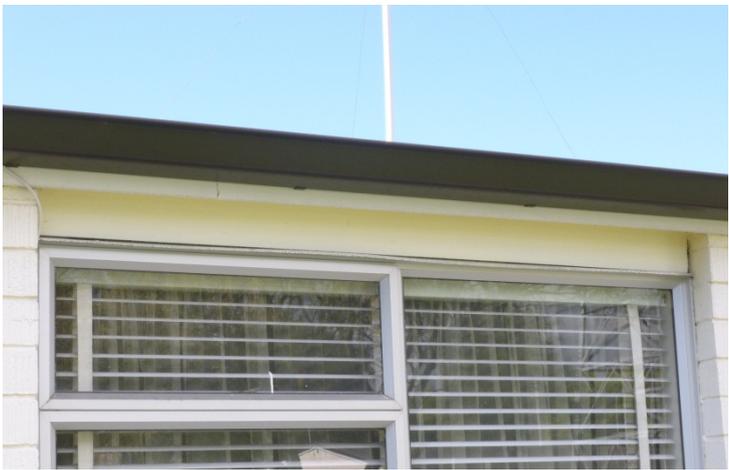
It was noted that there was some separation cracking between the fire wall and the longitudinal walls. It was also observed that most of the windows have moved down slightly, resulting in a gap appearing along the top (photo 6). A loose veneer block was observed at the end of Block B (photo 7).

6.	Typical gap above windows

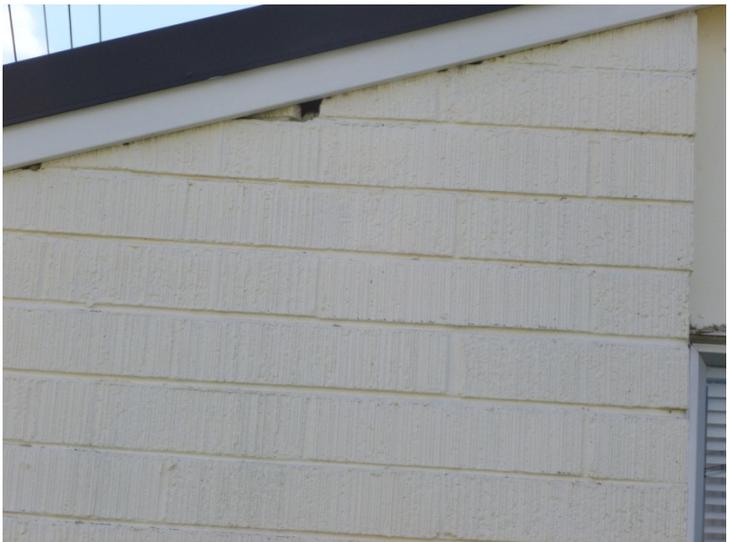
7.	Loose brick at the end of Block B
