Nayland Street Housing Complex PRO 1454

**Detailed Engineering Evaluation
Quantitative Assessment Report**

Quantitative Assessment Report

130 Nayland Street, Sumner,

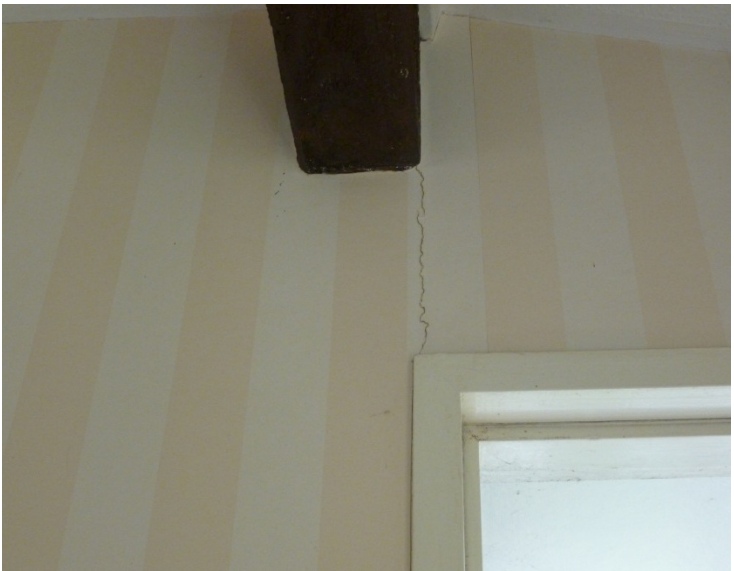
No significant damage to internal plasterboard lining was observed in any of the units. Minor vertical cracking was observed in the linings above and below doors and window frames, this was consistent in all units (photos 9 and 11).

9.	Typical vertical crack from front door

- Veneer at height (gable ends) have the veneer ties checked.
- The separation between the veneer and firewall be repaired.
- Repair work be carried out to repair the separation between Units 3 and 4, including foundations.
- Cosmetic repairs be undertaken as required.
- Strengthening schemes be developed to increase seismic capacity of Block A to 67%NBS.

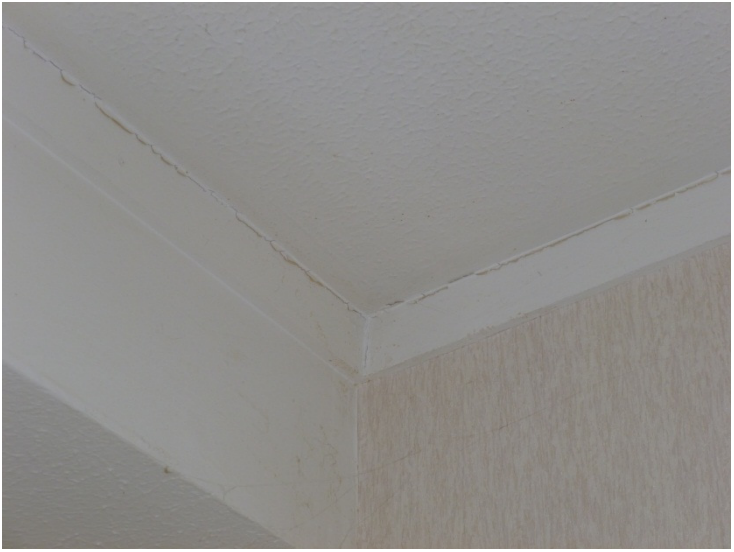
Minor non-structural damage was observed in all flats. Separation cracking around the ceiling was common (photo 10). This form of damage was observed to be more significant in Unit 4.

10.	Typical separation cracking between ceiling and wall

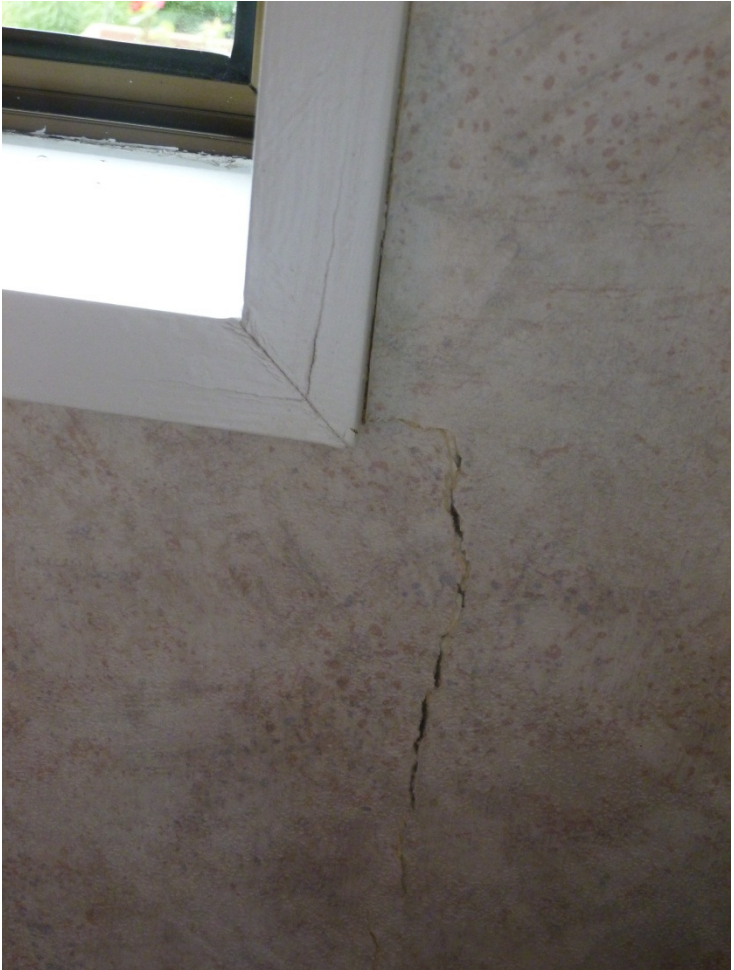
11.	Typical cracking from corner of bedroom window in Unit 4

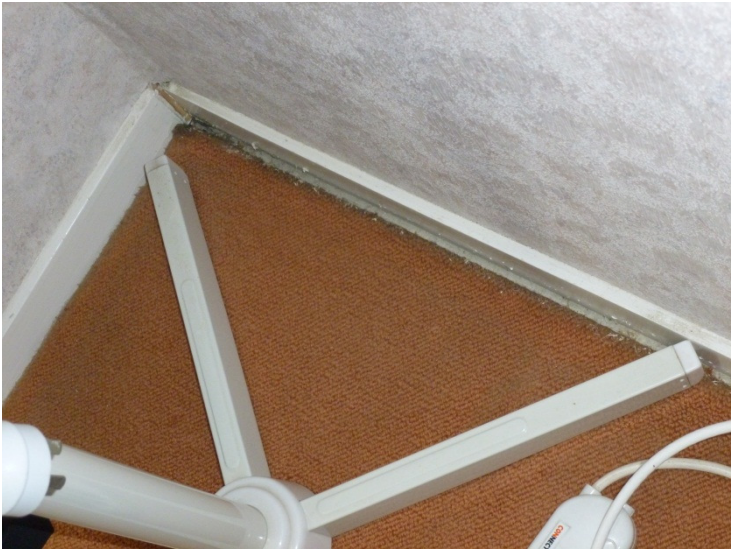
Significant separation along the firewall was observed in Unit 4 (photos 12 and 13), corresponding to exterior separation of the veneer and firewall (photo 14).

12.	Separation of floor and wall along firewall in Unit 4

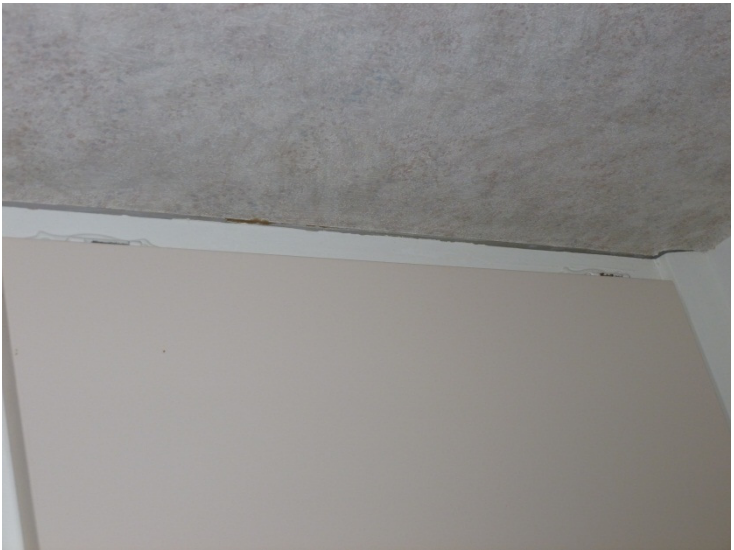
13.	Separation between ceiling and wall along fire wall in Unit 4

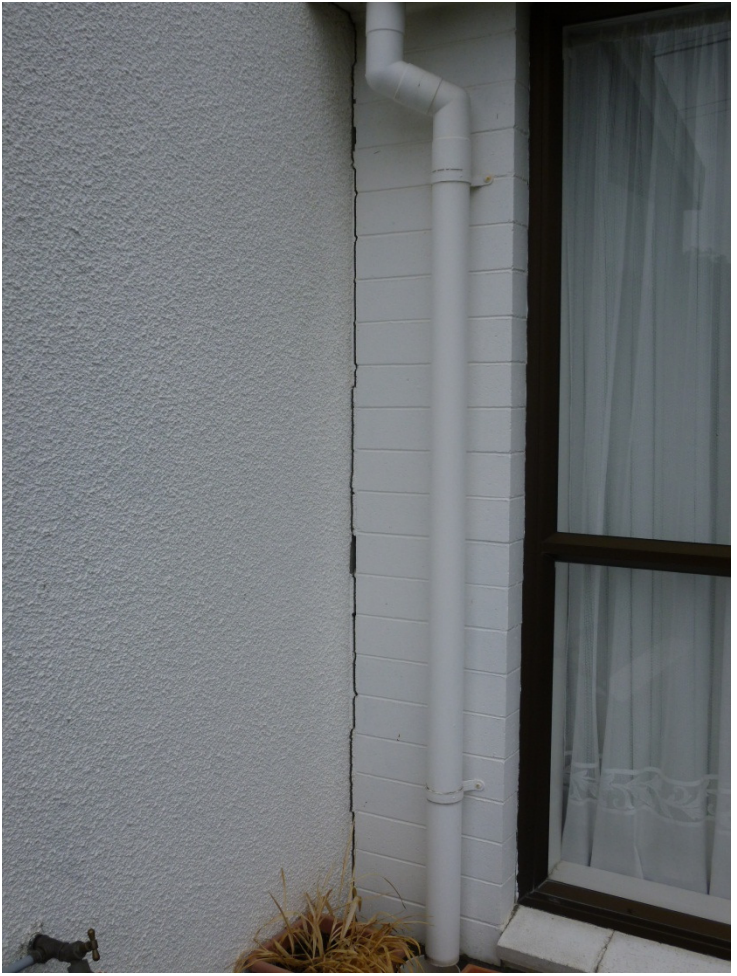
14.	Splitting between veneer and firewall (Units 3-4)

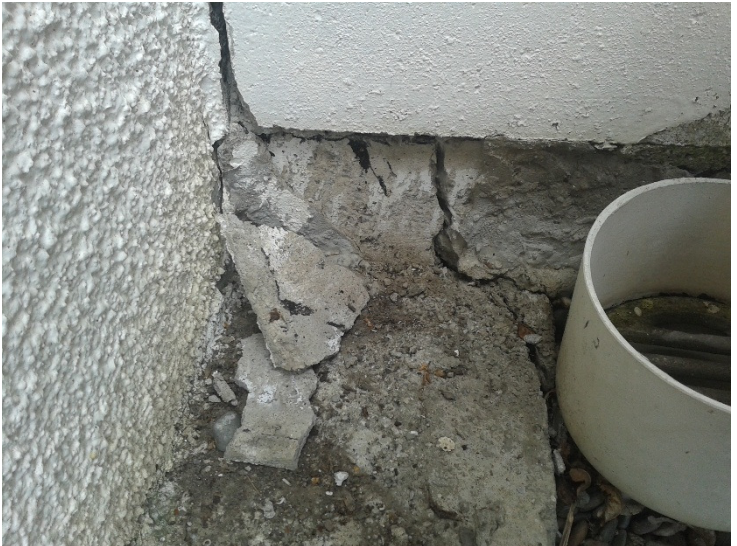
The crack seen between the lounge floor and firewall in Unit 4 is 10mm wide and propagates outside into a significant crack through the footing between Units 3 and 4 (photos 15 and 16). This is likely to have fractured the reinforcement crossing this crack.

15.	Foundation cracking at the base of split firewall between Units 3 and 4

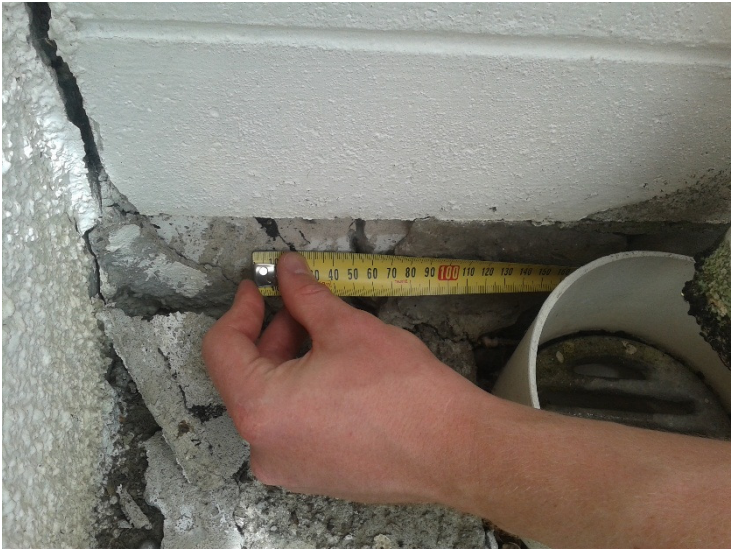
16.	Foundation cracking at the base of split firewall between Units 3 and 4

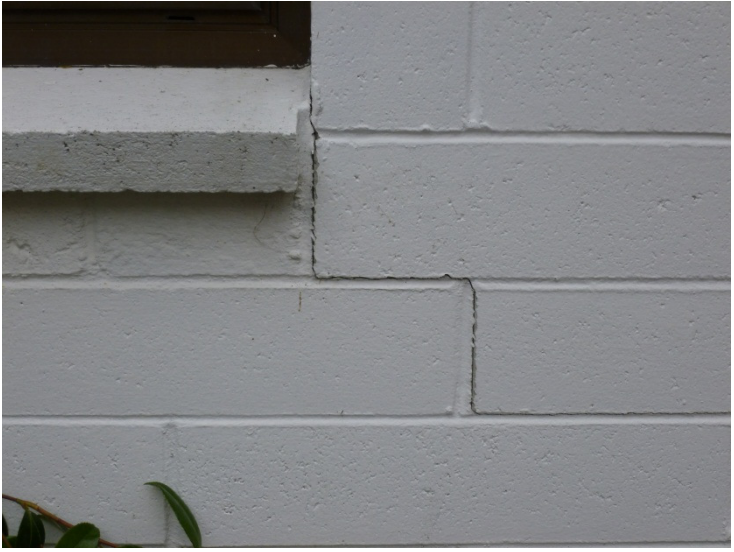
Stepped cracking in the exterior block veneer was observed in all units. A loose block in situ was observed in the veneer at Unit 1. Cracking of pathways was widespread.

17.	Typical stepped cracking in block veneer

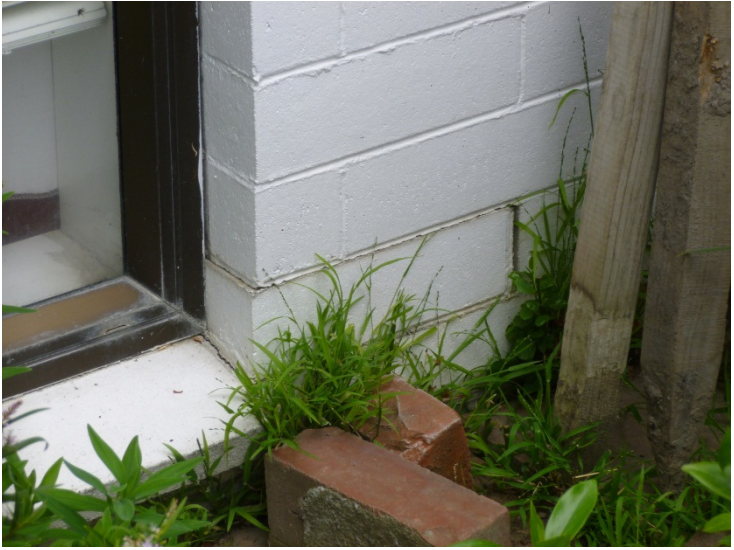
18.	Loose brick in veneer
