New Brighton Crèche Combined
Report
Qualitative Engineering Evaluation

Reference: 227257
Prepared for:
Christchurch City Council

Address: 109 Beresford Street

Date: 17 October 2013

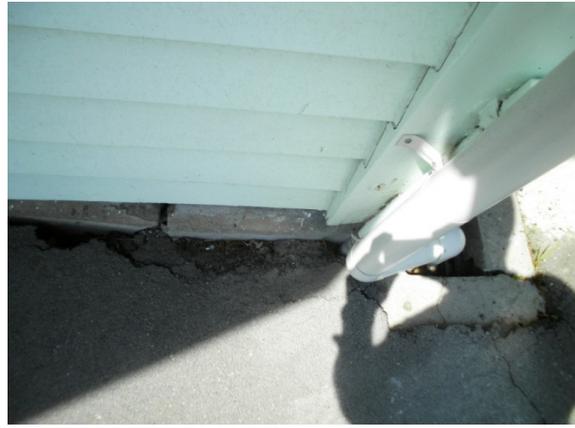
Horizontal crack in perimeter footing

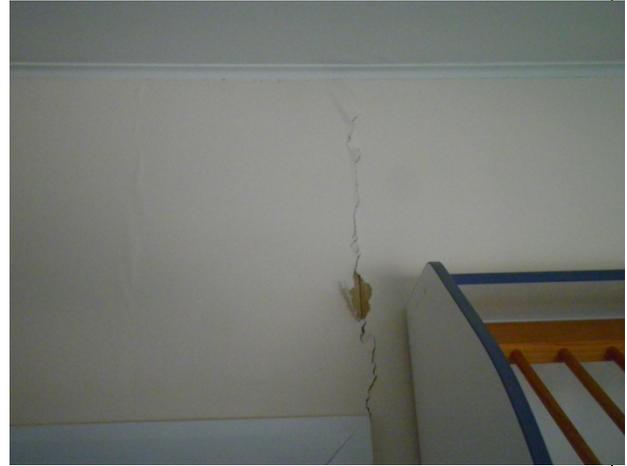
Cracks in ceiling, ceiling wall intersection and at intersection of wall.
