Christchurch City Council

PRK_1475_BLDG_001 EQ2

Toilets - Nicholson Park

QUALITATIVE ASSESSMENT REPORT

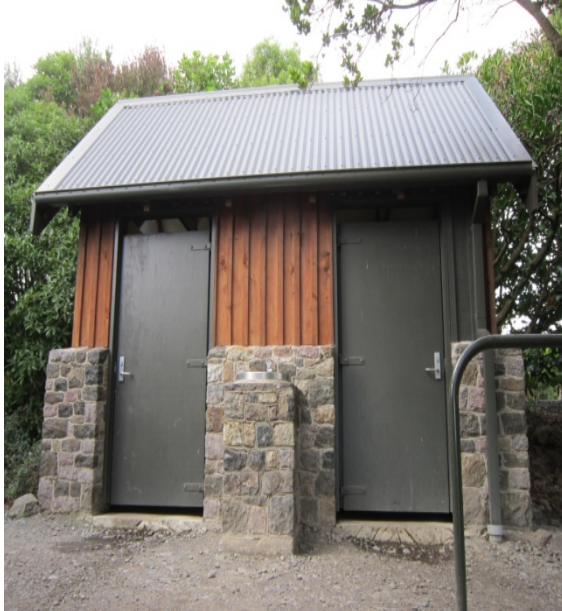
Photo 1: View looking east at the structures

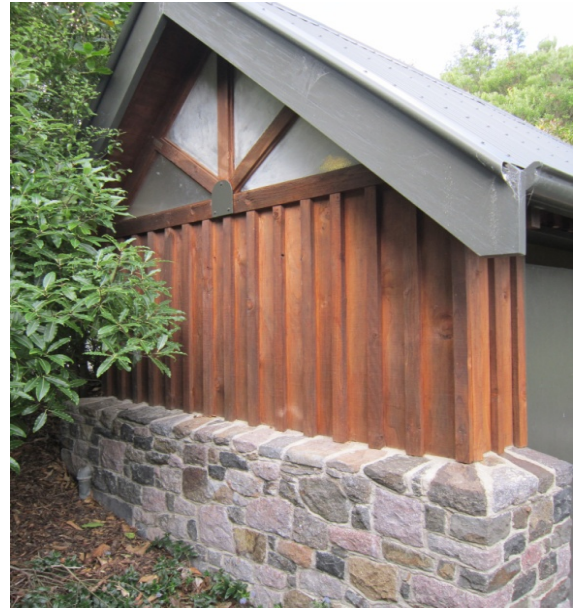
Photo 2: North side of the building showing construction – Steel cladding, timber roof trusses, light timber framed walls and stone masonry

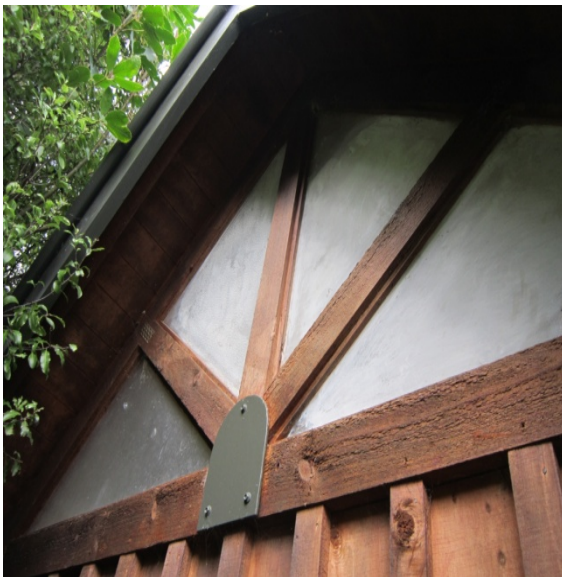
Photo 3: Close up of timber truss

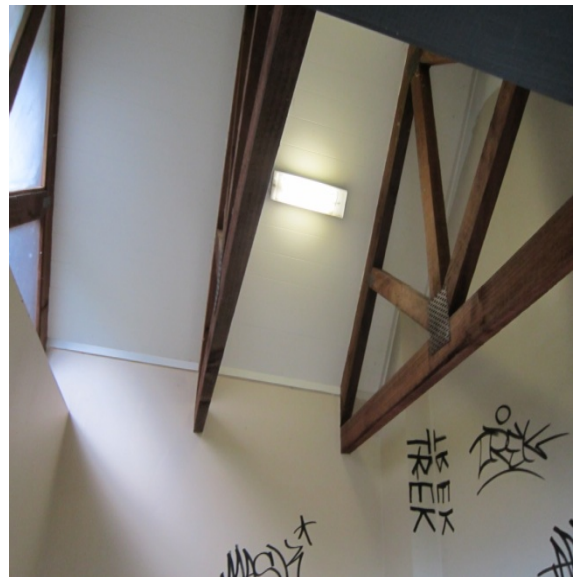
Photo 4: Timber trusses spaced at approx 800mm crs.

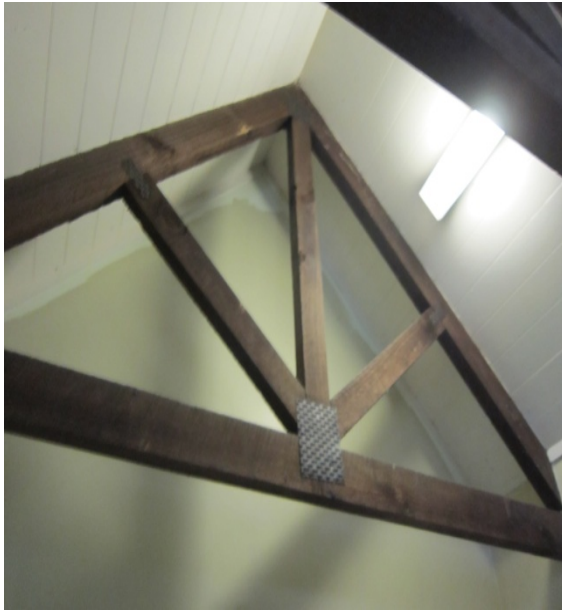
Photo 5: Trusses connected using nail plates which do not appear to have suffered damage

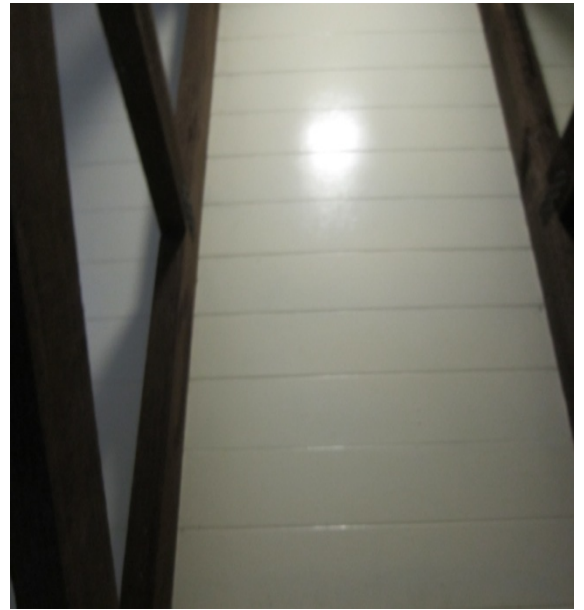
Photo 6: Tongue and groove roofing supports

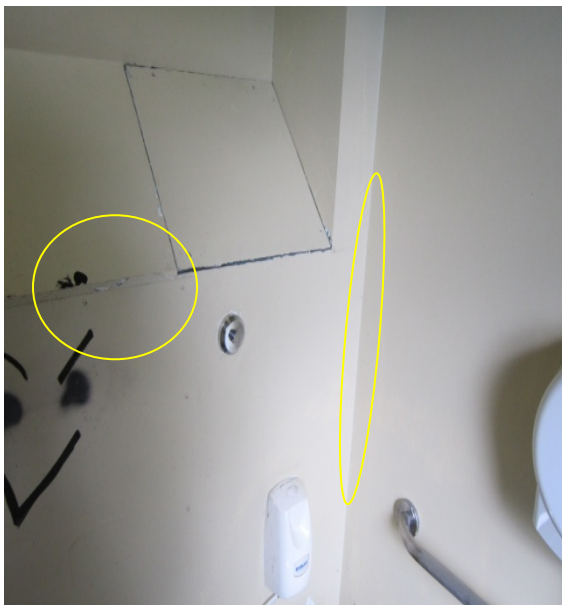
- 1) Hairline-0.4mm cracking of the concrete floor slab radiating from floor penetrations in both toilets. Photos 9 and 10
- 2) Separations opening at joints of internal plasterboard linings
Photos 7 and 8

Photo 7: Separations of internal lining along joint lines

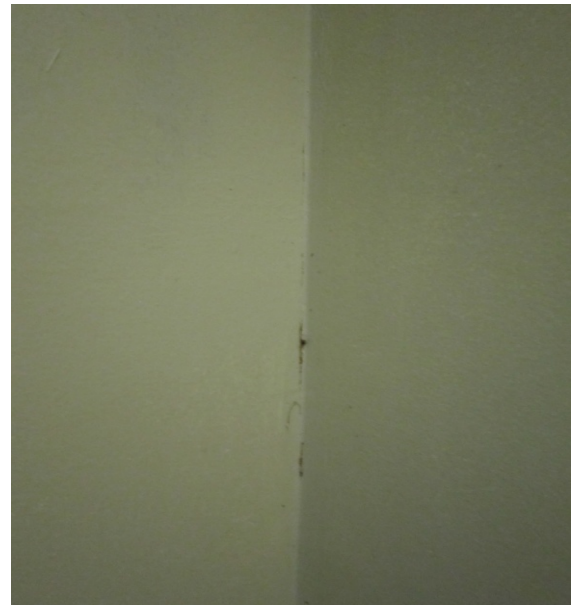
Photo 8: Typical separation of linings in corners

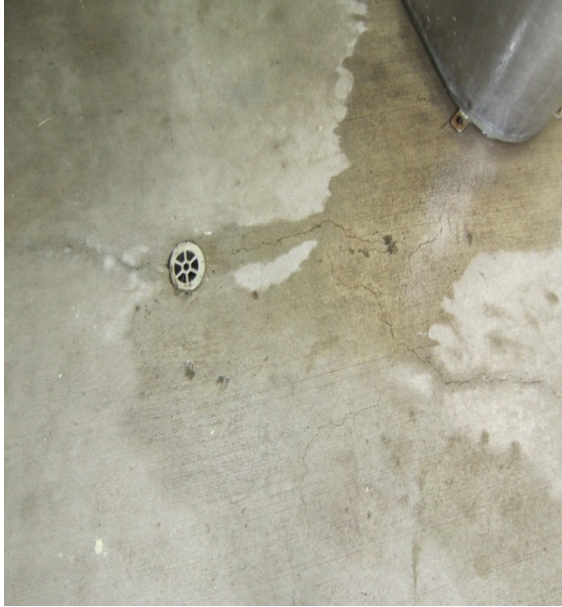
Photo 9: Cracking propagating through floor slab from drainage penetration hairline ~ 0.4mm cracks

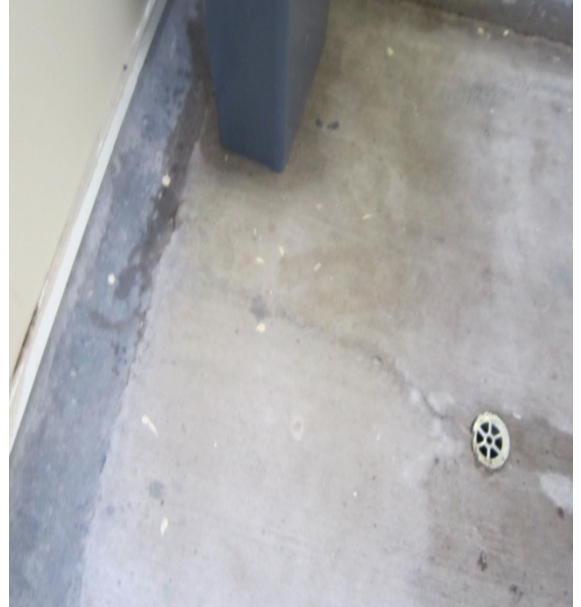
Photo 10: Similar cracking in both toilets

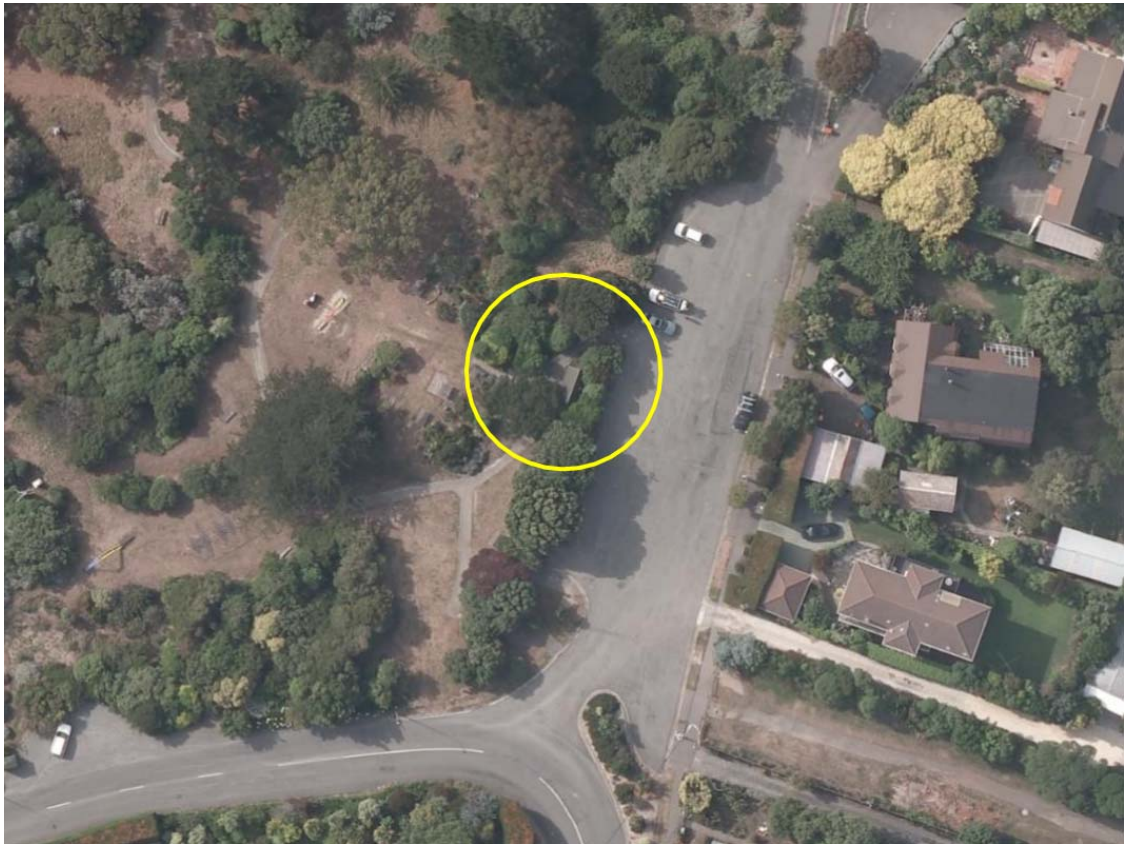
■ **Figure 4 – Aerial photography from 24 Feb 2011 (<http://viewers.geospatial.govt.nz/>)**

Aerial photograph of the site taken shortly after the 22 February event shows no visible surface evidence of any land damage or damage to the property or neighbouring properties..

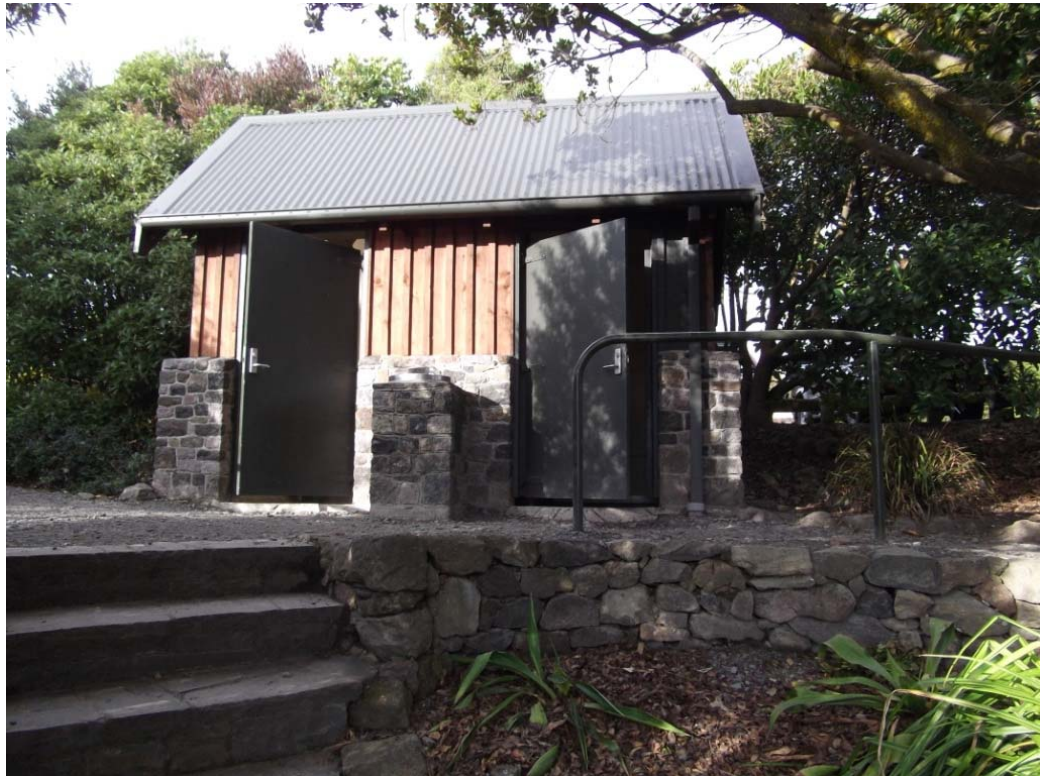
The building was noted to be a light weight timber structure with stone masonry around the lower 1 m of the walls, sheet metal roof and slab on grade foundation. A crack less than a 1 mm wide was noted in the concrete ground slab in the northern toilet. It is difficult to determine whether this is related to construction or the earthquakes. No cracking was noted in the hard pack gravel paths around the toilet building.

■ **Figure 5 - Overview of the building (western wall).**

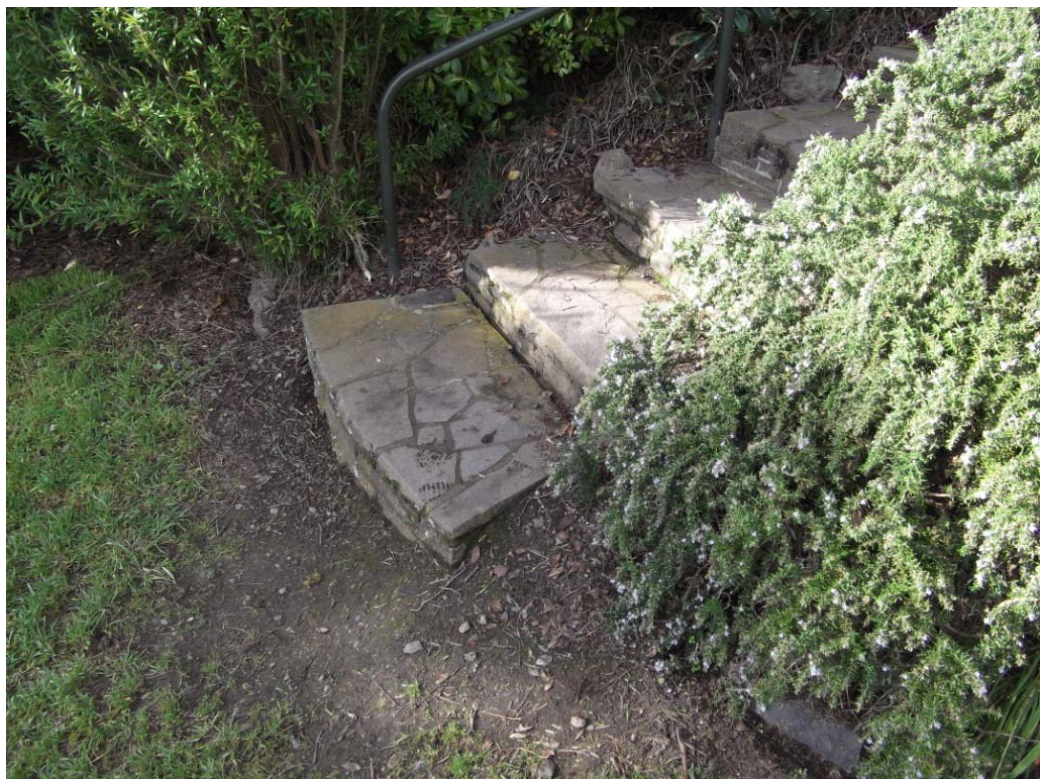
A 5mm gap/separation was noted between two of the stairs approximately 10 and 15 m west of the building. The movement is localised to the individual steps and is likely due to settlement of the fill immediately below the steps.

■ **Figure 6 – 10 mm crack in between steps approximately 15m west of the building.**

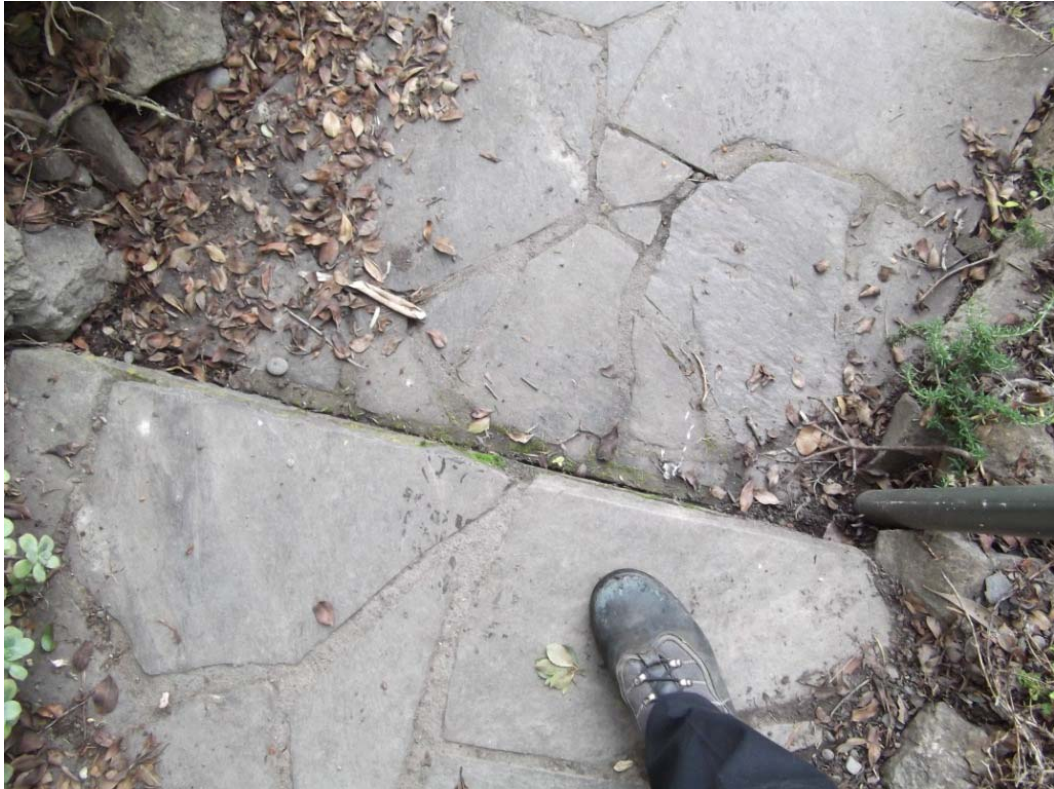
- **Figure 7 – 5 mm crack between steps approximately 10m west of the building.**
