# Norman Kirk Memorial Pool - Lean-to Shelter Detailed Engineering Evaluation BU 3513-006 EQ2 Qualitative Report

**Prepared for Christchurch City Council (CCC)**

**By Beca Carter Hollings & Ferner Ltd (Beca)**

12 July 2013

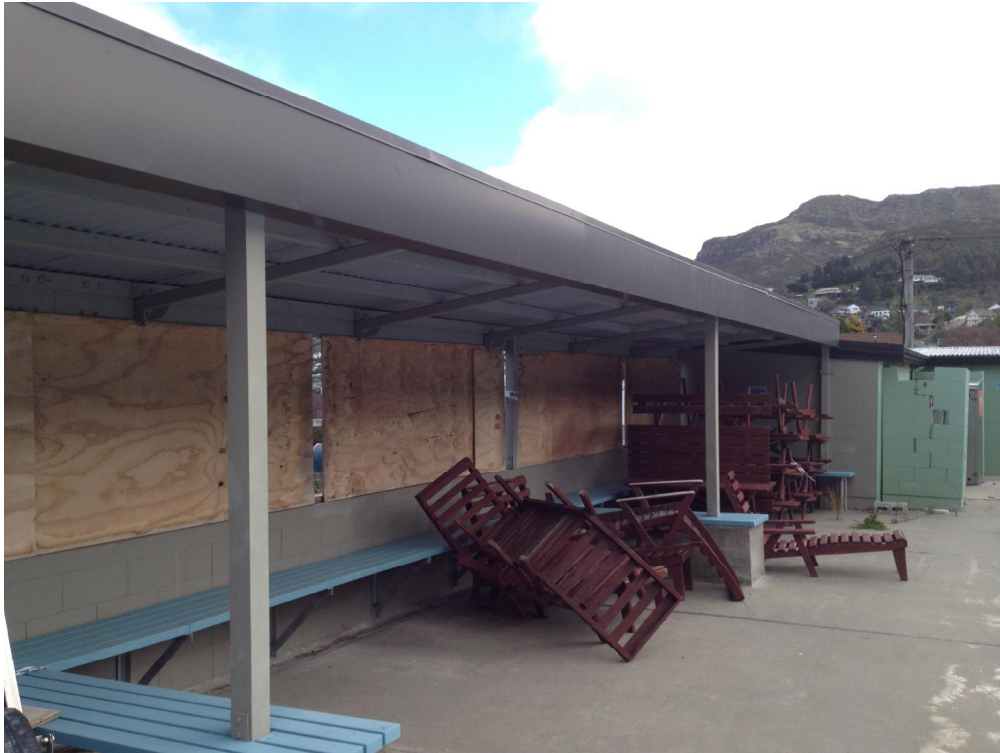
**Photo 1:** External view of Lean-to Shelter (view from north-east). Temporary plywood cladding has been installed to replace the broken glazing.

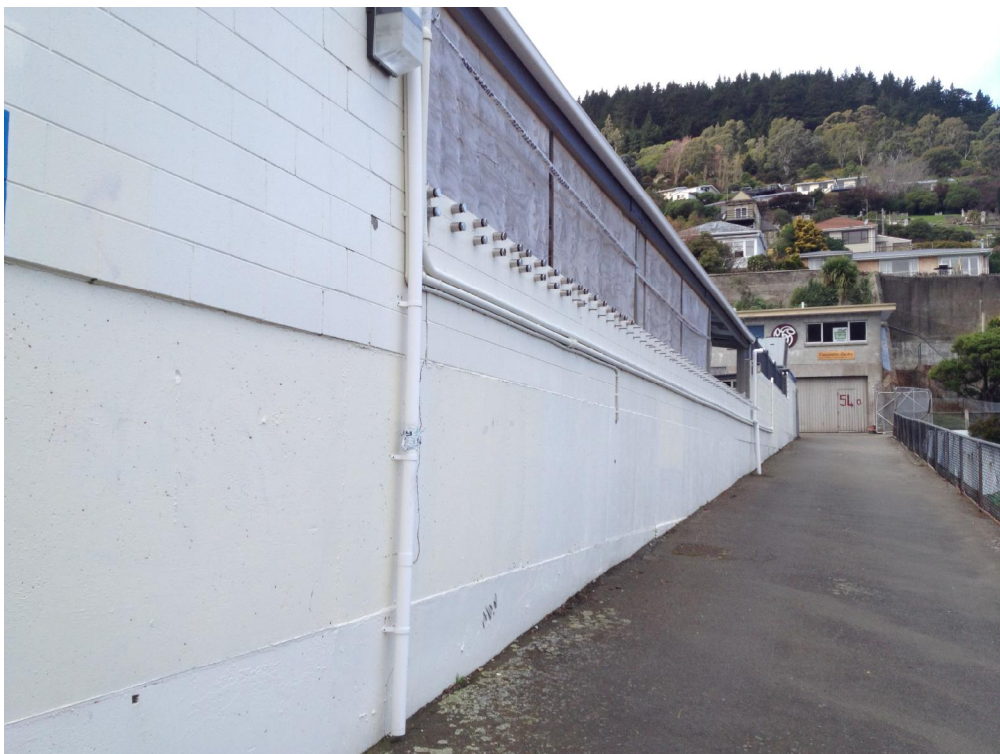
**Photo 2:** External view of Lean-to Shelter and retaining wall (view from south-west).

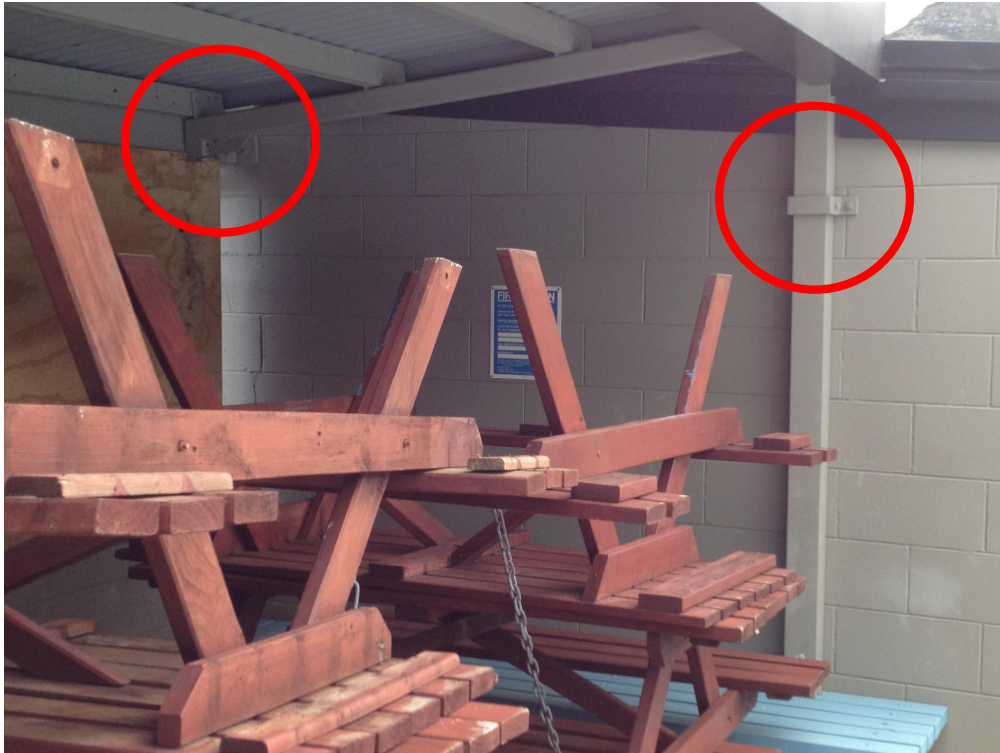
**Photo 3:** Connections to adjacent Ladies' Change Room eastern masonry wall.

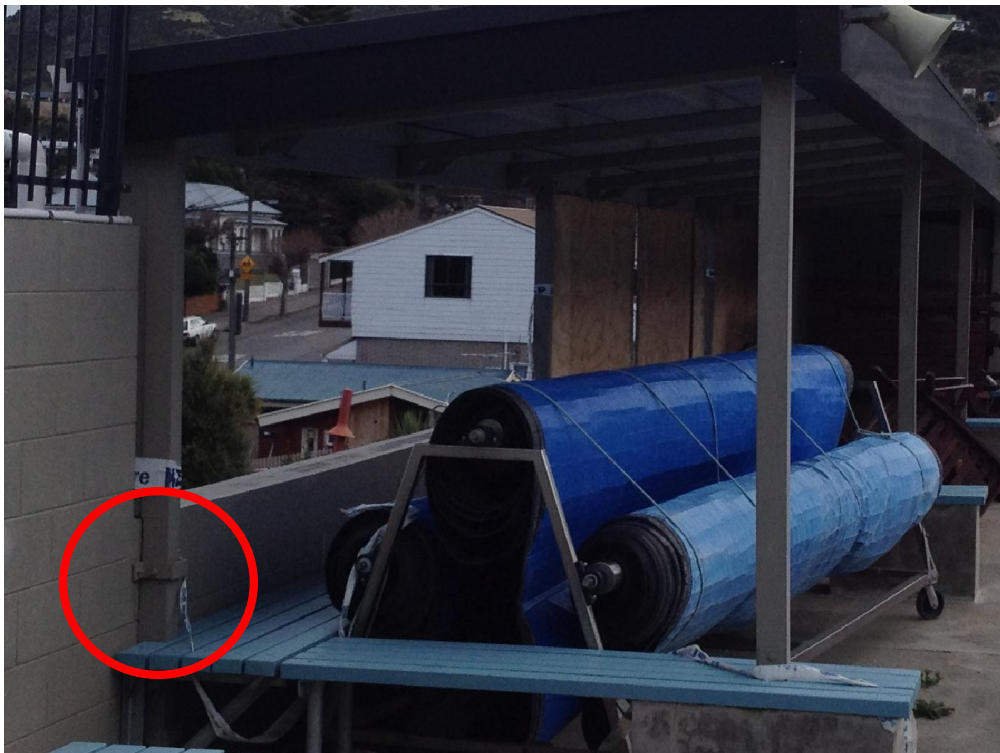
**Photo 4:** Connection to concrete masonry wall extending to the east.

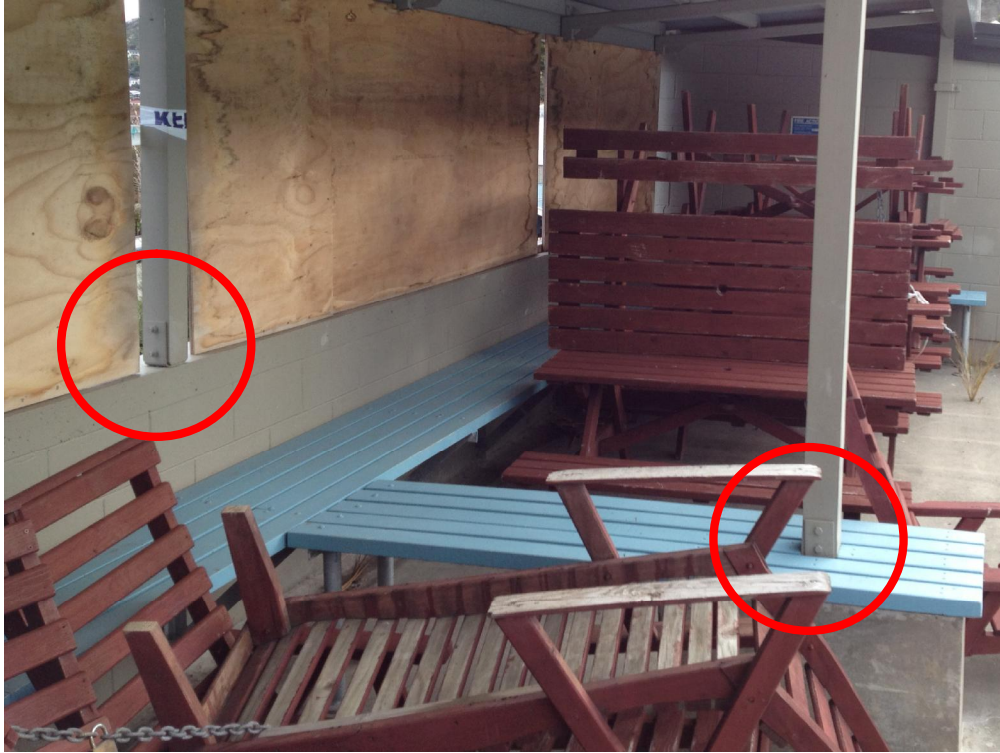
**Photo 5:** U-bracket connections between columns and concrete plinth (on the right) and concrete masonry wall (on the left).

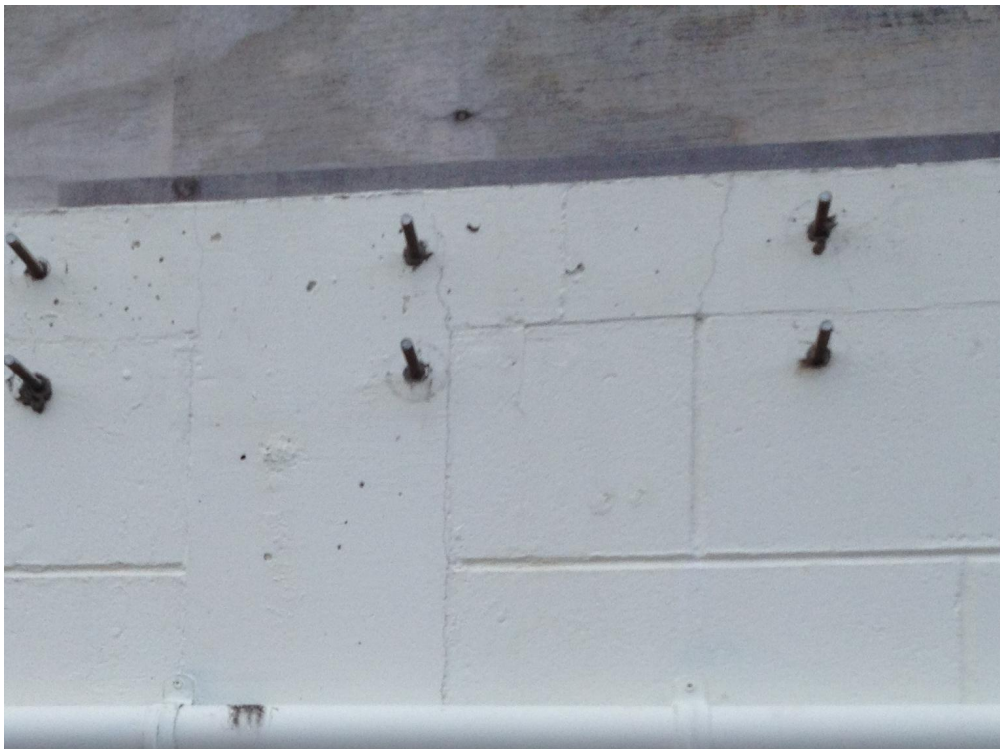
**Photo 6:** Concrete bond beam on top of the partial-height masonry block wall (view from south).

**Damage Description:** Cracking to concrete band beam.

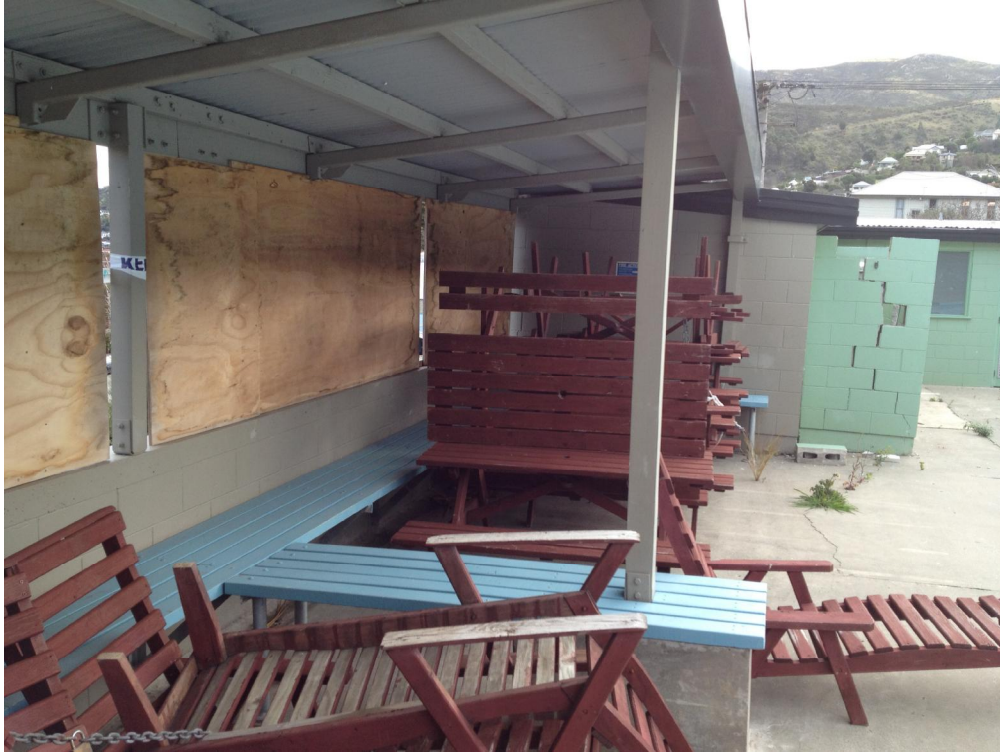
**Photo 7:** Lean-to Shelter structure (view from east).

**Damage Description:** Bowing of timber columns.

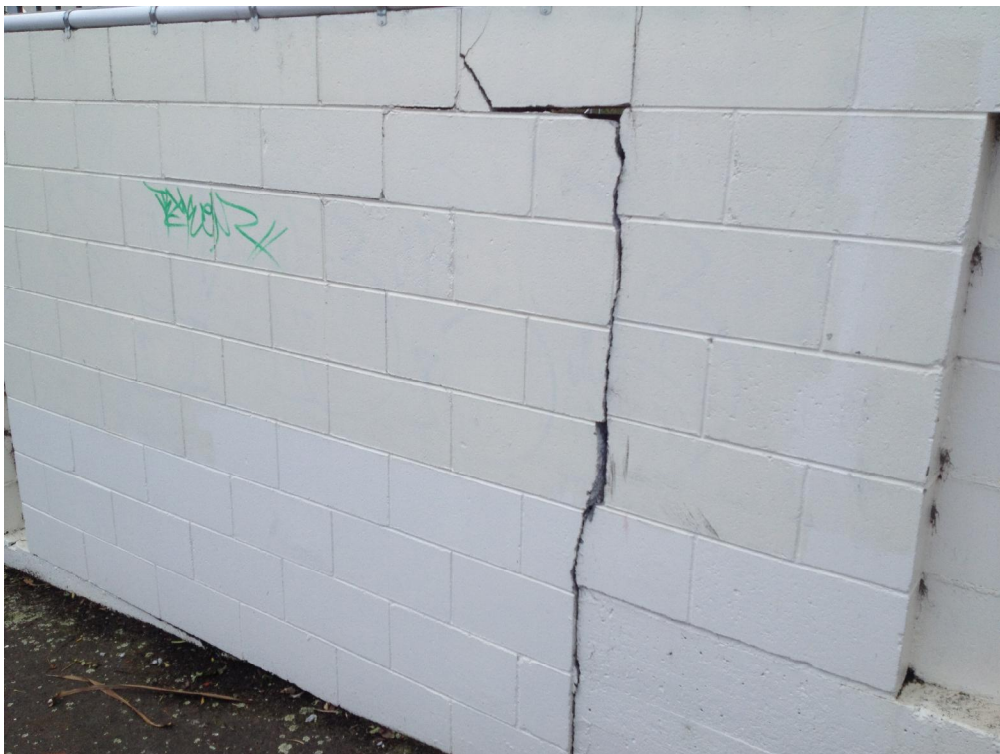
To the east of the Lean-to Shelter (along the driveway to the south of the site) is a partially filled and lightly reinforced concrete masonry block wall that sustained damage to both the blocks and mortar. The cracking is vertical in nature and the damage observed suggests local differential settlement. It was identified that the likely cause for the differential settlement is the founding of the concrete masonry wall on two concrete retaining walls (refer Photo 6 in Appendix A). The differential settlement on the western side of the cracking coincides with the differential settlement and sloping pavement in the Lean-to Shelter proximity.

**Photo 8:** Adjacent concrete masonry block wall along driveway between Main Plant Room and Lean-to Shelter. The Lean-to Shelter is to the left of this photo (view from south).

**Damage Description:** Cracking and differential settlement of concrete masonry block wall.

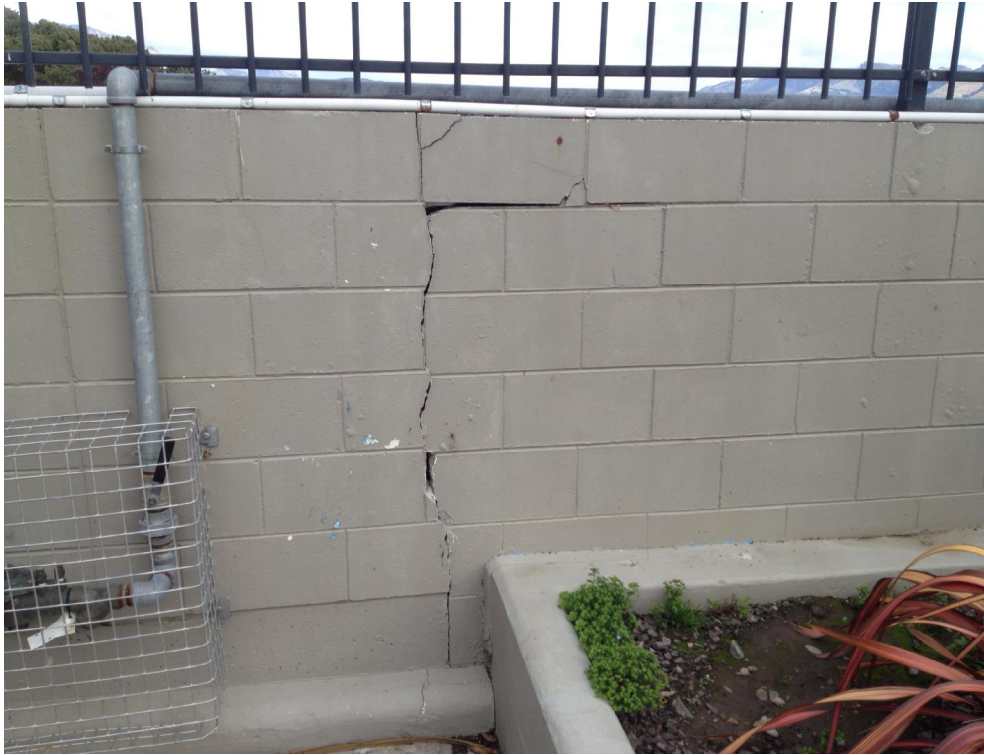
**Photo 9:** Adjacent concrete masonry block wall along driveway between Main Plant Room and Lean-to Shelter. The Lean-to Shelter is to the right of this photo (view from north).

**Damage Description:** Cracking and differential settlement of concrete masonry block wall.

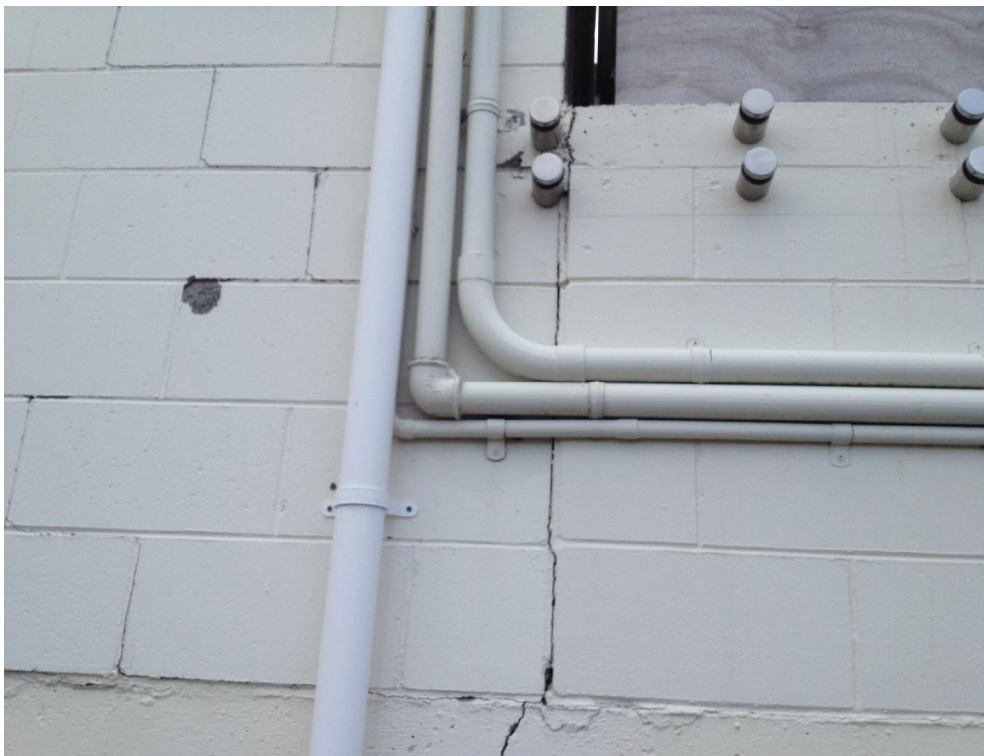
**Photo 10:** Concrete masonry block wall on southern side of Lean-to Shelter (western end).

**Damage Description:** Cracking of mortar and concrete masonry block wall.

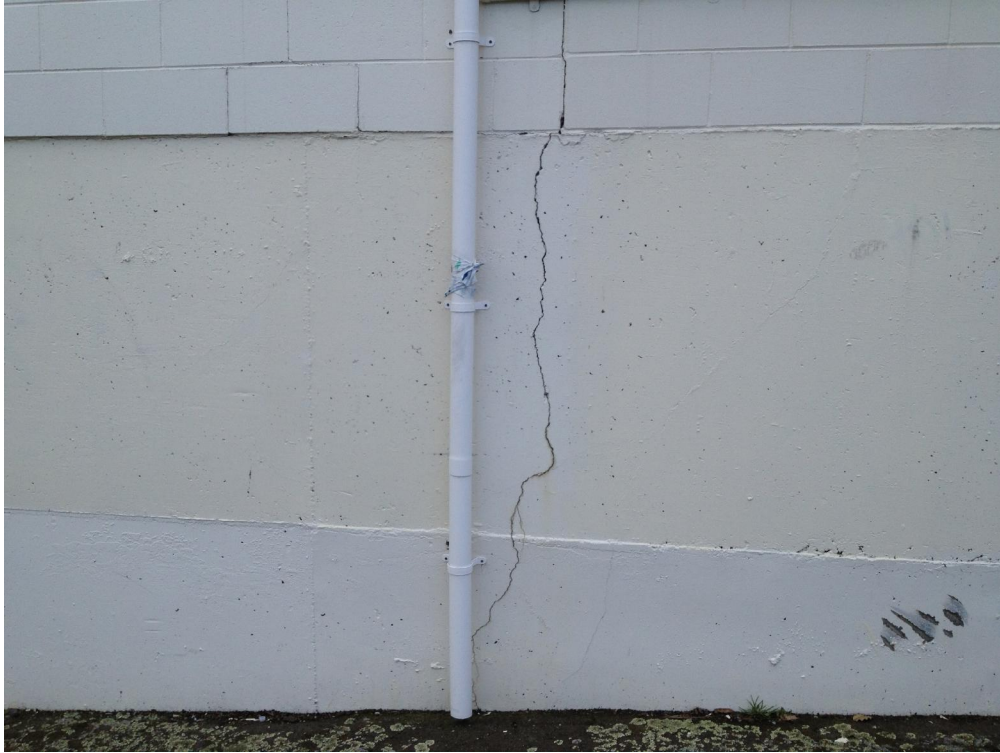
**Photo 11:** Concrete retaining wall on southern side of Lean-to Shelter (western end).

**Damage Description:** Cracking of concrete retaining wall and concrete masonry mortar.

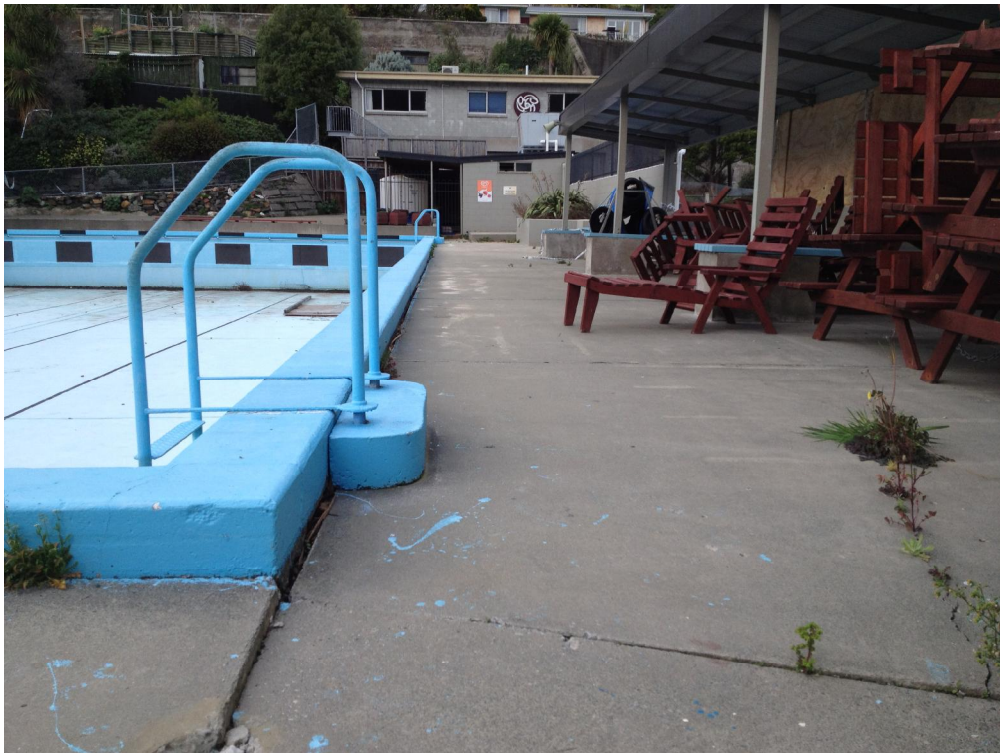
**Photo 12:** Pavement between pool and Lean-to Shelter.

**Damage Description:** Cracking/separation between pool and pavement. Differential settlement is evident as the pavement slopes to the right in this photo.

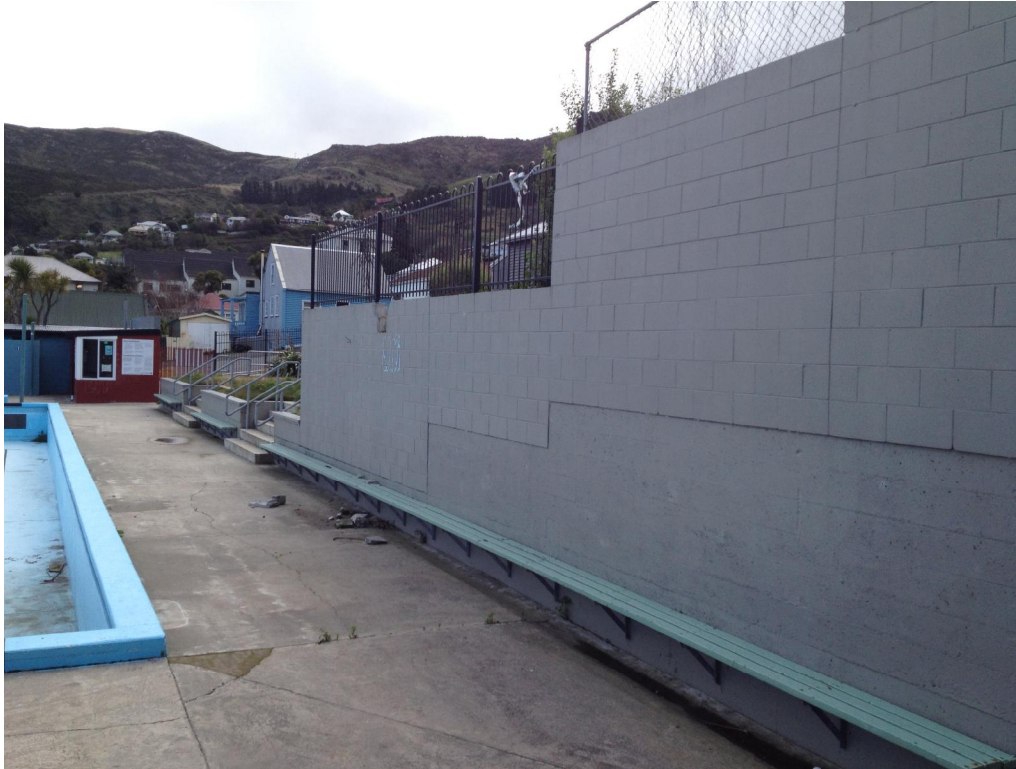
To the north side of the pool is a concrete retaining wall approximately 2m high with a 2m high concrete masonry block fence on top that is significantly damaged (refer Photo 13 and Photo 14 in Appendix A). The block fence section appears to be very lightly reinforced and has minimal fill. It appears likely that the block fence will need to be demolished and reconstructed with an appropriately engineered replacement.

**Photo 13:** Concrete retaining wall and concrete masonry block fence to the north of the pool (view from south-east).

**Damage Description:** Cracking and differential settlement of concrete masonry block wall.

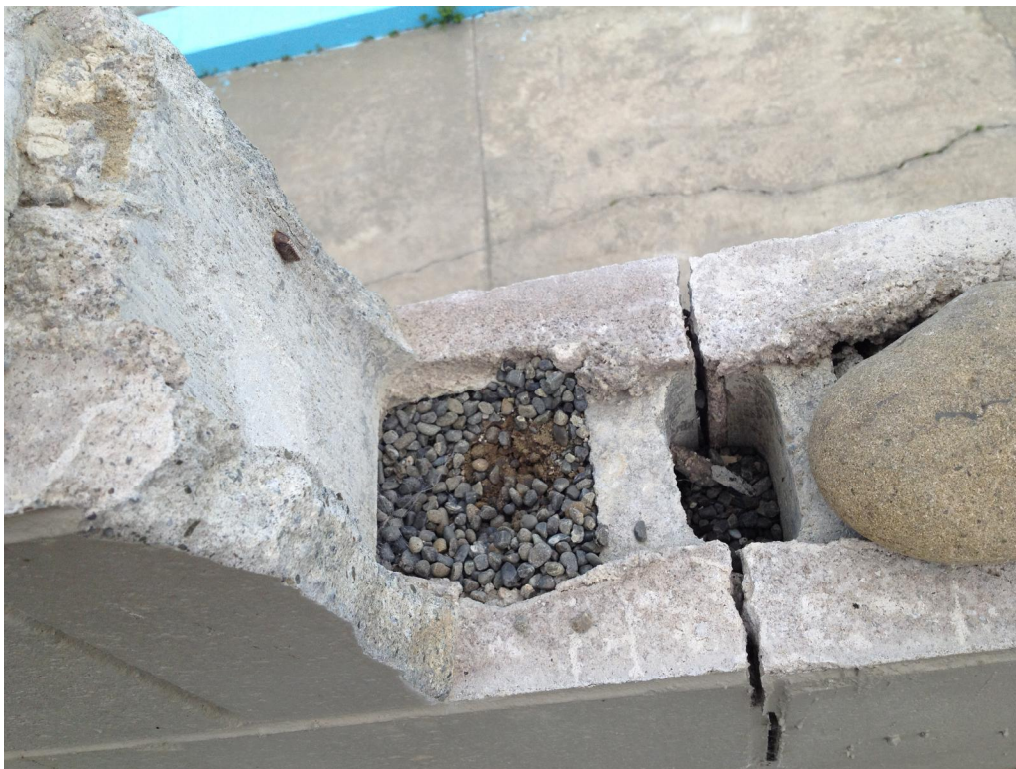
**Photo 14:** Concrete masonry fence to the north of the pool.

**Damage Description:** Cracked and dislodged concrete masonry units.
