Norman Kirk Memorial Pool – Nursery Building Detailed Engineering Evaluation BU 3513-005 EQ2 Qualitative Report

Norman Kirk Memorial Pool Nursery Building BU 3513-005 EQ2

Detailed Engineering Evaluation Qualitative Report – SUMMARY Version 1

54a Oxford St
Lyttelton

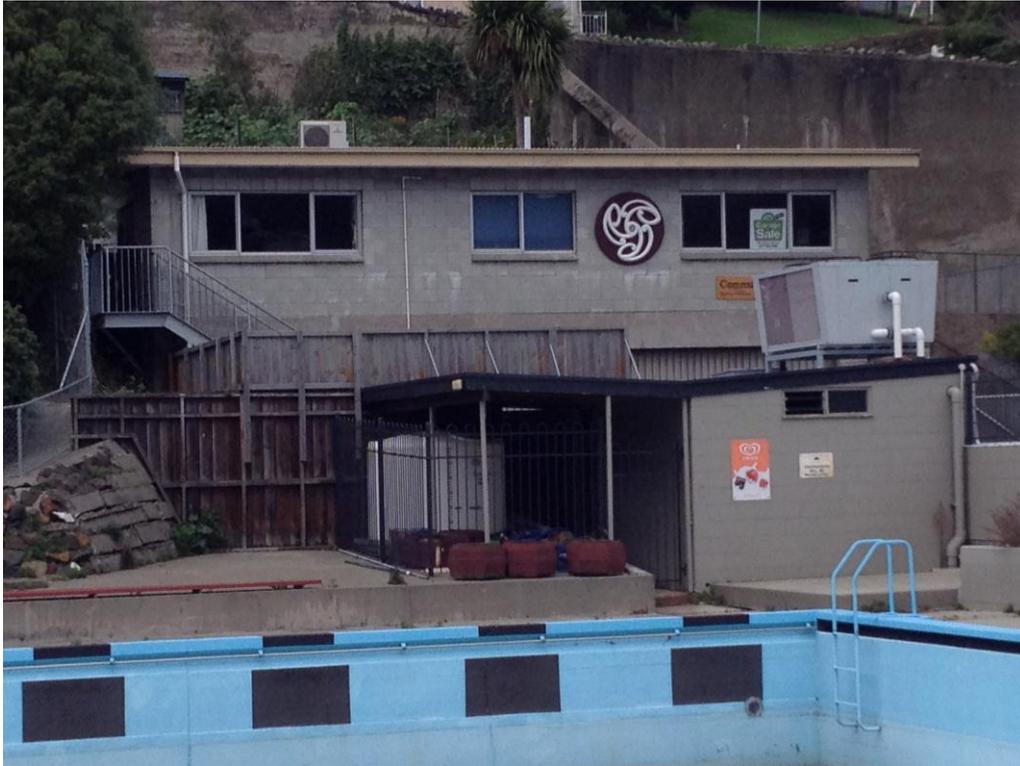
Photo 1: External view of Nursery Building (in background).

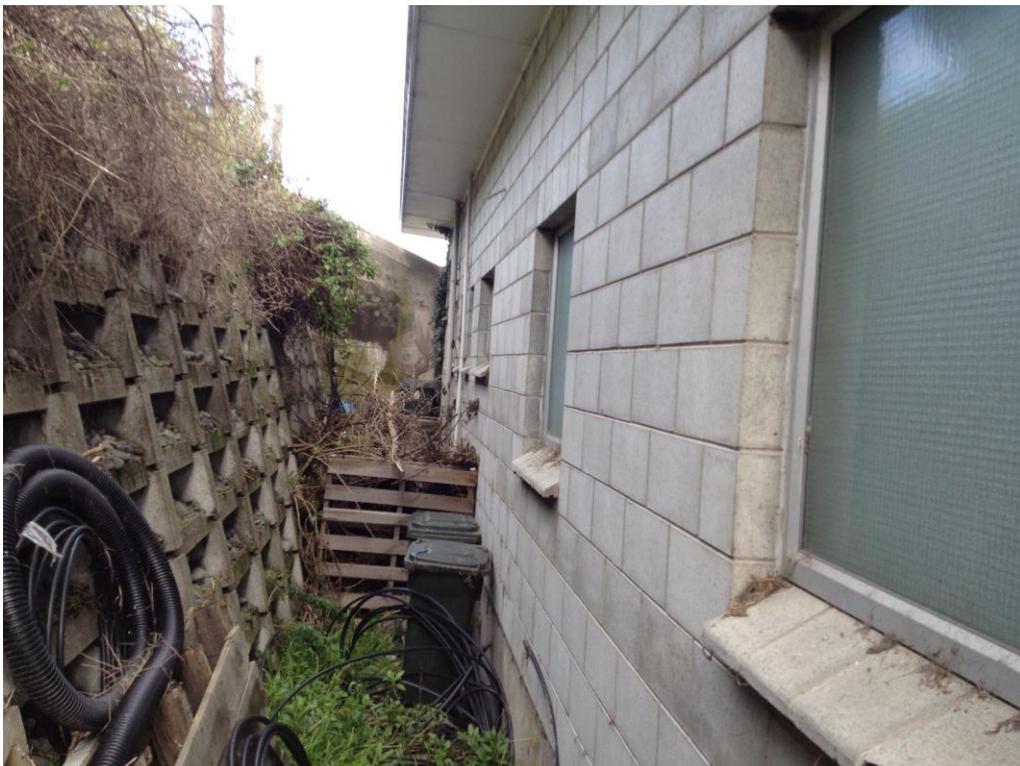
A crib retaining wall exists to the east of the Nursery Building with a retaining height that extends above the roof level of the building. Although no damage was noted, there is a potential landslide risk (for the Nursery Building) and this has been included in the calculation of the seismic capacity using the Initial Evaluation Procedure.

Photo 2: Crib Wall (left) to the east of Nursery Building (note: this is at first floor level).

- A geotechnical investigation is undertaken into the stability of the surrounding landscape and large retaining wall to the east of the site.
- Repairs that would bring the building back to an "as new" condition are typically entitled under typical replacement insurance policies. We suggest you consult with your insurance advisor as to how you wish to proceed.

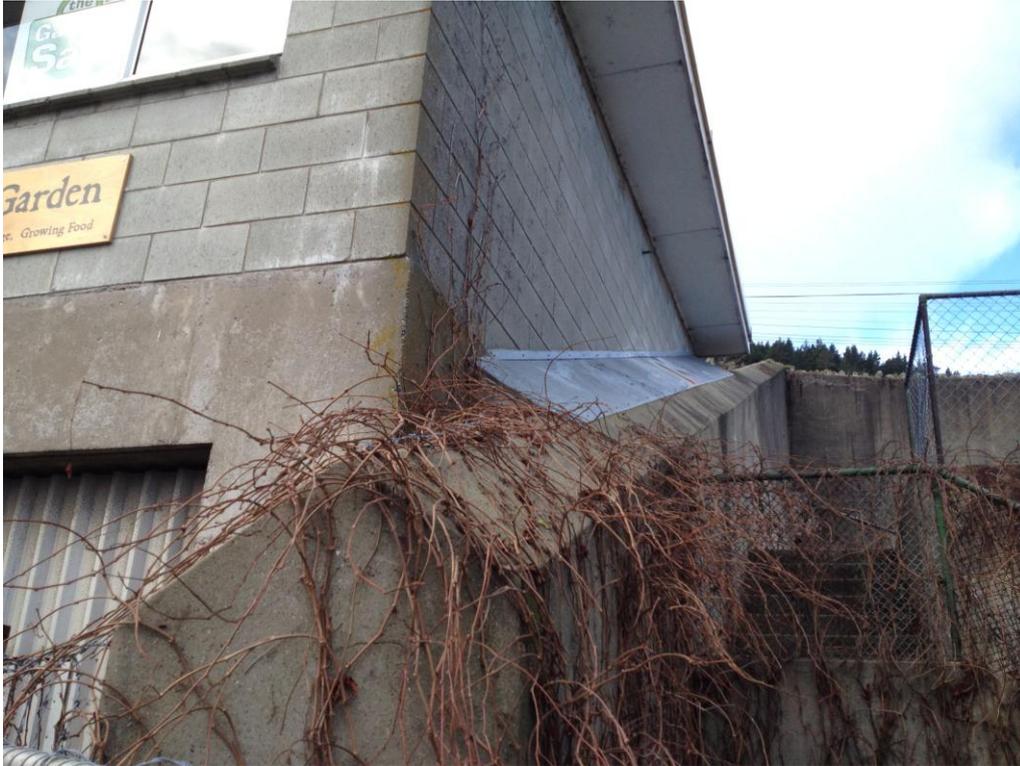
The Nursery Building is a stand-alone building, however it is located (and was constructed) immediately adjacent to a concrete retaining wall to the south. The retaining wall varies in height consistent with the natural slope of the site. At the south-west corner of the Nursery Building the top of the wall is approximately level with the first floor, and increases in height to around roof level at the south-eastern corner. The pounding potential from the retaining wall has been included in the calculation of the seismic capacity using the Initial Evaluation Procedure. No damage to the retaining wall was visible, however no formal inspection was carried out as it is considered outside the scope of this DEE.

Photo 3: Retaining wall with pounding potential to the south of the Nursery Building.

- An investigation is undertaken to determine the structural integrity of the adjacent concrete retaining wall to the south, and crib retaining wall and concrete retaining wall to the east.

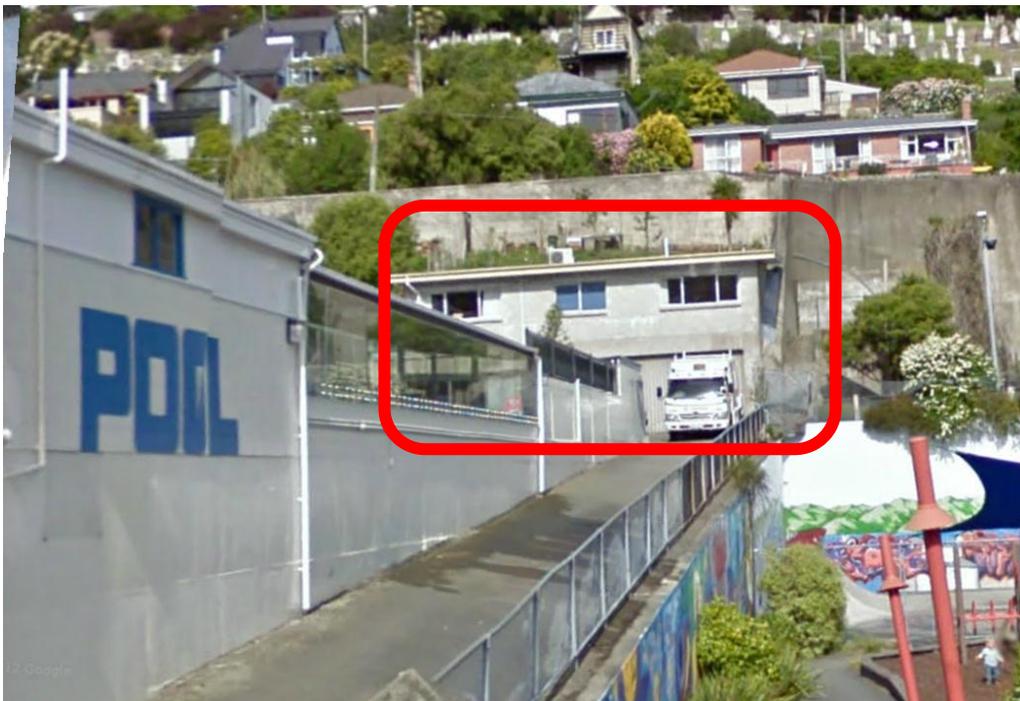
Photo 4: External view from the west, with concrete retaining walls to east and south shown.
Source: Google Maps.

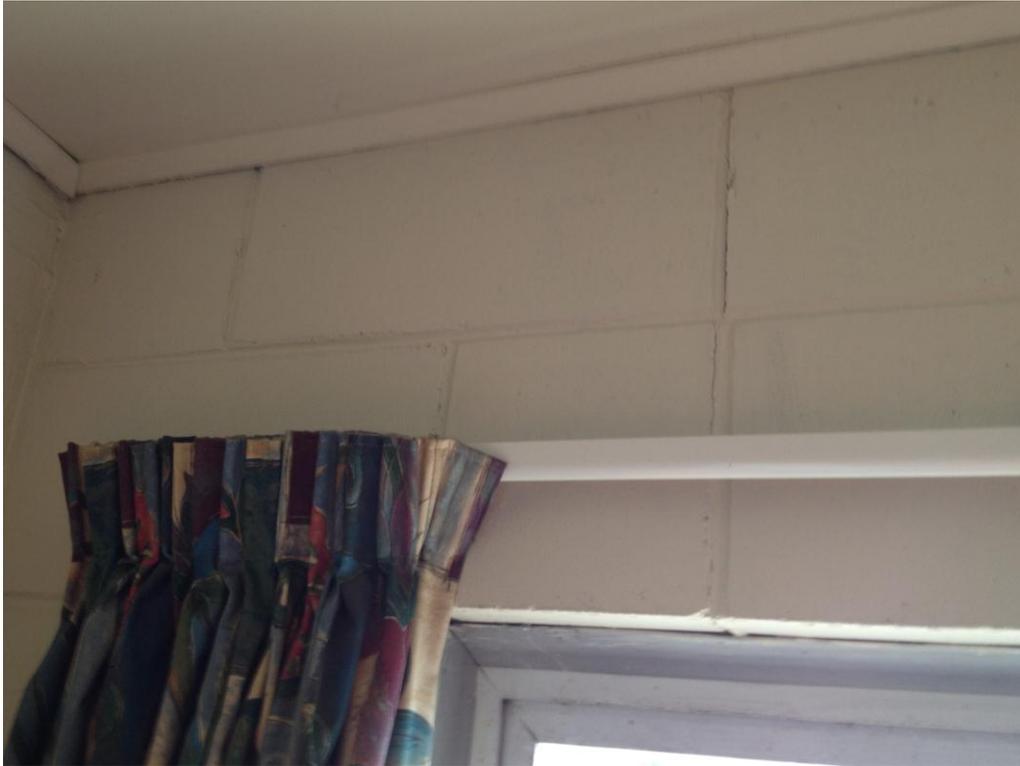
Photo 5: Internal concrete masonry block wall.

Damage Description: Cracking in concrete masonry block mortar.

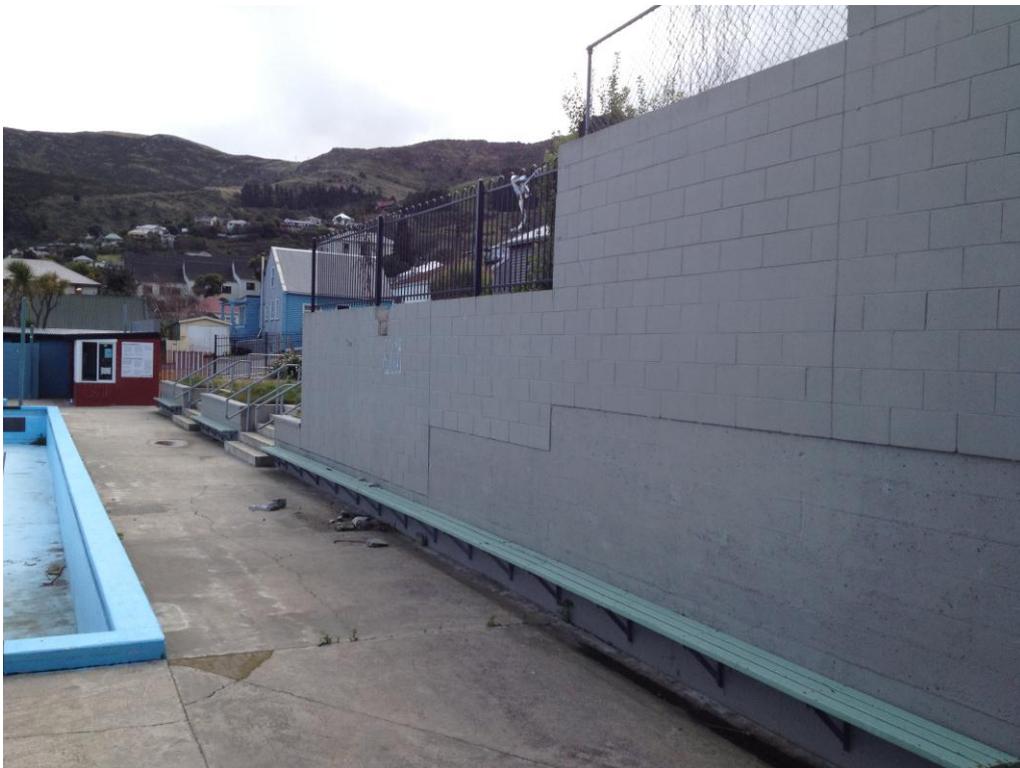
To the north side of the pool is a concrete retaining wall approximately 2m high with a 2m high concrete masonry block fence on top that is significantly damaged (refer Photo 6 and Photo 7 in Appendix A). The block fence section appears to be very lightly reinforced and has minimal fill. It appears likely that the block fence will need to be demolished and reconstructed with an appropriately engineered replacement.

Photo 6: Concrete retaining wall and concrete masonry block fence to the north of the pool (view from south-east).

Damage Description: Cracking and differential settlement of concrete masonry block wall.

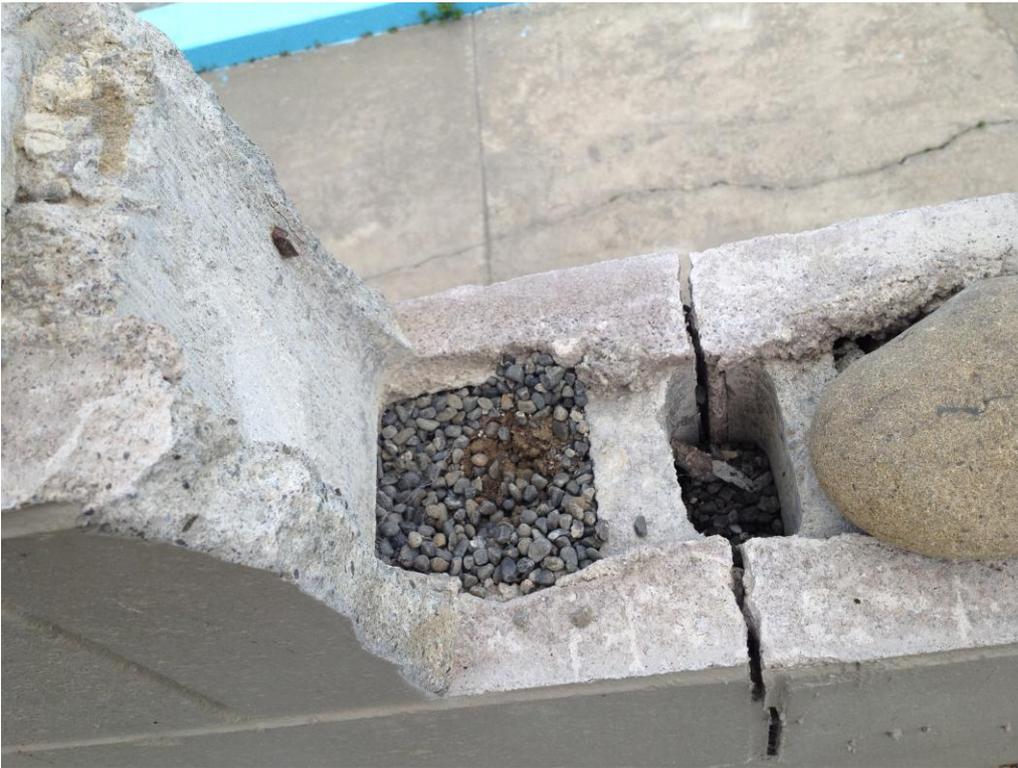
Photo 7: Concrete masonry fence to the north of the pool.

Damage Description: Cracked and dislodged concrete masonry units.
