**North Beach Community Crèche**  
**BU 2191-001 EQ2**  
**Detailed Engineering Evaluation**  
**Quantitative Report**

Date: 26 October 2012  
Reference: 6-QUCCC.87  
Status: Final

Detailed Engineering Evaluation  
Quantitative Report - SUMMARY  
Final

24 Rookwood Avenue, New Brighton, Christchurch

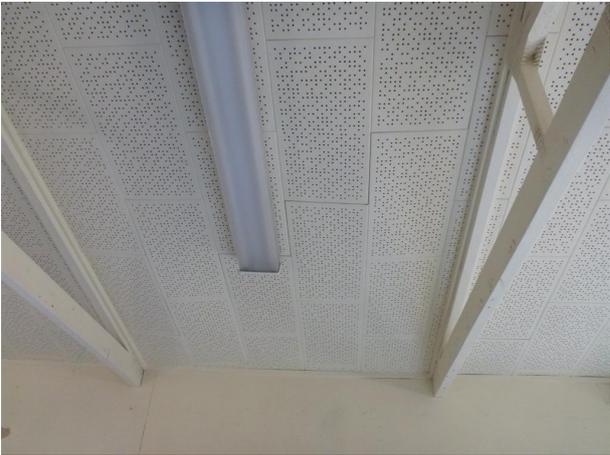
<u>Details Internal</u>		
21.	Deformation of the ceiling finishes in the plane of roof (extension)

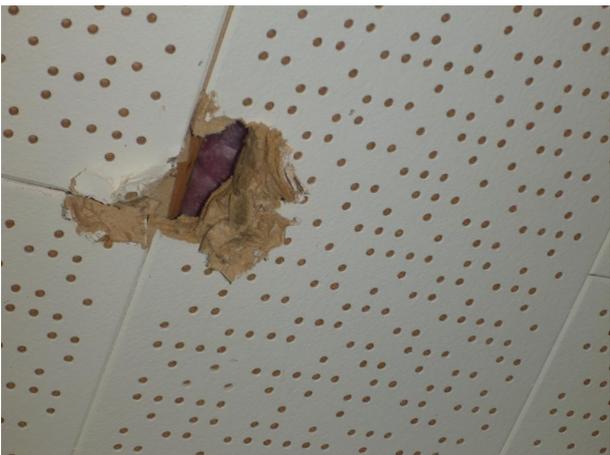
22.	Acoustic type ceiling tiles with no bracing value

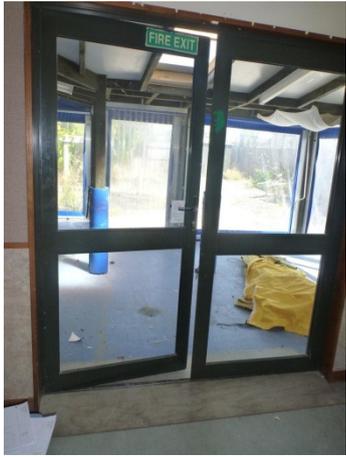
<p>26.</p>	<p>Door on south elevation of extension, leading to the enclosed veranda, which no longer closes due to deformation of the opening.</p>

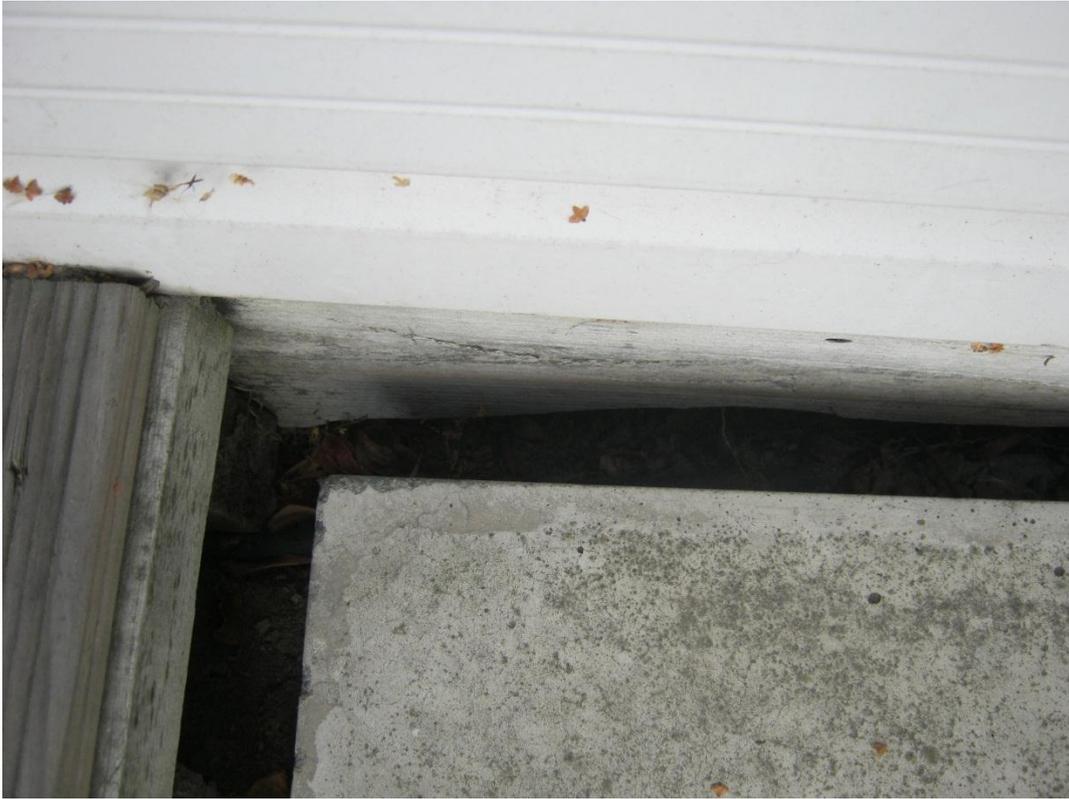
**Photo 3: Hole beside east side entrance pavers.**

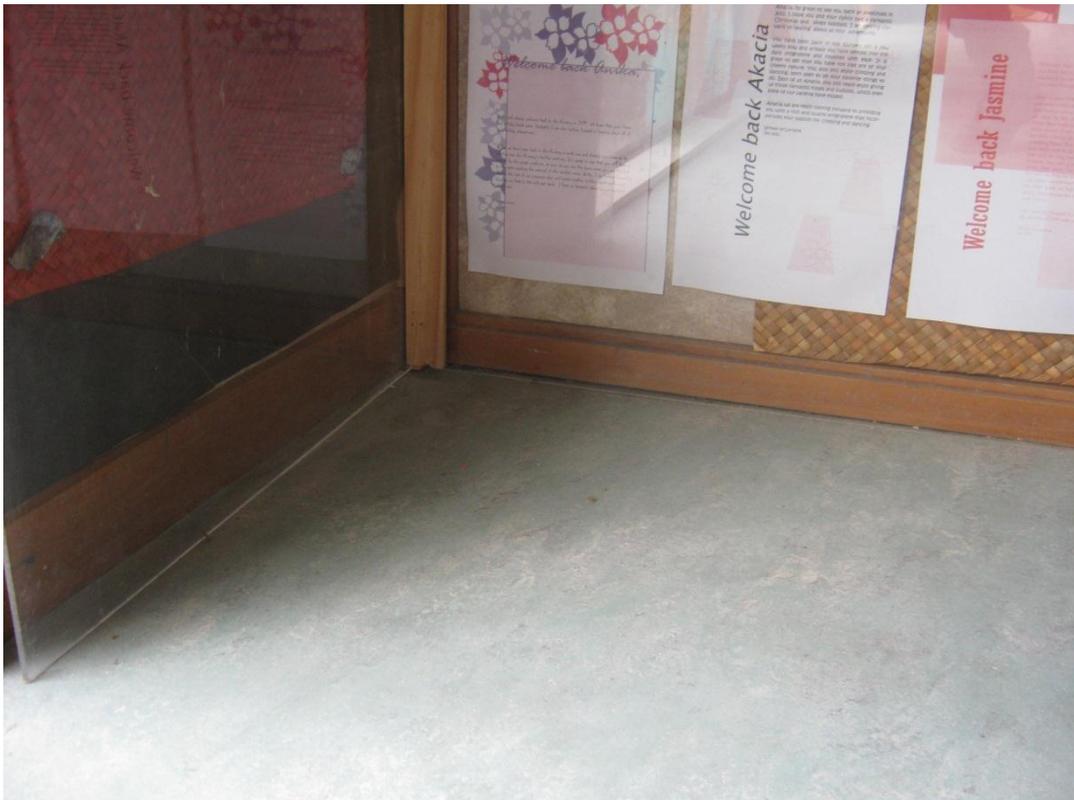
**Photo 4: Approximately 10mm settlement of the floor in the large room in west wing.**

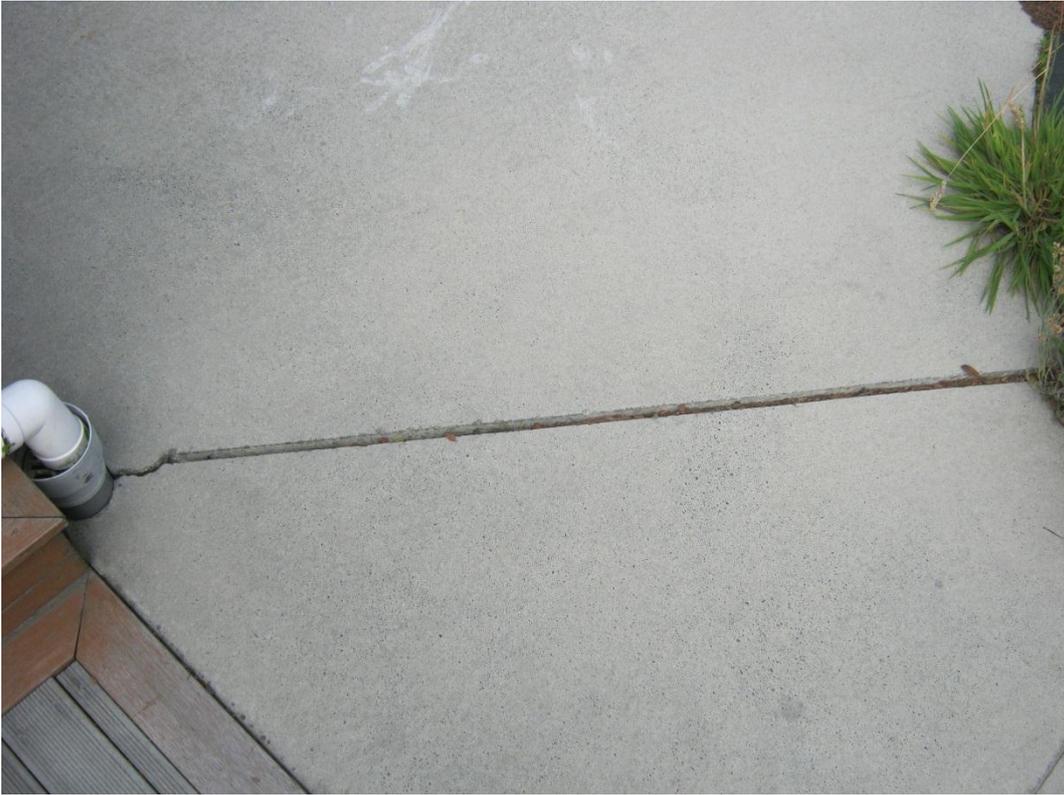
**Photo 5: Separation and cracking of concrete shrinkage cut.**

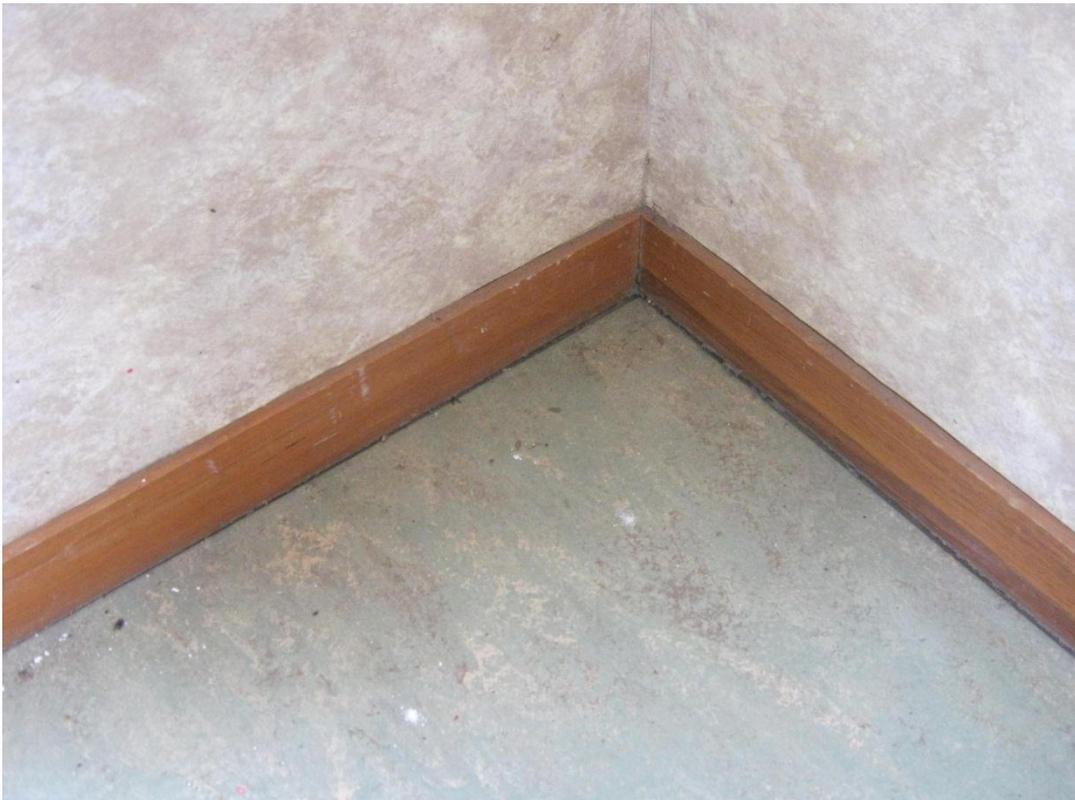
Differential settlement has caused the floor to be out of level throughout the building. In particular, the floor in the north west corner of the eastern wing of the building has settled by approximately 10mm. This settlement is consistent with the separation and cracking of the concrete paving on the exterior at this location. The differential settlement has caused the door on the western elevation to jam and the timber around the foundations has moved laterally.

**Photo 6: Settlement of the floor in the north west corner of the main room in the eastern wing.**

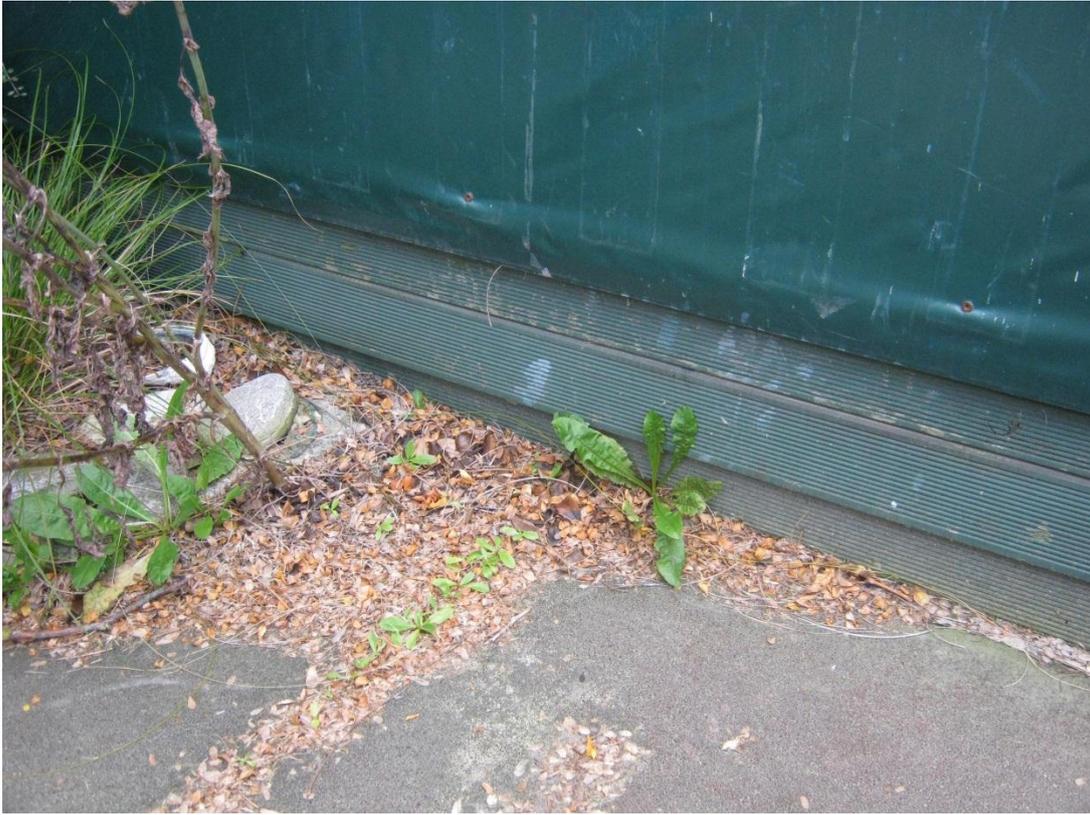
**Photo 7: Lateral displacement of timber boards.**

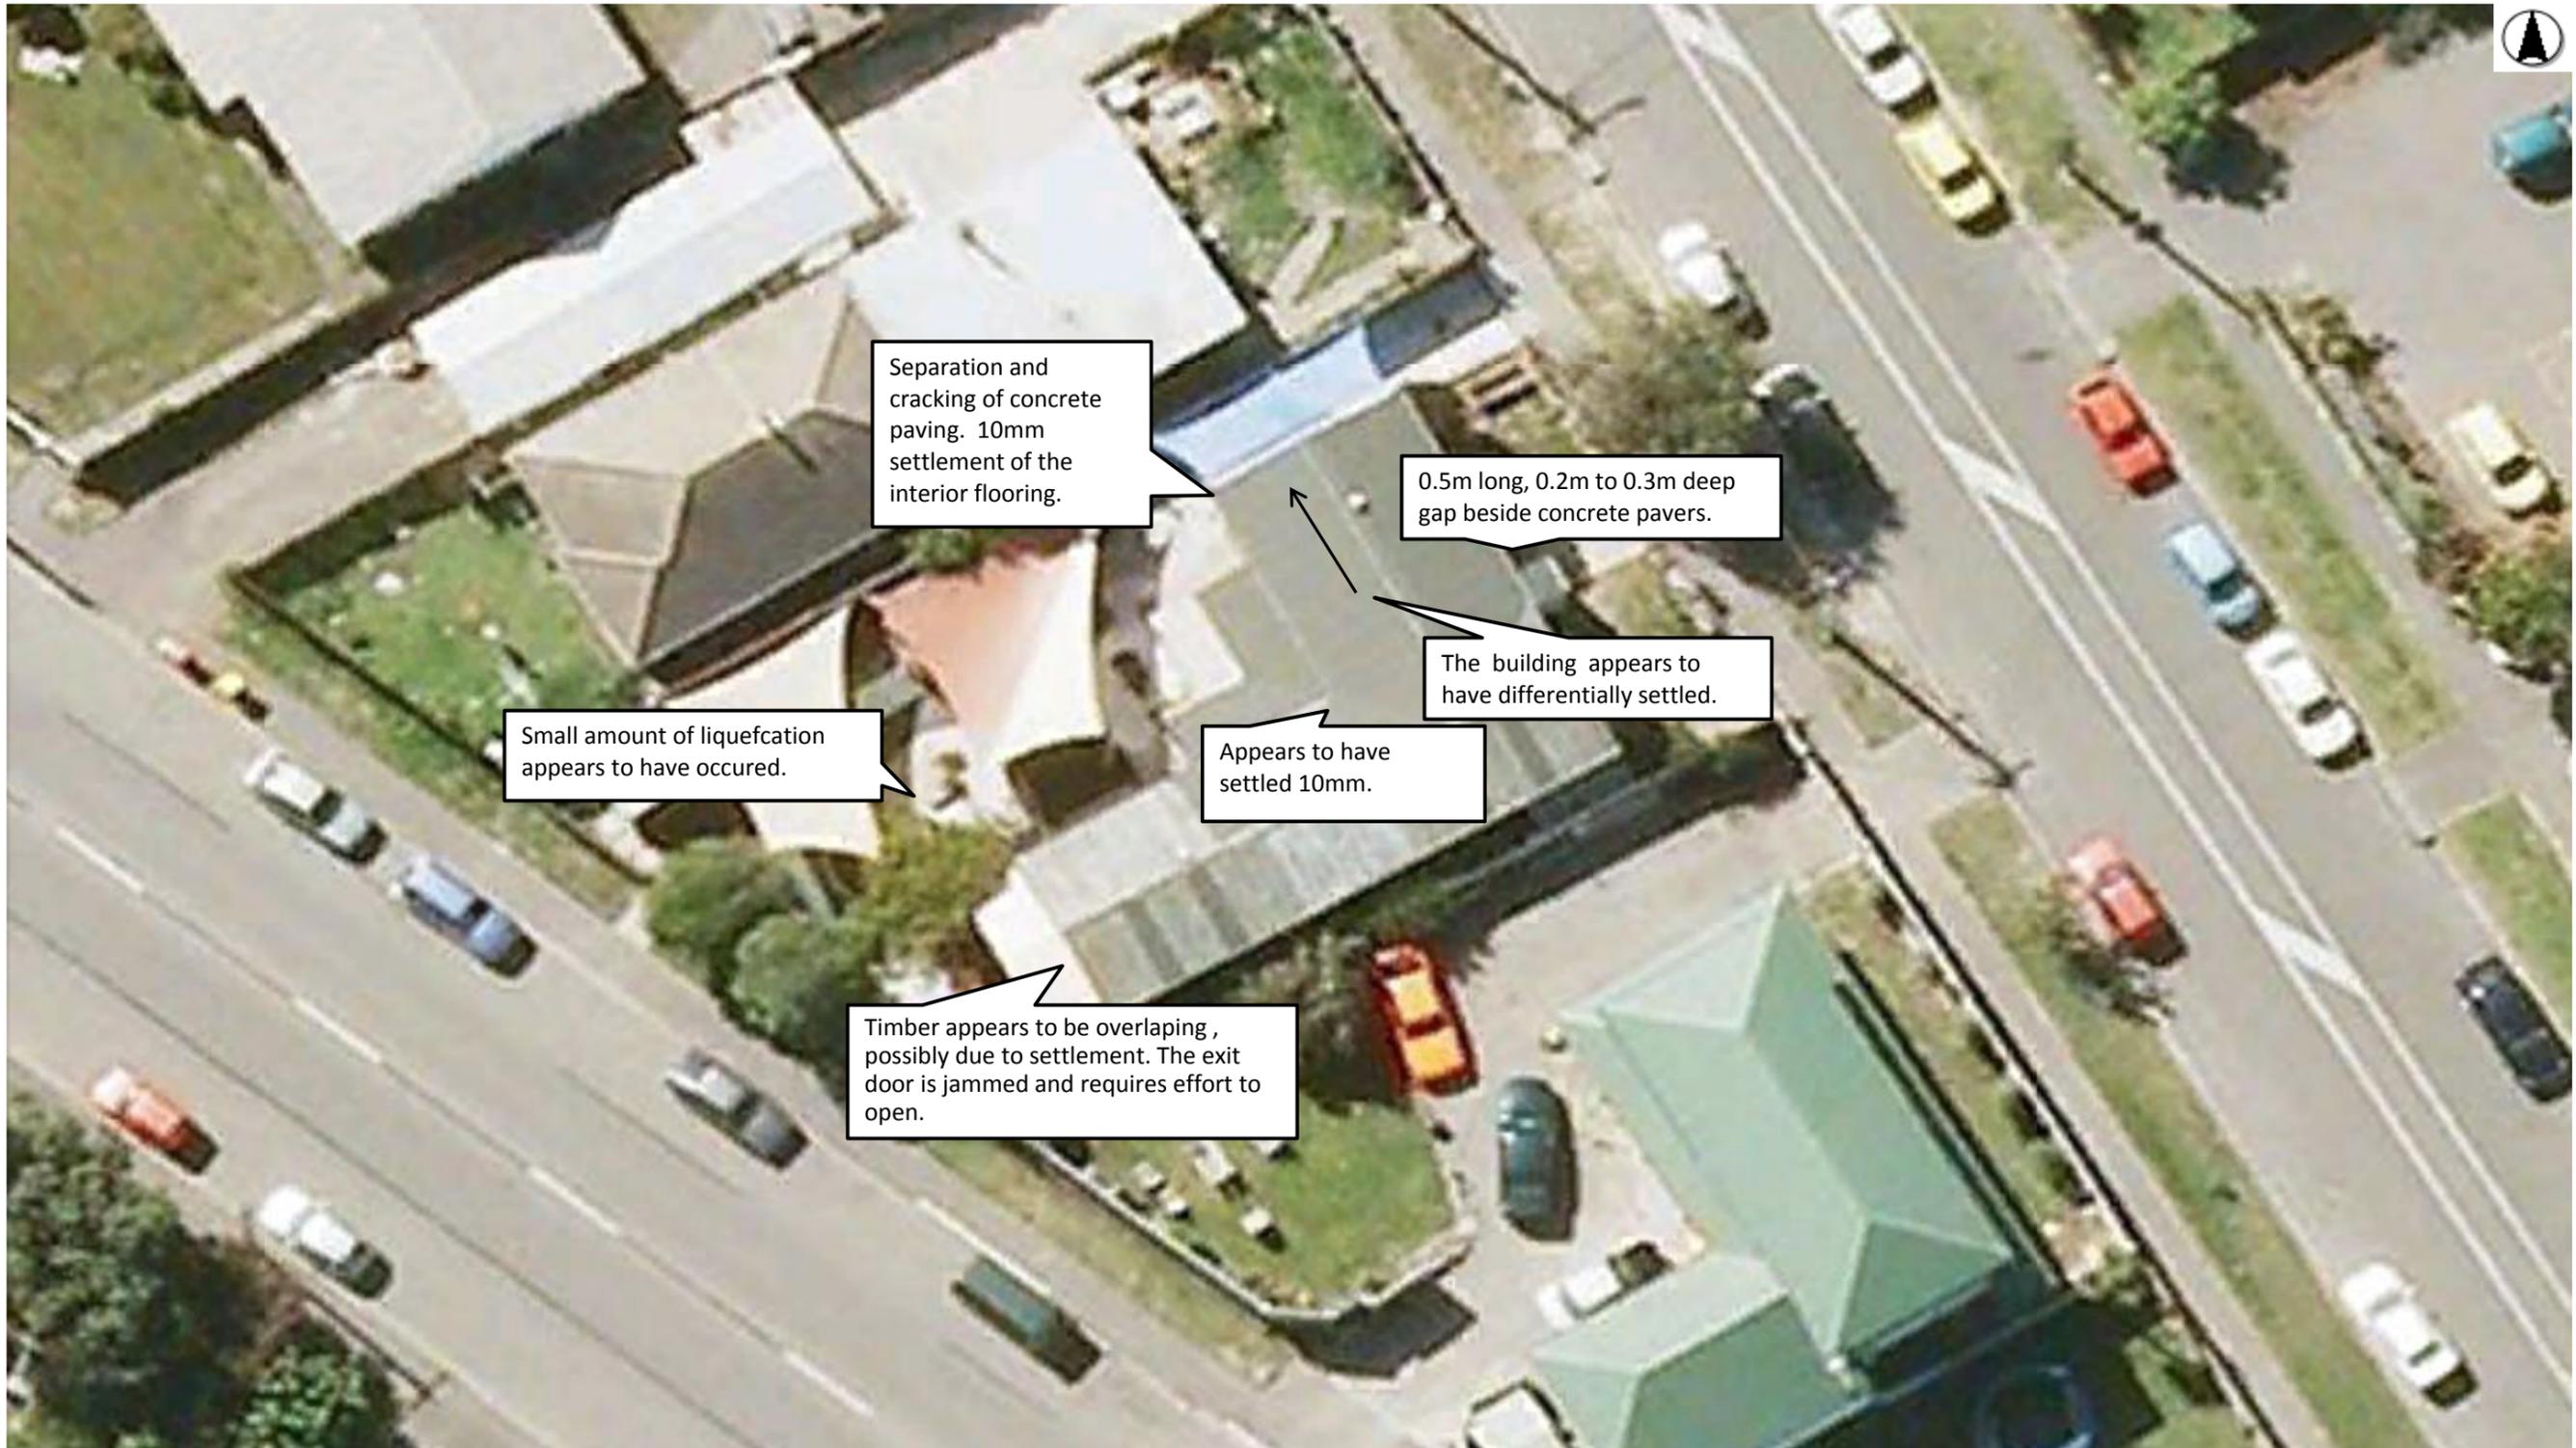
Separation and cracking of concrete paving. 10mm settlement of the interior flooring.

0.5m long, 0.2m to 0.3m deep gap beside concrete pavers.

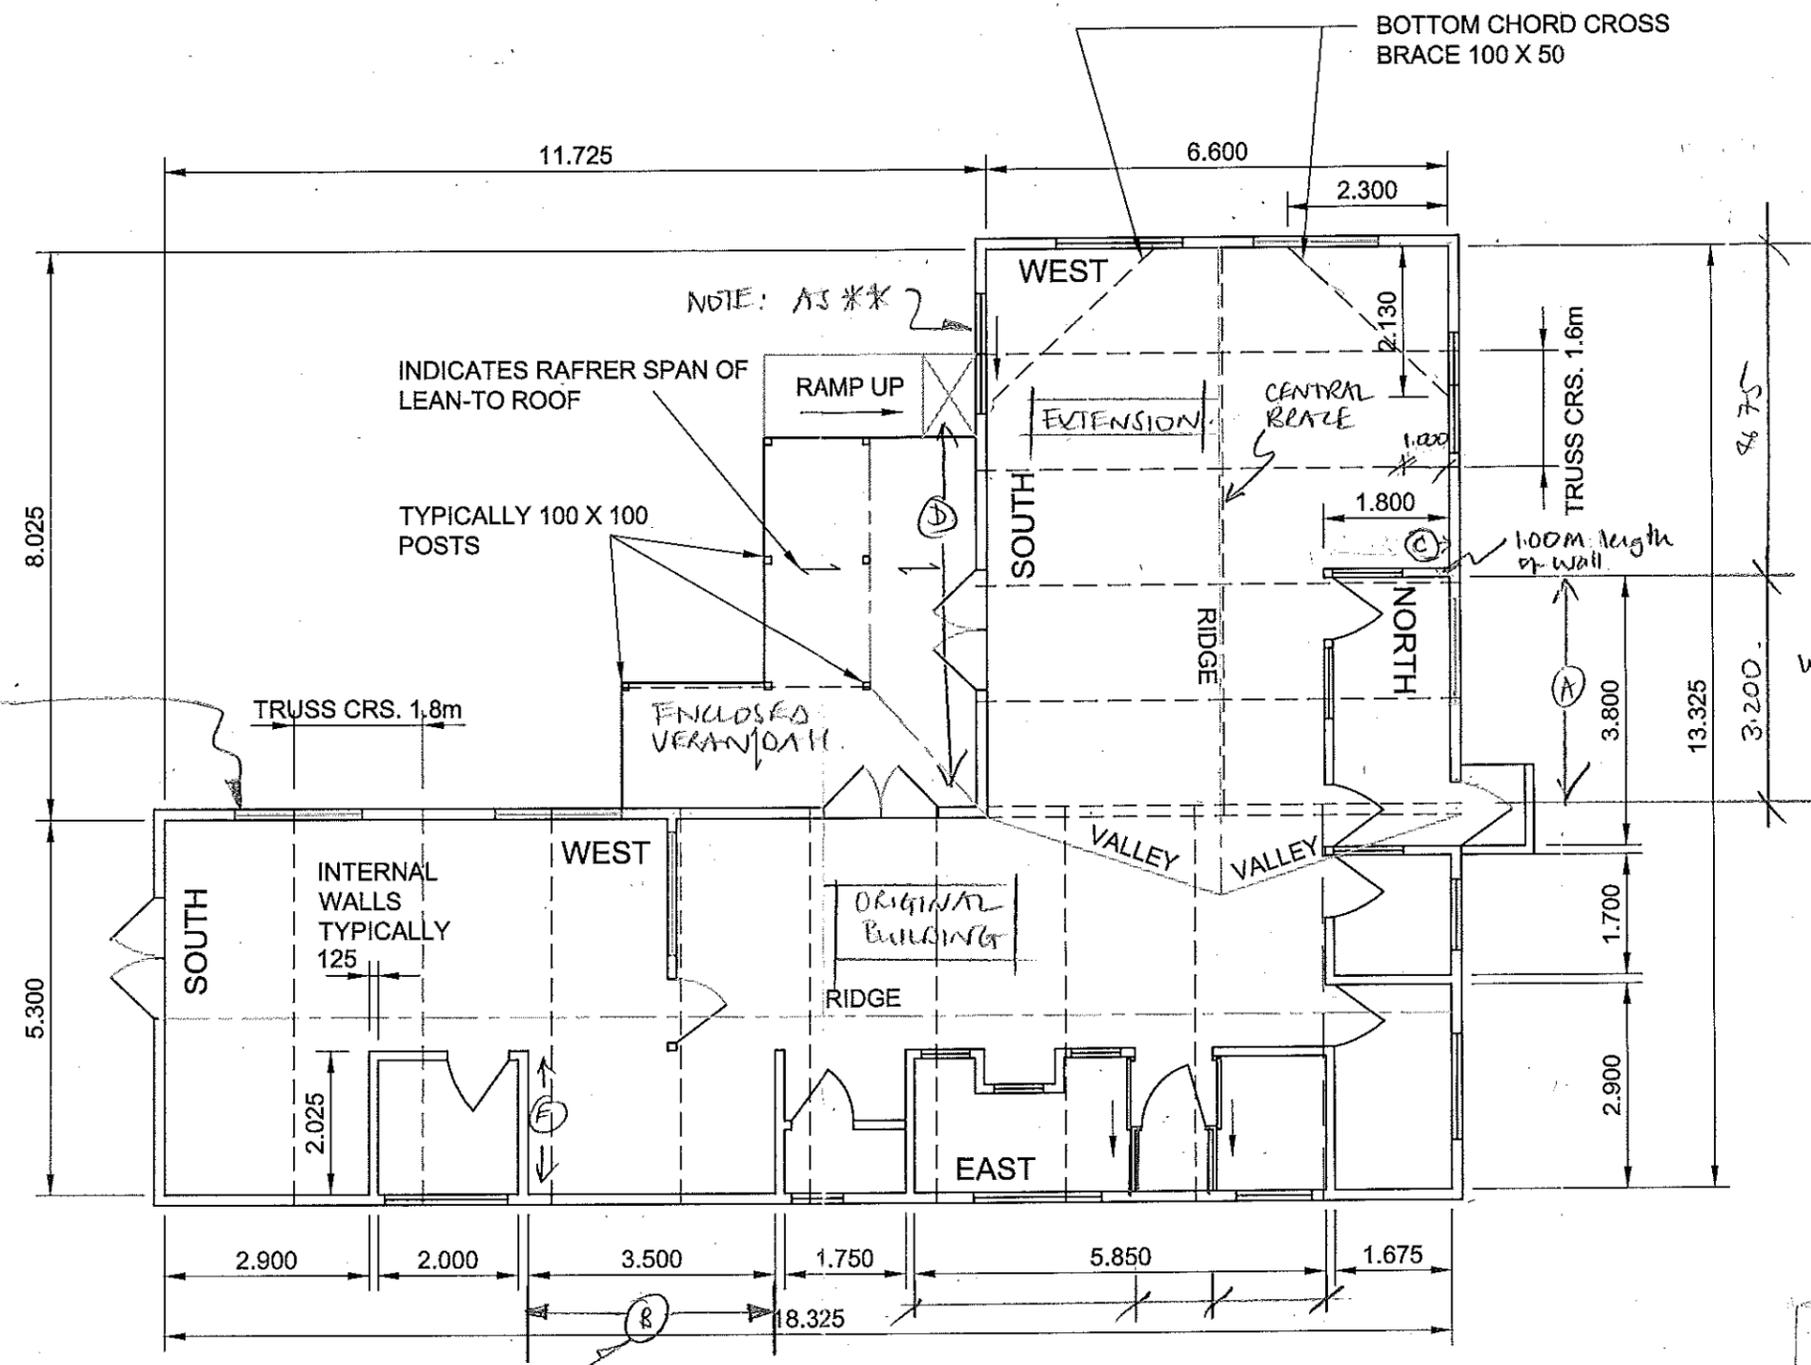
**PLAN**  
SCALE 1 : 100

\*\*  
NOTE: THE WALL OF THIS ELEVATION HAS NO LATERAL SUPPORT OVER ITS LENGTH, SO IT IS ASSUMED THAT OUT OF PLANE LOADS ARE SUPPORTED BY THE OPPOSITE WALL
