**Nunweek Park Toilets/Pavilion/Changing Rooms**  
**PRK 0305 BLDG 002 & PRK\_0305\_BLDG\_003**  
Detailed Engineering Evaluation  
Quantitative Report  
Version 2 FINAL

240 Wooldridge Road

Christchurch City Council

**Date**  
15 August 2013

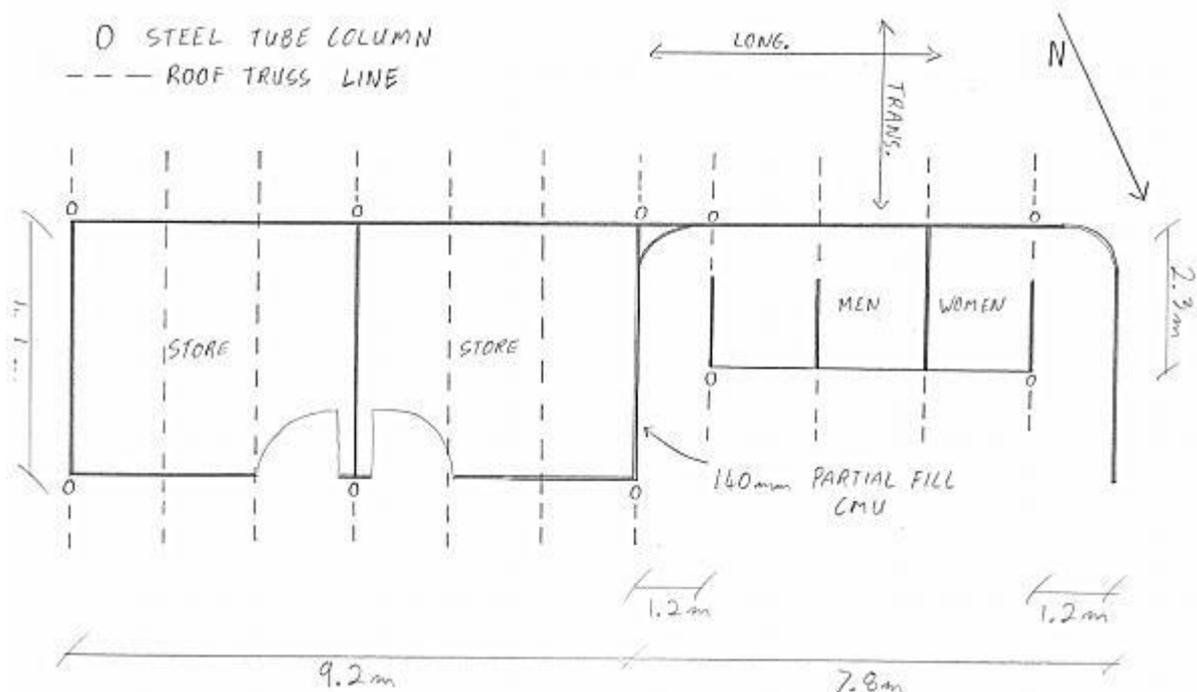
**Figure 2 Plan Sketch Showing Key Structural Elements**

The overall structure comprises of two separate units (toilet and sports stores) with independent roof structures linked by a single wall. Roof and wall construction is consistent throughout. The roof is formed by curved lightweight metal cladding supported by steel tube purlins rigidly connected to similar trusses. Steel circular hollow columns extend from the roof structure to foundations. Walls extending from strip footings to eaves level are lightly reinforced partially grout filled 140mm concrete masonry units.

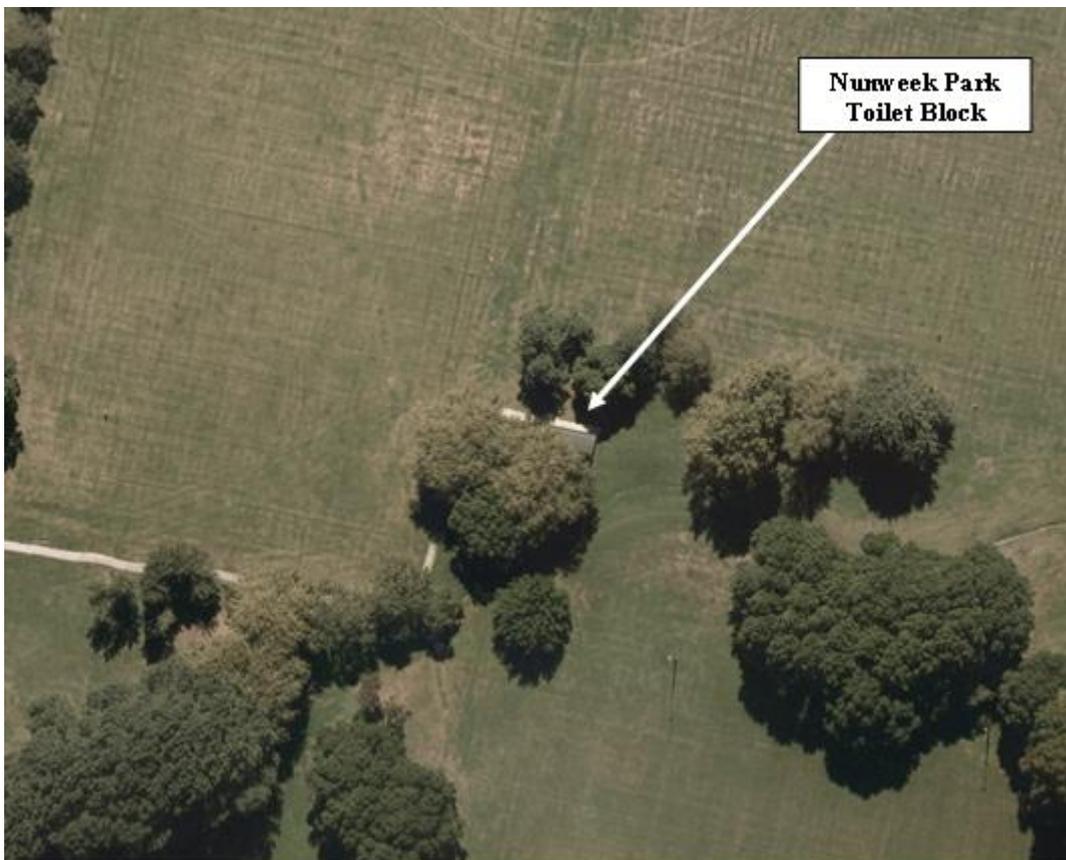
Figure 3 Post February 2011 Earthquake Aerial Photography<sup>3</sup>

Aerial photography taken following the 22 February 2011 earthquake shows no signs of liquefaction outside the building footprint or adjacent to the site, as shown in Figure 3.

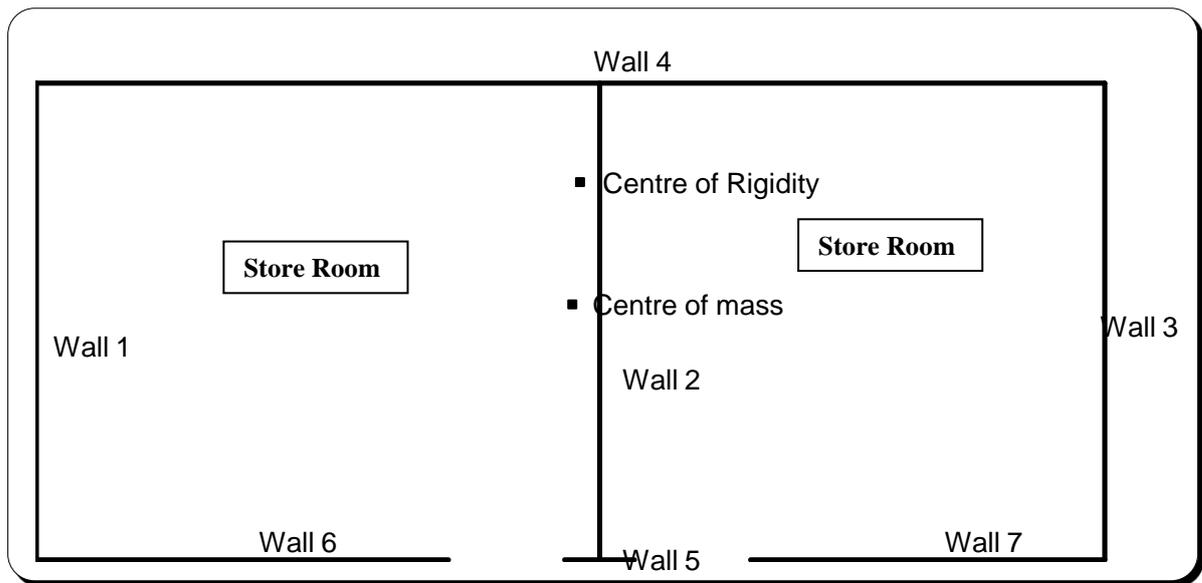
Figure 4 Pavilion wall layout

Following a detailed assessment, the pavilion has been assessed as achieving 46 %NBS. All the block walls have been assessed to be less than 67% NBS. Under the New Zealand Society for Earthquake Engineering (NZSEE) the building is considered to be an Earthquake Risk building. No critical structural weaknesses or collapse hazards have been identified in the building and as such the building can remain occupied as per the Christchurch City Councils policy regarding Earthquake Prone buildings.

As the structure has been assessed to have a %NBS greater than 33% NBS but less than 67% NBS, it is deemed to be an Earthquake Risk building. All the block walls have been assessed to be less than 67% NBS. It is recommended that wall strengthening options be explored and implemented to bring the %NBS of the building up to a minimum of 67% NBS in accordance with NZSEE guidelines.

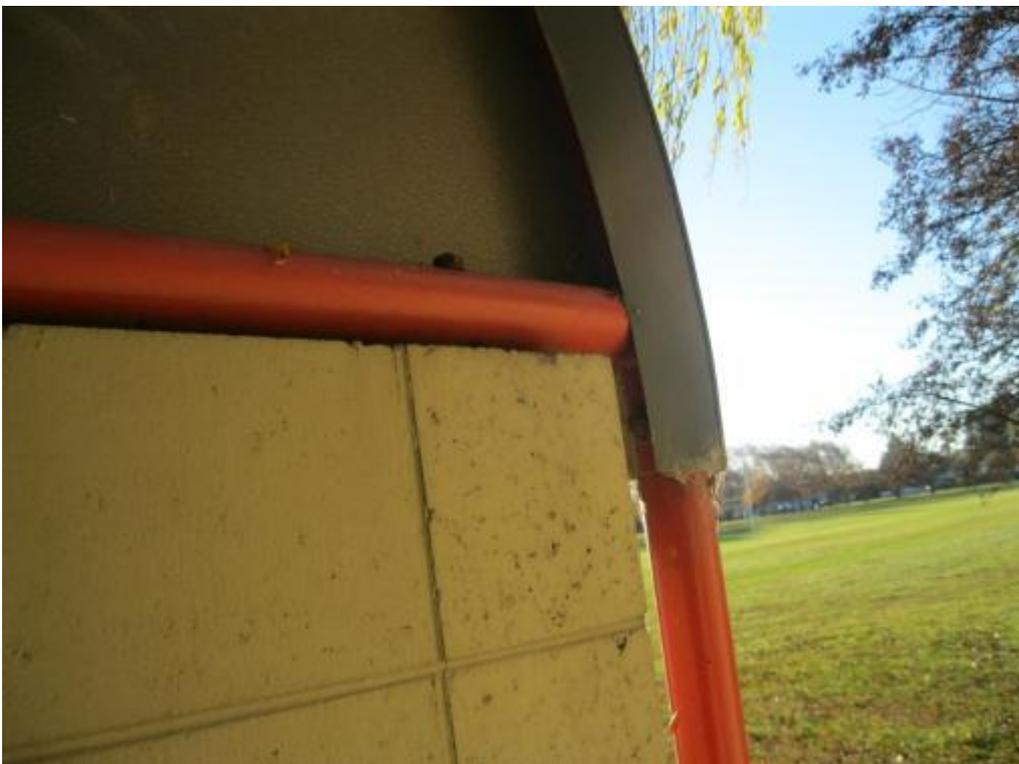
The frames provide seismic load resistance to brace the roof and transfer the seismic roof loads to the masonry walls below through bolted shear connections on top of the masonry walls at each tube post.

**Photograph 4 Roof wall bolt connection**

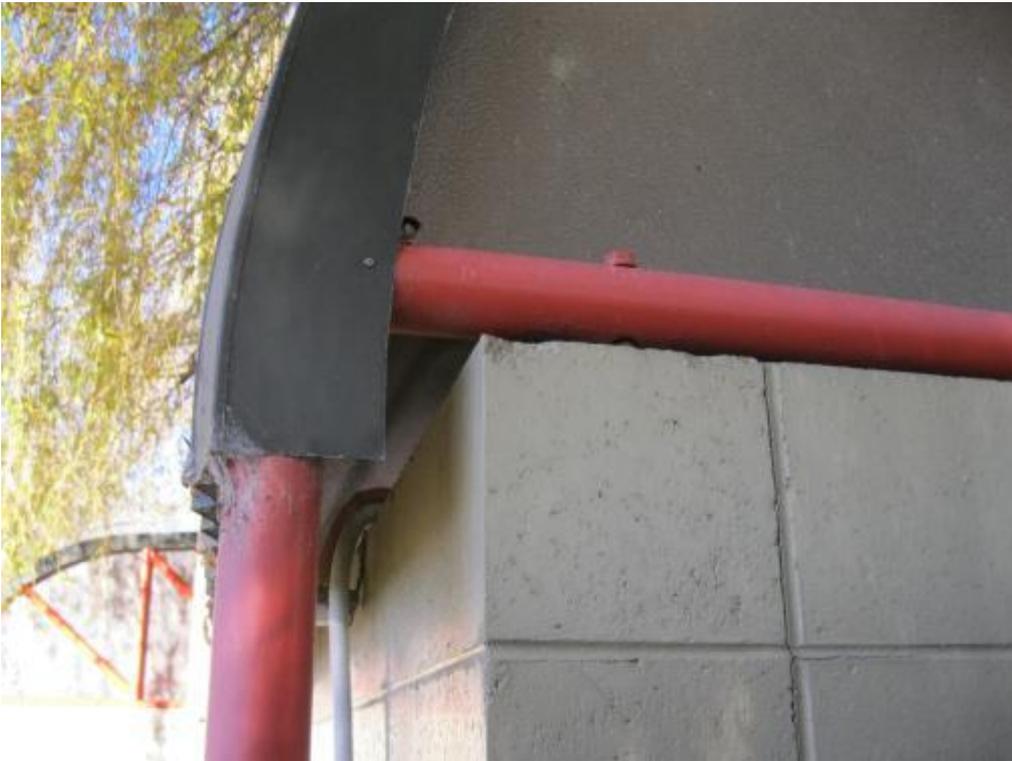
A slight crack was noted in a vertical mortar joint, though damage was not sufficient to affect structural performance.

**Photograph 5 Crack in mortar joint.**

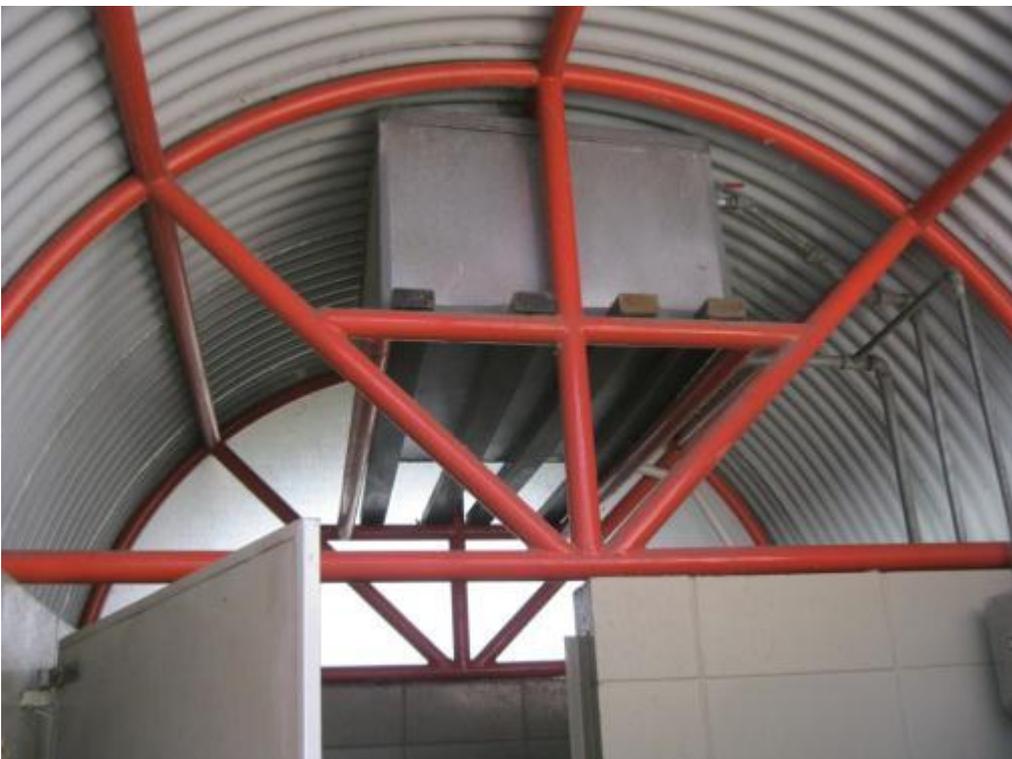
**Photograph 6 Roof truss with rigid purlin connections.**
