Okains Bay Community Centre
BU 3696-001 EQ2
Detailed Engineering Evaluation
Quantitative Report
Christchurch City Council

Detailed Engineering Evaluation Quantitative Report

Date: October 2012
Reference: 6-QUCCC.63
Status: Final V2

Okains Bay, Banks Peninsula

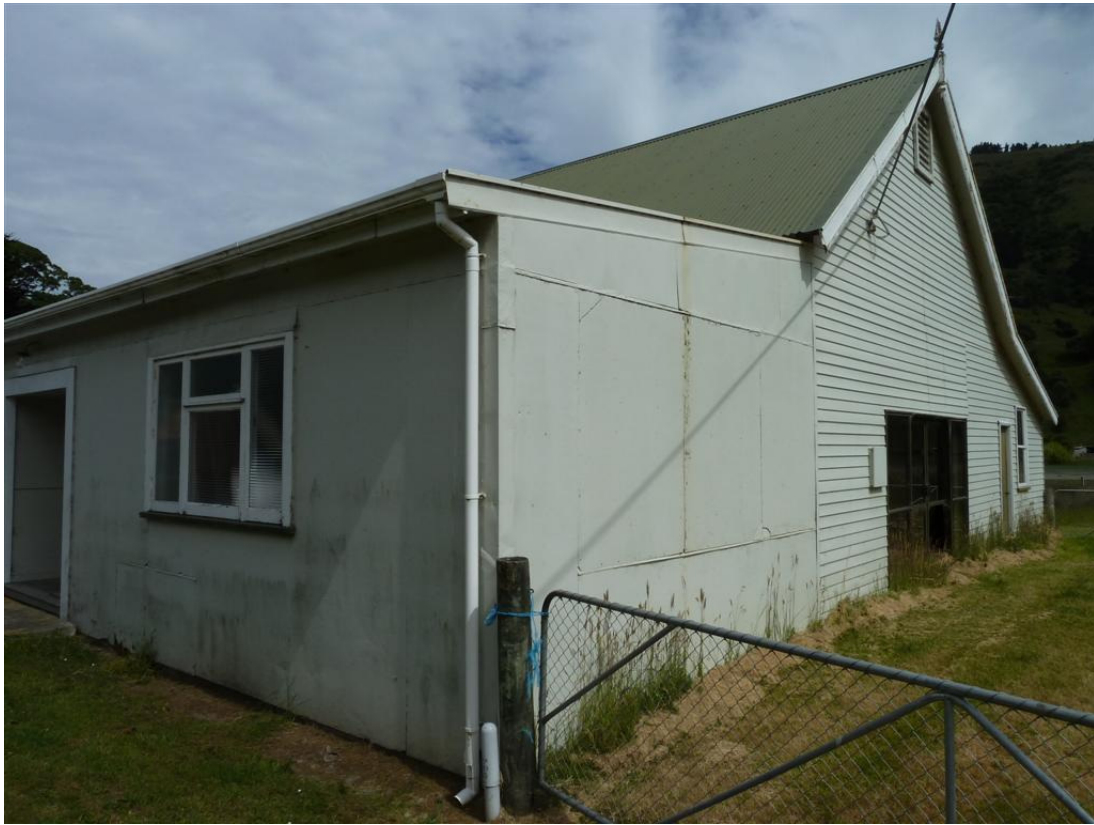
Photo 1: View of the building from the south-east

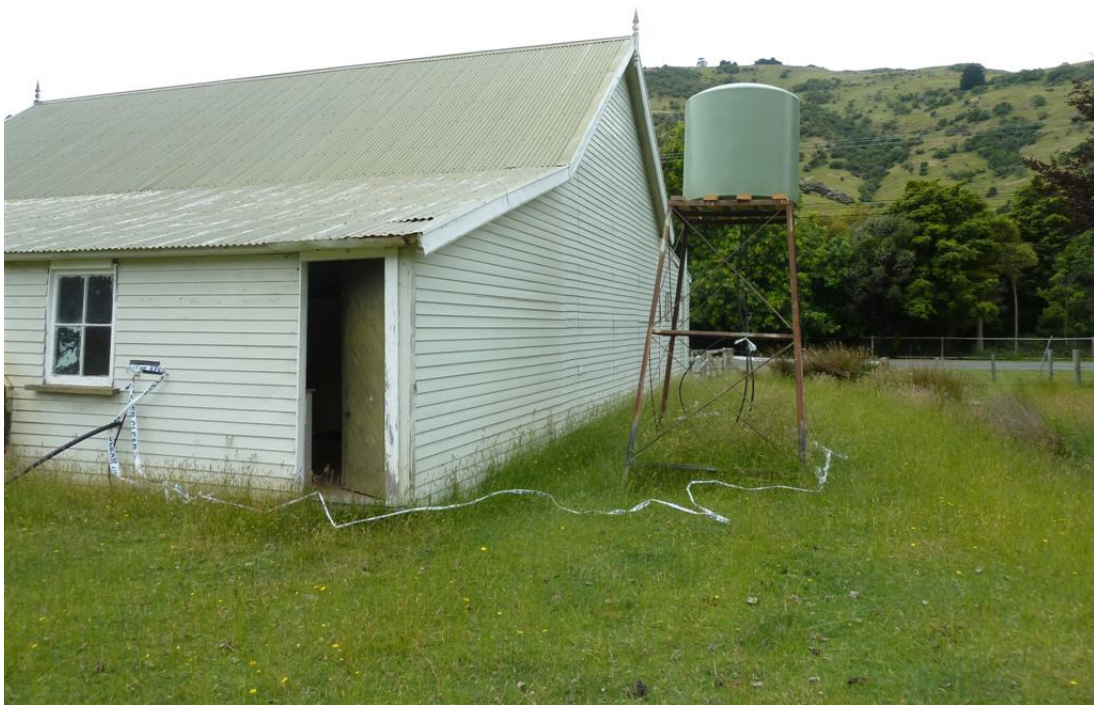
Some minor damage to internal linings was observed. The water tower (now removed) was leaning towards the building.

Photo 2: View of the building from the north-west. This also shows the water tower (now removed)

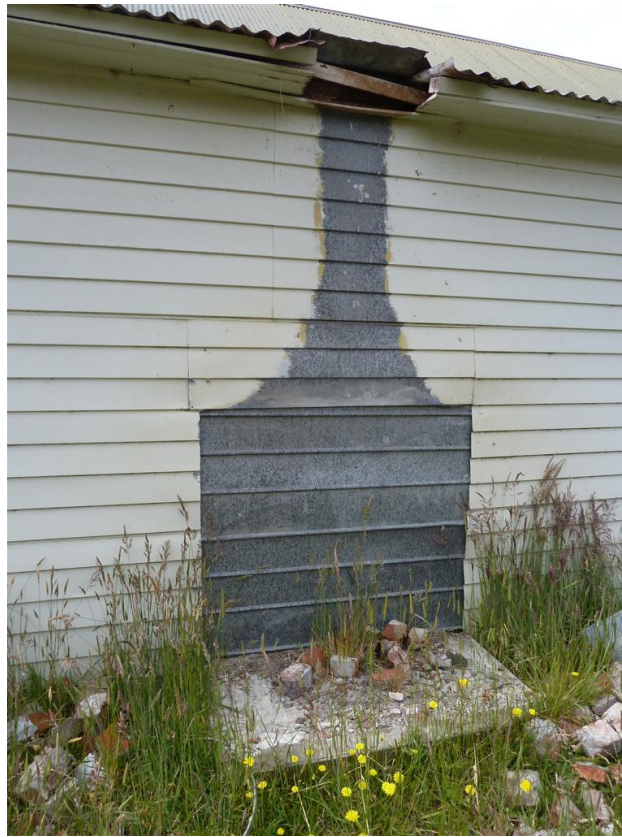
The building has suffered some damage to internal linings. A brick chimney at the rear of the building also collapsed and the water tower (now removed) had a noticeable lean.

Photo 3: Showing the location of the brick chimney that collapsed

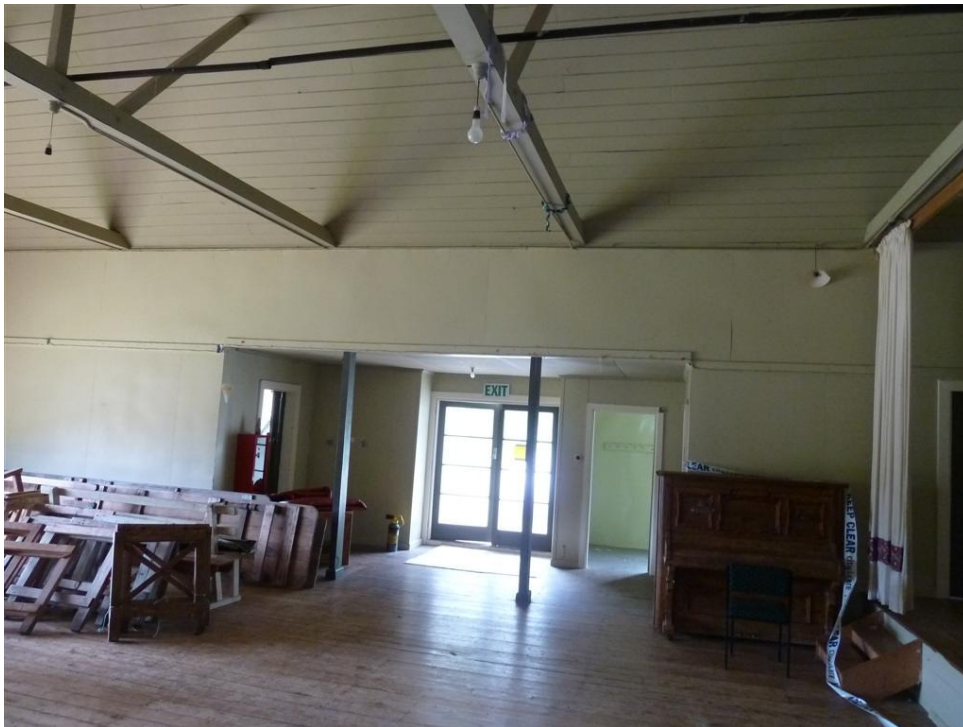
It has been assumed that the tongue and groove ceiling lining acts as a diaphragm.

Photo 4: General internal location shot. Shows tongue and groove ceiling

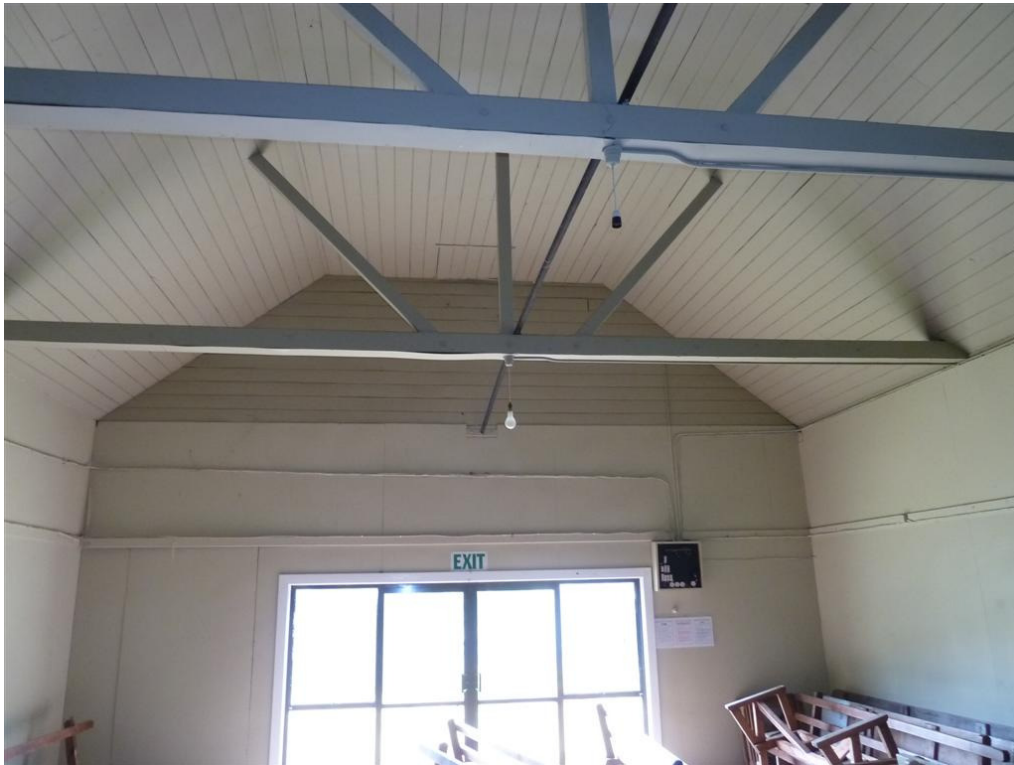
The building has a calculated capacity of approximately 40% NBS as limited by the wall lining in the north-south direction. This is governed by the eastern wall with the large opening.

Photo 5: Internal view of eastern wall with large opening (prior to strengthening). Shows bottom section of roof trusses

- a) A strengthening scheme be developed to increase the overall capacity of the building to at least 67% NBS.

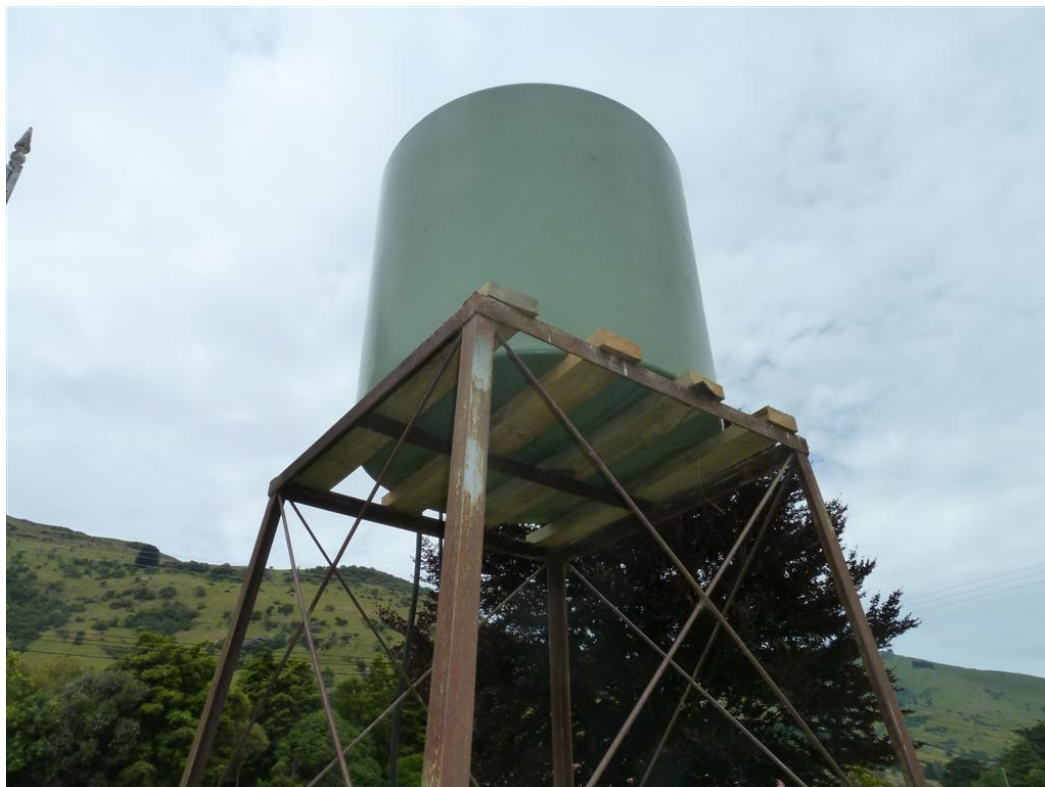
Photo 6: Water tank sitting on top of the braced steel frame (now removed)
