**Old Akaroa Plunket Room
(Café Truby's)
PRK 3643 BLDG 001**

**Detailed Engineering Evaluation
Quantitative Assessment Report**

Date: September 2013
Reference: 6-QUCCC.32
Status: Final

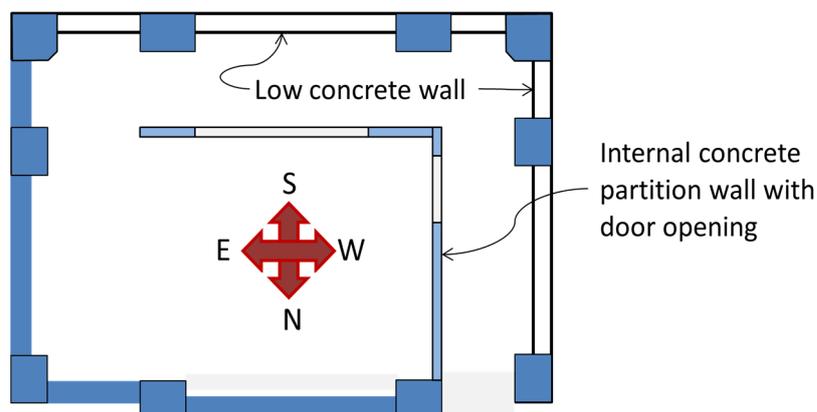
Figure 1 - Schematic Plan

Seismic force in both the N-S and E-W directions is generated by the response of the roof mass and the perimeter reinforced concrete ring beam. The lateral load is transferred to the foundation via the moment resisting reinforced concrete frame around the perimeter of the building.

The wall infill along the north and east elevation appears to be constructed of lightly reinforced concrete. Similarly the internal wall partitions are also constructed of lightly reinforced concrete with door openings. These internal walls are not considered to be part of the lateral load resisting system because the capacity of the fixings, if any, to the roof structure is not likely to be sufficient to transfer the required forces parallel to the wall.

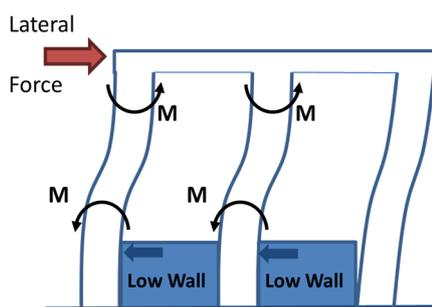
Figure 2 - Lateral Restraint Diagram

In determining the reliable strength of the west elevation frame, we assumed that only two out of the three columns are effective in providing lateral resistance. This is primarily due to the presence of a low infill wall between the columns. The low wall provides restraint to the column base and hence reduces the effective clear height, which in turn increases the column stiffness and attracts greater lateral load. The lateral resistance from the far end column is ignored because there is no evidence of reinforcement tying the column into the infill wall to provide an active restraint.

Similarly for the E-W direction, we assumed only three out of the four columns of the north elevation frame are effective in providing lateral restraint.

- (a) The seismic rating of the building is approximately 50% of the current building code new building standard, and is therefore not classed as an earthquake prone building.
- (b) If it is required to improve the rating to more than 67% NBS, the west elevation concrete frame will need to be strengthened.
- (c) Further feasibility studies to be undertaken to determine the most cost effective strengthening option in order to increase the rating to 100%.
