CHRISTCHURCH CITY COUNCIL  
PRO 1017 B001  
Opawa Children's Library  
Louisson Place, Opawa

QUANTITATIVE ASSESSMENT REPORT  
FINAL

- Rev C
- 11 February 2014

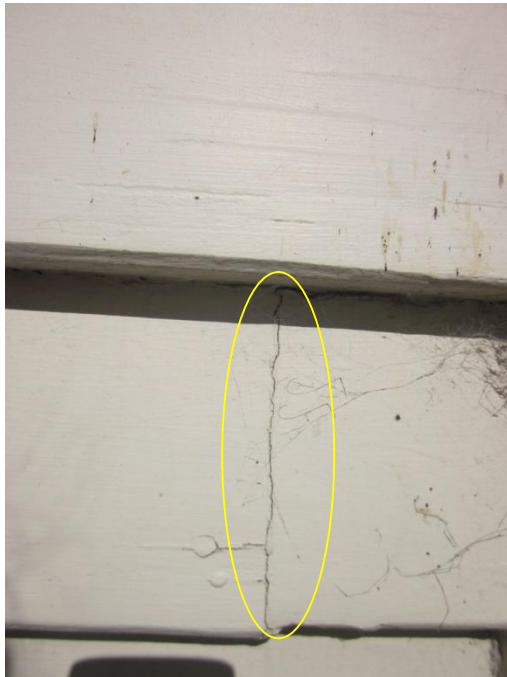
- 1) Vertical hairline cracking present at weatherboard joints, (typical) (PHOTO 3 & 16).
- 2) Hairline cracking along the timber trim and fascia board joint present on the north wall. Damage in the NW corner is most likely existing damage that has been exacerbated by the earthquake (PHOTO 5).

Photo 3: Hairline Cracking at Weatherboard Joints (typical)

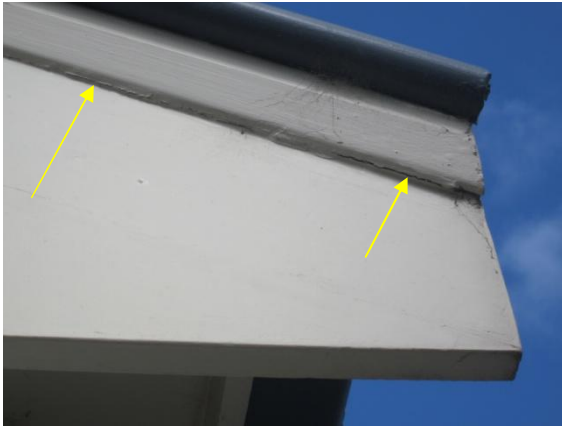
Photo 5: Hairline Cracking along Timber Trim & Fascia Board Joint (Damage in NW end appears to be existing damage that has been exacerbated by the EQ)

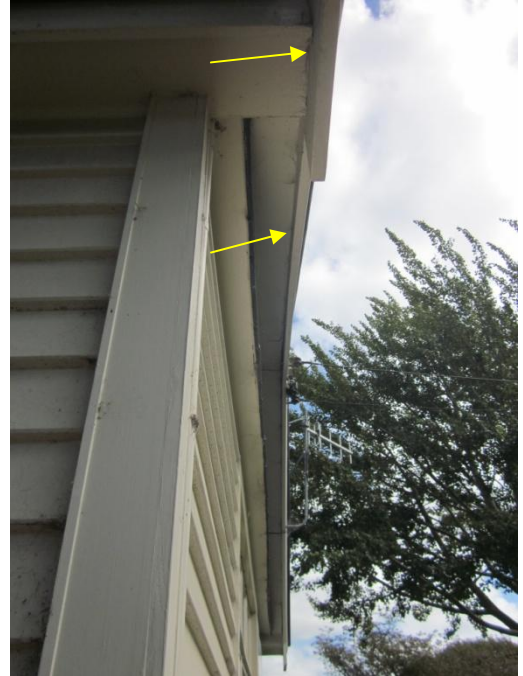
Photo 6: Hairline Cracking along Soffit Lining and Fascia Board Joint

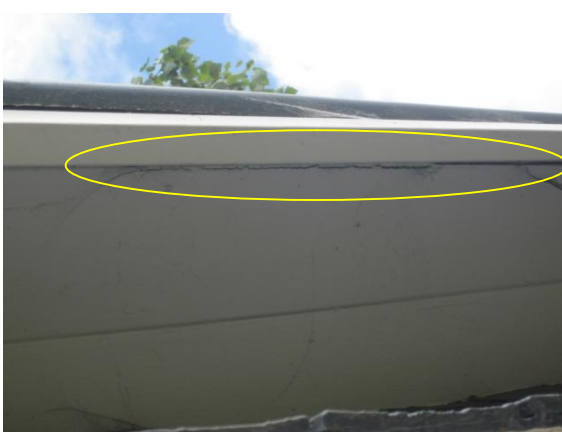
- 3) Hairline cracking present along the soffit lining and fascia board joint on the north wall. Some of the damage appears to be existing damage that has been exacerbated by the earthquake (PHOTO 7).
- 4) Hairline cracking present around the window architrave and weatherboard joint. Occurs on the two northern windows on the east wall and the window on the south wall (PHOTO 9).
- 5) Existing cracking in the weatherboard joints in the SE and SW corner appear to have been exacerbated by the earthquake (PHOTO 11).

Photo 7: Close up of Photo 7

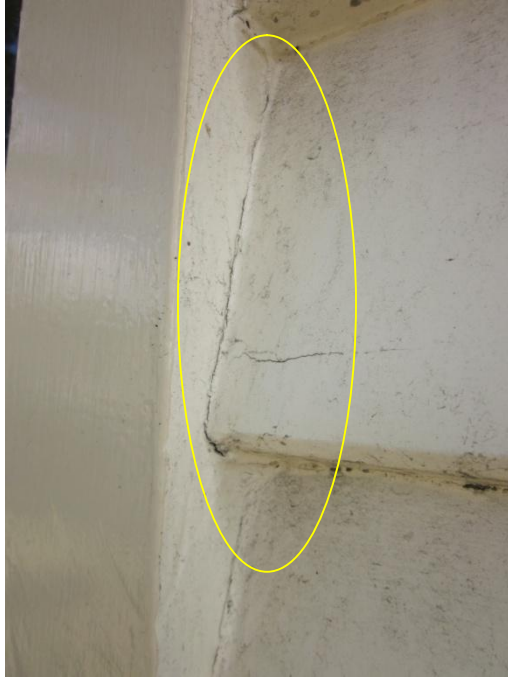
Photo 9: Hairline Cracking along the Window Architrave and the Weatherboard Joints

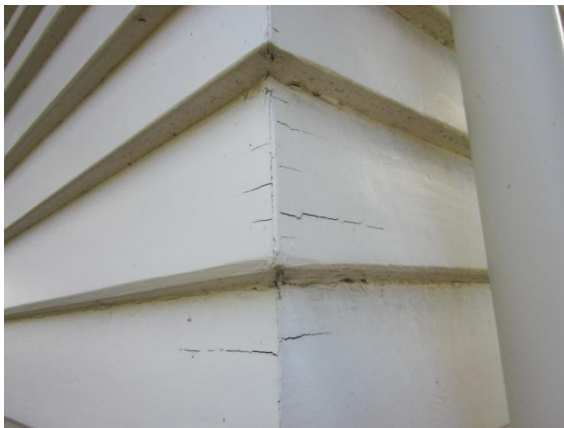
Photo 11: Existing Damage in the South East corner Exacerbated by EQ (SW Corner Similar)

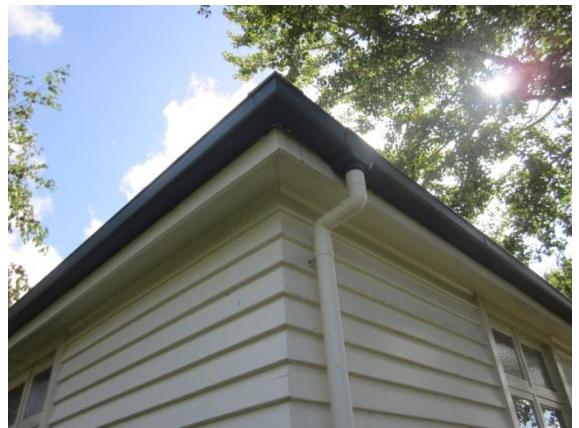
Photo 12: Hairline Crack along the Soffit Lining Mitre Joint

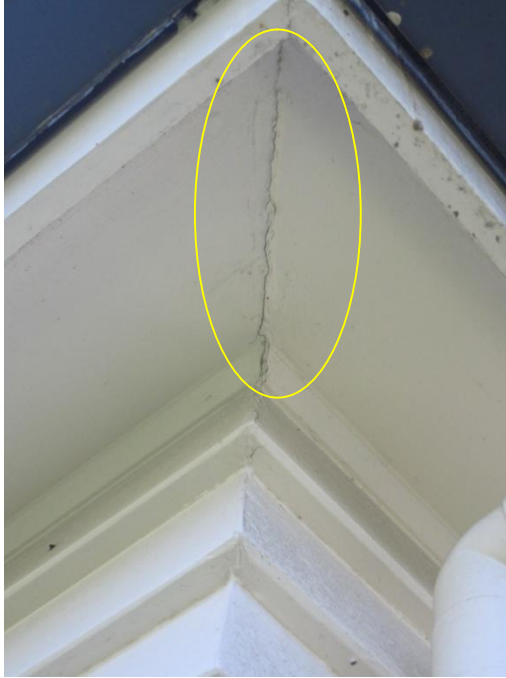
Hairline cracks present at the soffit lining joints on the south wall and at the mitre joint in the SE corner (PHOTO 13 & 14).

Photo 13: Close up of Photo 12

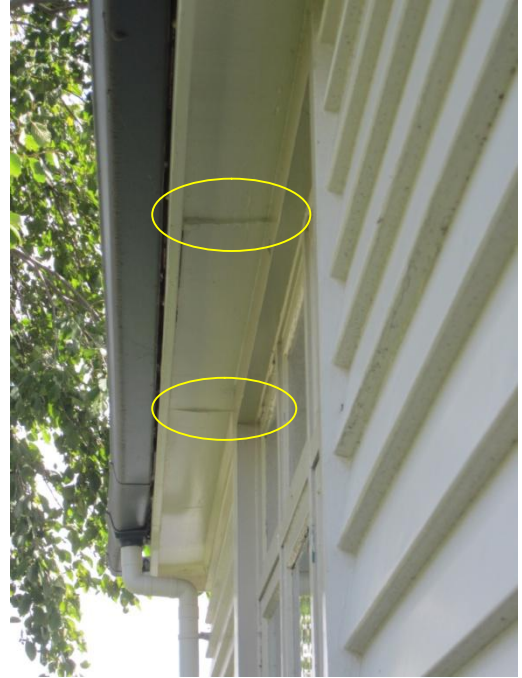
Photo 14: Hairline Cracking along Soffit Lining Joints on the South Wall

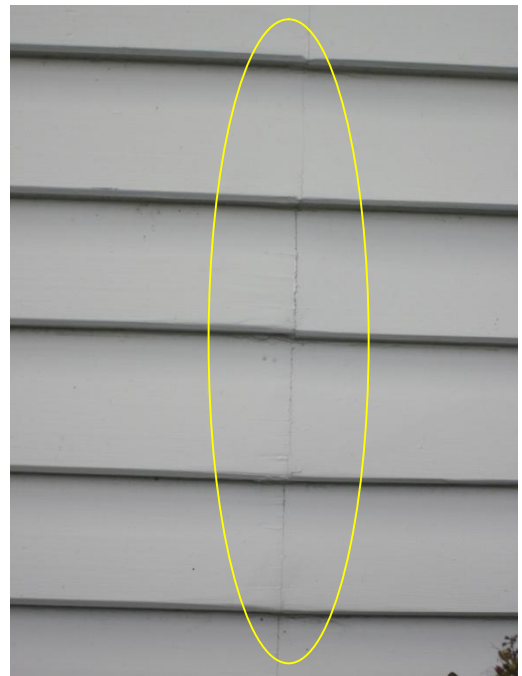
Photo 16: Hairline Cracks along Weatherboard Joints on the West Wall (typical)

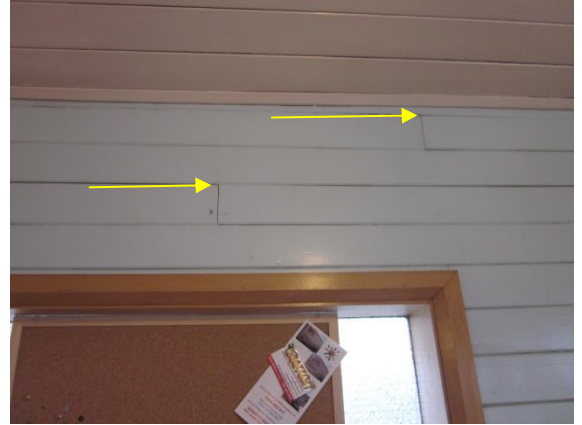
- 1) Hairline cracks present at the tongue and groove joints in the library (PHOTO 18).
- 2) Hairline cracks present along the scotia and ceiling lining joint in the toilet area (PHOTO 20).
- 3) Mitre joints on the window architraves in the toilet area have opened up (PHOTO 21).

Photo 18: Hairline Cracks along Tongue & Groove Joints

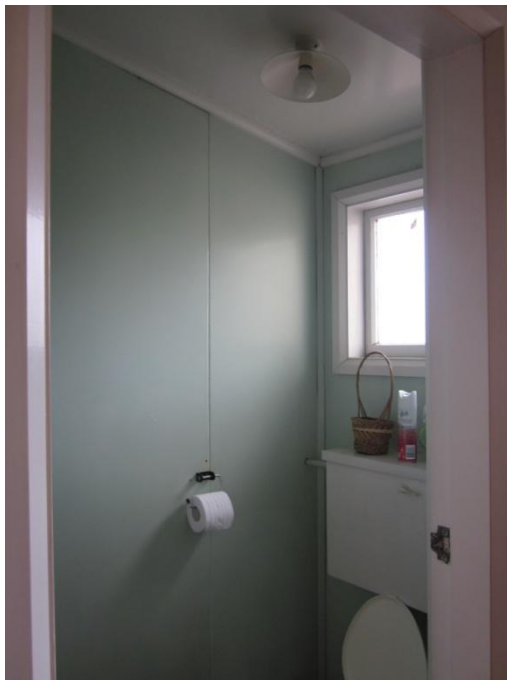
Photo 19: Hairline Cracks along the Scotia and Ceiling Lining Joint

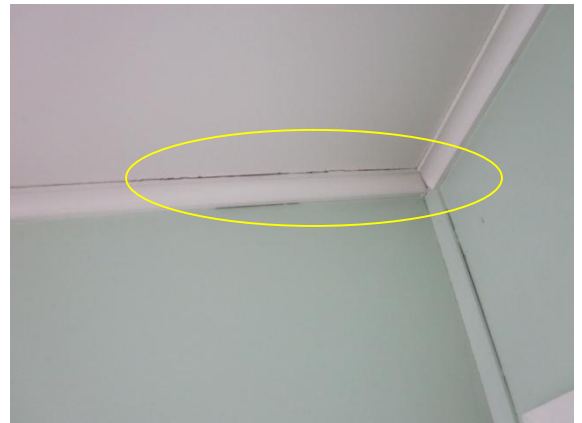
Photo 20: Close up of Photo 19

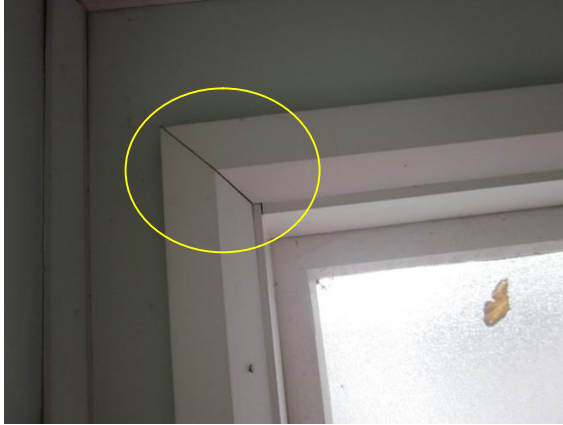
Photo 21: Mitre Joints on the Window  
Architrave in the toilet Area have Opened up
