Owen Mitchell Reserve Toilet
PRK 0086 BLDG 001 EQ2
Detailed Engineering Evaluation
Quantitative Report
Version FINAL

100 Grimseys Road, Redwood

Christchurch City Council

Date
14 March 2013

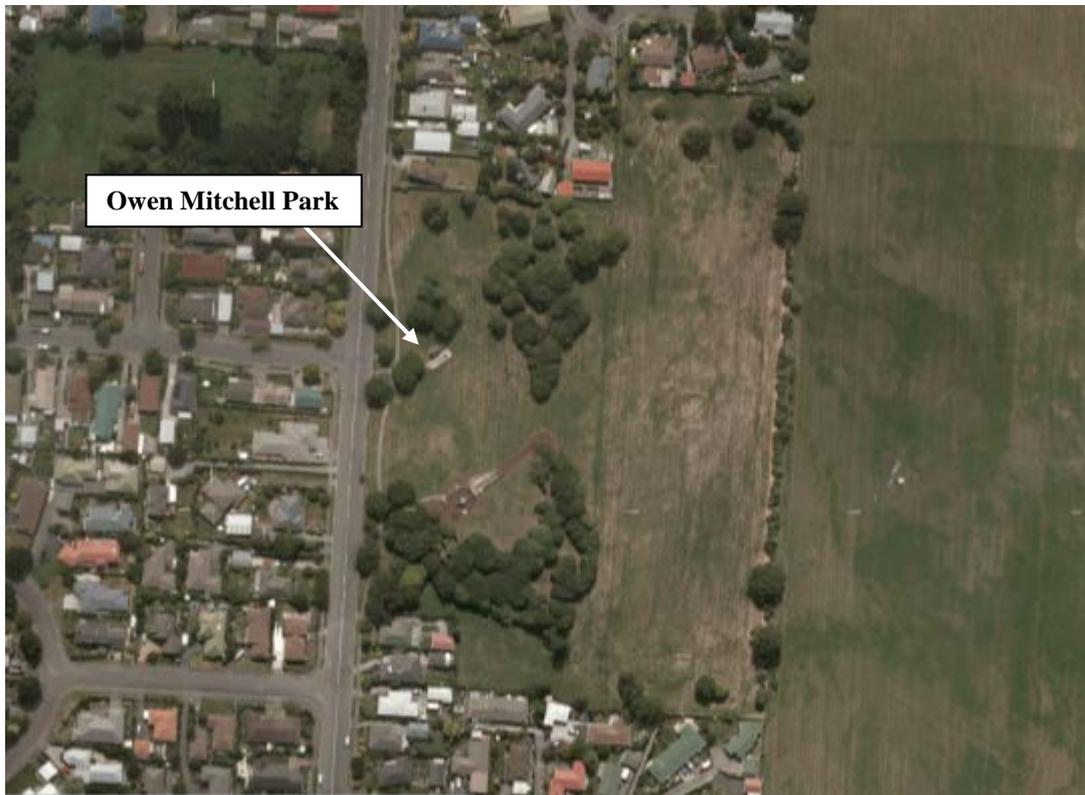
Figure 6.1 Post February 2011 Earthquake Aerial Photography ²

Aerial photography taken following the 4 September 2011 and 22 February 2011 (Figure 6.1) earthquake shows no obvious signs of liquefaction outside the building footprint or adjacent to the site. However, minor liquefaction was evident in the surrounding area.

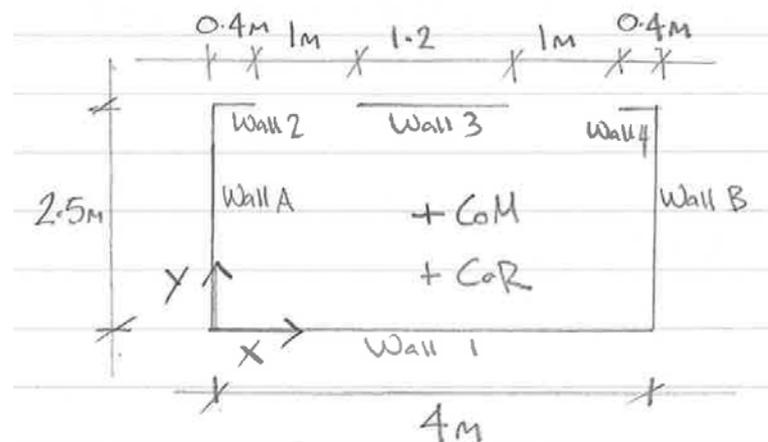
Figure 8.1 Concrete masonry wall layout and labels

In the longitudinal direction, there is a stiffness eccentricity due to the door openings along the south-eastern side of the building. As a result, the wall running the full length of the building on the north-west side of the building resists the majority of the lateral load for an earthquake occurring in the longitudinal direction.

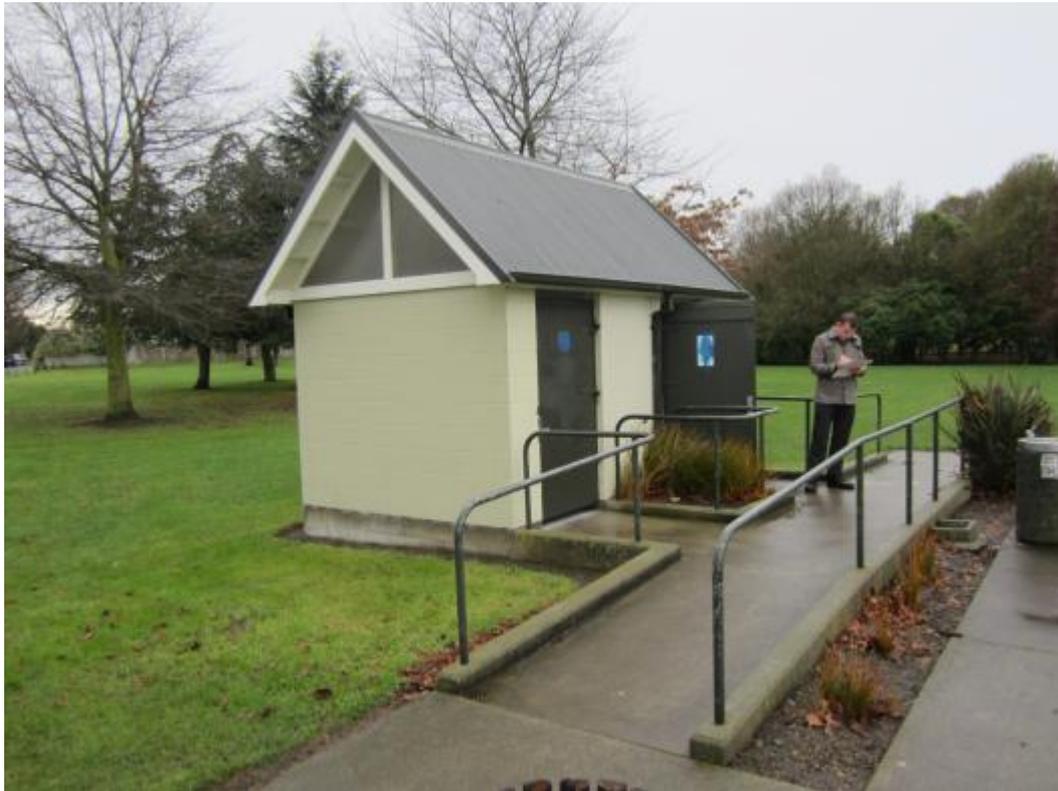
Photograph 1 View of building from the south

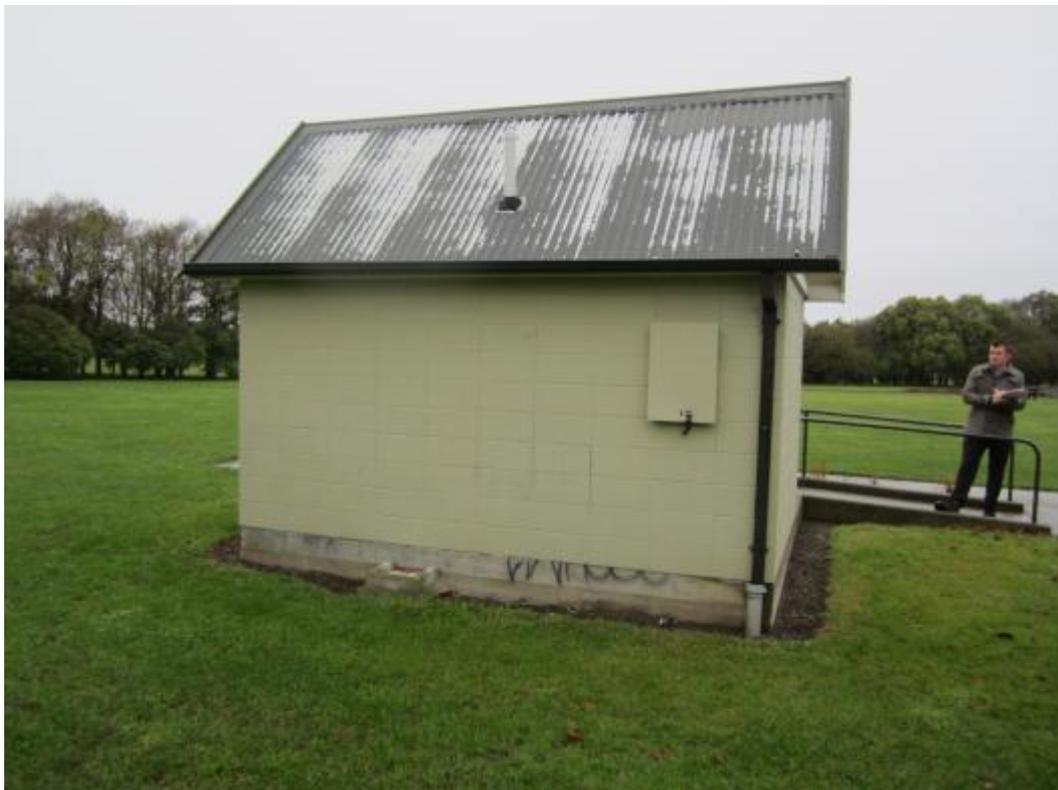
Photograph 2 Rear concrete masonry wall

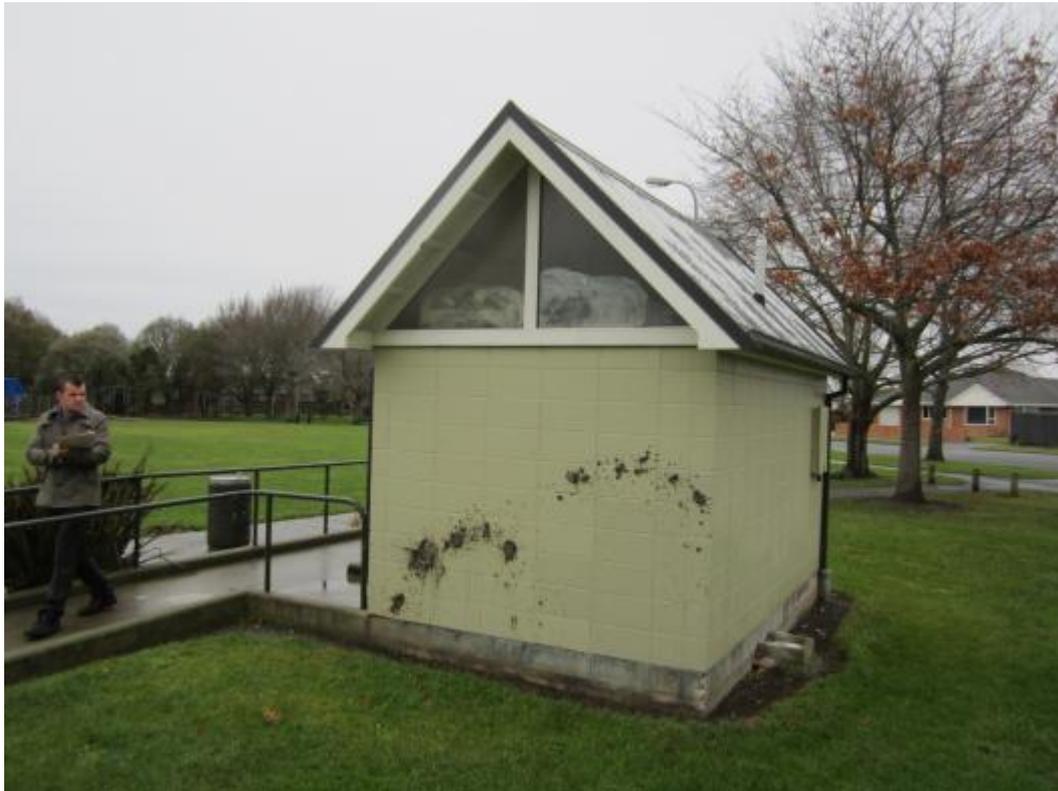
Photograph 3 View of duo-pitched timber roof structure

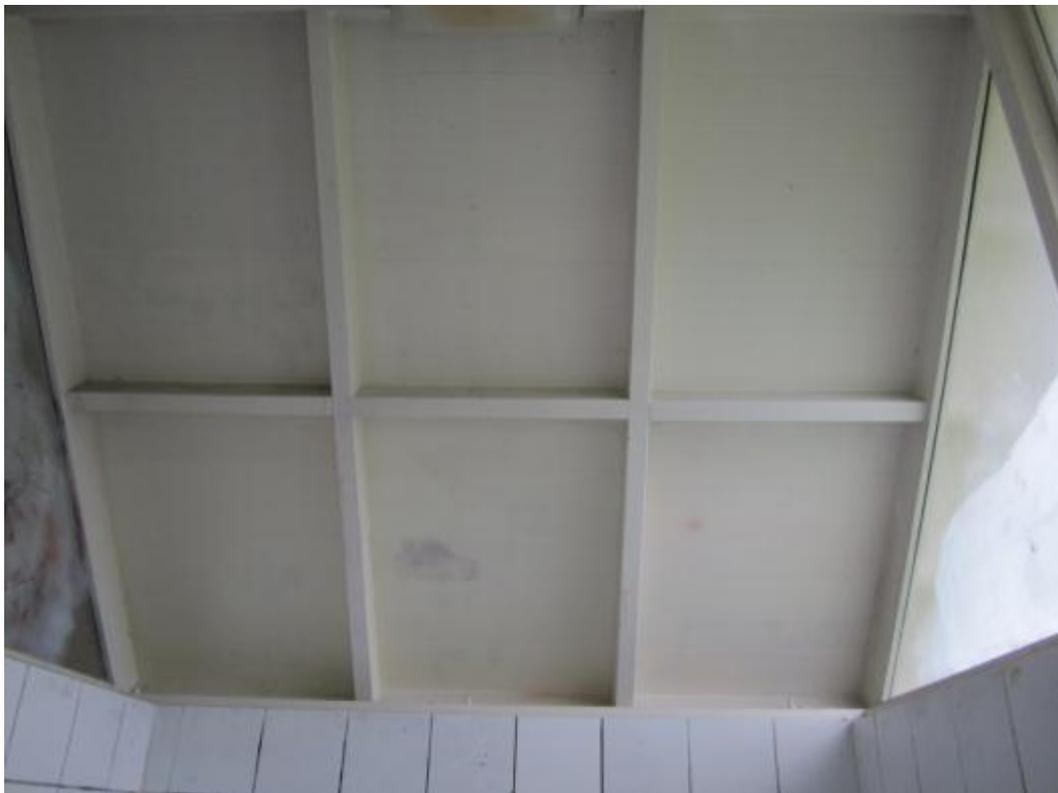
Photograph 4 View of timber sarking in roof structure

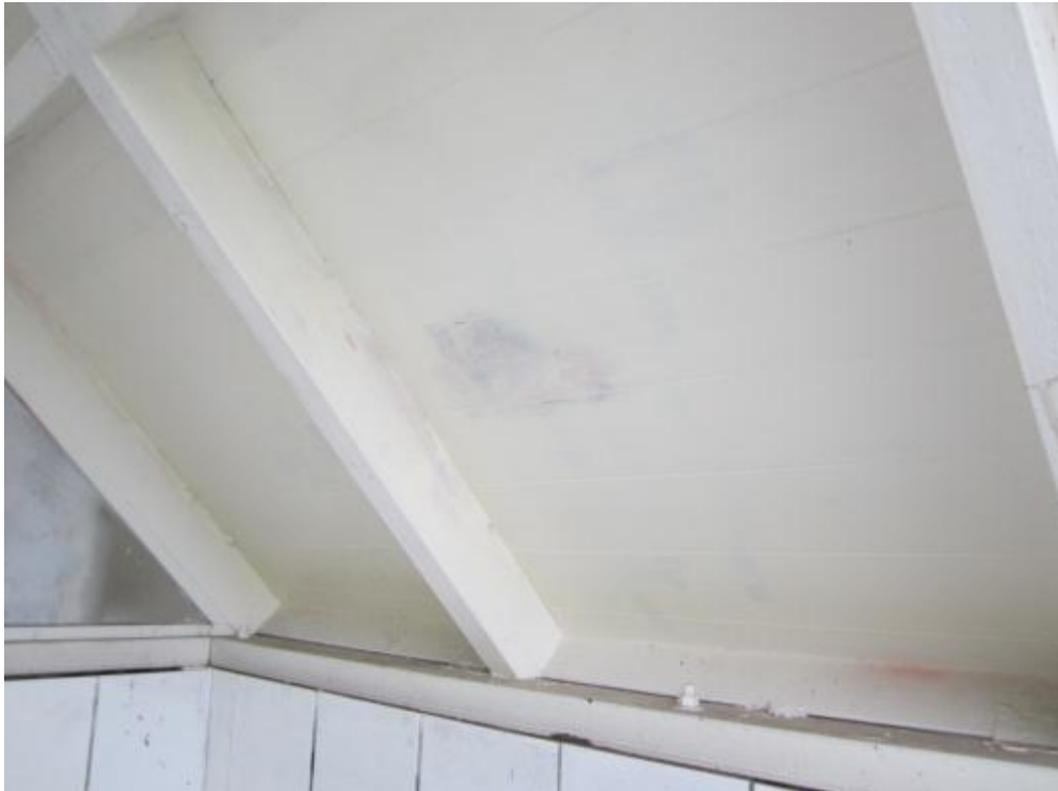
Photograph 5 Connection between timber roof framing and concrete masonry walls

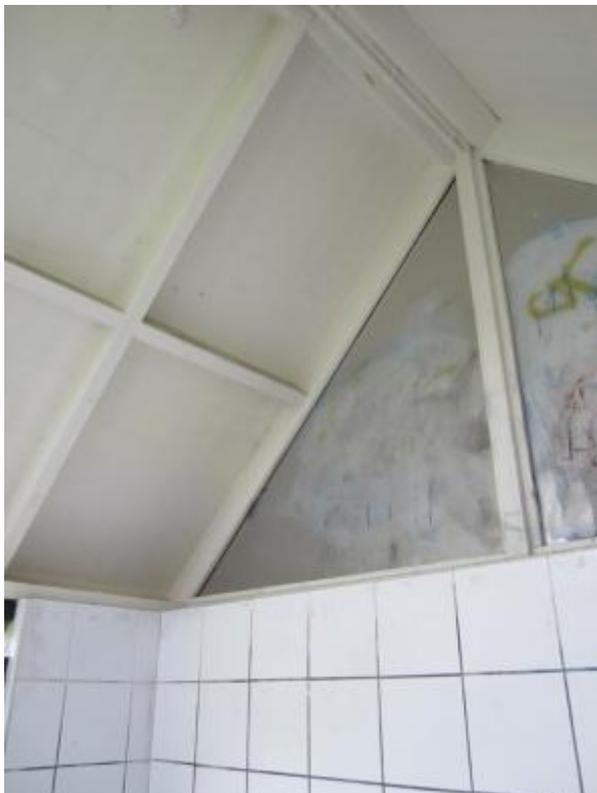
Photograph 6 Central timber post supporting timber ridge beam
