Owen Mitchell Reserve Toilet
PRK 0086 BLDG 001 EQ2
Detailed Engineering Evaluation
Quantitative Report
Version FINAL

100 Grimseys Road, Redwood

Christchurch City Council

Date
14 March 2013

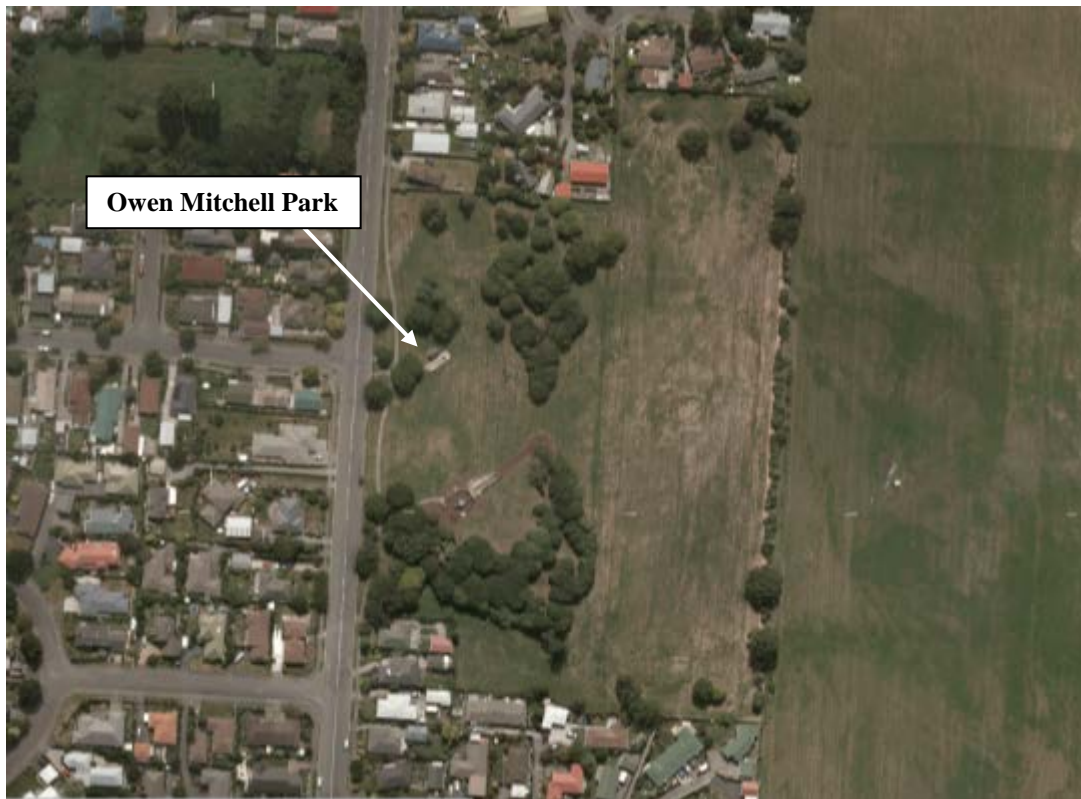
Figure 6.1 Post February 2011 Earthquake Aerial Photography ²

Aerial photography taken following the 4 September 2011 and 22 February 2011 (Figure 6.1) earthquake shows no obvious signs of liquefaction outside the building footprint or adjacent to the site. However, minor liquefaction was evident in the surrounding area.

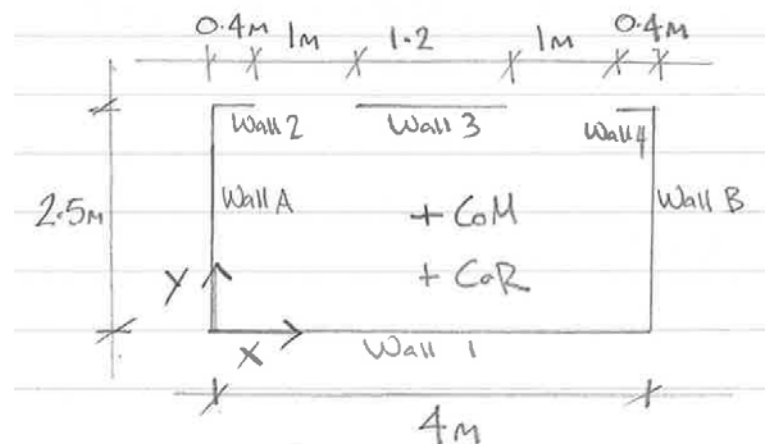
Figure 8.1 Concrete masonry wall layout and labels

In the longitudinal direction, there is a stiffness eccentricity due to the door openings along the south-eastern side of the building. As a result, the wall running the full length of the building on the north-west side of the building resists the majority of the lateral load for an earthquake occurring in the longitudinal direction.

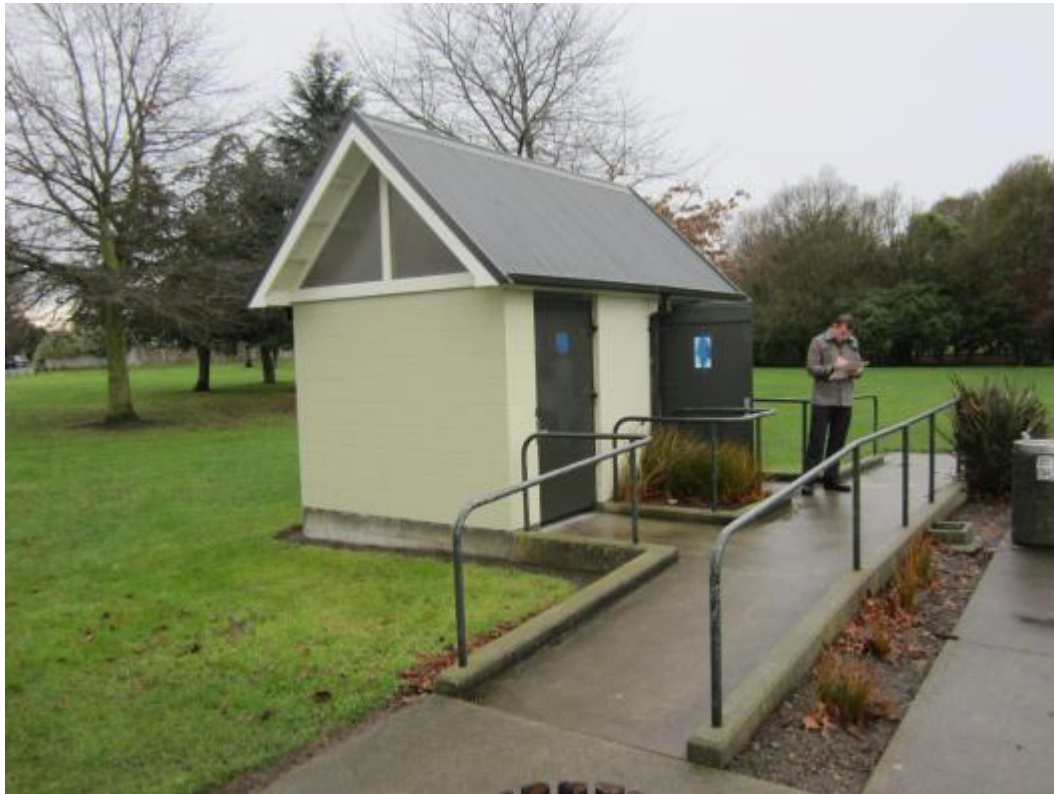
Photograph 1 View of building from the south

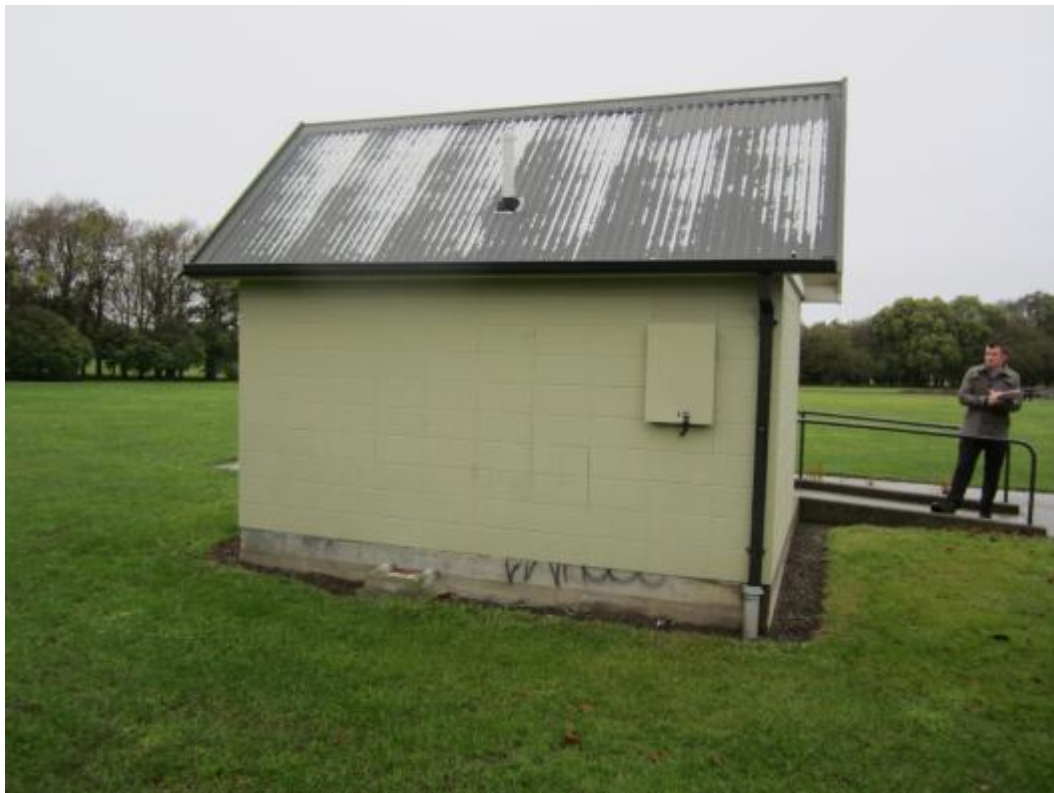
Photograph 2 Rear concrete masonry wall

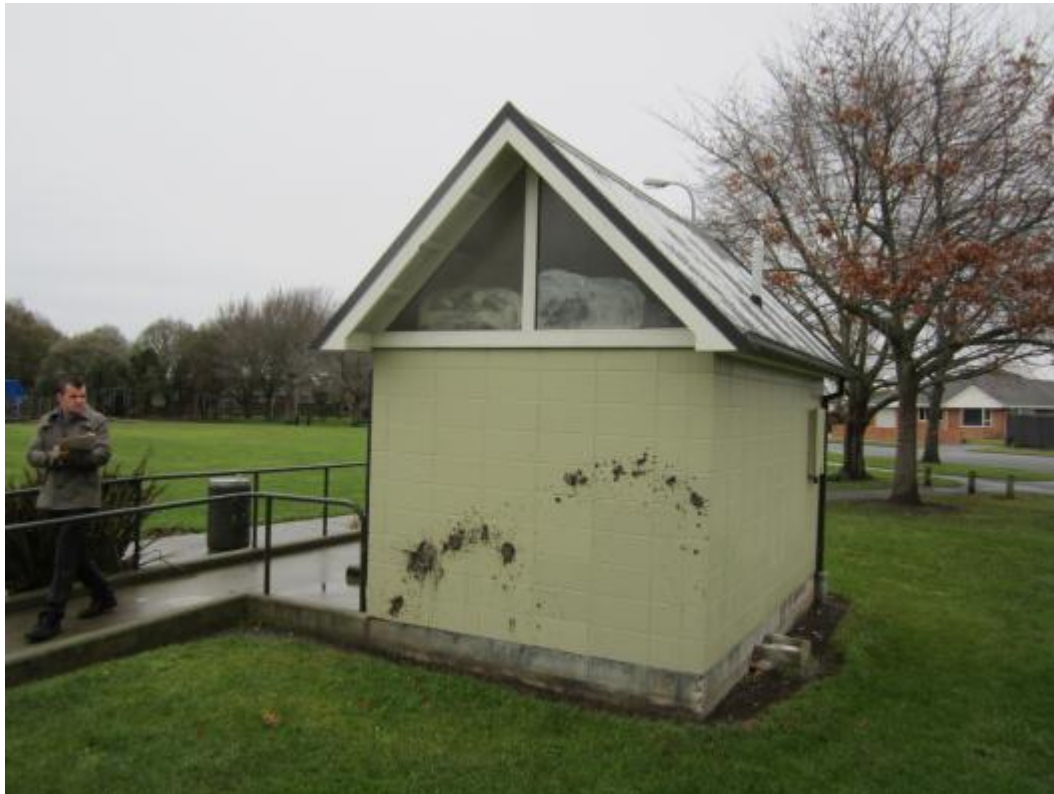
Photograph 3 View of duo-pitched timber roof structure

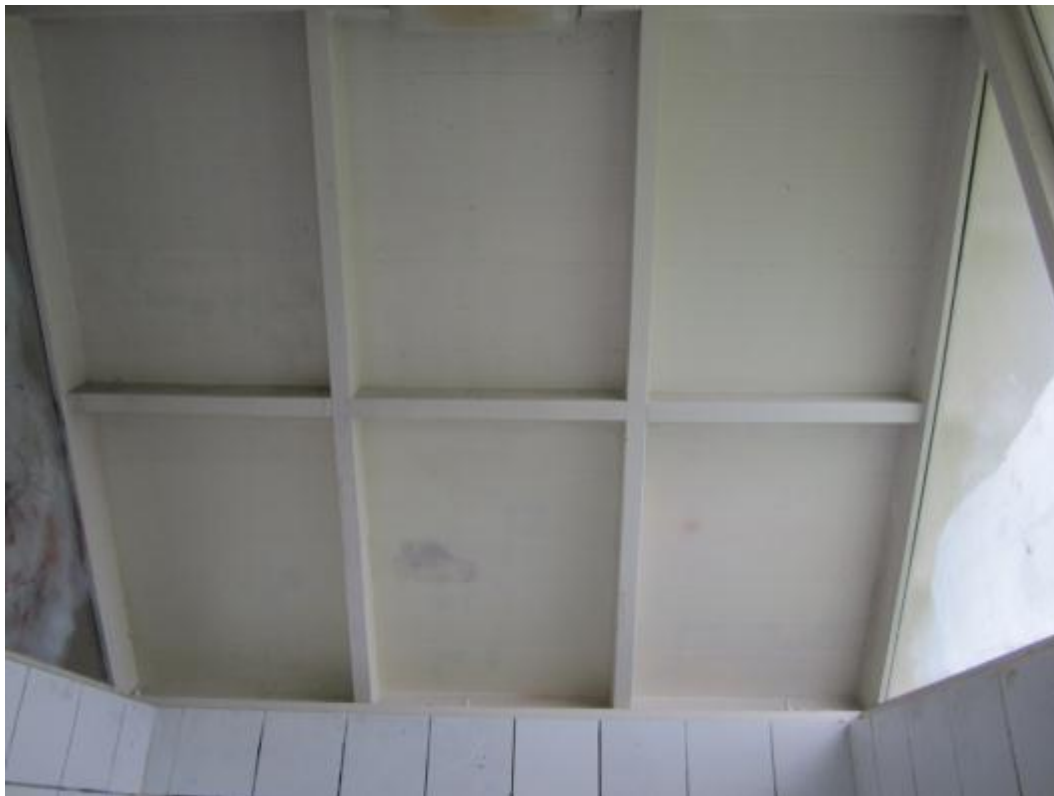
Photograph 4 View of timber sarking in roof structure

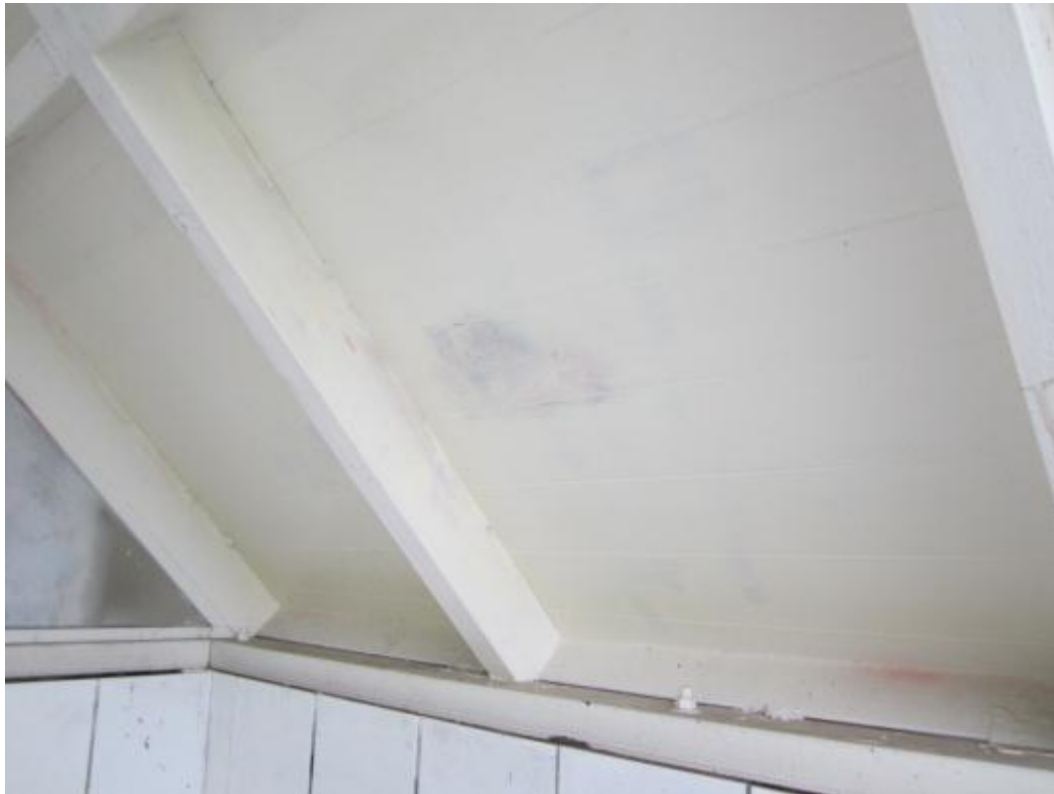
Photograph 5 Connection between timber roof framing and concrete masonry walls

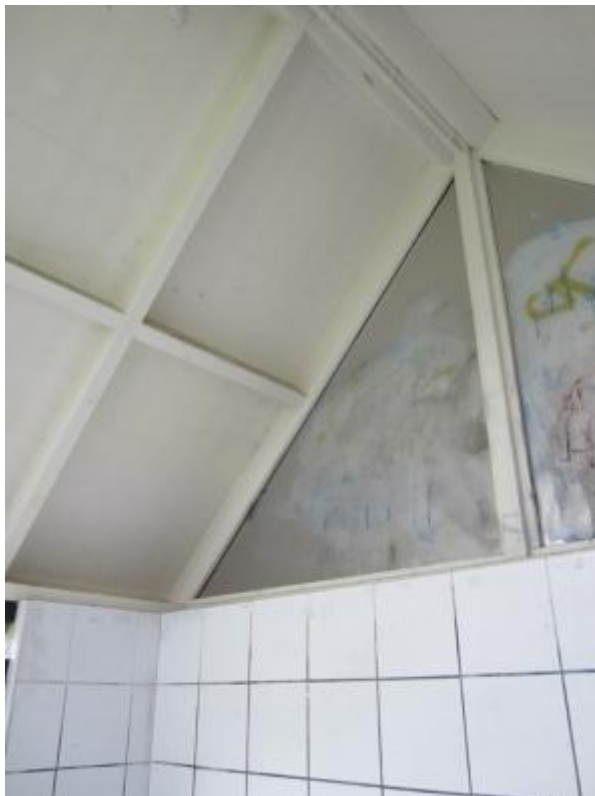
The roof structure consists of a 45 degree duo-pitch roof formed by corrugated sheet metal on timber sarking supported by timber purlins and rafters. A timber ridge beam running the length of the structure is supported at each end and at midpoint by timber posts. The timber posts are supported by the transverse concrete masonry end walls and the transverse central timber wall. The central post supporting the timber ridge beam is shown in Photograph 6.

Photograph 6 Central timber post supporting timber ridge beam
