Paeroa Pump Shed  
Qualitative Engineering Evaluation

**Reference:** 231561  
**Prepared for:**  
Christchurch City Council

**Functional Location ID:** PRK 2936 BLDG 002  
**Address:** 6 Paeroa Street, Riccarton

**Revision:** 2  
**Date:** 2 July 2013

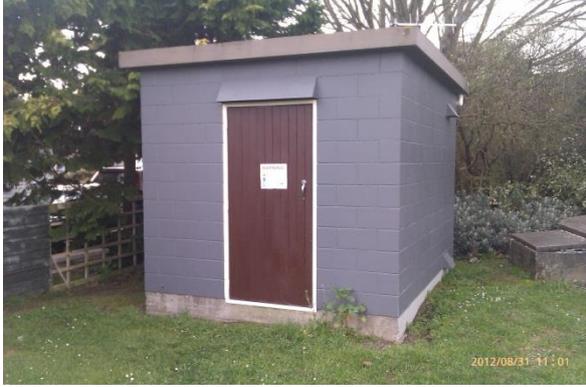
<p>General view of the Paeroa Pump Shed.</p>

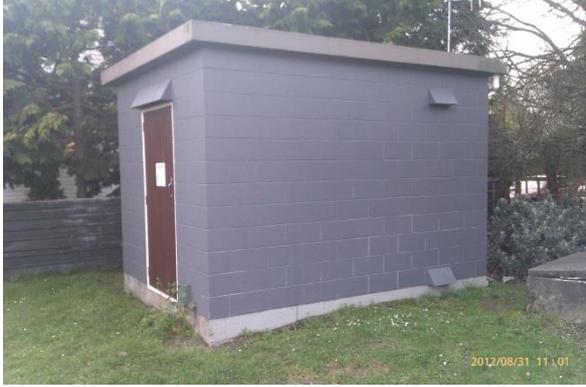
A photograph of a small, square, grey-painted shed with a dark brown door. The shed is situated on a grassy area with trees in the background. A timestamp '2012/08/31 11:01' is visible in the bottom right corner.
<p>Side view of the Paeroa Pump Shed.</p>

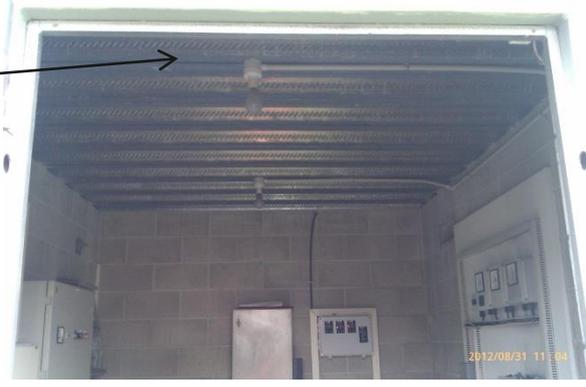
A photograph showing the side profile of the grey shed. The door is on the left side. The shed is on a grassy area with trees in the background. A timestamp '2012/08/31 11:01' is visible in the bottom right corner.
<p>General view of the roof.</p> <p>Bondek roof. →</p>

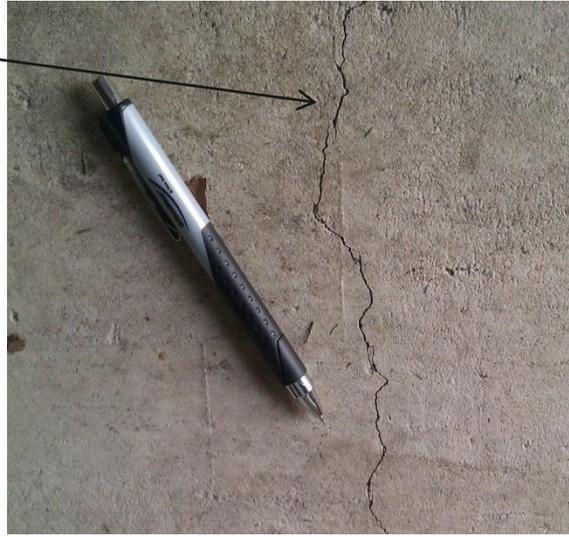
It was observed that the building has not suffered any structural damage. There is a minor crack in the foundation, which has likely occurred due to concrete shrinkage rather than earthquake damage.

Existing crack in the slab-on-grade.

Suspected to be a shrinkage crack.
