Parklands Community Centre
Qualitative Engineering Evaluation

Functional Location ID: BU 0115 001 EQ2

Address: 75 Queenspark Drive, Parklands

Reference: 227675

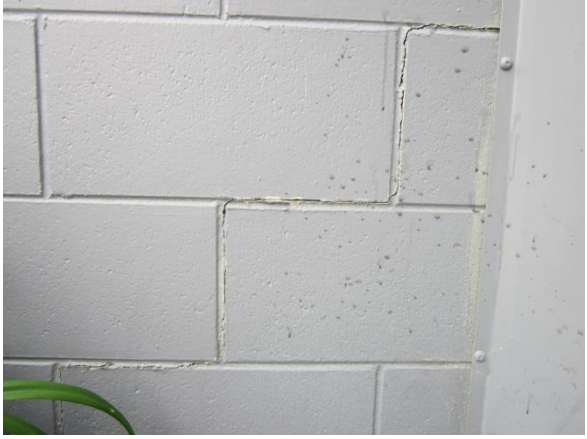
- a) Be prone to step cracking in the mortar joints due to excessively dry mortar and high seismic accelerations; and
- b) Detach from the timber framing due to missing or inadequate masonry ties.

<p>Step cracking in the exterior concrete masonry veneer wall of the Church adjacent to the gymnasium.</p>

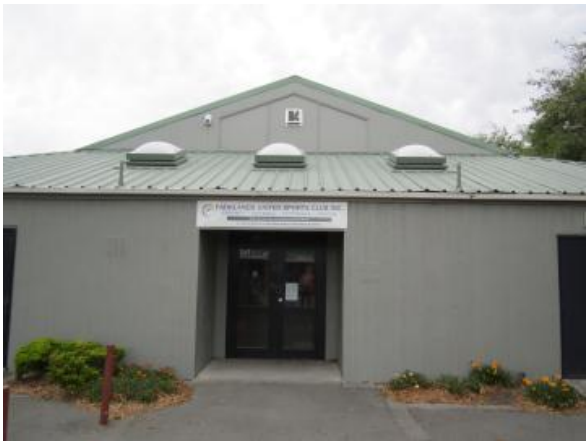
<p>Northern elevation of Sports Hall.</p>

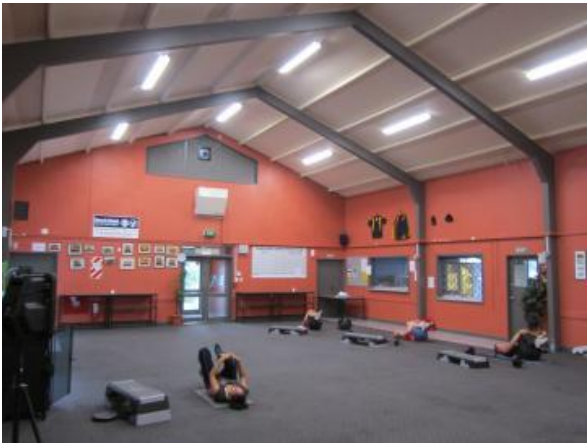
<p>Internal view of Sports Hall showing glulam timber portal frame.</p>

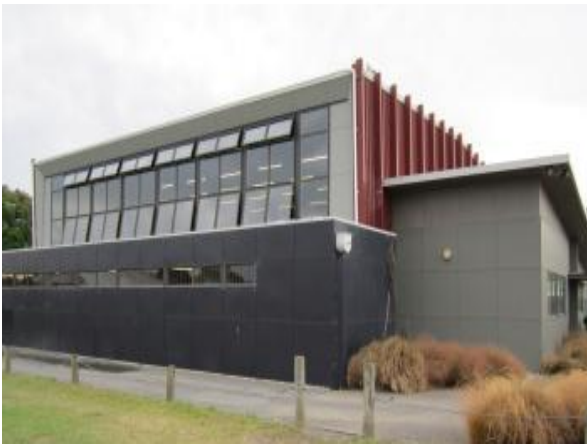
<p>Southern Elevation of the Gymnasium.</p>

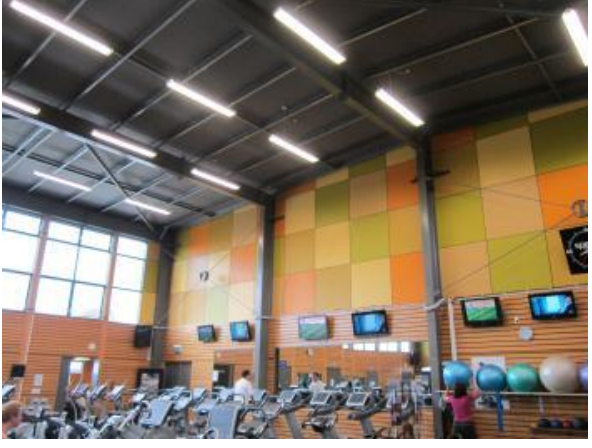
<p>Interior view of the Gymnasium showing the welded steel portal frames.</p>

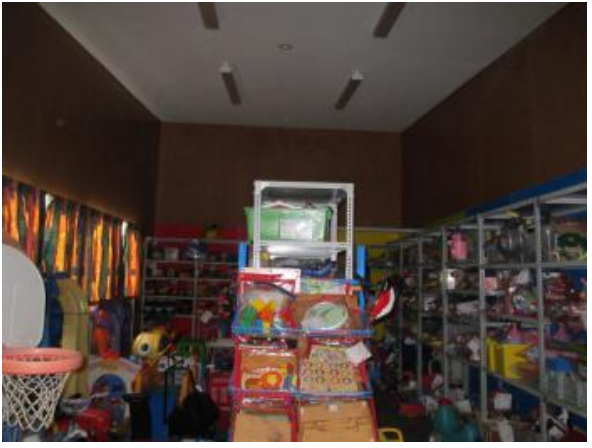
<p>Interior view of the storage room of the Gymnasium.</p>

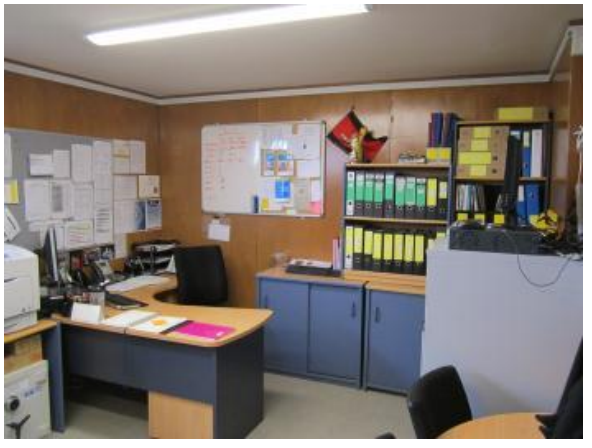
<p>Interior view of the offices on the Southern elevation of the Gymnasium.</p>

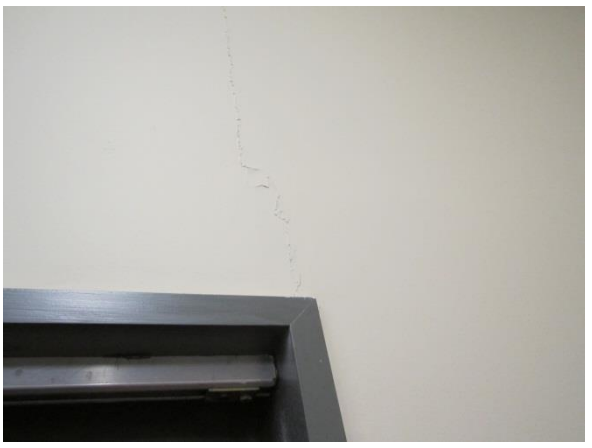
<p>Cracking in the wall linings above the door lintel in the Gymnasium.</p>
