# **Phillipstown Community Centre** **BU 2336 – 001 EQ2**

## **Detailed Engineering Evaluation** **Quantitative Report**

**39 Nursery Road, Phillipstown**

Date  
08<sup>th</sup> March 2013

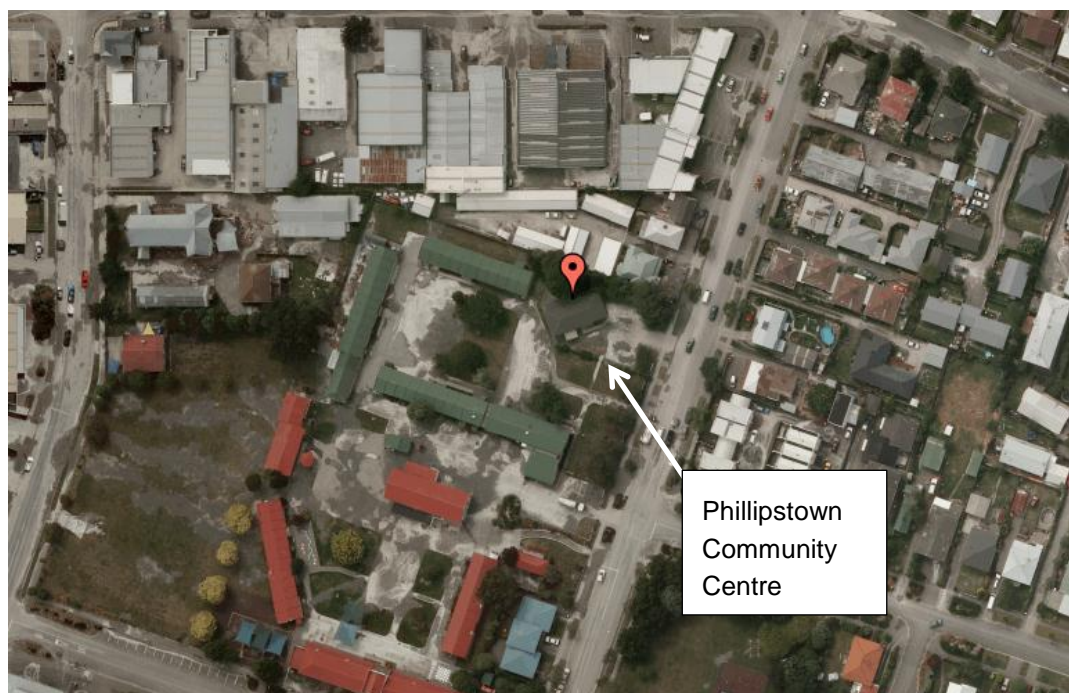
**Figure 3 Post February 2011 Earthquake Aerial Photography**

Aerial photography taken following the 22 February 2011 earthquake shows signs of significant liquefaction outside the building footprint and adjacent to the site, as shown in Figure 3.

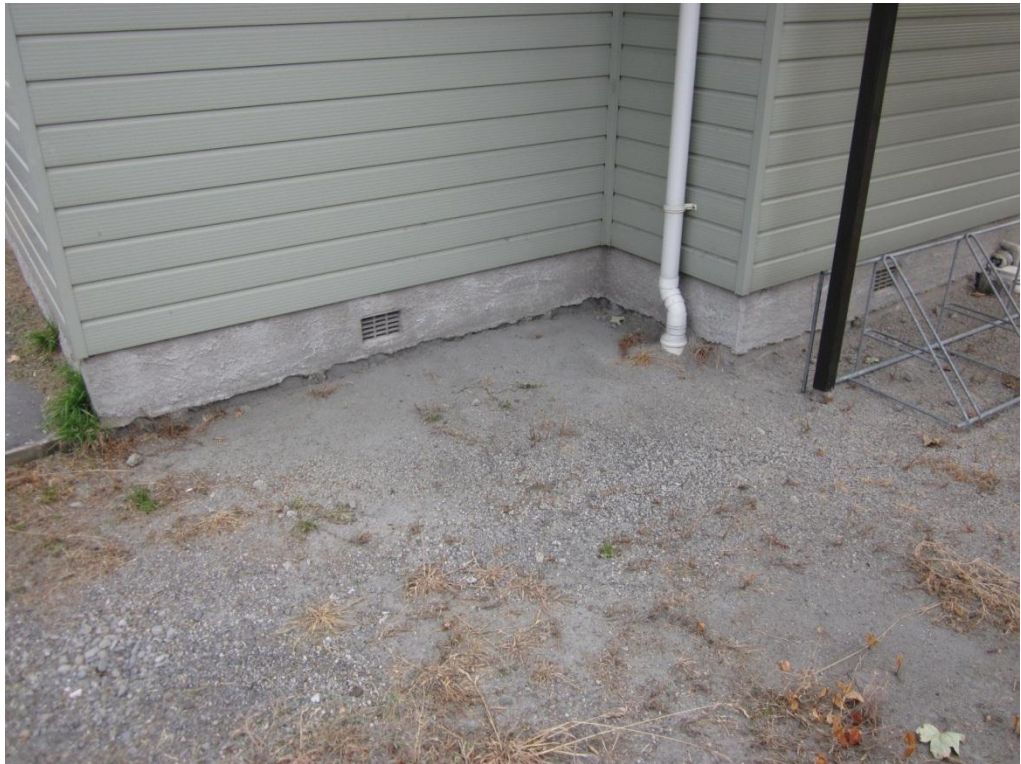
There was evidence of liquefaction at the surface in the post-earthquake aerial photography (see Figure 3). Ground damage to the property as a result of liquefaction was observed during the site visits and the tenant indicated that after the February 22<sup>nd</sup> earthquake, there was approximately 300mm deep layer of sediment covering the majority of the car park. Several areas of the paved car park have risen and fallen to create an uneven surface. A paved area of approximately 20m<sup>2</sup> at the south west of the building was severely damaged by liquefaction. Evidence of settlement of the site was observed in this area. The surrounding land has dropped approximately 100-120mm with a significant amount of fine sand sitting on the ground surface.

**Photograph 3 Area where pavement was destroyed and settlement of surrounding ground occurred as a result of liquefaction.**

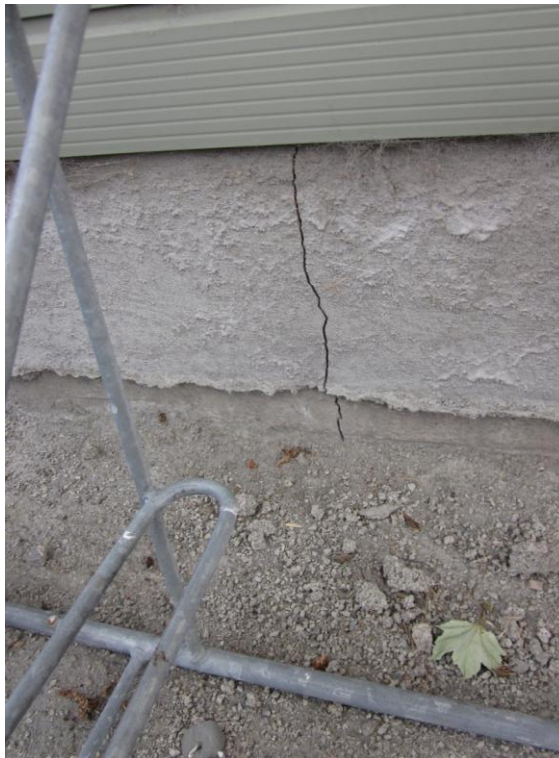
Cracking was noted at several locations on the building's perimeter foundation walls (see Photograph 4 to Photograph 6). The majority of the cracks appear to be cosmetic but it is evident that several of the cracks penetrate through the plaster finish and into the reinforced concrete foundation.

**Photograph 4 Vertical cracking to perimeter footing in the south-west of the building.**

Repair work should be carried out on all cracking observed in the building. The building foundations have settled significantly due to liquefaction in previous seismic events and it is recommended that remedial works be carried out to re-level the building as necessary. Severe liquefaction can be expected under significant earthquakes. Future ground damage from earthquakes may lead to further foundation settlement or damage and as a result, foundation strengthening is recommended. Any remedial works to foundations should be undertaken in accordance with MBIE's guidelines for TC3 land, due to the high levels of estimated settlement.

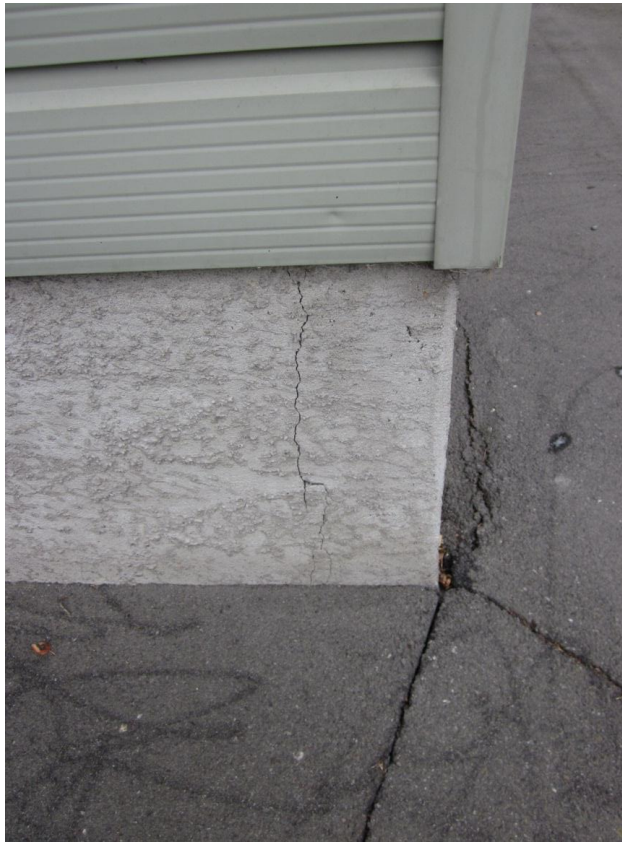
**Photograph 5 Cracking to strip footing in the south-east corner of the building.**

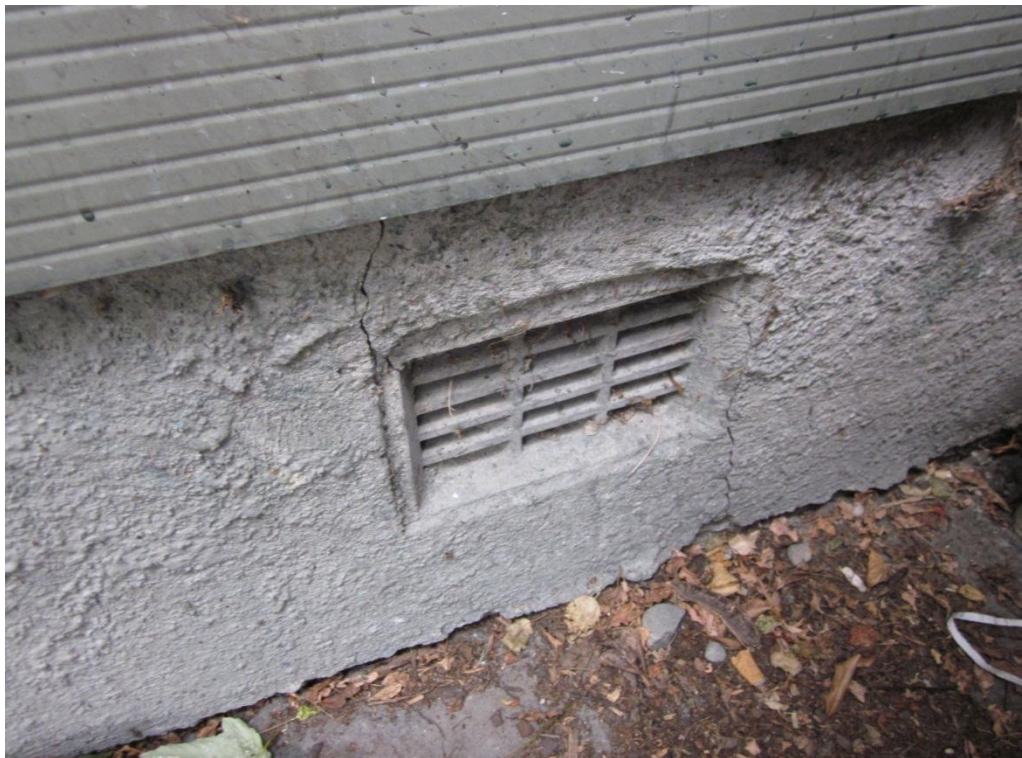
**Photograph 6 Cracking to the strip footing to the north of the building.**

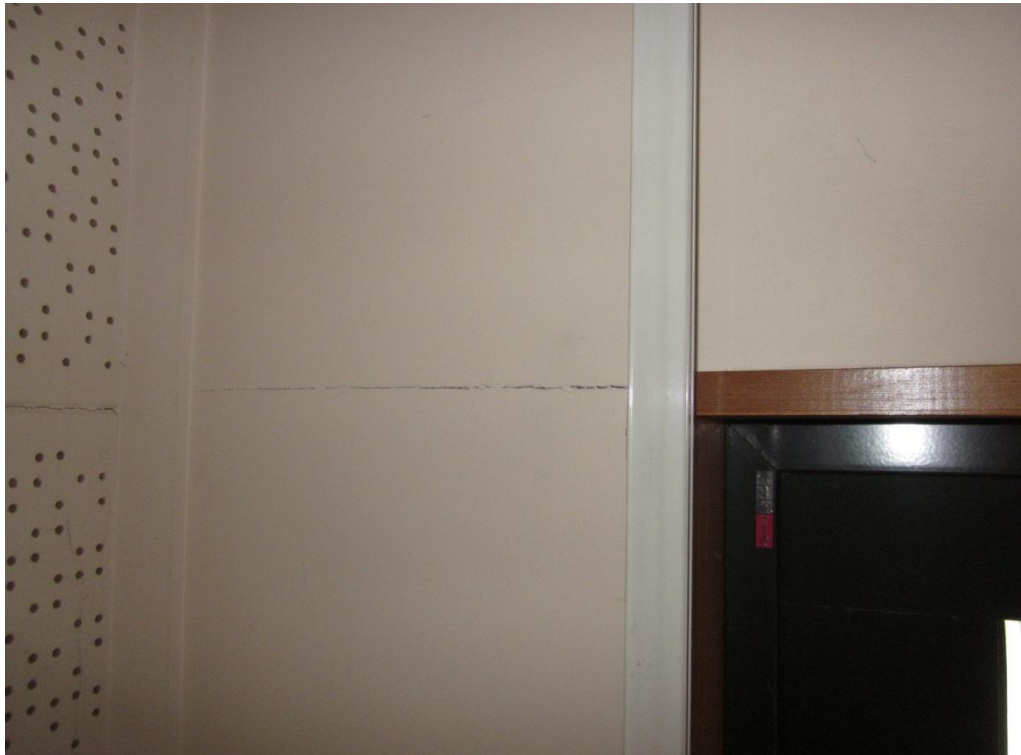
Cracking was noted to the internal plasterboard lining in several locations throughout the building, primarily above window and door openings (see Photograph 7 and Photograph 8). These cracks are not considered to be significant.

**Photograph 7 Damage to GIB lining above doors.**

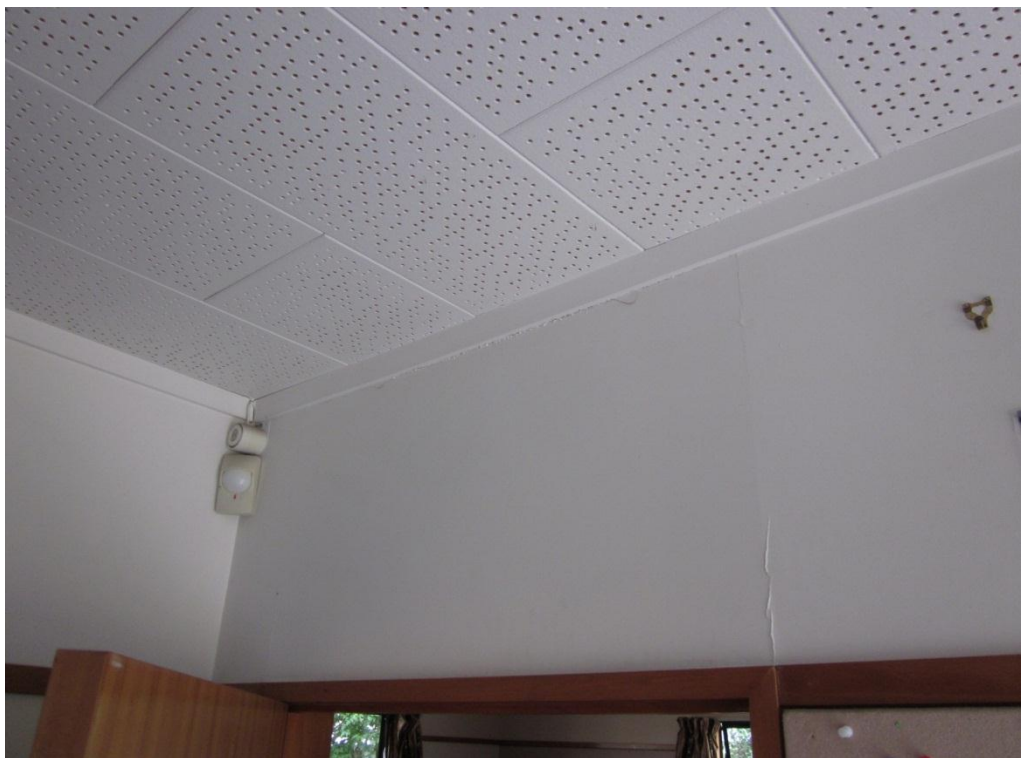
**Photograph 8 Damage to GIB lining above doors.**

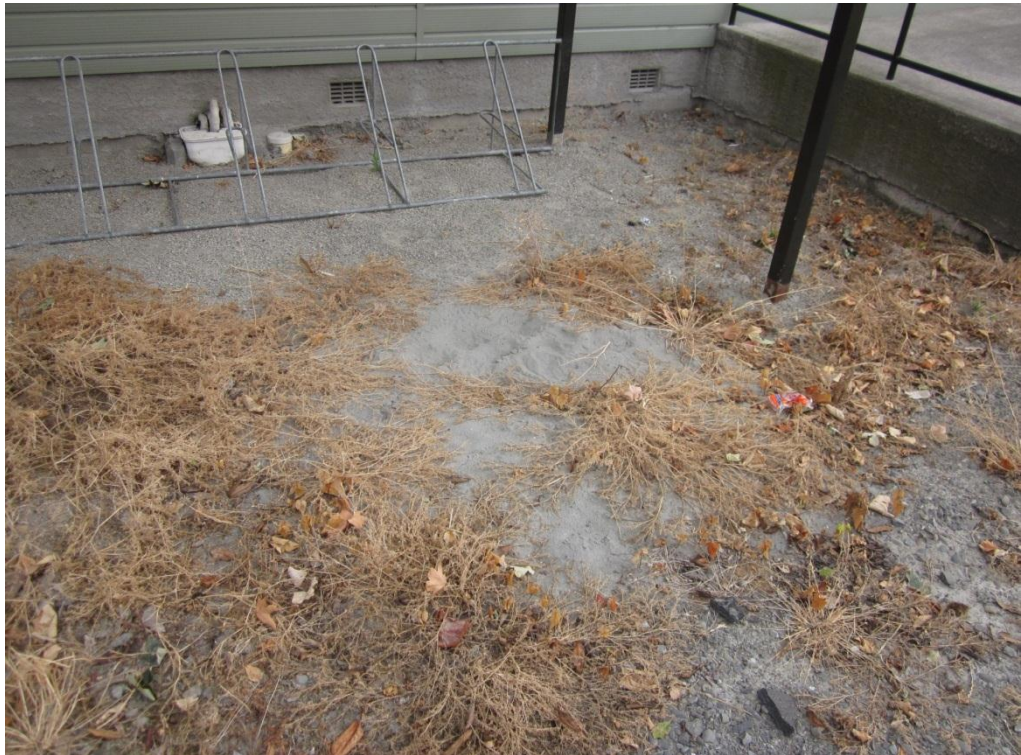
**Photograph 9 Evidence of liquefaction and settlement of site to south of the building.**

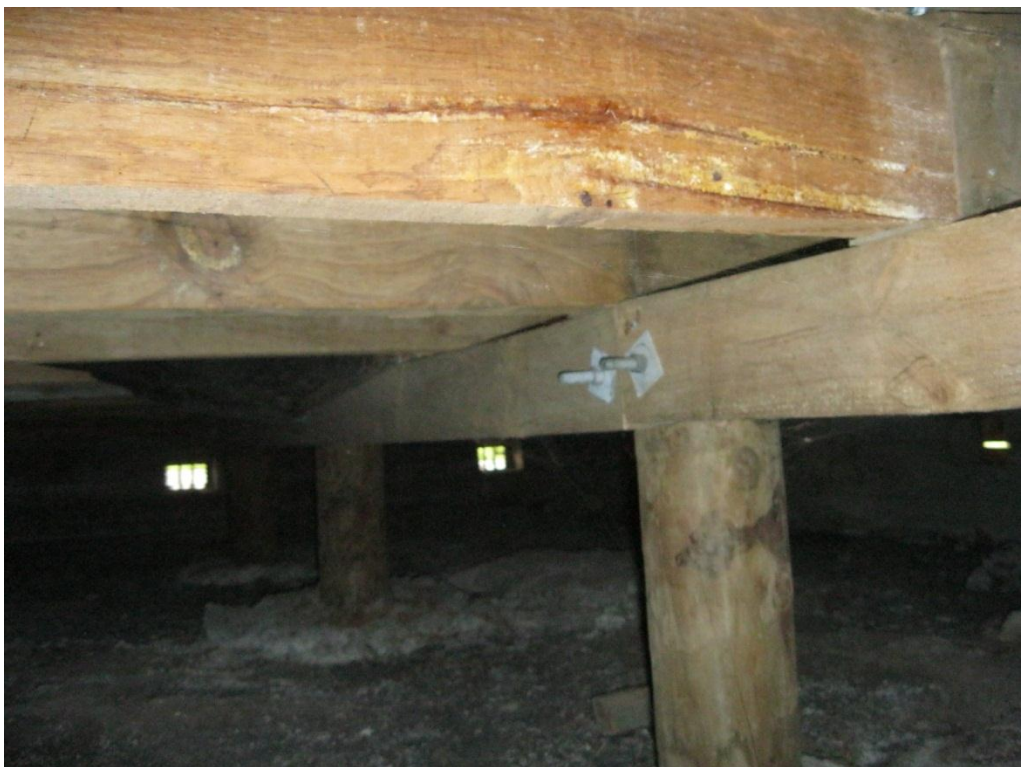
**Photograph 10 Timber piles and bearers near the west of the building viewed from sub-floor space**

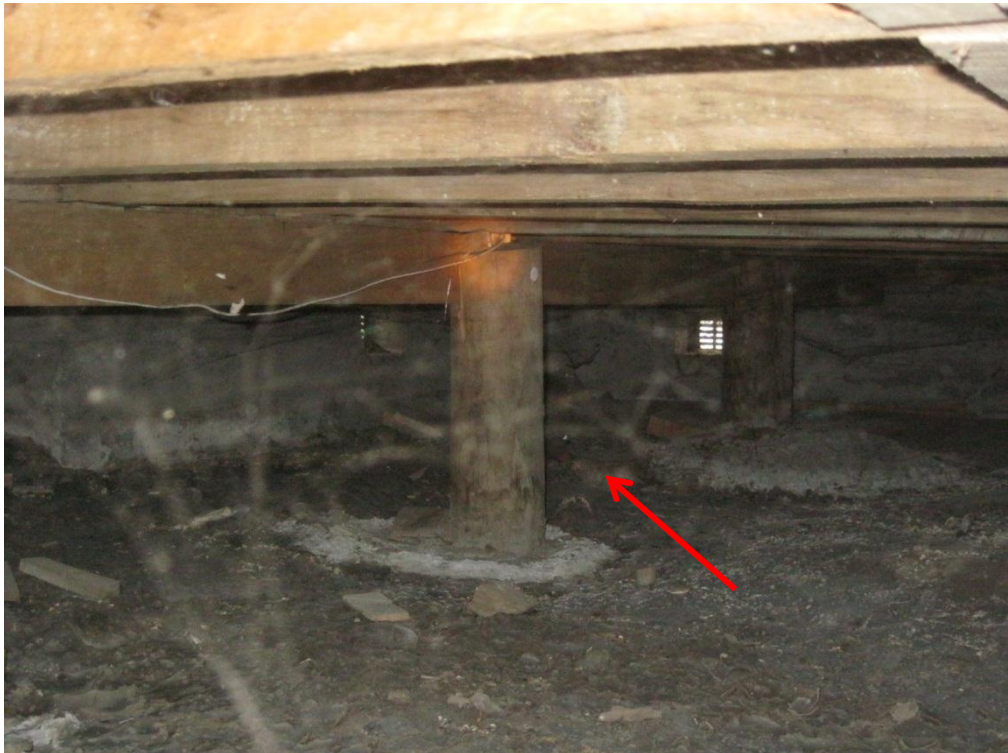
Residual displacements of the structure were noted during the inspection of the building. The south-west corner of the building appears to have settled. The difference in floor levels at the main entrance to the building and the south west corner was measured to be 38mm. It was evident from the site inspections that the west end of the building is sloping towards the south. Doors in the west of the building have a tendency to swing closed as a result of the displacement. It was also noted that the glass door to the timber decking area is askew and does not close smoothly, suggesting residual displacement in this area of the building.

**Photograph 11 Foundation piles at the south-west of the building where building has settled most. Evidence of significant liquefaction was observed at location of arrow.**

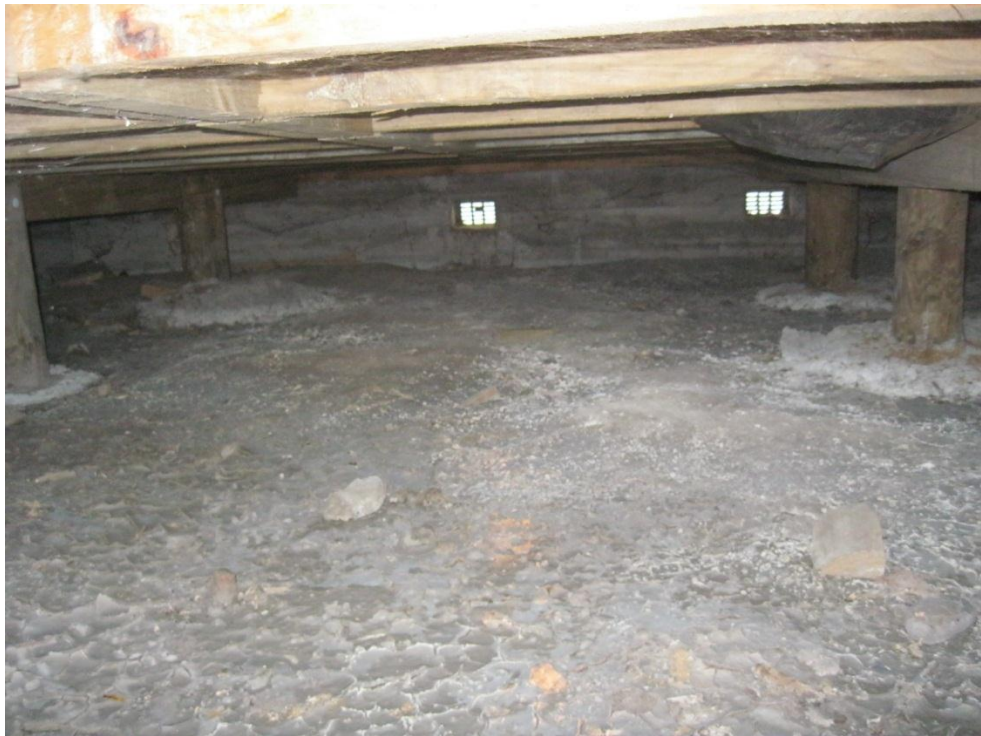
An inspection of the sub-floor space was carried out on 26<sup>th</sup> September 2012. The visual inspection of the sub-floor space was conducted from the location of the access hatch only and it was not possible to carry out closer inspections of all the piles due to lack of access (see Photograph 10 to Photograph 12). No noticeable damage to the connections between the timber bearers and the piles were noted, however the piles near the south west corner of the building appear to be leaning slightly. Evidence of liquefaction of the ground under the building was also observed.

**Photograph 12 Evidence of liquefaction of ground under the building.**
